# **Third Five-Year Review Report**

**FMC YAKIMA**

**Superfund Site**

**SEPTEMBER 2008**

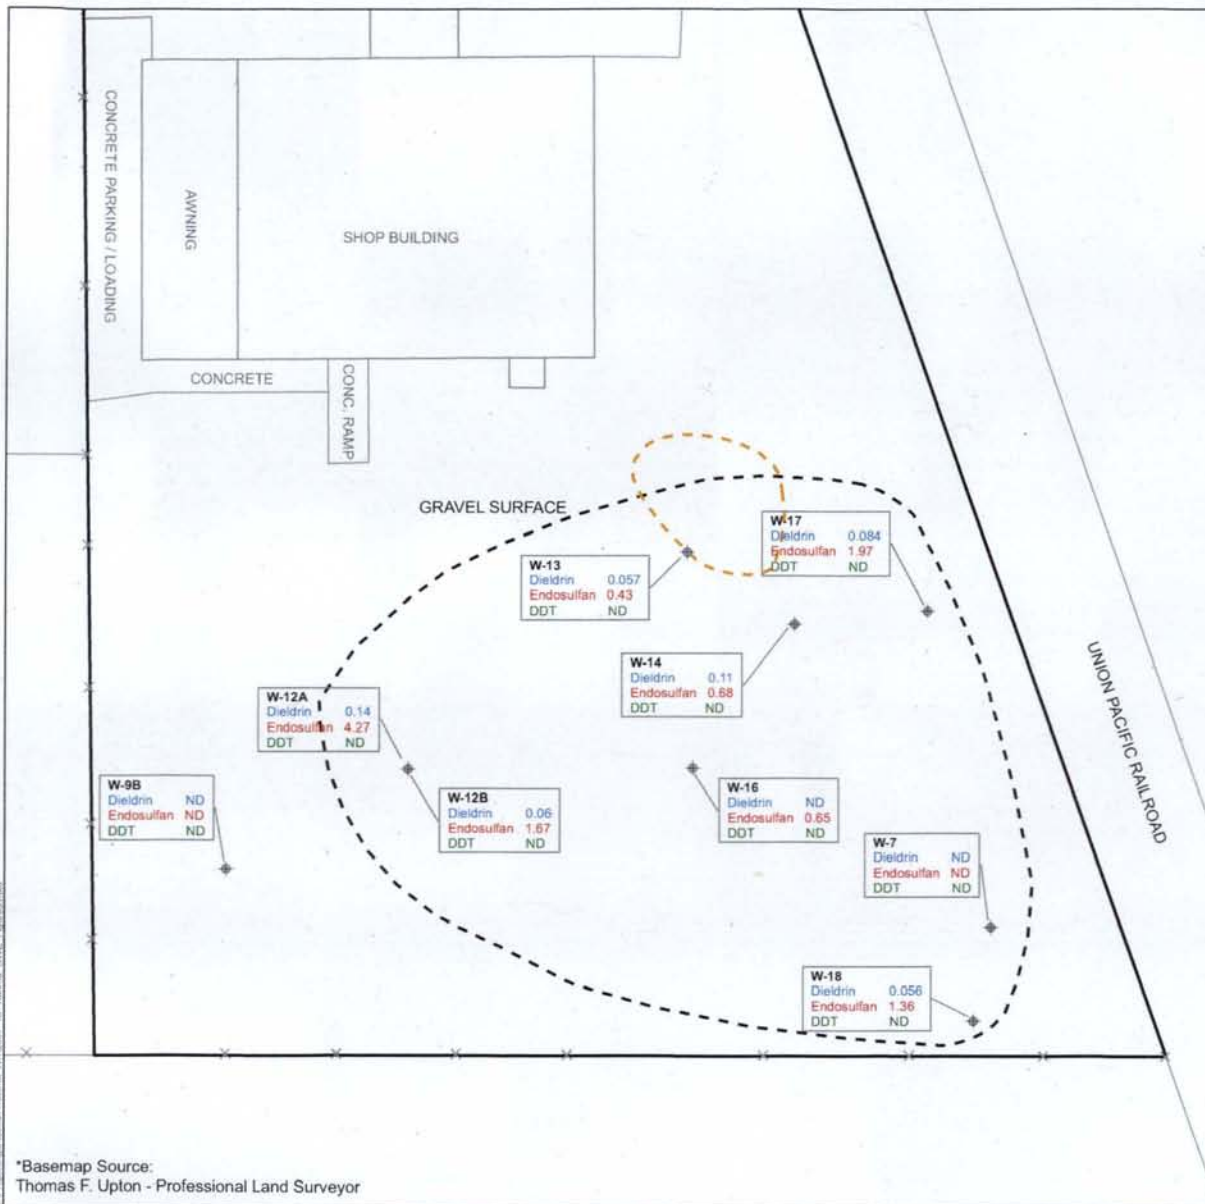
The 2007 groundwater samples contained low levels of pesticides (see Table 2 or Figure 3 in Appendix A.1). The highest detected level for dieldrin (0.14 µg/L) occurred at well W-12A (see Table 2 or Figure 3). The highest detected level of endosulfans (4.27 µg/L) was also found at well W-12A. When this data is plotted with data from previous monitoring events, an overall decreasing trend can be observed (see Figures 4 and 5 from Appendix A.1) since the completion of soil remedial action, although dieldrin concentrations remain above pre-excavation levels.

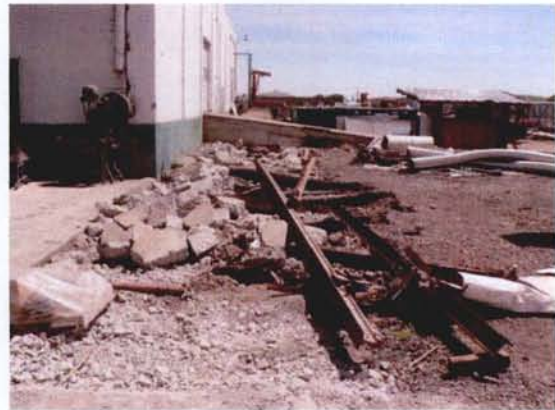
Demolition of old railroad spur looking east towards the southwest corner of Stephens Metal Products warehouse

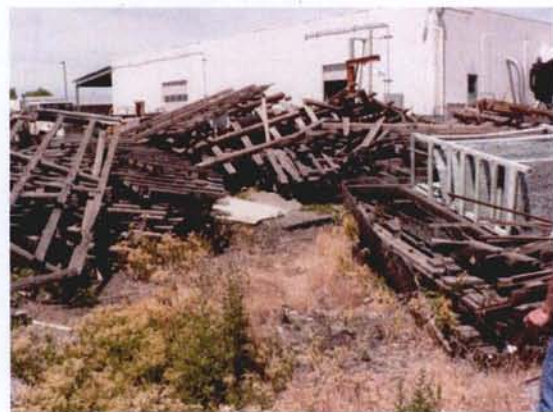
Debris around monitoring well W-13
