FIVE YEAR REVIEW
PESSES CHEMICAL COMPANY
SUPERFUND SITE
FORT WORTH, TEXAS
JUNE 2000

**PESSES CHEMICAL COMPANY
SUPERFUND SITE
FIVE YEAR REVIEW
JUNE, 2000**

Subject: Pesses Chemical Company - Fort Worth, Texas
SW Registration No. None; EPA Identification No. None
Biannual Operations & Maintenance (O&M) Inspection

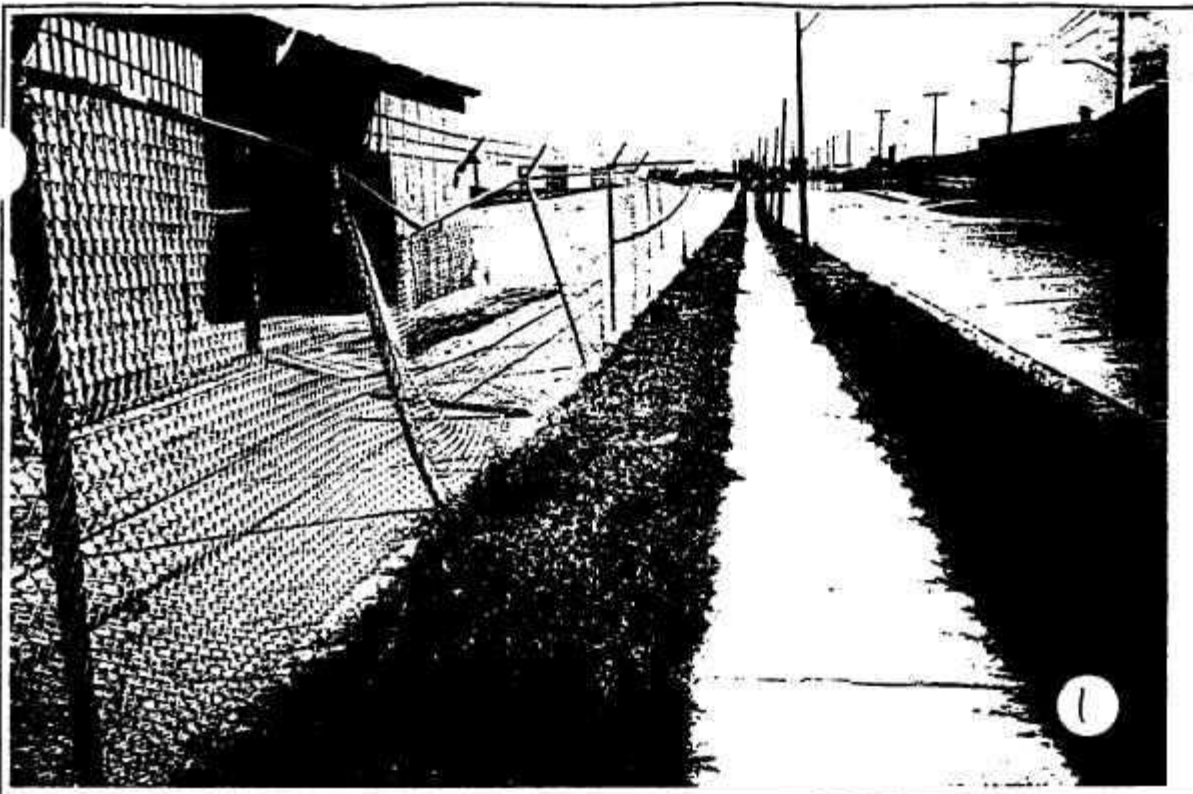
Photo #1 - The damaged portion of the perimeter fence included approximately 20' located along the west side of the site as shown above. Photo taken facing south.

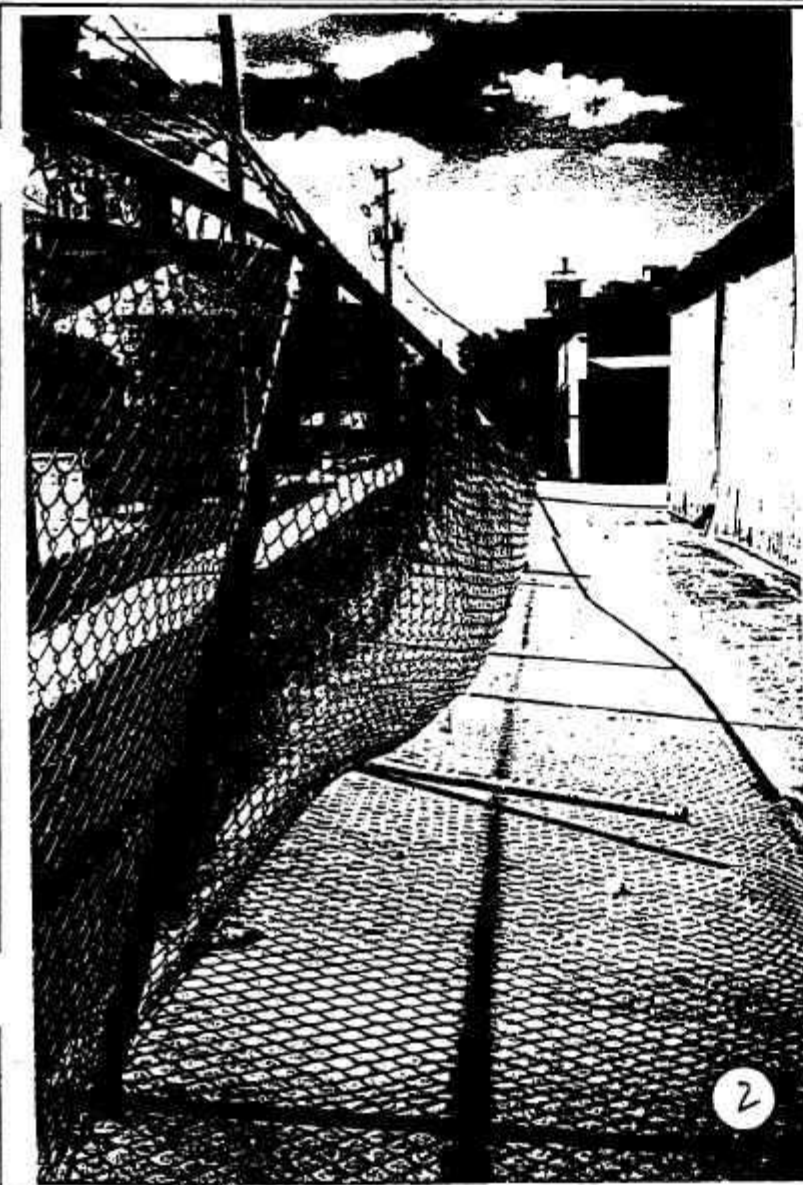
Photo #2 - Damage included three fence posts and stretched wire as shown at the left. It appeared vagrants had been getting under the stretched wire along the bottom portion and entering the site.

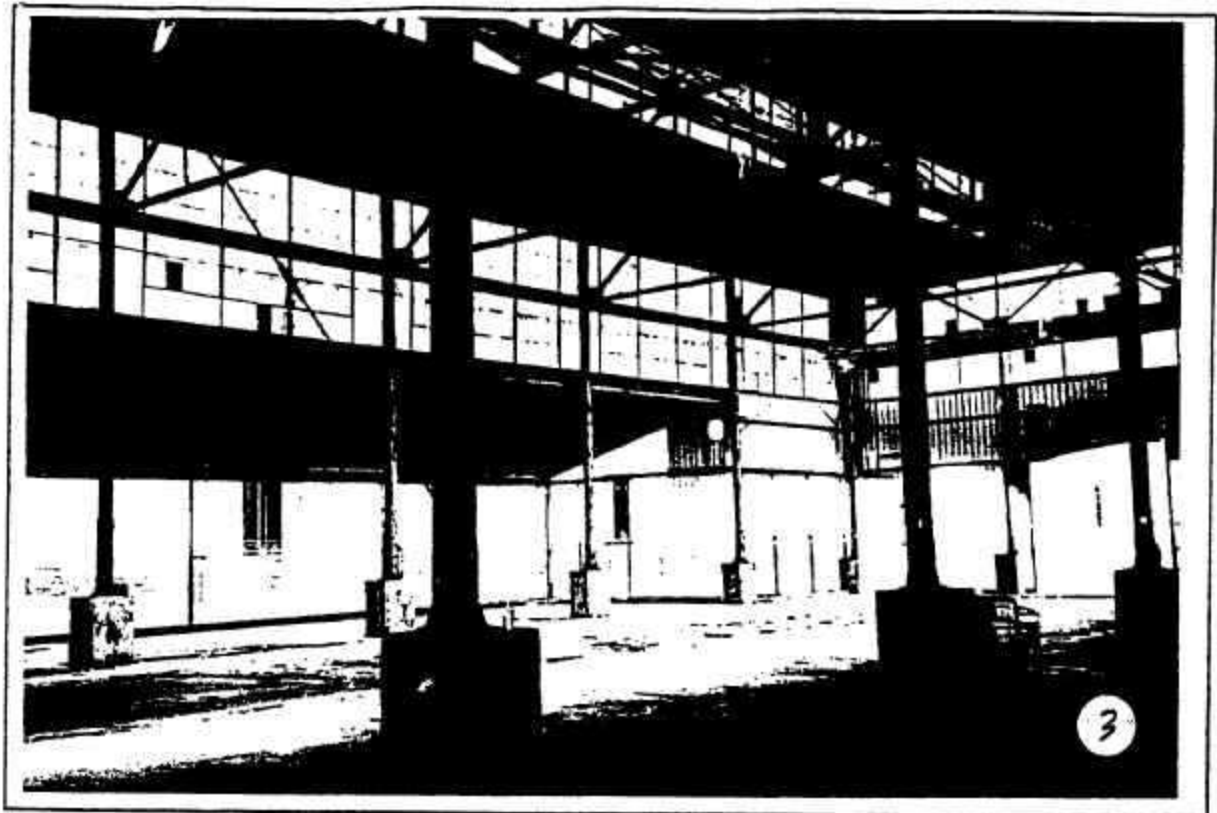
Photo #3 - Photo of the interior of the on-site process building where vagrants apparently took shelter during evening hours. Photo taken inside the structure facing southeast.

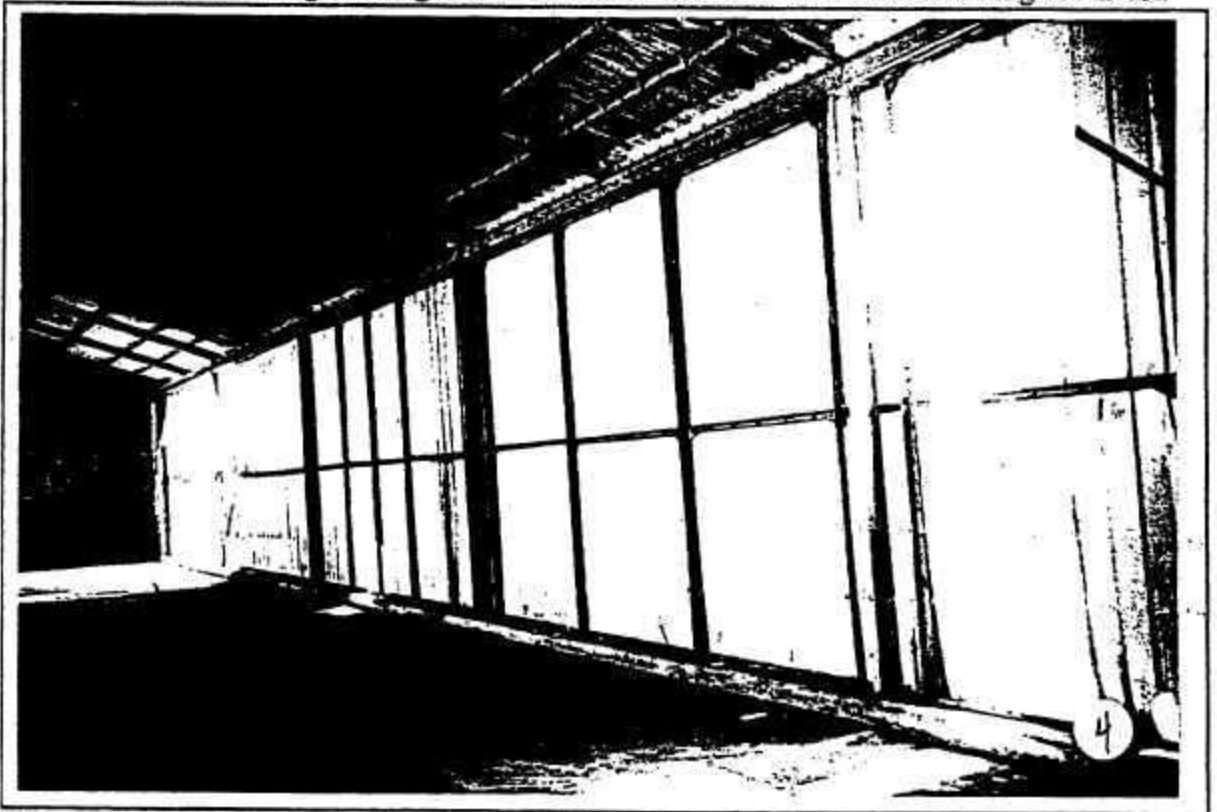
Photo #4 - Metal portions of the building were being stripped and apparently sold as salvage and used to sleep on inside the building. Photo taken inside the structure facing southwest towards the street.

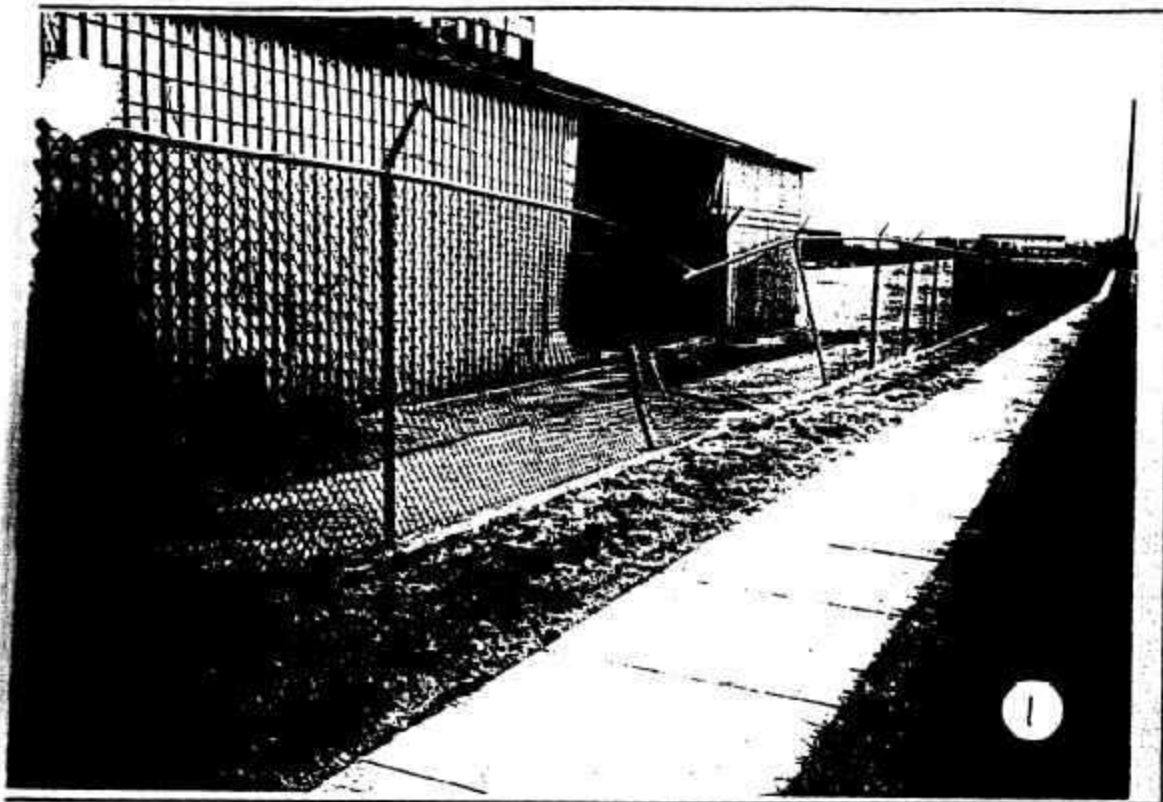
During the inspection, a 20' portion of the perimeter chain link fence and two posts located along the west portion of the site along South Main Street had been damaged from a vehicle impact. The extent of damage and location is shown on the attached site sketch and photographs. The damage had occurred several weeks ago, apparently from a hit and run accident. The adjacent facility manager was instructed to notify the TNRCC immediately when such incidents occur so that appropriate action could be taken in a timely manner. The site was left locked and secured.

Photo #1 - (13:15 pm) - A 20' portion of the chainlink fence surrounding the site had been damaged from a vehicle impact as shown above. Photo taken from South Main Street facing SE.

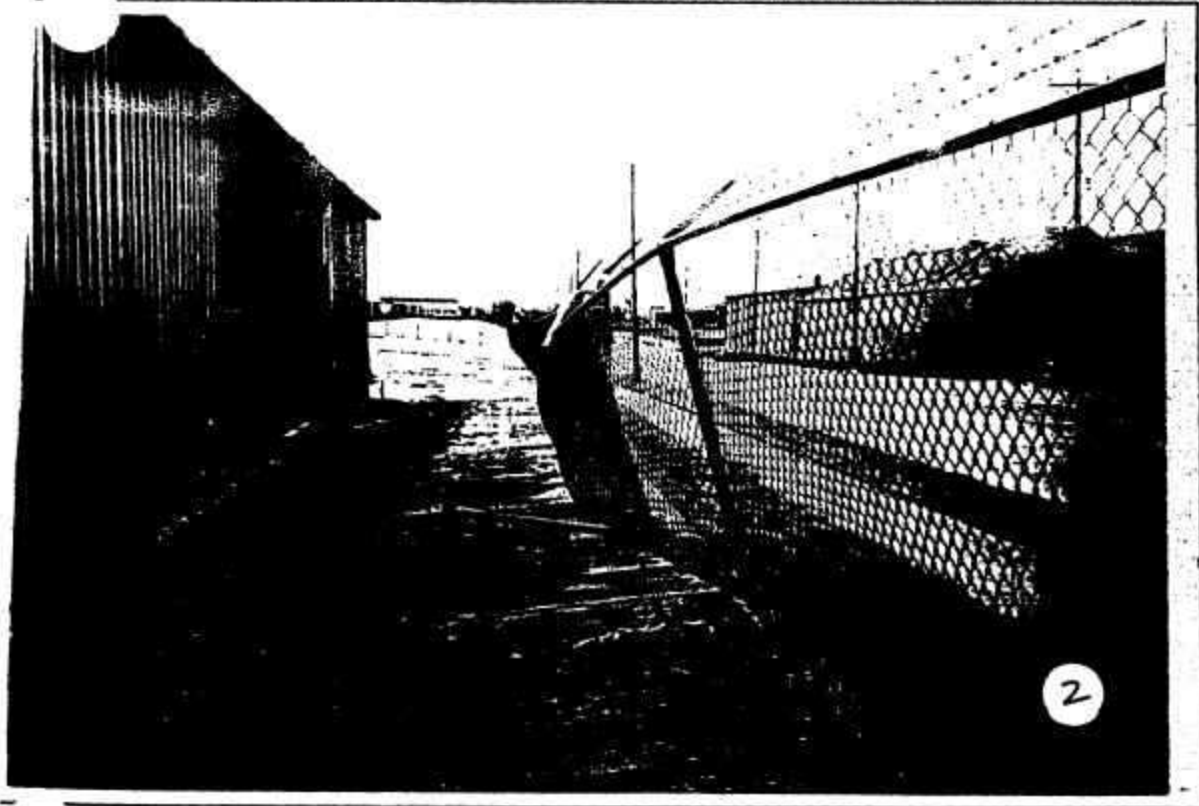
Photo #2 - (13:20 am) - Two of the fence posts were noted damaged and the chain link fence had been stretched but not penetrated as shown above. Photo taken just inside the west entrance gate facing south.

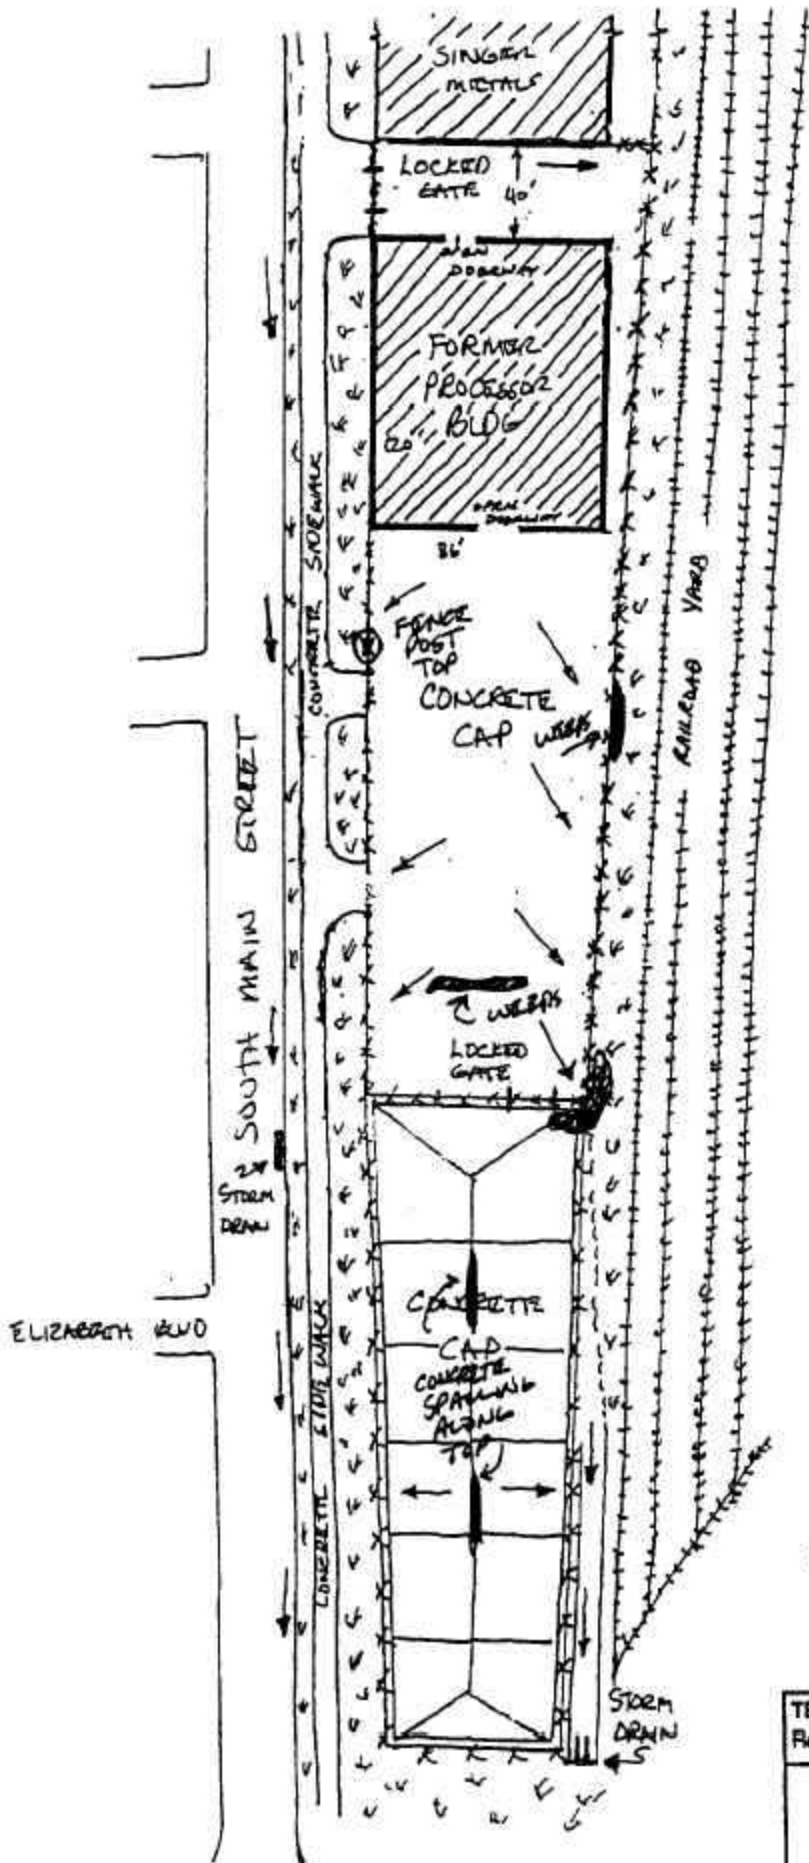
During the inspection, the concrete covered area in the northern portion of the site and the sloped concrete cap in the southern portion of the site were noted in good condition with no seepage or erosion noted from the top or side seams. However, it was noted that several areas along the edges of the top center seam of the sloped concrete cap were spalling and minor maintenance is recommended. The two areas are marked on the attached site sketch.

In addition, one of the fence line top posts had come loose and the barbed wire was sagging in this area. It was noted that weeds were established in several of the cap seams along the east perimeter and north central area and a small tree (0.5" diameter) was growing in one of the seams. Recommend minor maintenance to correct the above noted deficiencies (locations marked on attached site sketch). The site was left locked and secured.

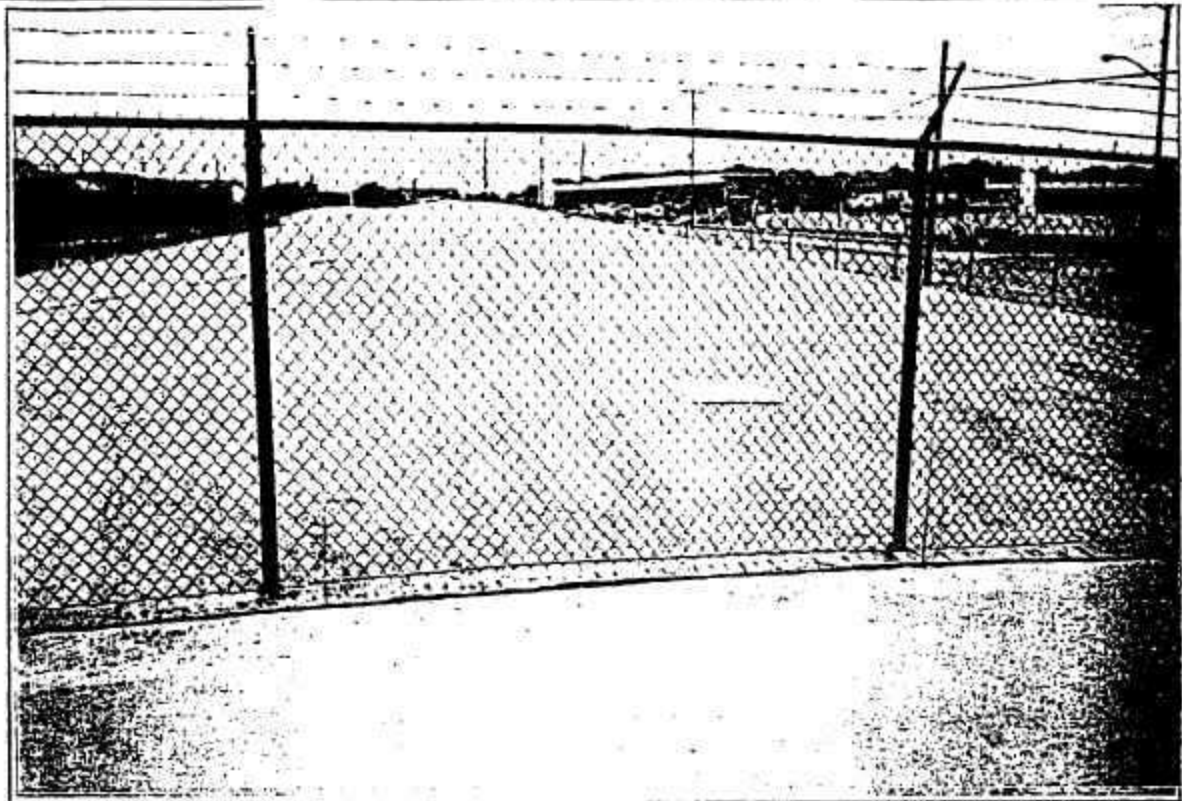
Photo #1 - Warning signs were posted on the end caps of the concrete section located on the south portion of the site as shown above. Photo taken facing south.

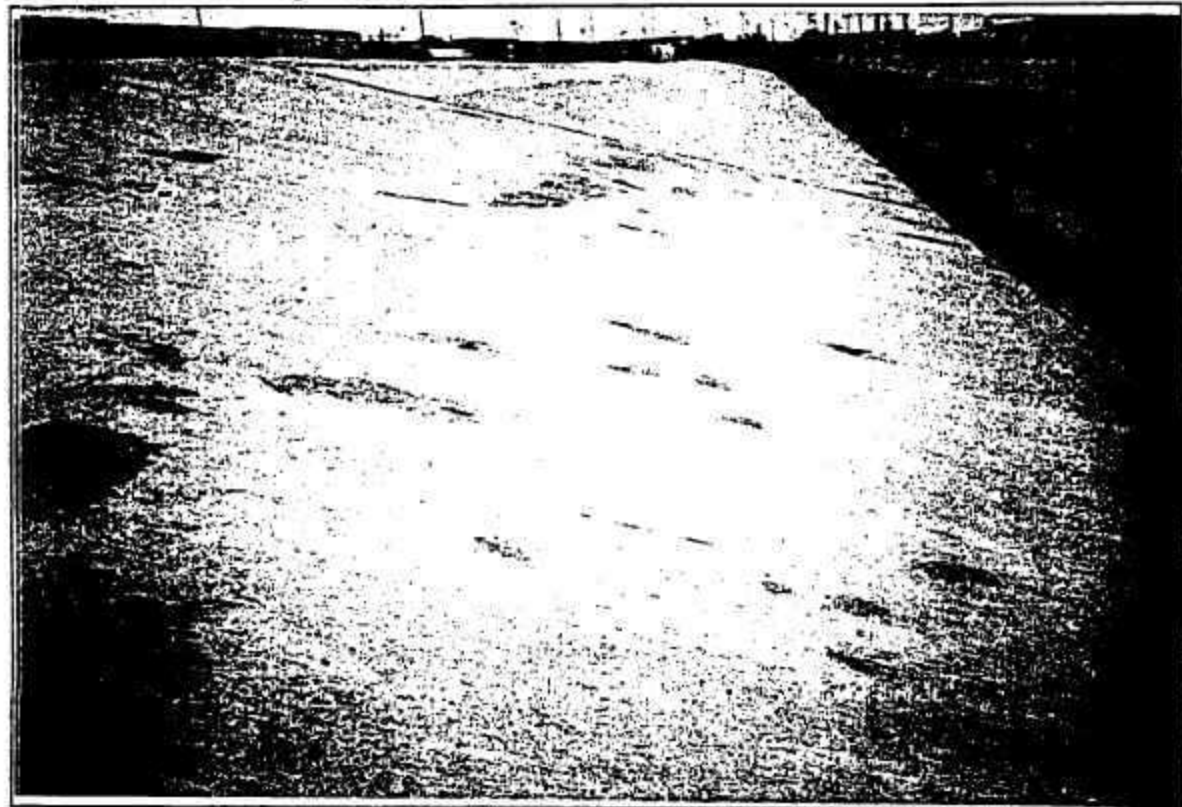
Photo #2 - Warning signs were also placed every 200' along the east and west portions of the concrete cover as shown above. Photo taken facing south.

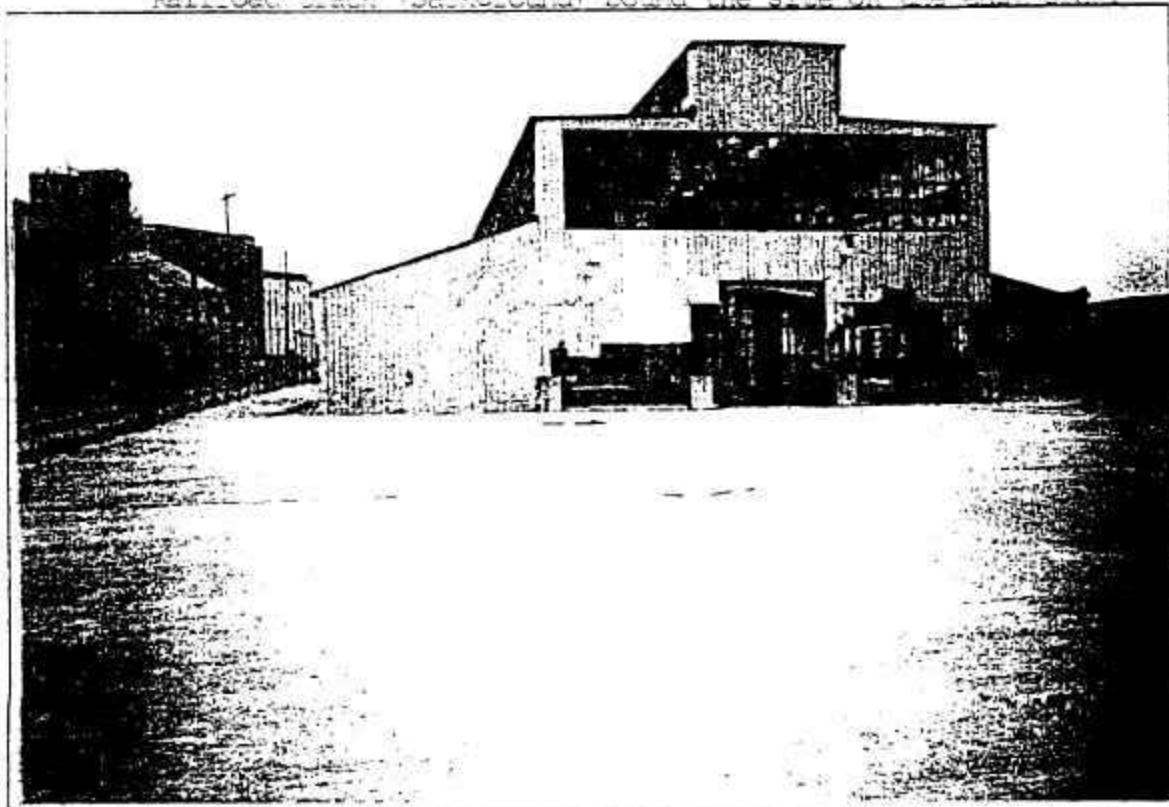
Photo #4 - South side of former processing bldg shown above. Window were noted broken from high winds. Glass noted swept up. Concrete area noted free of cracks and no evidence of seepage noted.

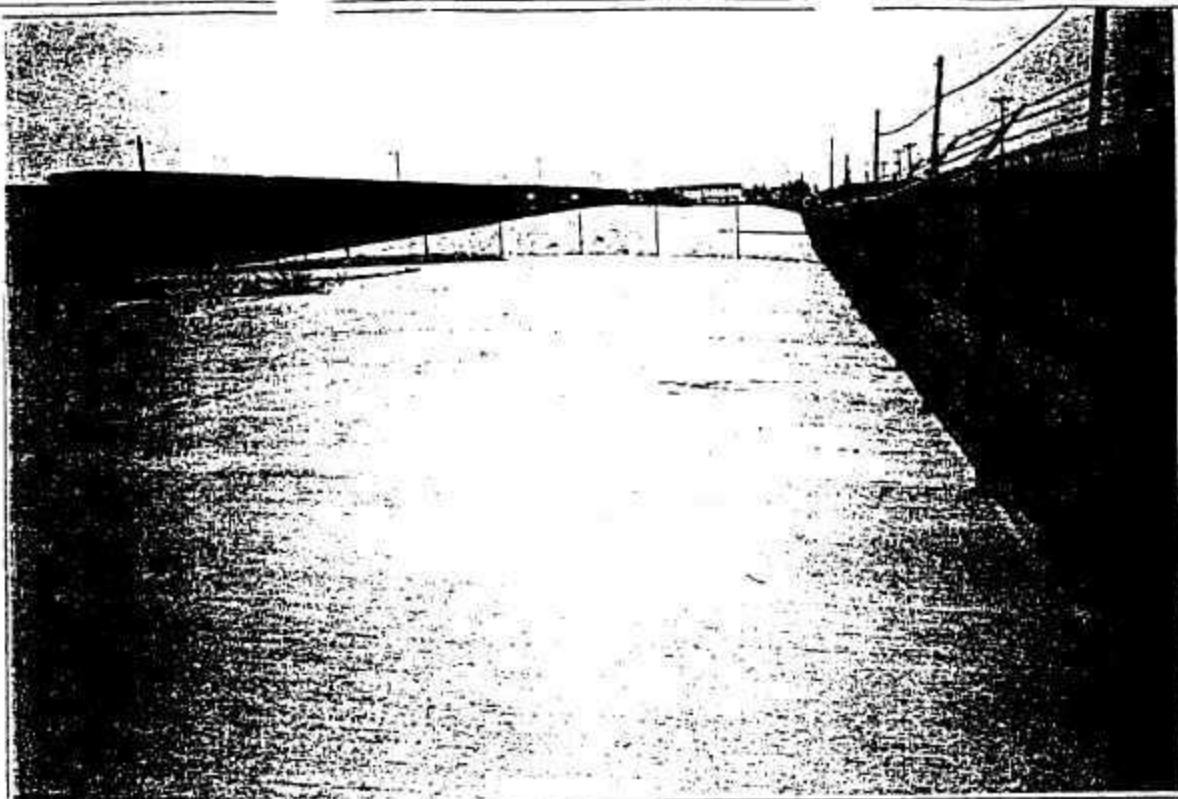
Photo #5 - South portion of the concrete area adjacent to the former processing building shown above. No cracks or evidence of seepage noted along the west side of the property. Photo taken facing south.

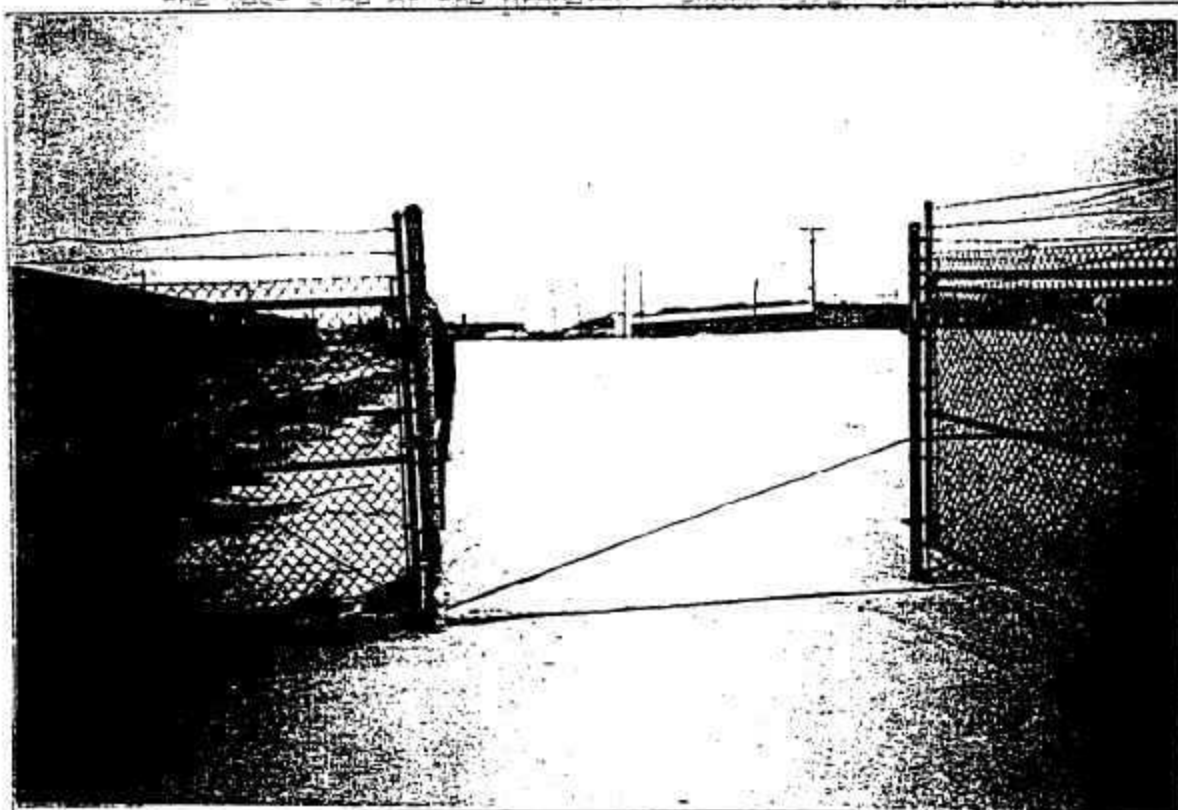
Photo #6 - Capped portion entrance gate shown above. Keys maintained by TNROCC Region 4 Office, Ft. Worth. Perimeter fence noted intact and site was secure. No Trespassing signs were not posted.

Concerning the results of the investigation, recommend that site security be enhanced by properly posting the perimeter fence. In addition, copies of gate keys to the two outside gates were requested from the adjacent business owner.

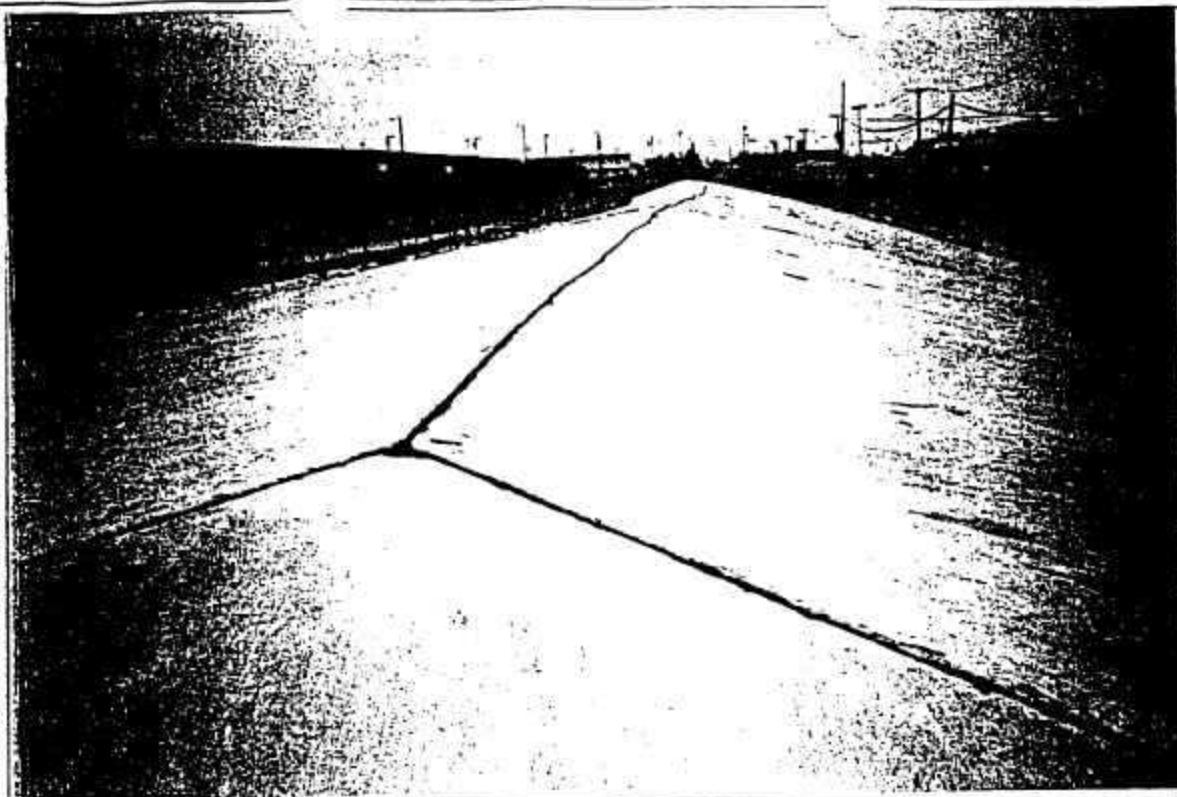
Photo #7 - Grouting in slab seams was noted in good condition along sides and top as shown above. Photo taken facing south from north end of cap.

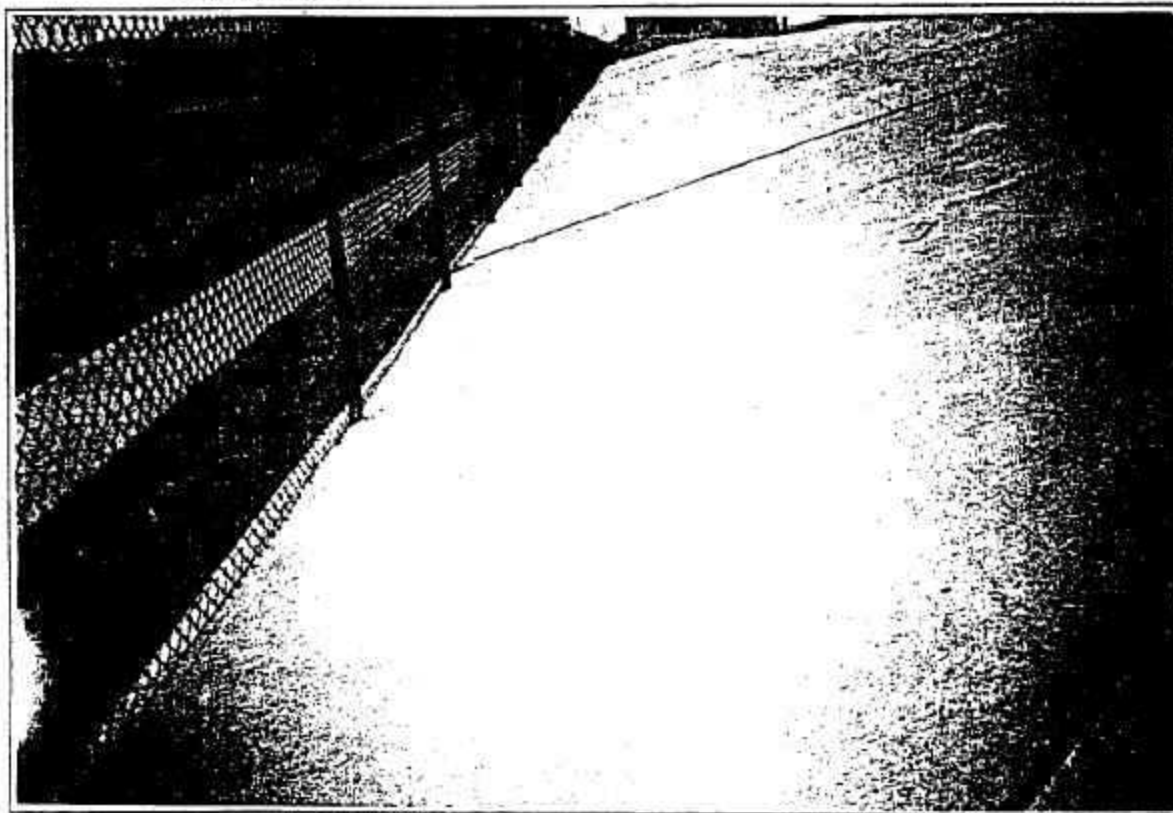
Photo #8 - West side of cap was noted clean with no cracks or evidence of seepage along the edges as shown above. Photo taken facing north.

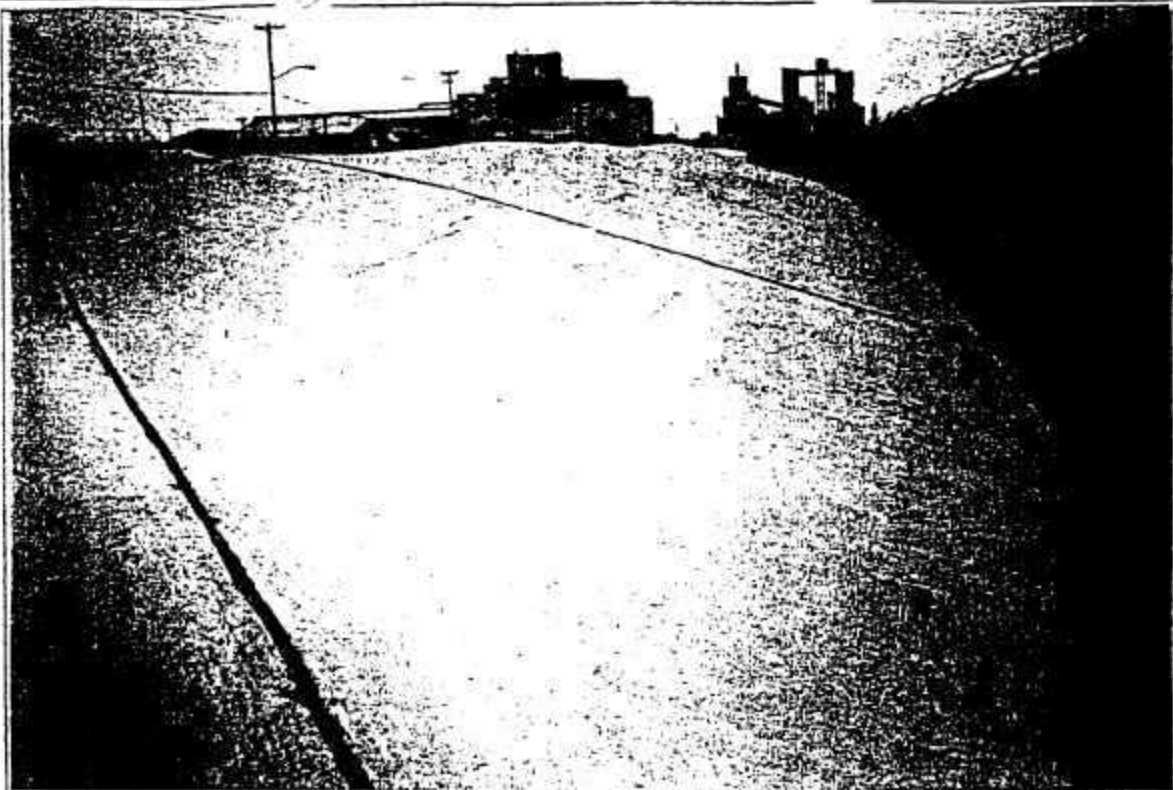
Photo #9 - East side of cap was also noted clean with no cracks or evidence of seepage along edges as shown above. Photo taken facing north.

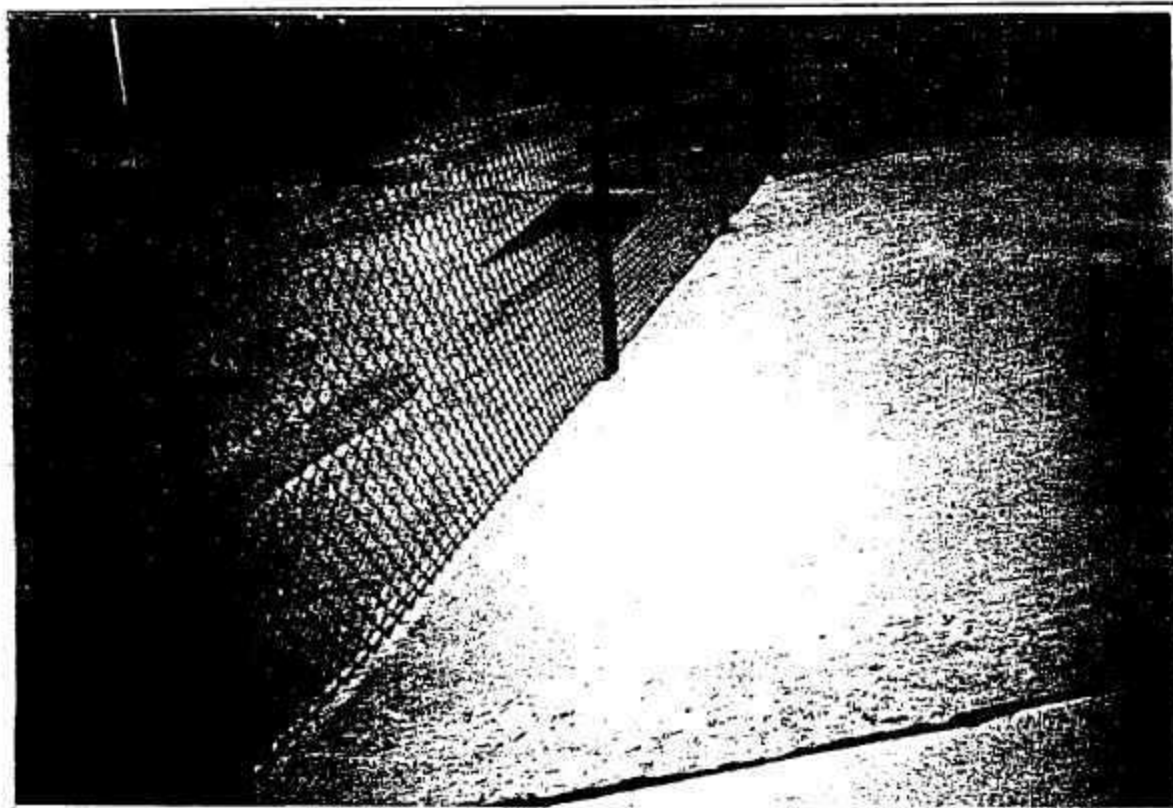
Photo #10 - The storm drain located on the southeast corner of the site shown above. No evidence of seepage entering the drainage pathway along the east perimeter of the site was noted. Photo taken facing southeast.
