First Five-Year Review Report
For
Buckingham County Landfill Superfund Site

Dillwyn, Virginia

Prepared By:
U. S. Environmental Protection Agency
Region III

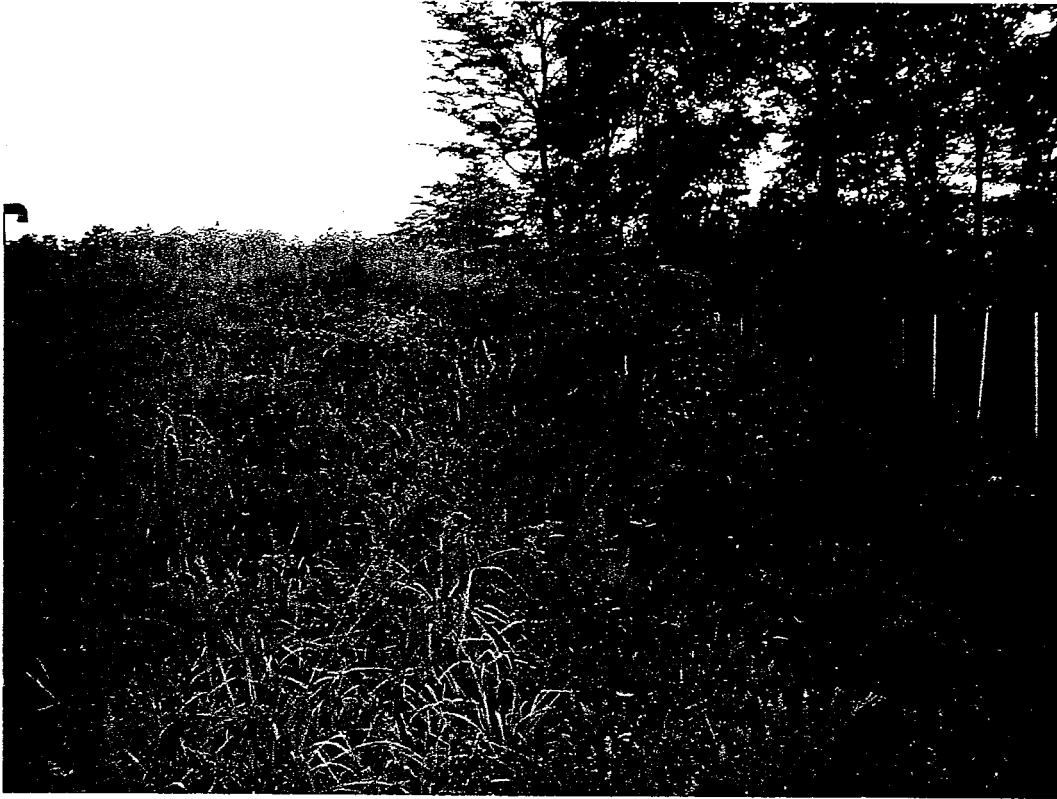
Photo 1

Description: View of gate area on east side of landfill. Note trees growing on cap.

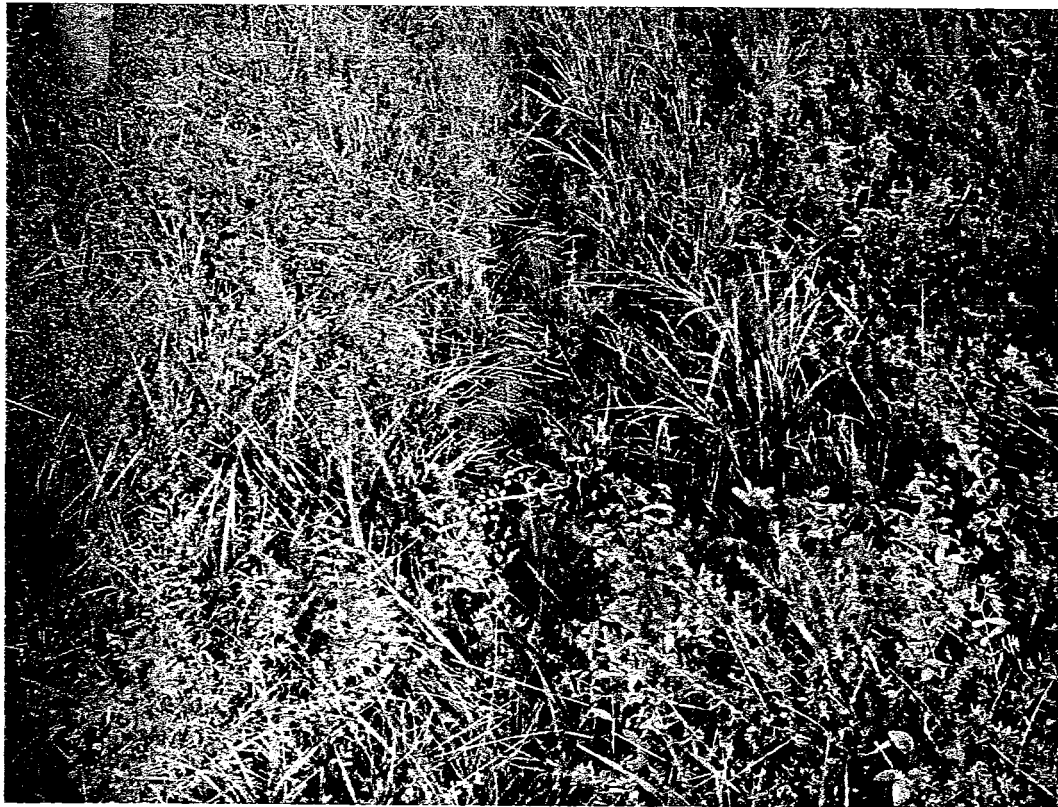
Photo 4

Description: Looking down at exposed jute matting for erosion.

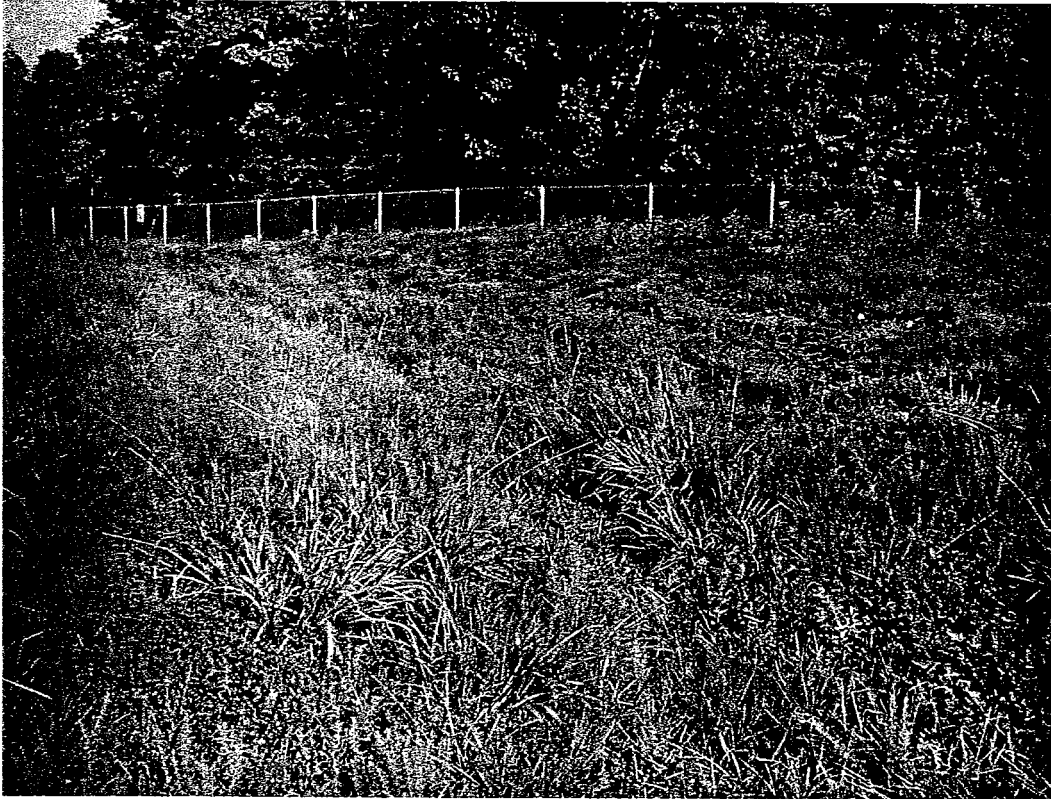
Photo 5

- The drainage swale running southeast to northwest on the cap is not adequately conveying water flow off the cap surface. Pools of water and saturated soil and vegetation due to ponding water was noted during the assessment. This condition may lead to infiltration of water through the cap and/or may indicate that the drainage layer is not properly conveying water off the cap. The condition was not observed during the follow-up Site Inspection.

Description: View of drainage swale, with bare soil spots to the right.

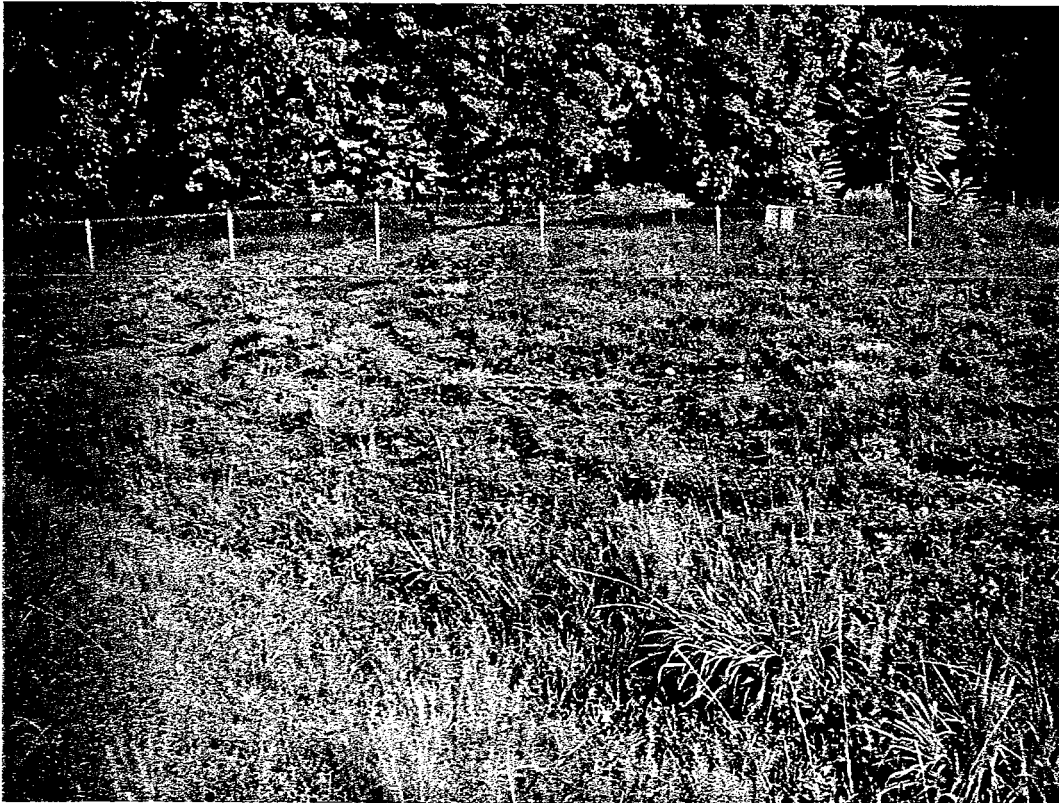
Photo 6

Description: Bare soil from erosion next to drainage swale.

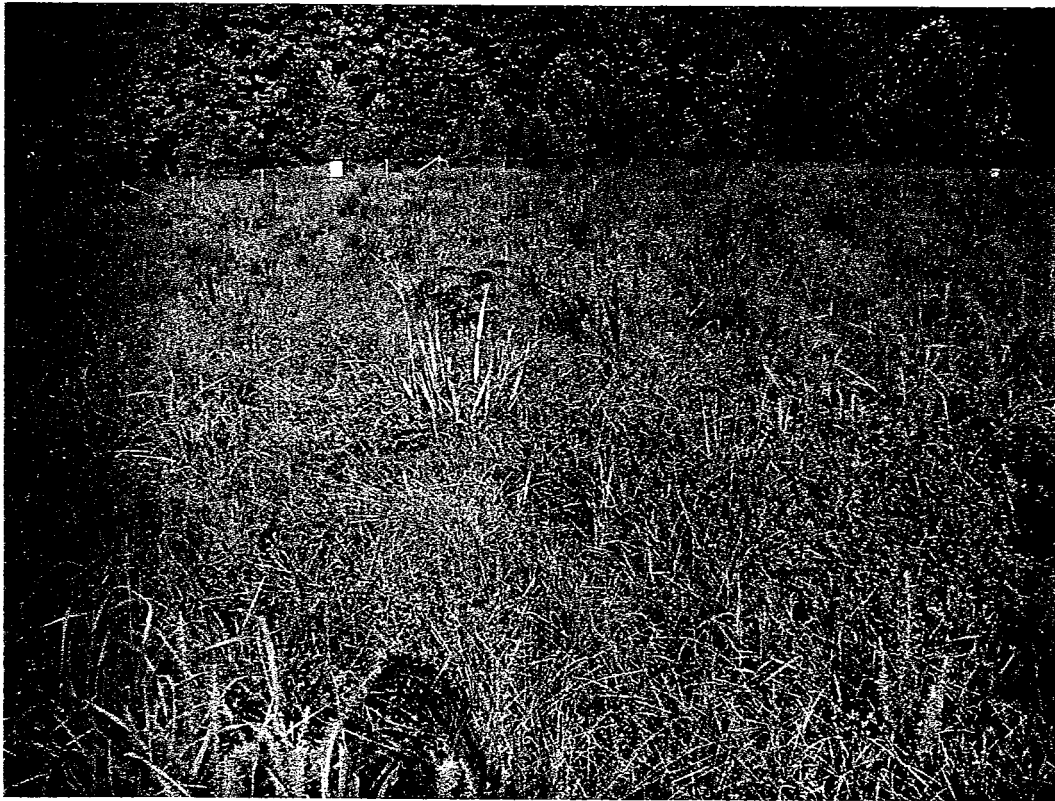
Photo 7

- The vegetated cap has not been mowed recently; overgrowth is evident. Improperly maintained vegetation can cause a reduction in the drainage off the cap surface and may lead to infiltration under the cap. At the time of the Site inspection saplings were noted as being present on the

Description: Southwest corner of landfill with large quantities of overgrowth.

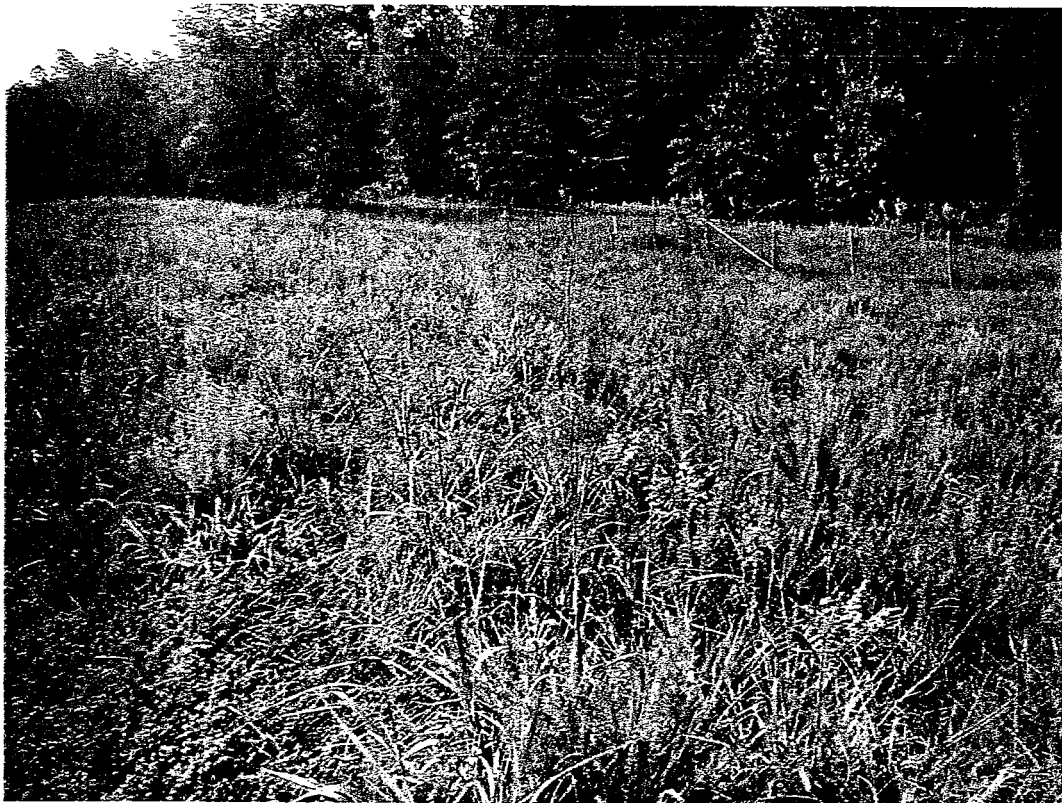
Photo 8

Description: Northeast corner of landfill, with overgrowth.

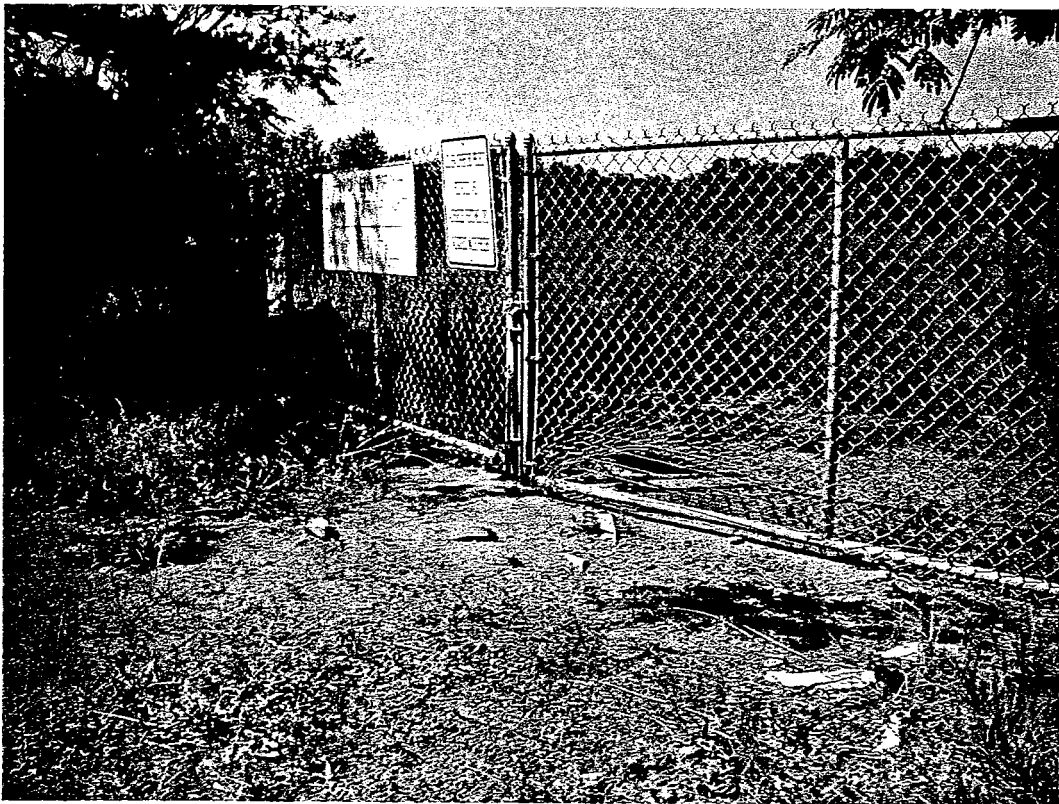
Photo 10

- Due to soil erosion and/or animals burrowing over an extended time period, a gap between the bottom of the Site security fence and the ground surface has remained. At the time of the technical assessment numerous holes were noted in the security fence surrounding the cap. During the Site inspection it was noted that maintenance had been done on the fence and the holes were patched with wire.

Description: Repaired hole in fence at front gate.

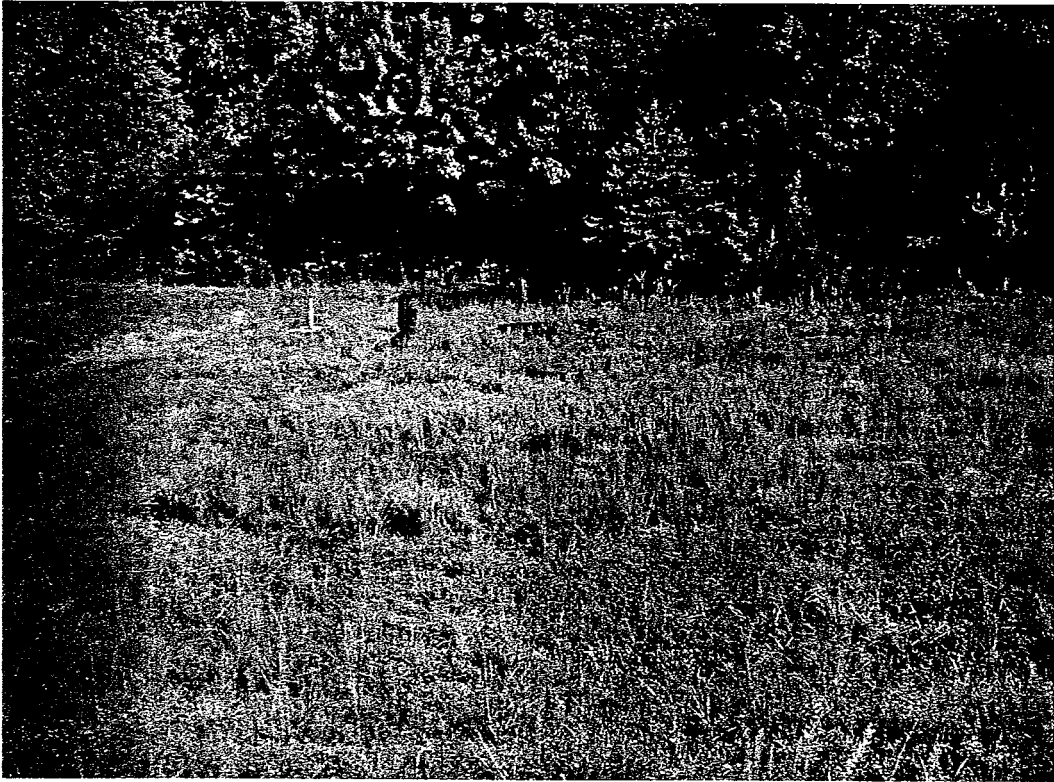
Photo 13

Description: Monitoring well with unused plastic tubing/piping.

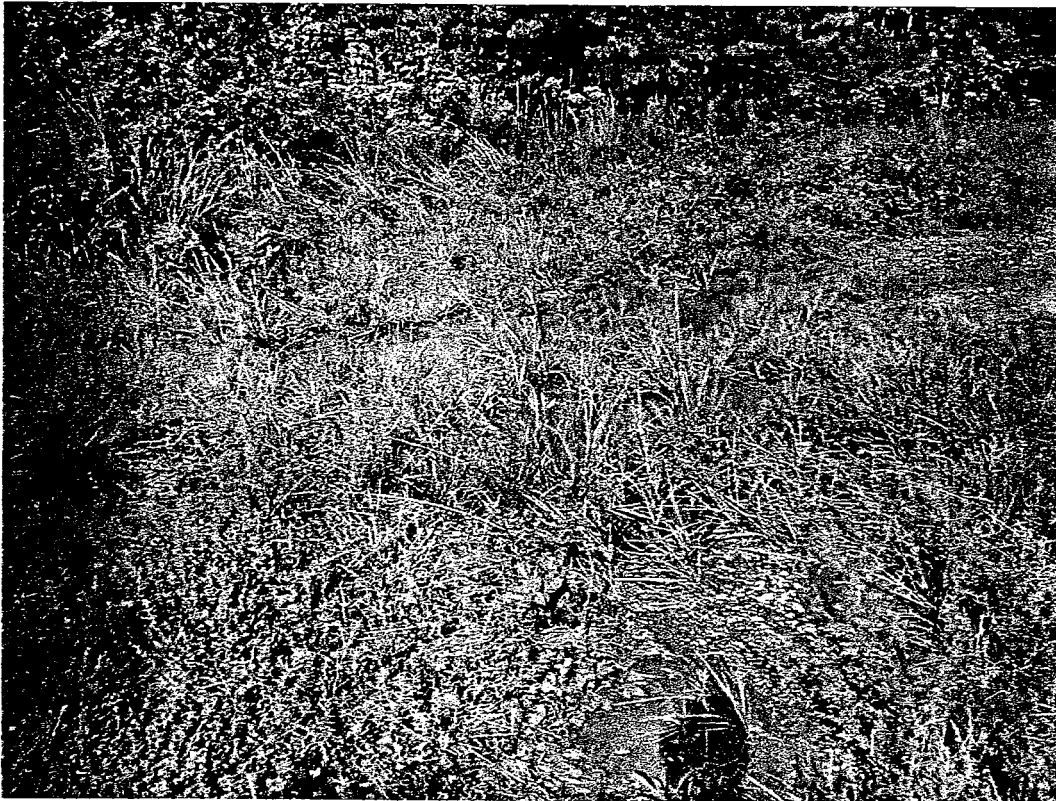
Photo 16

Description: Erosion along access road outside of fence on west side of landfill.

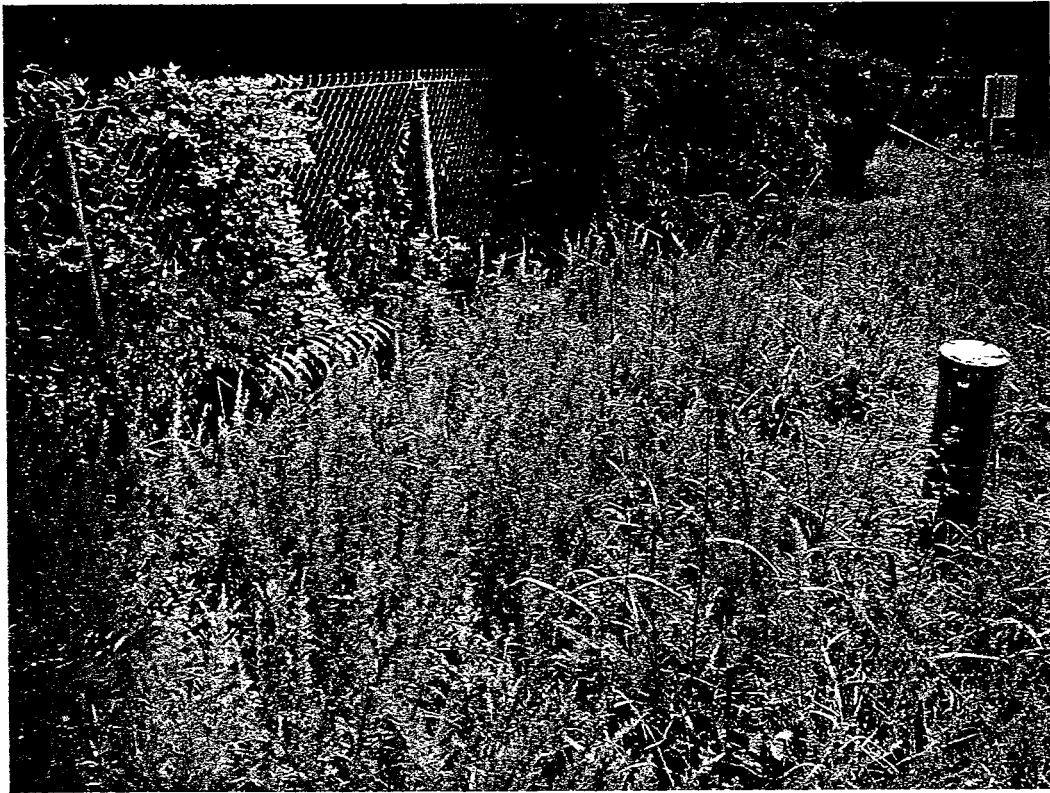
Photo 19

Description: Southeast corner of landfill. Note extensive overgrowth of vegetation.
