SUPERFUND THIRD FIVE-YEAR REVIEW REPORT

A.L. Taylor (Valley of Drums)

Brooks, Bullitt County, Kentucky

February 2003

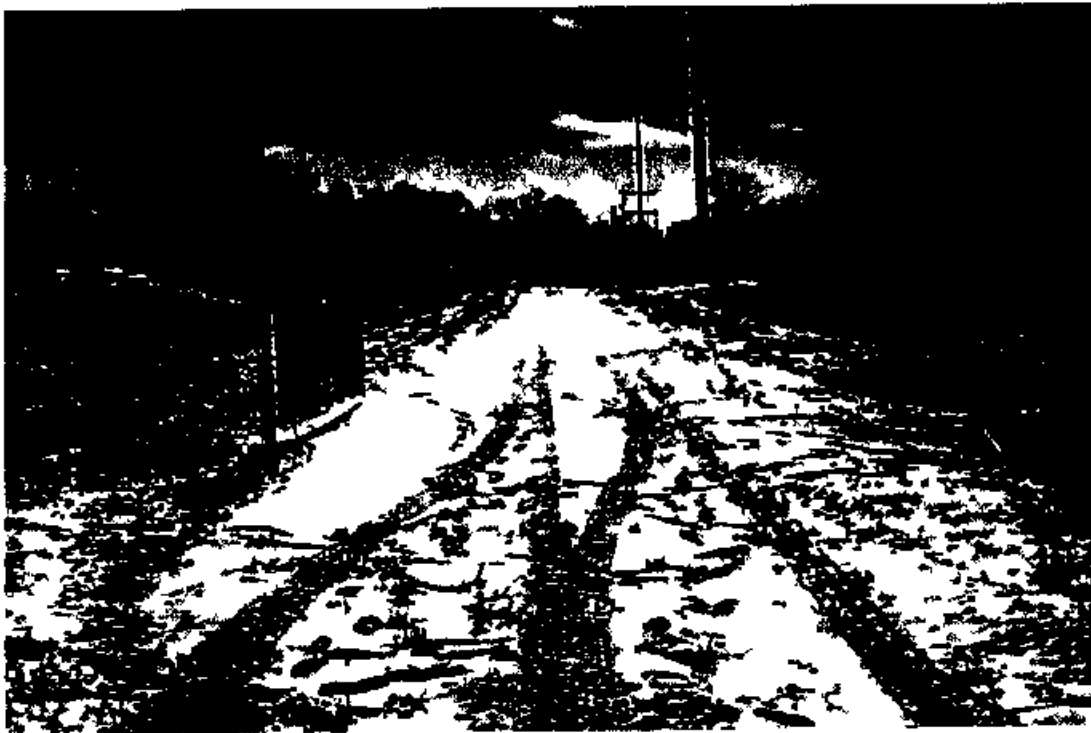
surrounding the landfill is in excellent condition. The front and rear gates are securely locked with padlocks. In addition to KDNREP, Louisville Gas & Electric (LGE) has access through both front and rear gates since their power lines traverse the Site. Proceeding along the access road through the Site, USACE observed that the road is in excellent condition and the rear gate is locked and in good condition (Photo #20).

Photo #20 Southerly view of rear gate and Access Road traversing the cap, Louisville Gas & Electric power poles on west edge of Access Road.
