SUPERFUND FIVE YEAR REVIEW REPORT

LEE'S LANE LANDFILL

LOUISVILLE, JEFFERSON COUNTY, KY

JUNE 2003

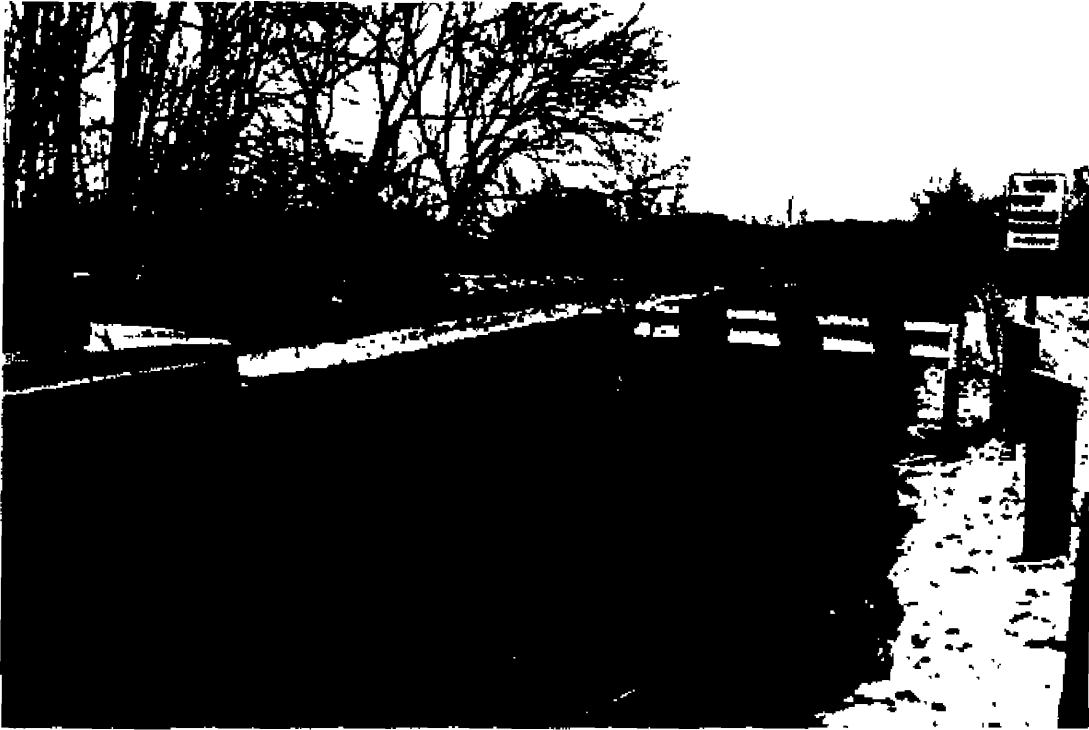
1. The access gate across the Lee's Lane entrance appears to be in good condition. It prevents motor vehicles from entering, but quad-runner ATVs can very easily go around the gates, see Photograph 1 and Figure 4.

Photograph 1 – Entrance Gate at Lee’s Lane

2. Site security issues have historically been a major problem and are currently of concern. Uncontrolled trespasser quad-runner ATV traffic significantly degrades site access, could destroy surface cover, and could be a significant liability issue. Although, there is no known damage to the site due to trespassers to date, there is a high potential for vandalism to site facilities such as the monitoring wells and monitoring equipment. In addition, the recent construction of a new asphalt pedestrian pathway by the City of Louisville along the levee at the site provides a new environmental exposure route and possible safety and liability issues. The MSD, the City of Louisville, and the EPA need to evaluate the adequacy of current site security and

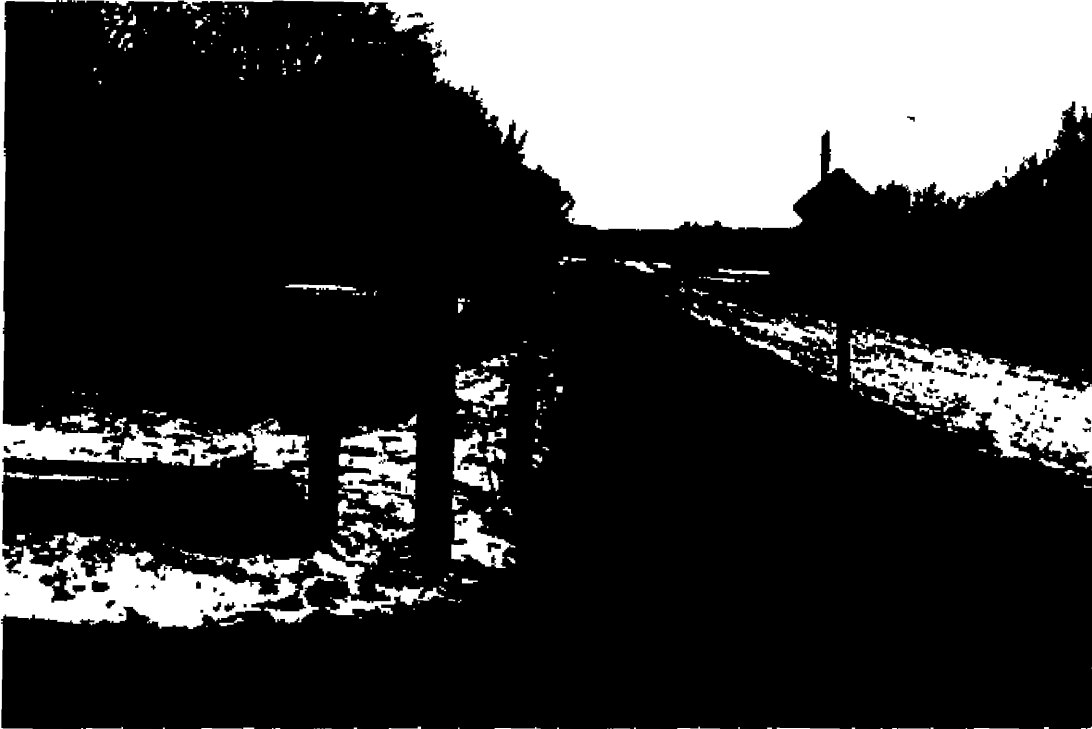
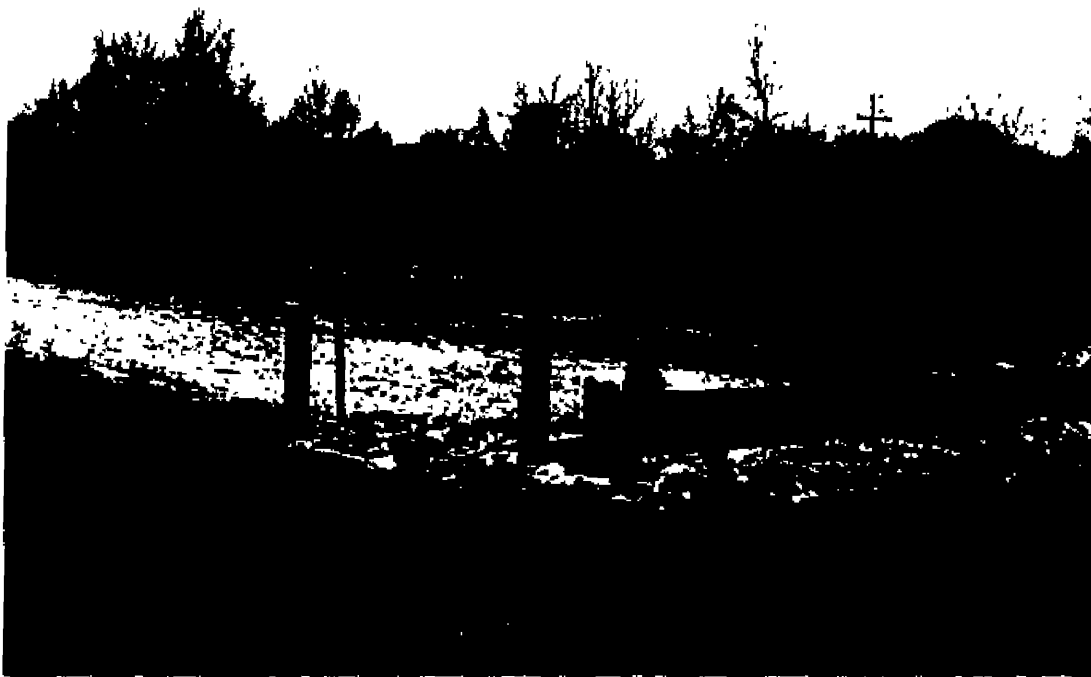
3. Although motor vehicles cannot travel along the asphalt path, pedestrians and quad-runner ATVs can. Cracking of the pavement indicates that it will begin to deteriorate rapidly under heavy traffic, see Photographs 5 and 6.

**Photograph 5A - View Looking South Along the Levee from the Lee's Lane Crossing
Note Asphalt Walkout Along Top of Levee**

Photograph 5B - View Looking South Along the Levee from the Lee's Lane Crossing
