## Five-Year Review Report

### First Five-Year Review Report for the Vandale Junkyard Superfund Site Washington County, Ohio

April 2004

United States Environmental Protection Agency  
Region 5  
Chicago, Illinois

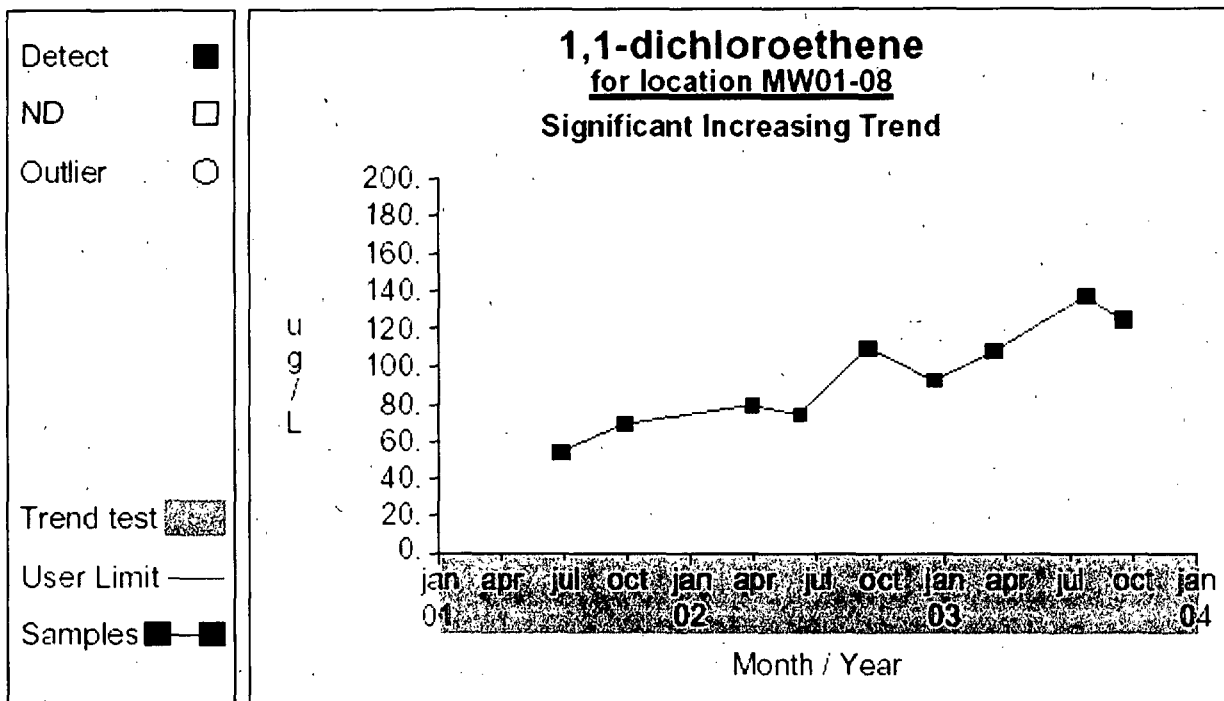
Figure 25

Overall, the quarterly monitoring appears to indicate steady-state conditions with regard to VOC levels in the groundwater over the recent past. At MW01-08, there is a statistically significant increasing trend for 1,1 DCE. This is the only statistically significant increasing trend identified by the trend analysis. In most cases, there is no clearly apparent increase or decrease in VOC concentrations since the quarterly monitoring began in 2001.

The contaminant that had an increasing trend was 1,1,-dichloroethene; this was at only One location, MW01-08. The most recent sample of 1,1,-dichloroethene at MW01-08 statistically exceeded previous sampling concentrations as well. These observations may indicate that contamination is becoming worse at this location. However, the presence of 1,1 DCE is most likely due to the degradation of 1,1,1-TCA, and the increase in a daughter product (1,1, DCE) may not indicate that natural attenuation is not functioning according to expectations.
