## FIRST FIVE YEAR REVIEW REPORT

### KENNECOTT SOUTH ZONE

OU 1 Bingham Creek  
OU 4 Large Bingham Reservoir  
OU 5 Copperton Tailings  
OU 10 Copperton Soils  
OU 11 Bingham Canyon  
OU17 Bastian Sink

June, 2004

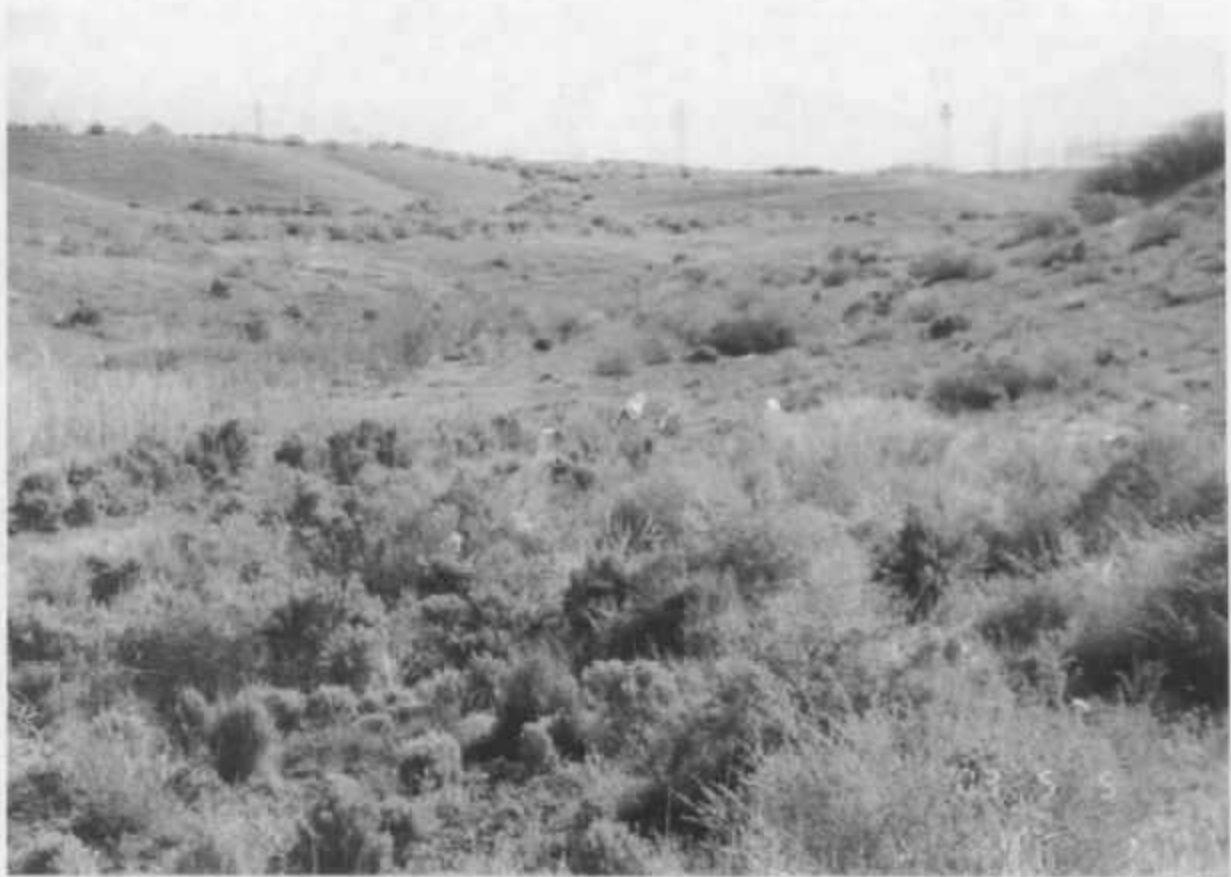
**Figure 7:** Revegetation of Bingham Creek

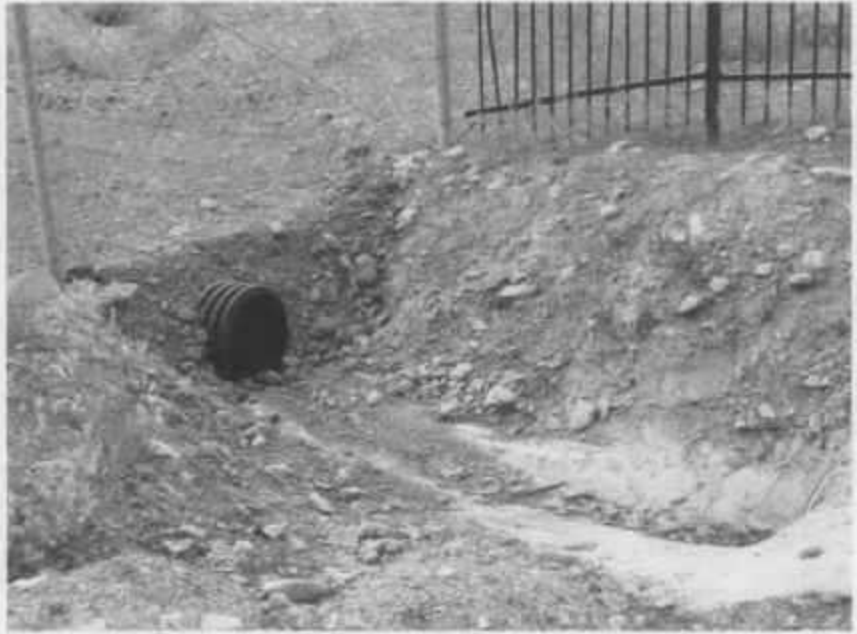
**Figure 10:** New inlet for road runoff to Bingham Creek

The erosion gully was filled in and the runoff from the roads was directed to a new pipe laid underground ending at the channel along the eastern side of Rt. 111. At the outlet of the pipe, rip rap was added to the creek channel to dissipate the energy at the intersection with the creek. The slope from the inlet of the new pipe to the outfall was sufficient to allow the pipe to be laid in a trench through the capping material only. The cap was thick enough near the roads that the wastes were not encountered during the trenching. The construction was accomplished using rubber tired equipment (as opposed to tracks) to minimize damage to the vegetation along the creek. The project was conducted using labor and construction equipment provided by the Trans Jordan Landfill and pipe provided by the City of South Jordan, with revegetation to be provided by Kennecott this fall. (See attached photos.) Project managers were Dwayne Wooley, General Manager of the Trans Jordan Landfill, and Steve Nobel, City Engineer of South Jordan City. Kennecott was consulted throughout the construction - they are the property owner of the creek channel in that area.

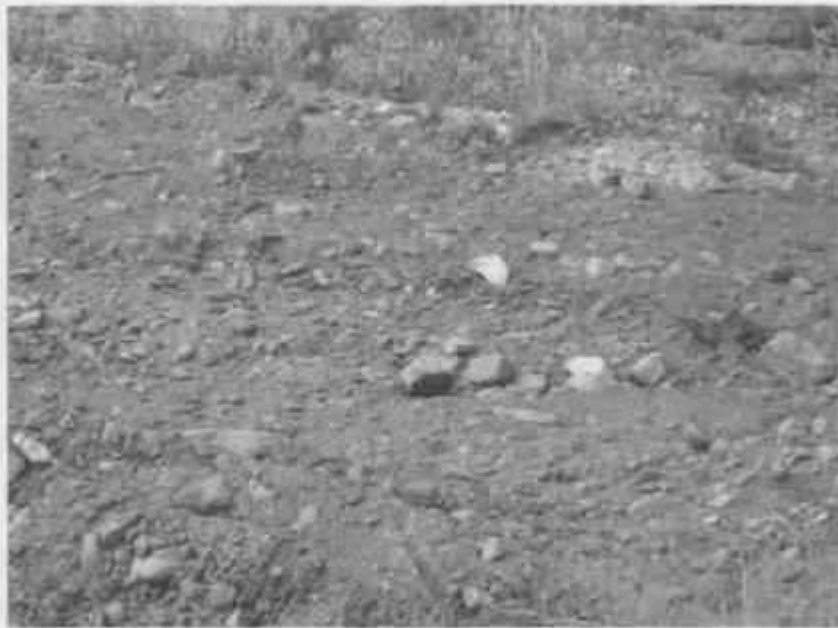
**Figure 12:** The erosion gully is filled in and regraded.

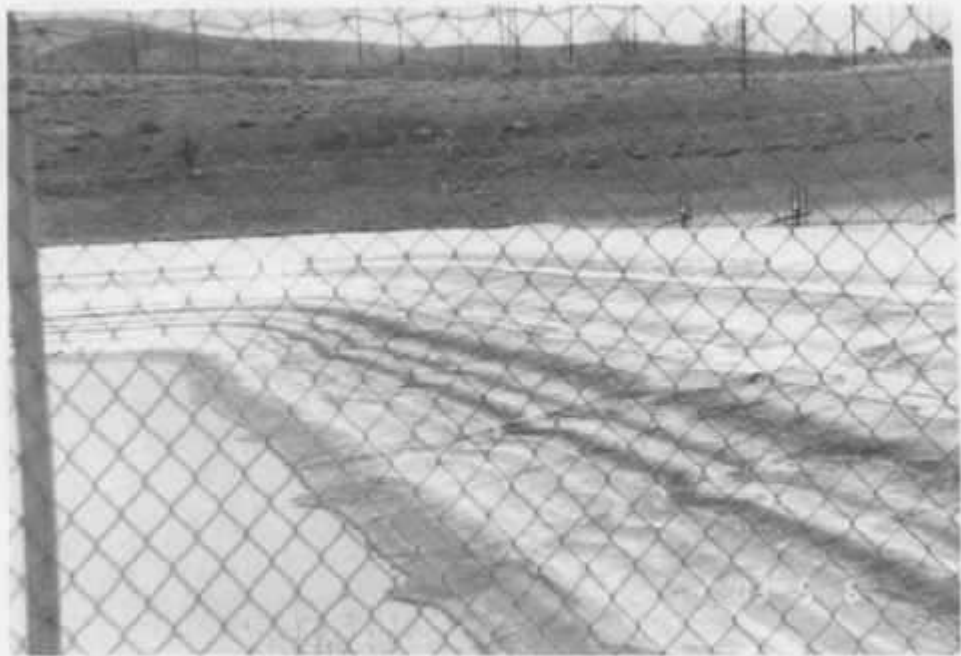
**Figure 13:** Zone 1 of the Large Bingham Reservoir showing different water levels

which zone is affected. Typically, the tears are at the extrusion welded seams during the winter. There are two welds where the liner sheets overlap, one at the top and one at the bottom. The failures are always the top weld. Ice buildup is a problem. He repairs the welds with a patch. He indicated to the team that there is usually some damage each spring, some years worse than others. Last year was a particularly bad year. A small tear along one of the welded seams was initially detected, but after the water level was dropped, the wind got under the tear and ripped the liner further. In the end, 220 feet of liner welds had been torn, three quarters of which was from one rip. There has never been a tear or failure of the bottom liner.

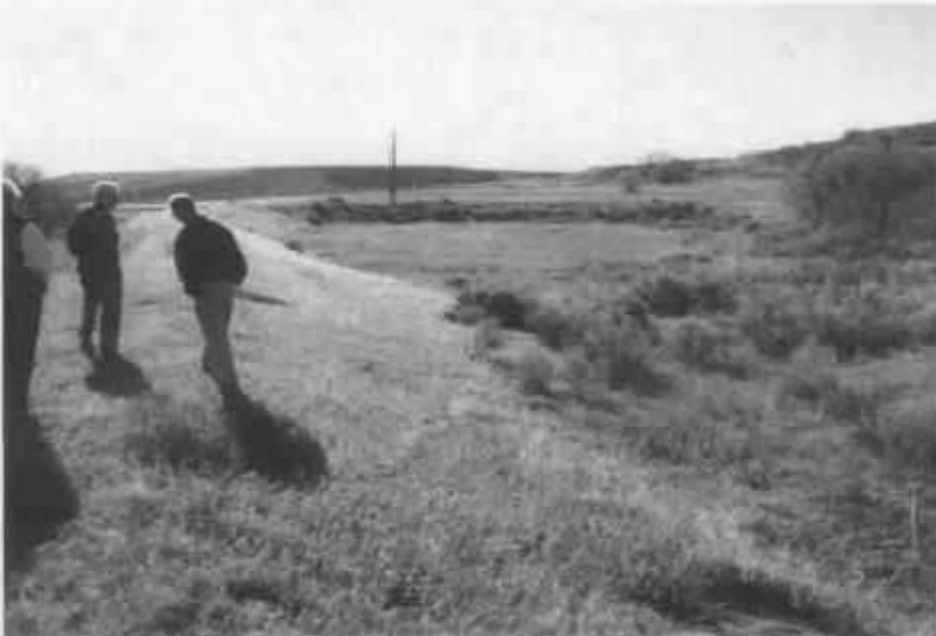
**Figure 16:** Stormwater retention basin dikes and revegetation of area

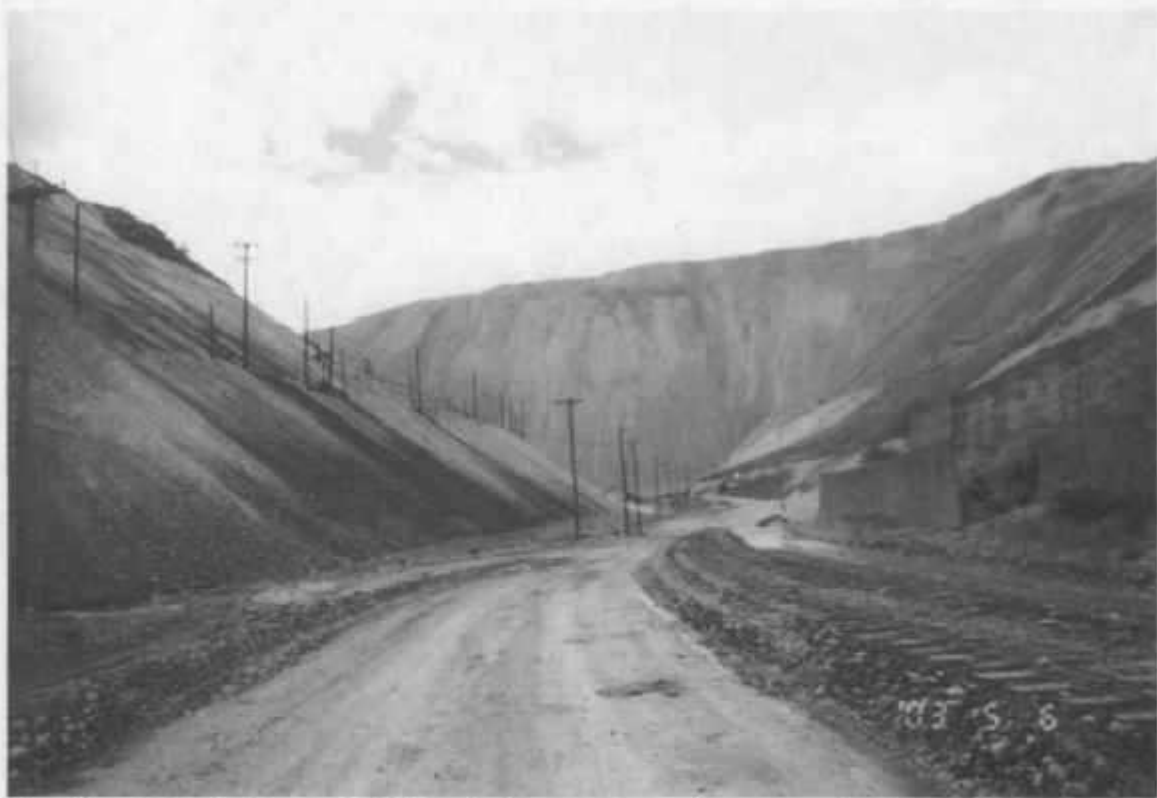
The historic Utah Copper Mill foundations and recently removed rail corridor up Bingham Canyon. The toe of the Bingham Mine dumps in the canyon are in the background. Since this photo was taken, the entire area has been buried by waste rock. The mill location and the former rail corridor are no longer accessible.

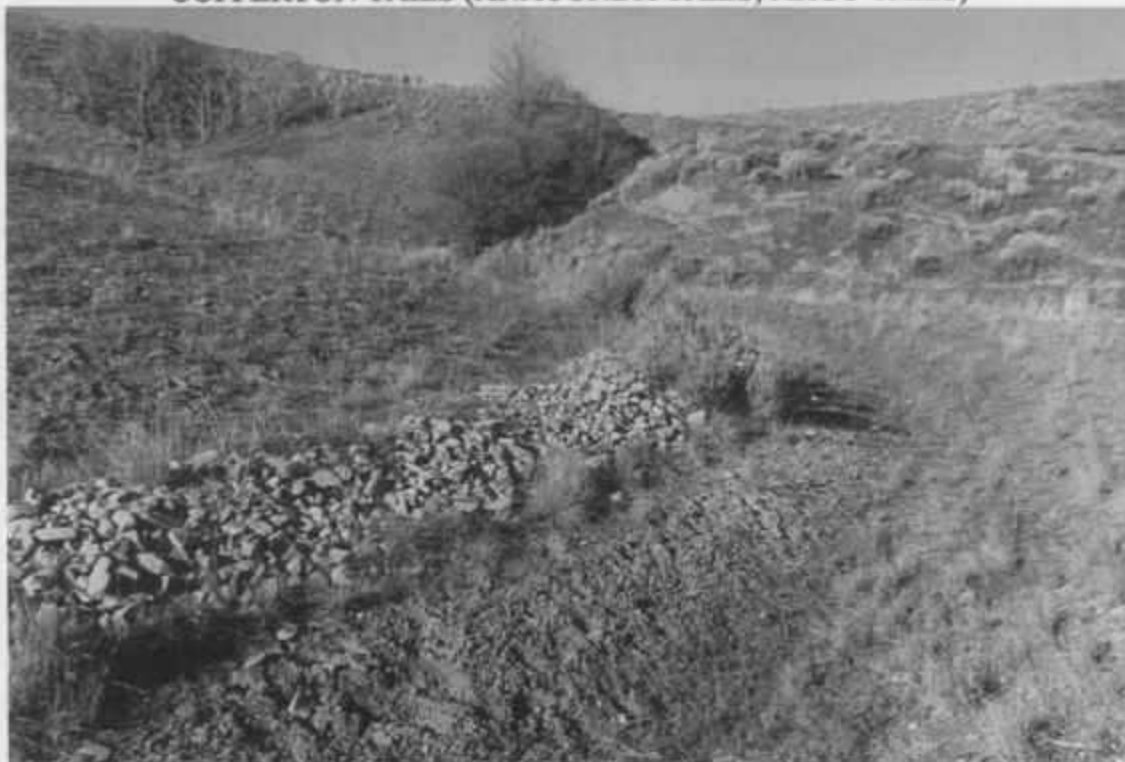
Riprap along edge of cap on western (upstream) side.

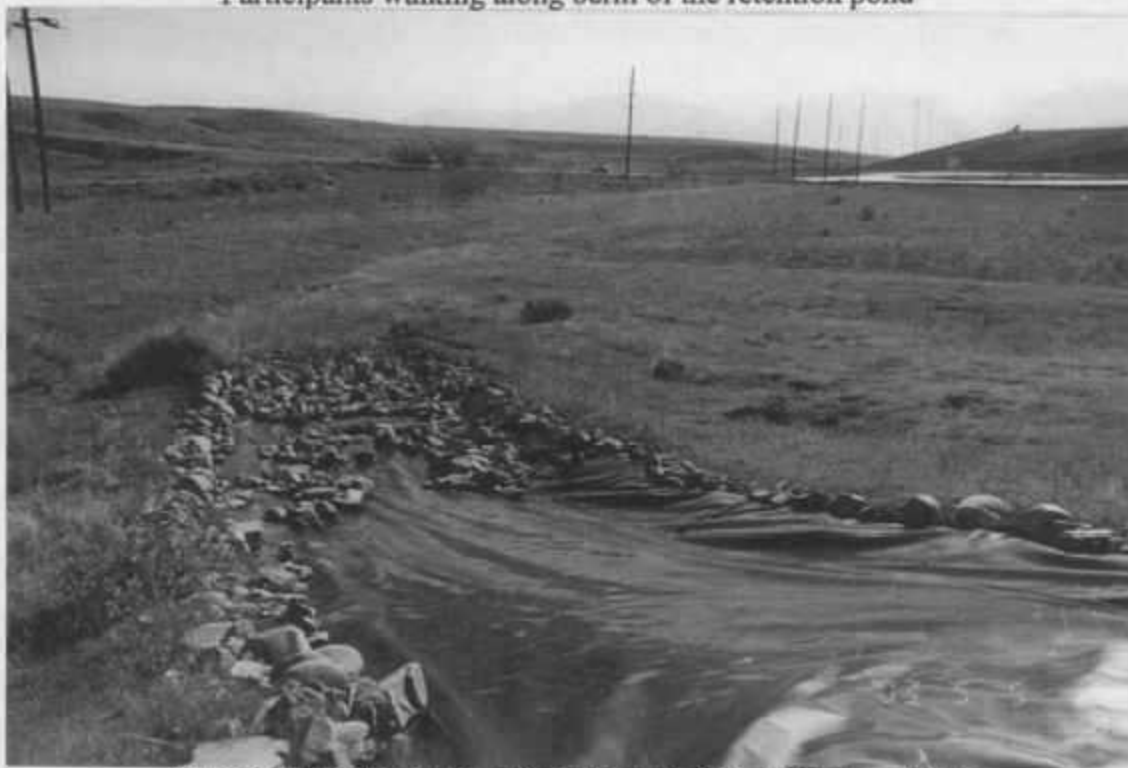
Retention Pond overflow chute showing deer hoof print marks

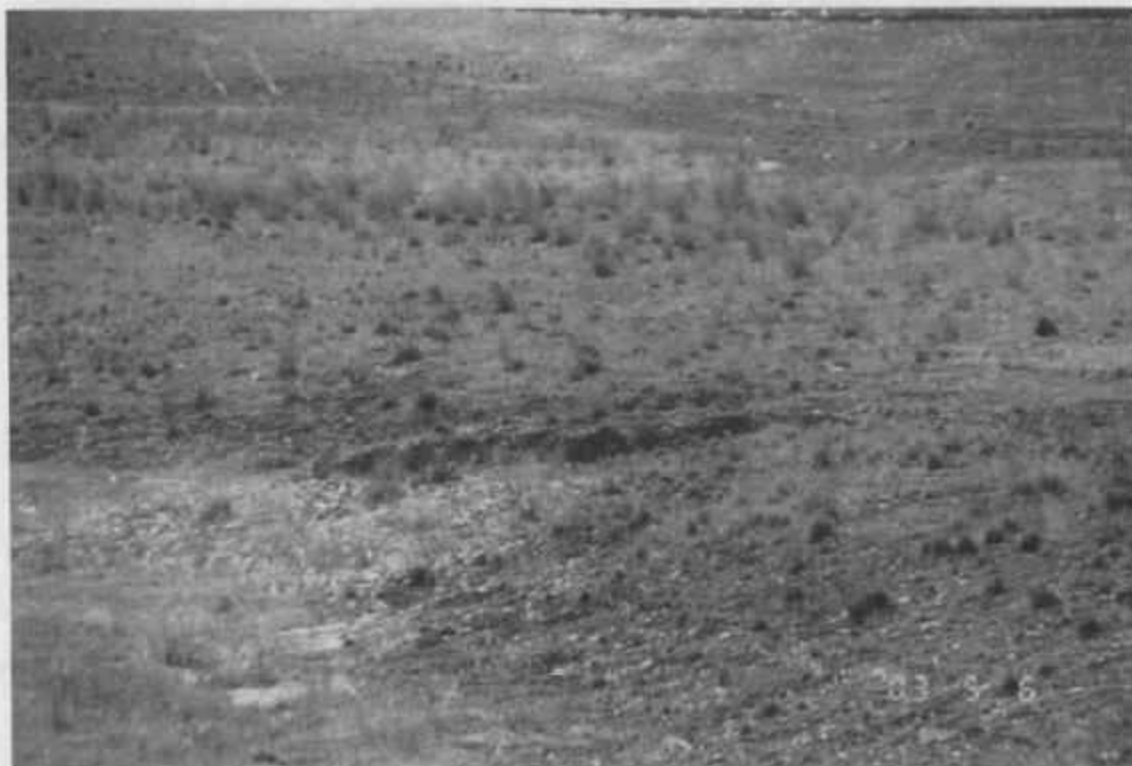
1. The cap covering the wastes in Bingham Creek Channel was experiencing erosional degradation at one location near Route 111 and the Trans Jordan Landfill. Although the erosion gully had not yet gotten deep enough to uncover the tailings, it was clear that this would be inevitable without intervention of some kind. In all other locations, the cap was undisturbed by erosion. (This erosion gully was filled in by a joint action by the Trans Jordan Landfill, the City of South Jordan, and Kennecott. The runoff water is now diverted to a pipe which carries the water underground to the channel. See Appendix D.)

Gully forming in banks of Bingham Creek near intersection with Rt. 111.

The team recommended that the erosional gully found where drainage from the access landfill road and Rt. 111 discharges into the creek channel be repaired before the erosion cuts completely through the cap and exposes the tailings underneath. As a result of this recommendation, the Trans Jordan Landfill management was contacted by EPA. The landfill general manager agreed to repair the problem with the help of the City of South Jordan (which now maintains Rt. 111), and Kennecott, the landowner.

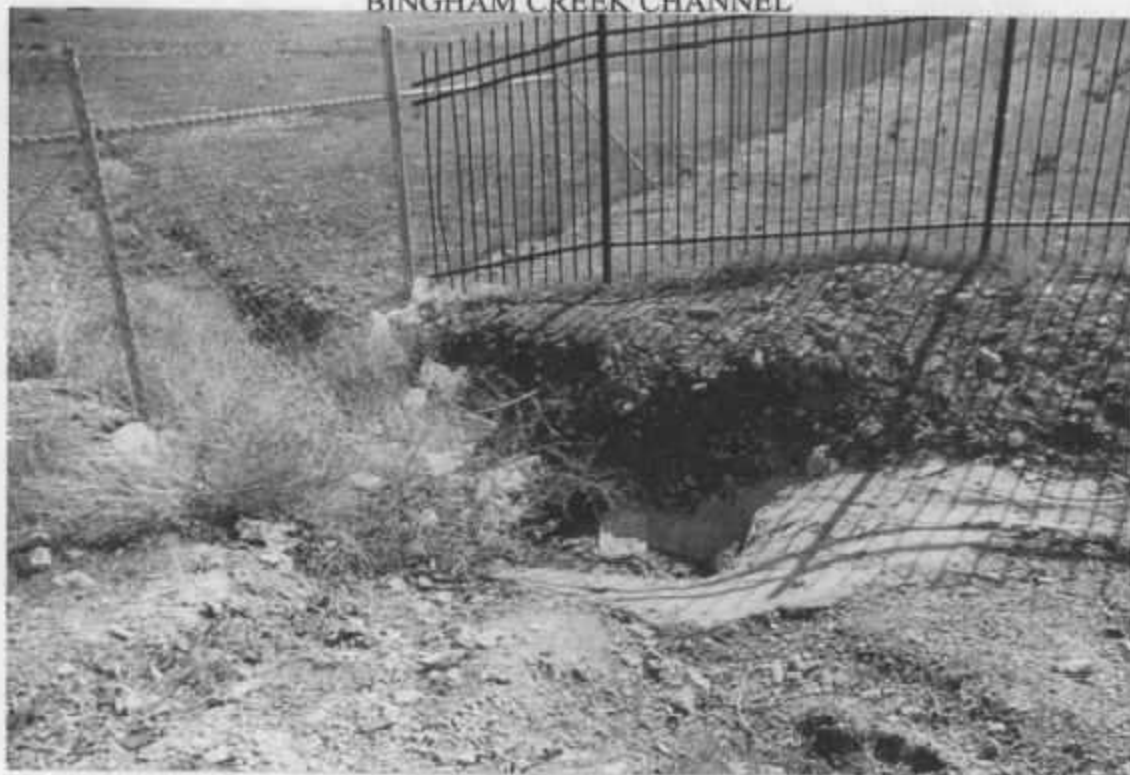
Ditch from highway and access road leading to erosion gully to Bingham Creek

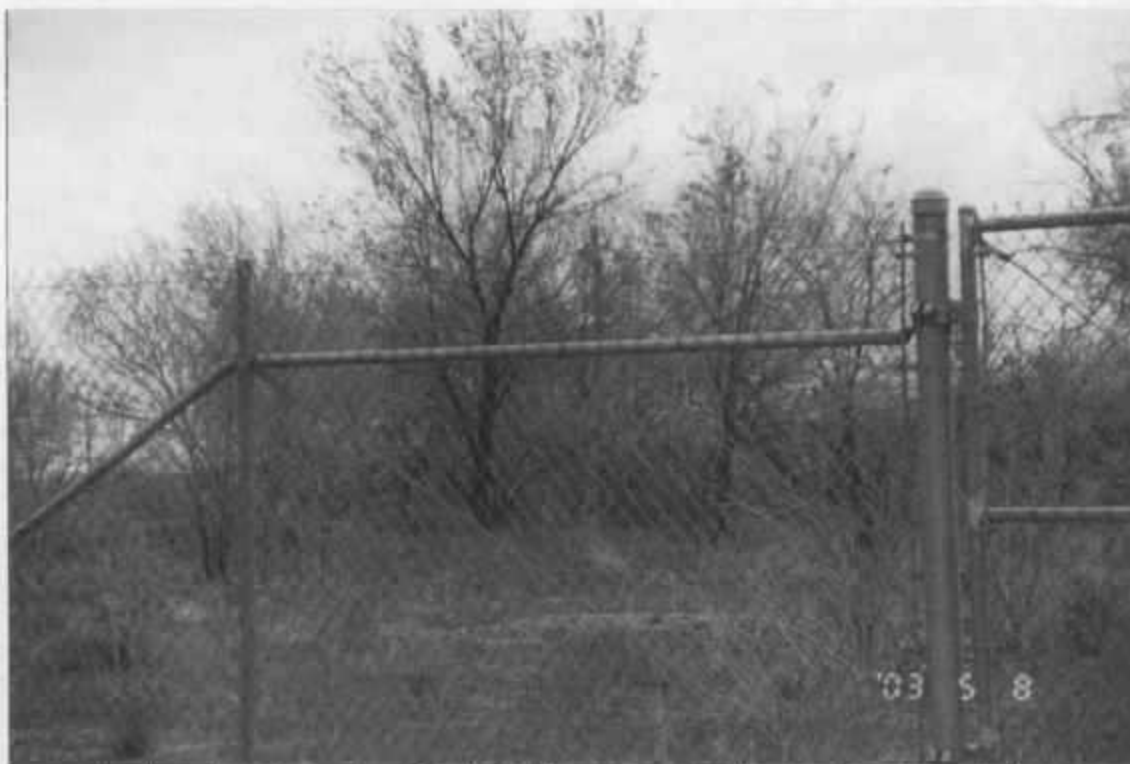
South end of Copperton Circle, tailings area still shows stressed vegetation
