United States Air Force

FIVE-YEAR REVIEW REPORT

Homestead Air Reserve Base, Florida

December 2004

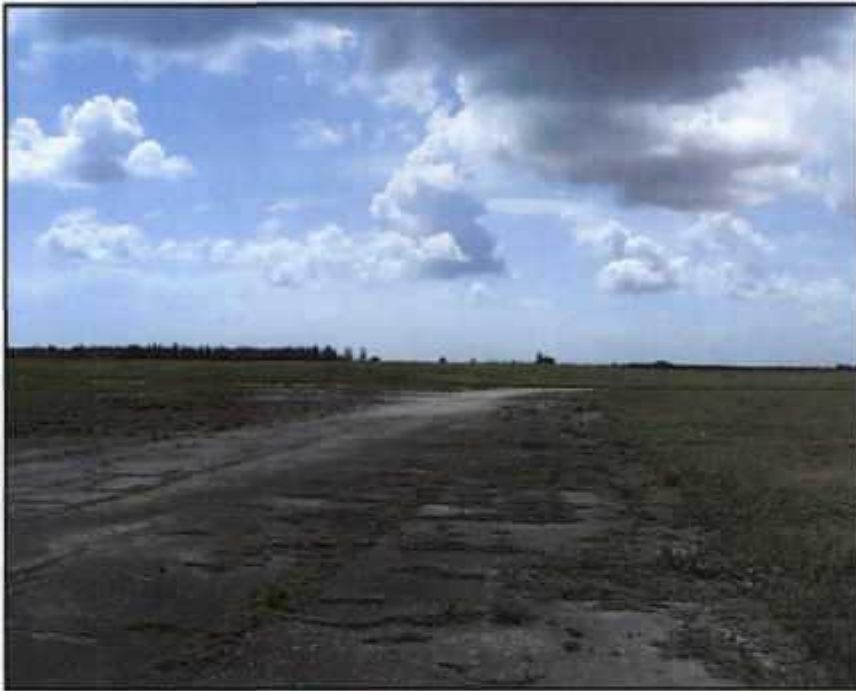
Photograph 1: Operable Unit 1 – Fire Protection Training Area No. 2

A site inspection was conducted on 8 August 2003. No indications of trespassing, vandalism, unauthorized excavation, or well installations were observed. Monitoring wells were visually inspected and found to be locked and in acceptable condition. No changes in on-site or surrounding land use were observed. Overall, the inspection indicated that the remedy is being implemented in accordance with the ROD and effectively precludes unauthorized access to the site.

The two years of ground-water monitoring required by the ROD have been completed. In addition, voluntary ground-water monitoring was conducted in 2001 and 2002. The data indicate that no significant contamination remains at levels of concern in the ground water at OU-1. Therefore, it is recommended that no further ground-water monitoring be performed and the ROD monitoring wells should be abandoned in accordance with applicable regulatory guidelines. The site should be granted a No Further Investigation (NFI) with LUCs status.

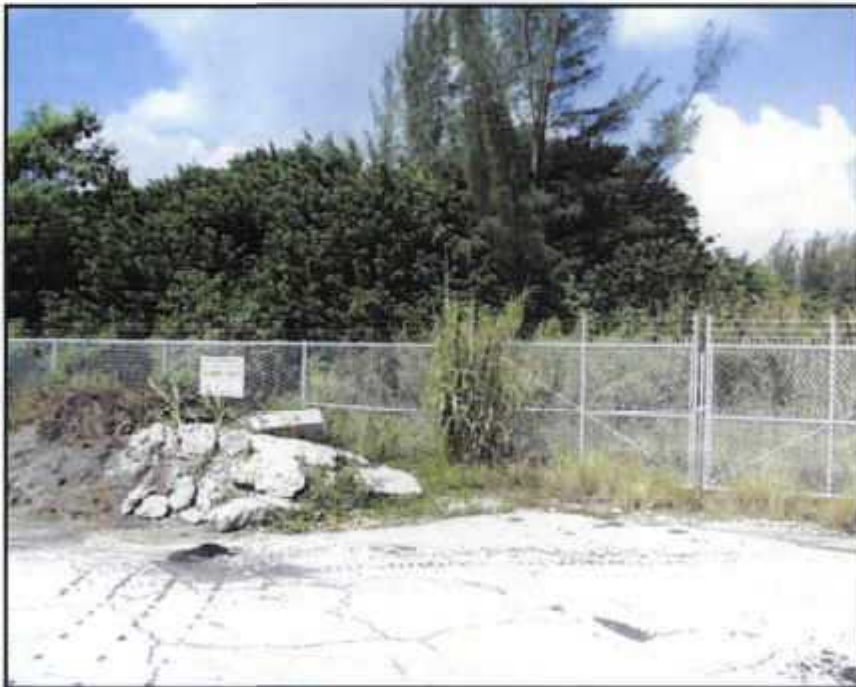
Photograph 2: Operable Unit 2 – Residual Pesticide Disposal Area

A site inspection was conducted at this site on 8 August 2003. Perimeter fencing required by the ROD remains in place and no damage was observed. In addition, although not required by the ROD, signs have been affixed to the fence to notify persons of the presence of environmental contamination. No indications of trespassing, vandalism, unauthorized excavation, or well installation were observed. Monitoring wells were not visually inspected due to their location within the fenced area in thick brush, but have been found to be in acceptable condition during annual ground-water monitoring events conducted at the site. No changes in on-site or surrounding land use were observed. Overall, the inspection indicated that the remedy is being implemented in accordance with the ROD and effectively deters unauthorized access to the site.

Residual soil contamination remains at OU-2 above concentrations that would allow unrestricted reuse and unlimited exposure. As a result, the LUCs established in the ROD should remain in place to ensure that human exposure to contaminated soil is restricted. However, review of the historical data suggests that the area requiring LUCs is significantly smaller than the current 20 acres. Therefore, it is also recommended that the BCT re-examine the extent of soil contamination to determine if the area requiring LUCs can be reduced.

The five years of ground-water monitoring required by the ROD have been completed and indicate that no contamination is present at levels of concern in the ground water at OU-2. Therefore, it is recommended that ground-water monitoring be terminated, and the ROD monitoring wells should be abandoned in accordance with applicable regulatory guidelines. The site should be granted NFI with LUCs status.
