**SECOND FIVE-YEAR REVIEW REPORT**  
**FOR**  
**CABOT CARBON/KOPPERS SUPERFUND SITE,**

**GAINESVILLE,**  
**ALACHUA COUNTY, FLORIDA**  
**EPA ID: FLD980709356**

April 2006

U.S. Army Corps of Engineers  
Mobile District  
109 Saint Joseph Street  
Mobile, Alabama 36602

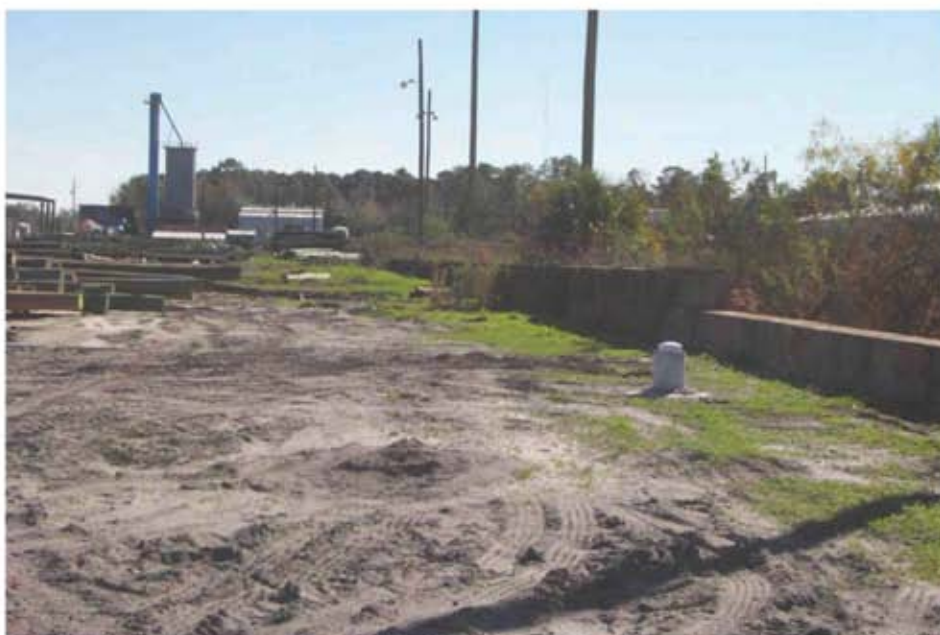
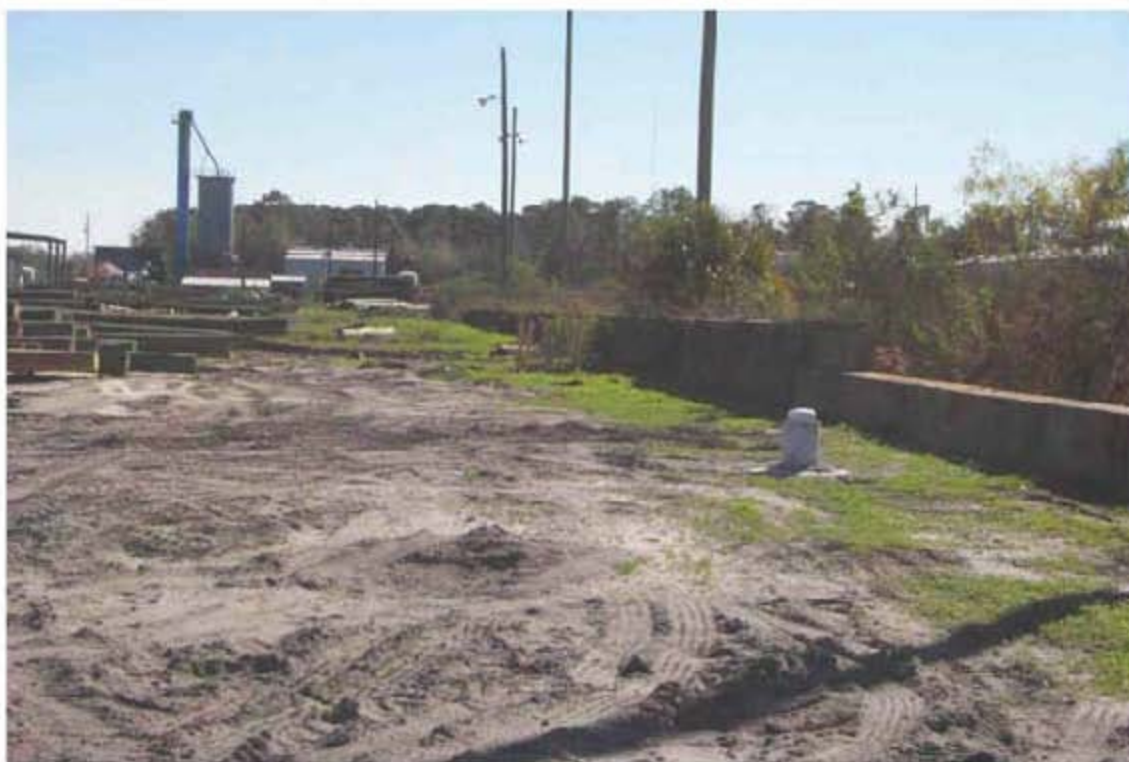
An active wood preserving plant and creosote treated timber storage is on this site. The North Lagoon was visited first. The North Lagoon was filled in years ago. The drip track area was visited next, where a new Floridan well had just been installed. The soil cuttings generated from the drilling of this well had to be transported off site and incinerated, due to the contamination. It was also noted that lighting had recently been installed in this area, with light poles, with the electrical wiring installed below grade. The monitoring wells and extraction wells were observed. The extraction wells have wooden fabricated pump houses. The treatment plant was visited next. Mr. McKinney described the pretreatment process. The drums containing drill cuttings from the ongoing Floridan well installation were also stored in the area of the water treatment plant, with Mr. McKinney in charge of composite sampling, characterization, proper hazard labeling and arranging for proper transport offsite.

**PHOTOGRAPH 10. CLOSE-UP, DRIP TRACK AREA, WITH NEW FLORIDAN WELL, KOPPERS, 1 FEB 06**

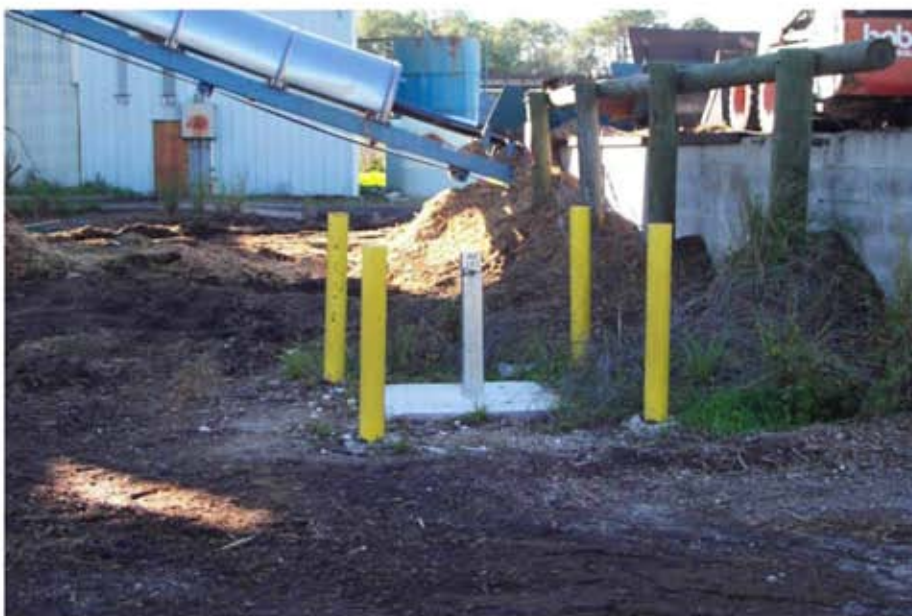
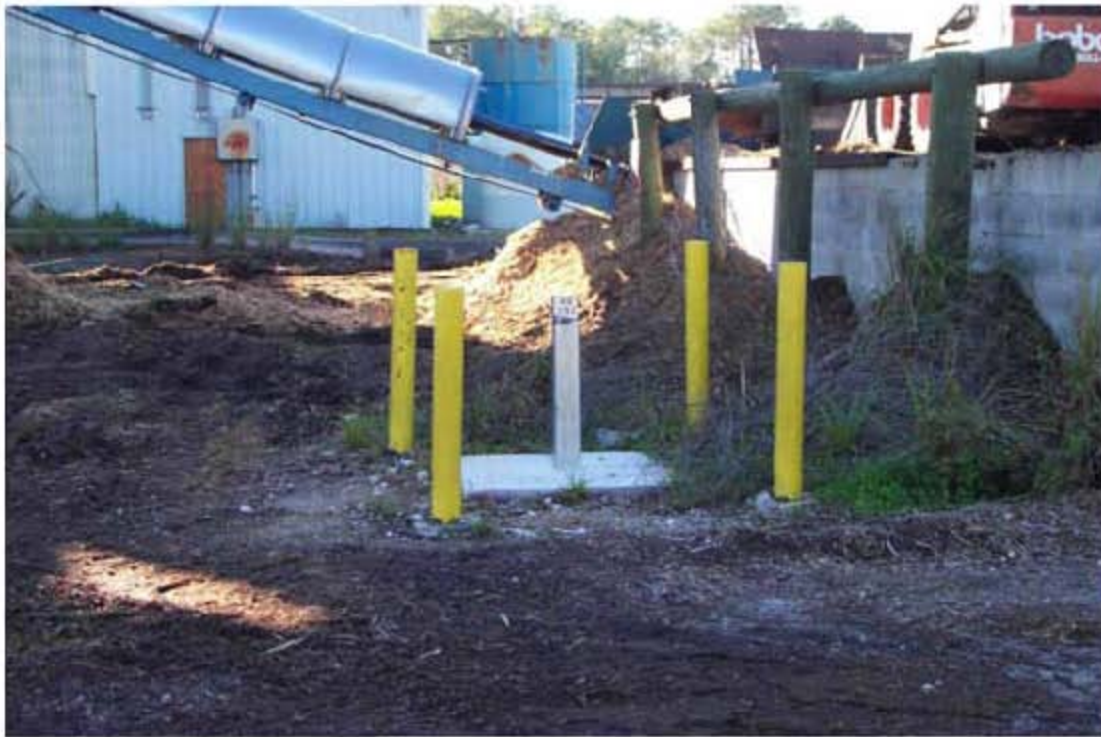
Remedial actions outside the ROD were also implemented at the Koppers site. DNAPL is bailed from five Upper Hawthorn wells biweekly, with approximately 0.4 gallons of DNAPL recovered from each well in each sampling event. This recovery effort began in 2005. Beazer evaluated some private wells in the area. This evaluation led to the abandonment of one well just west of the Koppers western boundary. This well is known as the Geiersbach well. It was an open-hole uncased well in the Floridan aquifer, found to have elevated levels of several organic constituents including phenols and naphthalene. In addition, several onsite wells were abandoned, to prevent cross contamination between aquifers. These wells, ITW-10 and ITW-21, may have been screened across the Upper Hawthorn. FW-1 is a Floridan well on the eastern boundary of Koppers. It was an open hole, uncased well. It was shortened as a preventative measure, to reduce the potential for acting as a conduit to deeper zones.

**PHOTOGRAPH 12. INTERMEDIATE AQUIFER MONITORING WELL, WITH DNAPL, KOPPERS, 1 FEB 06**

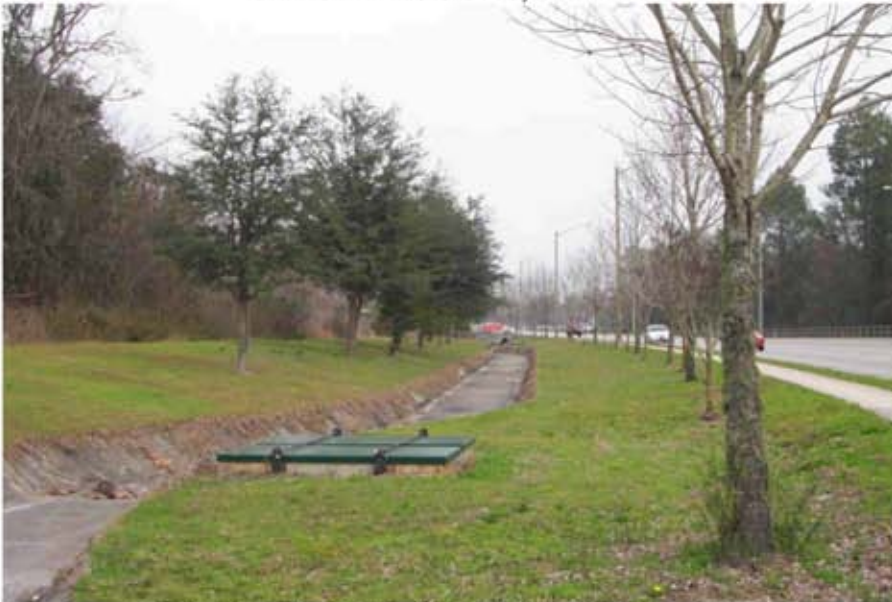
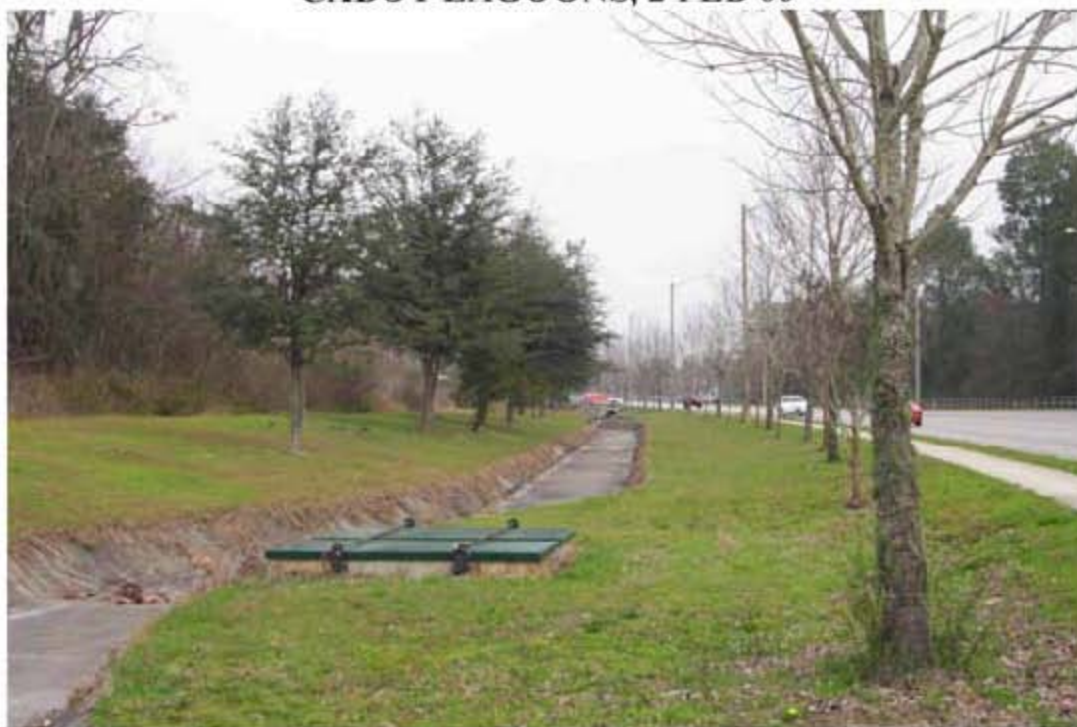
The trench, sump lids, lift station and appurtenances appeared to be in good condition. Erosion along the concrete side slope of the trench and drainpipe near the lift station that were observed and photographed in the last five year review were not observed during this site inspection. Bill

Campbell, site O&M operator, noted these deficiencies have been repaired since the last five-year review. Strong odors inside the lift station, over the grate of the flowing groundwater were noted. Odors near the sumps were also detected.

**PHOTOGRAPH 17. SUMP, CABOT TRENCH,  
2 FEB 06**

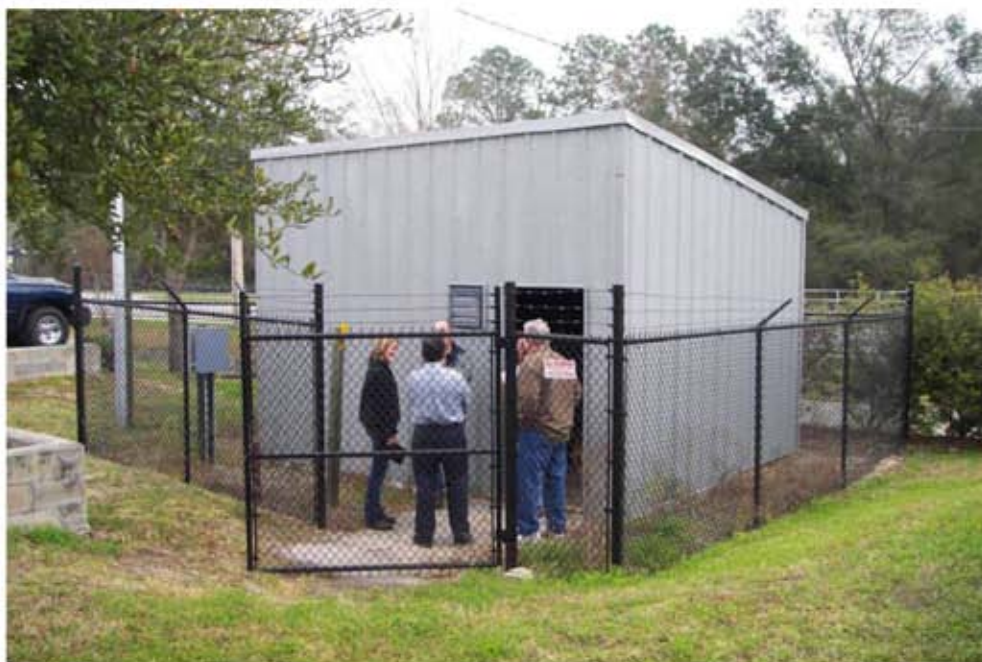
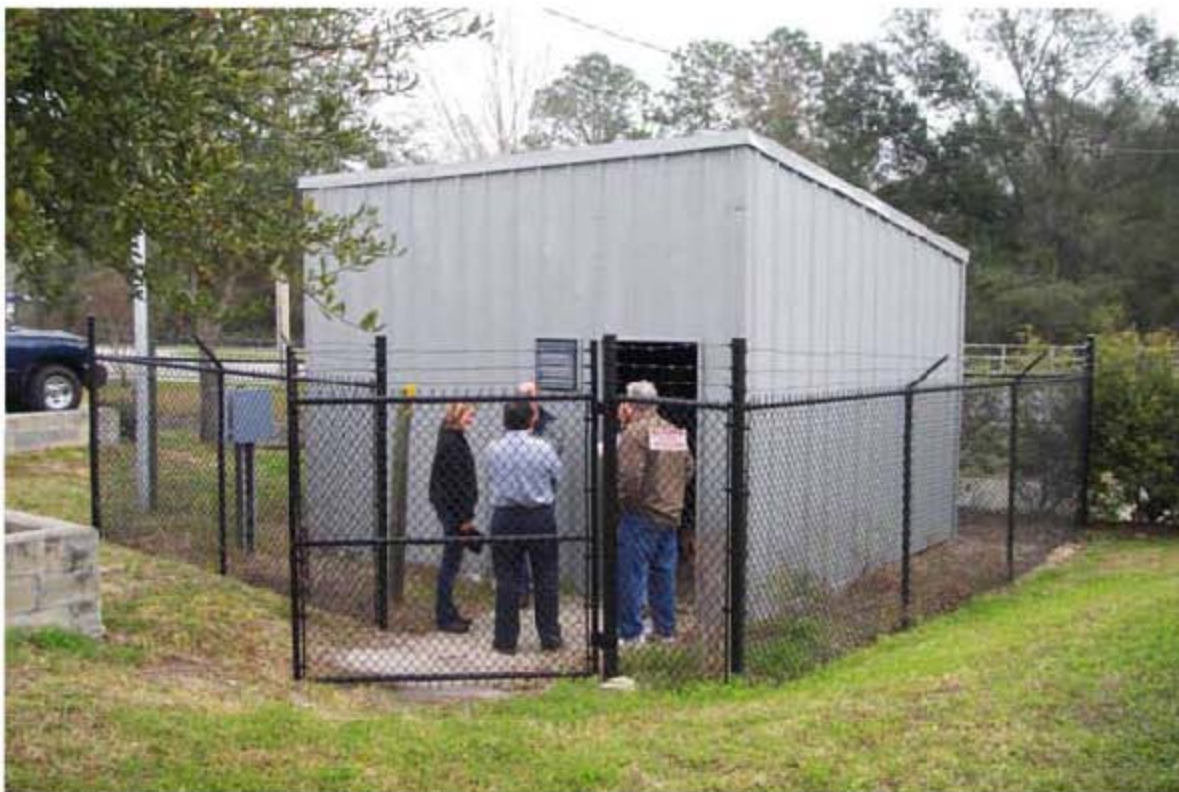
**PHOTOGRAPH 18. CABOT LIFT STATION, 2 FEB 06**

10. Air quality monitoring at Cabot Lift Station and the sumps should continue. Air monitoring should be performed over a period of at least two days during the summer, and seasonally. Data should be evaluated based on health and nuisance effects. Local regulatory agencies should be contacted regarding nuisance ordinances. At the lift station, the air samples should be collected near the vent. The effectiveness of the carbon filters installed to reduce odors emitting from the vent at the lift station should be monitored, with replacement of filters as necessary. Pilot studies to determine optimum treatment options should be considered.

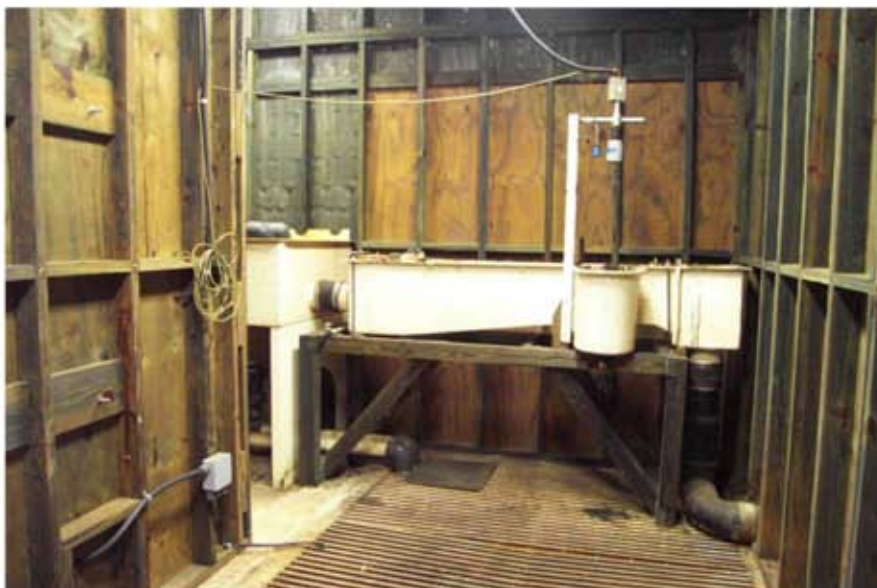
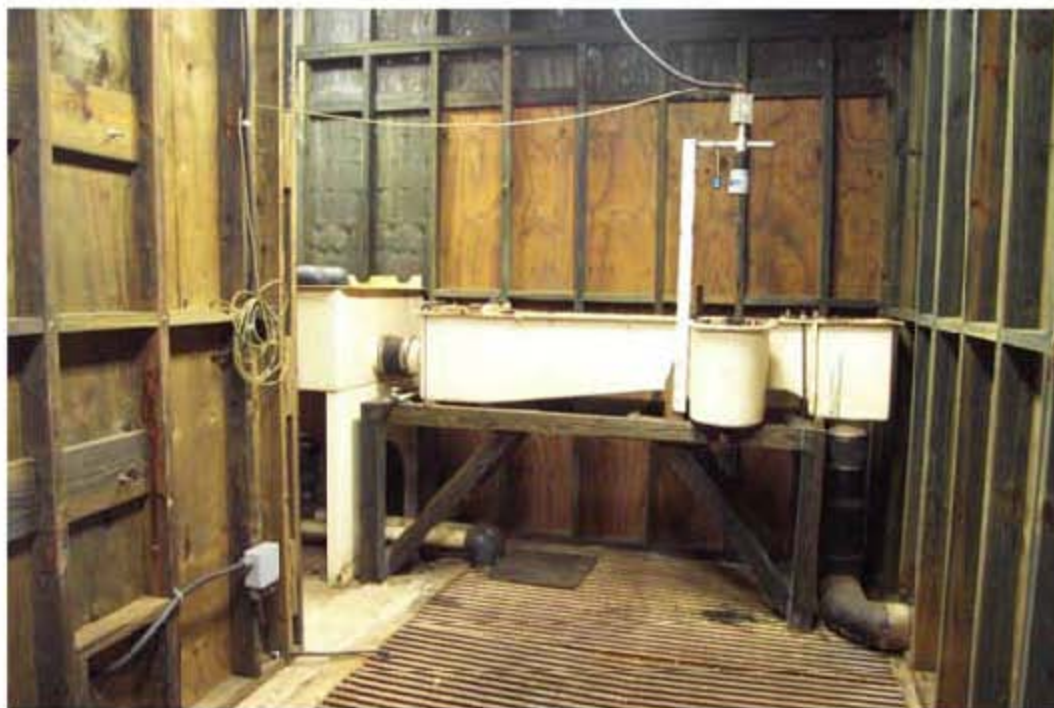
**PHOTOGRAPH 19. INSIDE CABOT LIFT STATION, CABOT  
2 FEB 06**

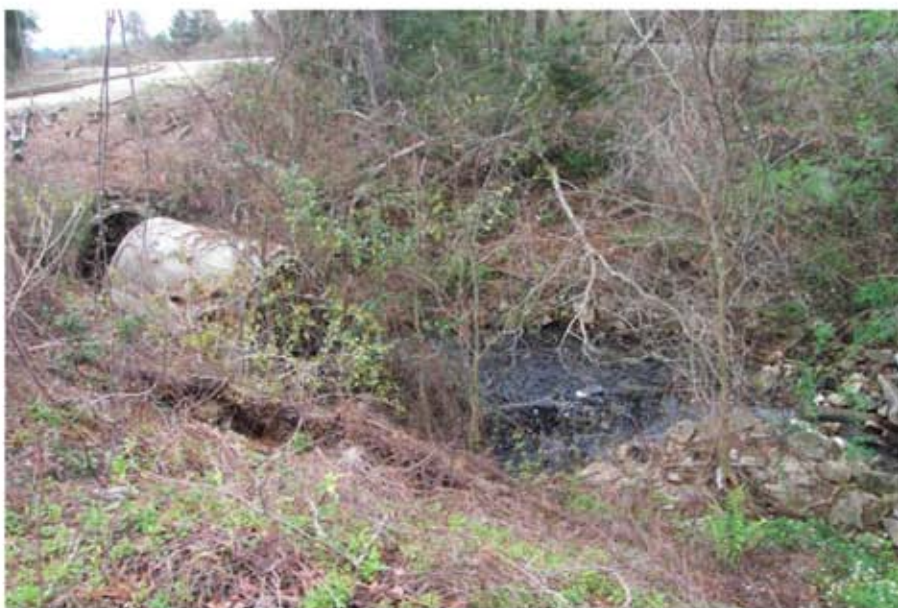
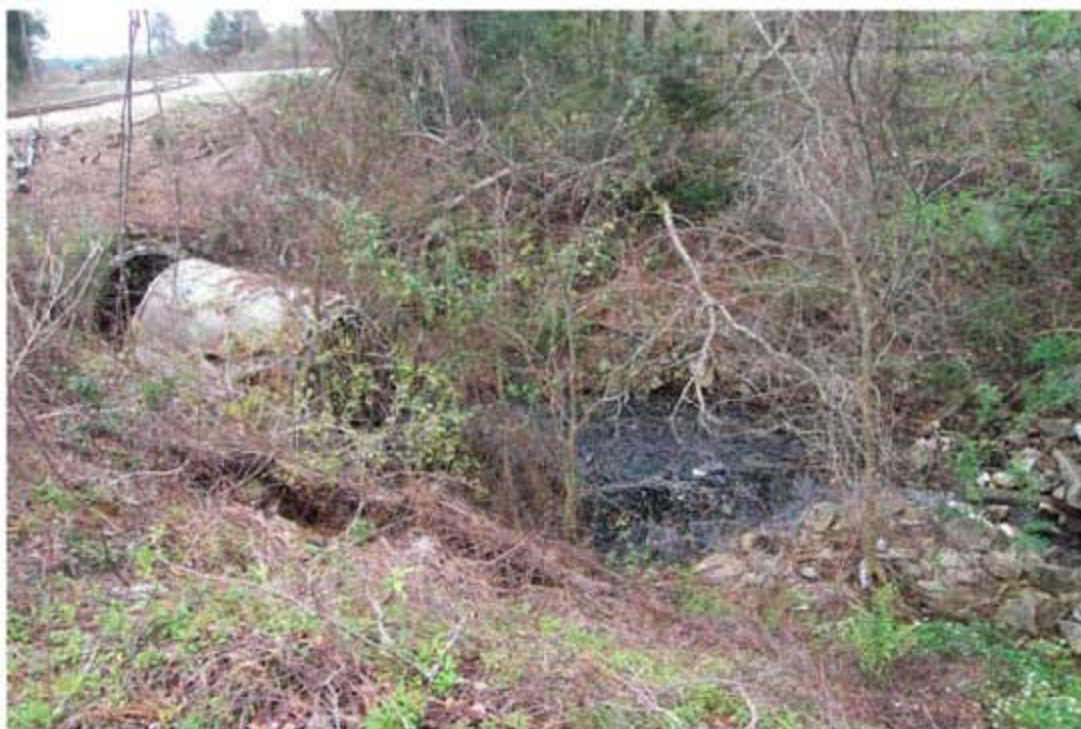
After the Cabot site inspection, Amy McLaughlin left, and John Herbert (GRU consultant) joined the group. John Mousa, Laura Roebuck, Kelsey Helton, and John Herbert traveled to the ditch, northeast and just offsite of Koppers. Faded FDER signage was posted along the ditch. Strong creosote odors were also detected at the bank. However, it was unclear if the odors were emanating from the Koppers property, where stacked creosote timbers were stored, or from the ditch and surface water. Dark, foamy substances in the surface water at the outfall in the ditch were observed.

**PHOTOGRAPH 20. DITCH NE OF KOPPERS NE BOUNDARY,  
2 FEB 06**

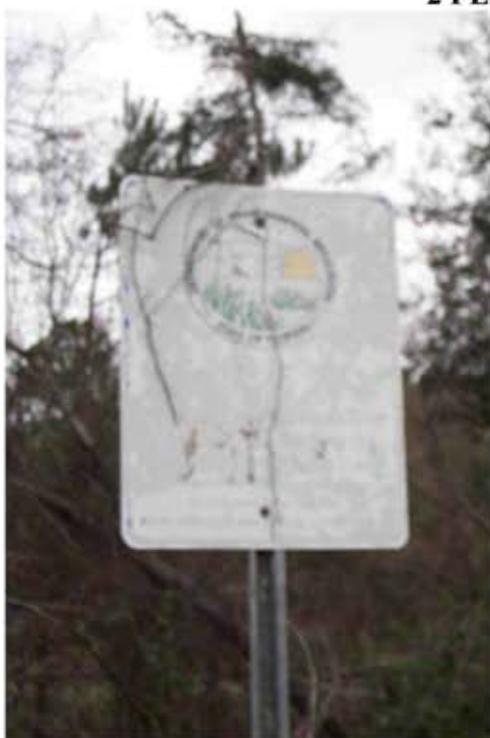
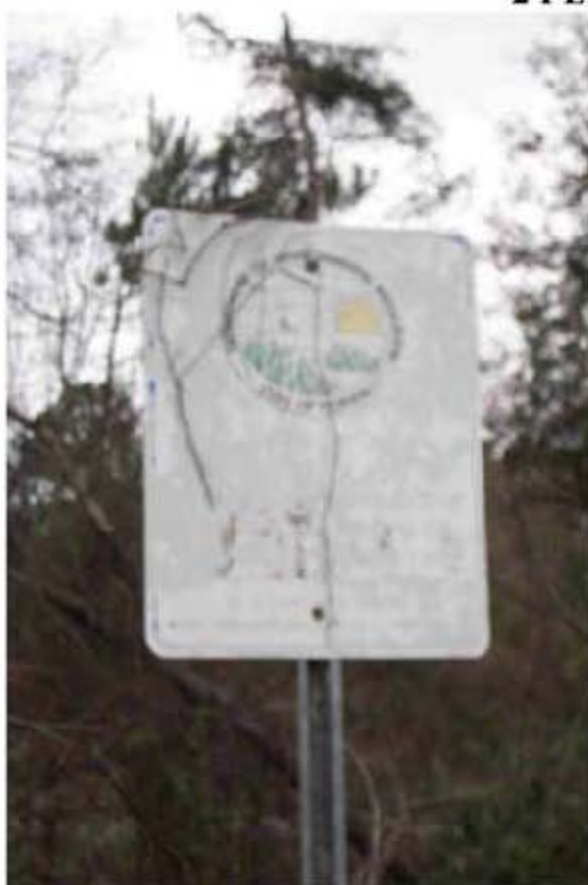
**PHOTOGRAPH 21.  
FADED FDEP (FDER)  
SIGN NEAR DITCH, NE  
OF KOPPERS**
