**Third
Five-Year Review Report**

**Syntex Facility Site
Verona
Lawrence County, Missouri**

September 2007

**Region 7
United States Environmental Protection Agency
Kansas City, Kansas**

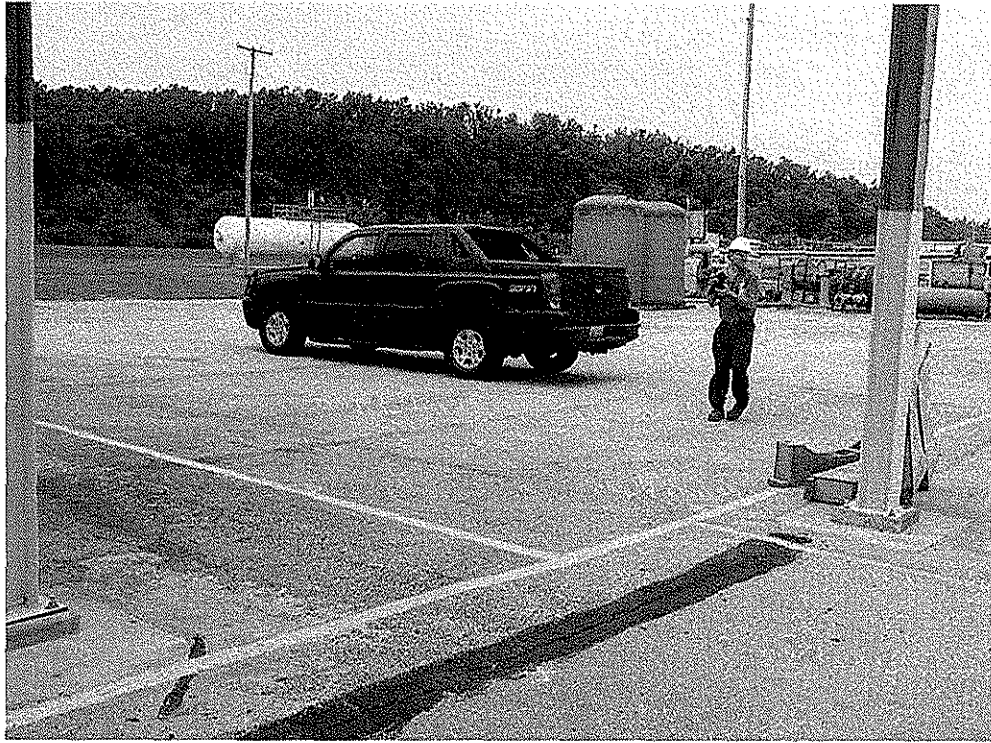
Areas inspected included the asphalt cover in the spill area and T-1 dike area. Painted yellow lines provided demarcation of each capped area. Overall the asphalt caps were in very good condition. There was one location in the T-1 dike area with some minor cracking along a previously sealed area. Since the objective of the cap is to prevent dermal contact and erosion of the underlying soil, this is not a significant issue. However, some additional asphalt sealant in this area would help prevent the progression of this crack.

Spill Area Asphalt Cap – truck parked on cap – delineated by yellow lines

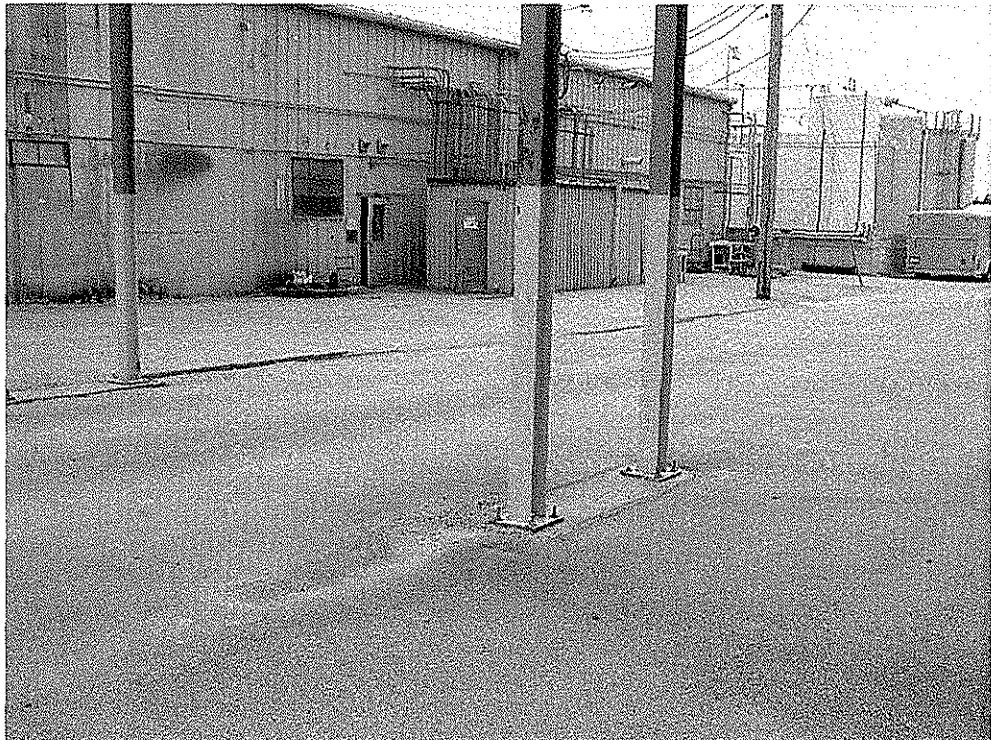
T-1 Dike Area Asphalt Cap

6. **Alternative Cover (armored rock, concrete, etc.)** N/A
Remarks Overall in very good condition. Minor crack sealing is recommended.

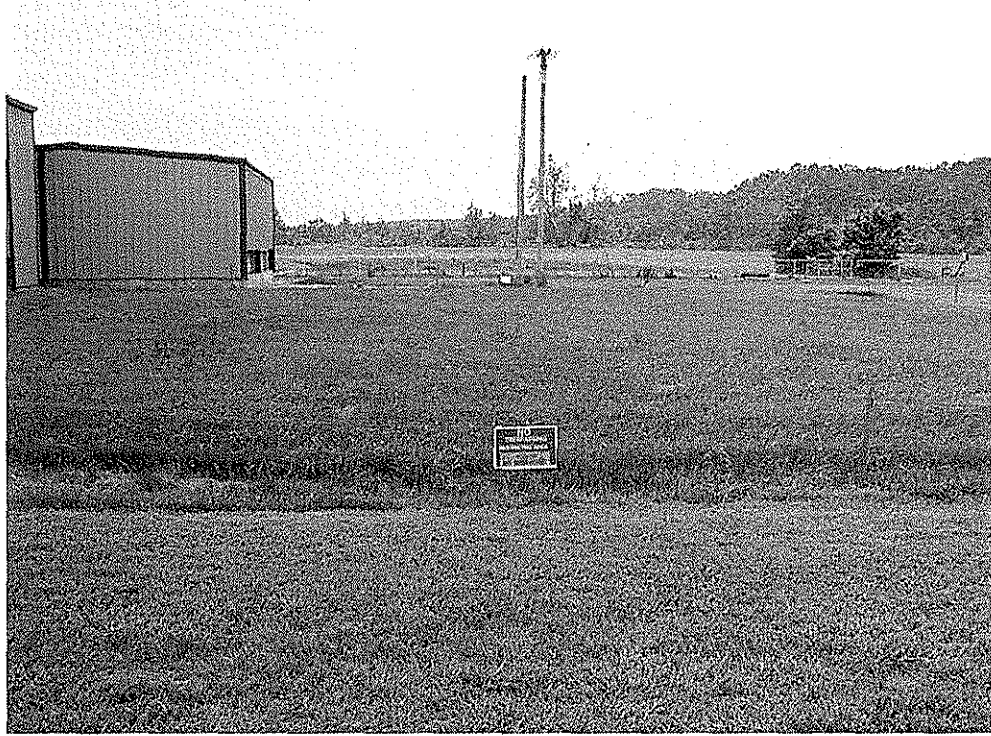
Vegetative covers in the Lagoon area, Irrigation area, Burn area, Slough area, and Trench area were also inspected. The vegetative covers were all in very good condition. Each area was demarcated with a single cable fence with warning sign hanging at frequent intervals along the fence. Thick vegetation was exhibited in all areas and no erosion or signs of distress were observed.

Irrigation Area Vegetative Cap – note warning sign

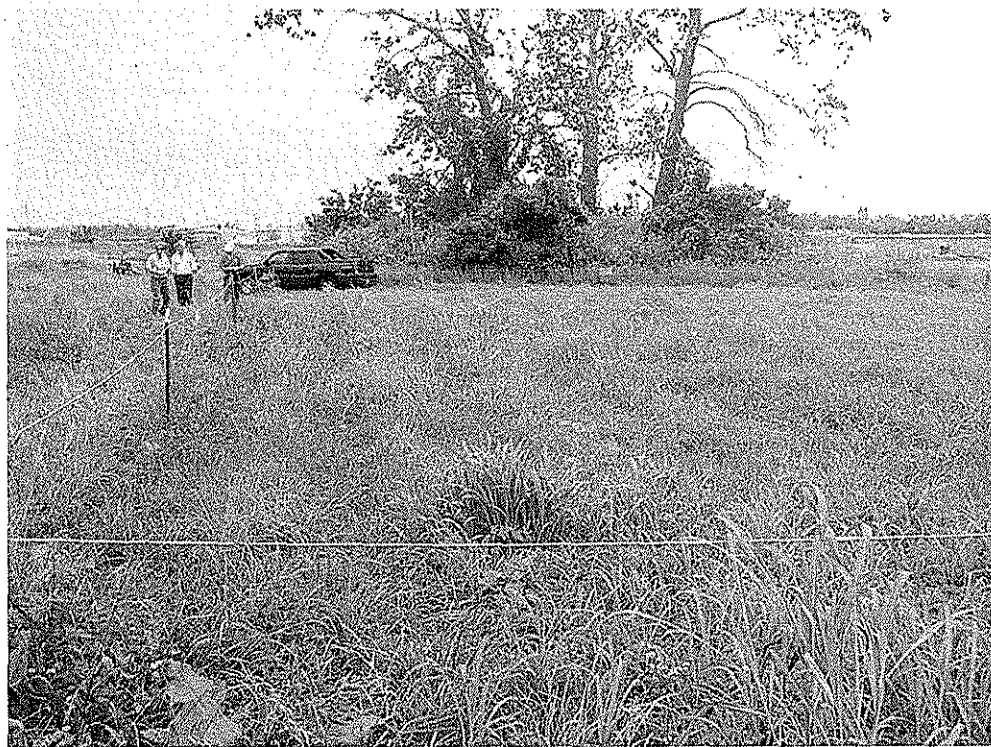
Burn Area Vegetative Cap

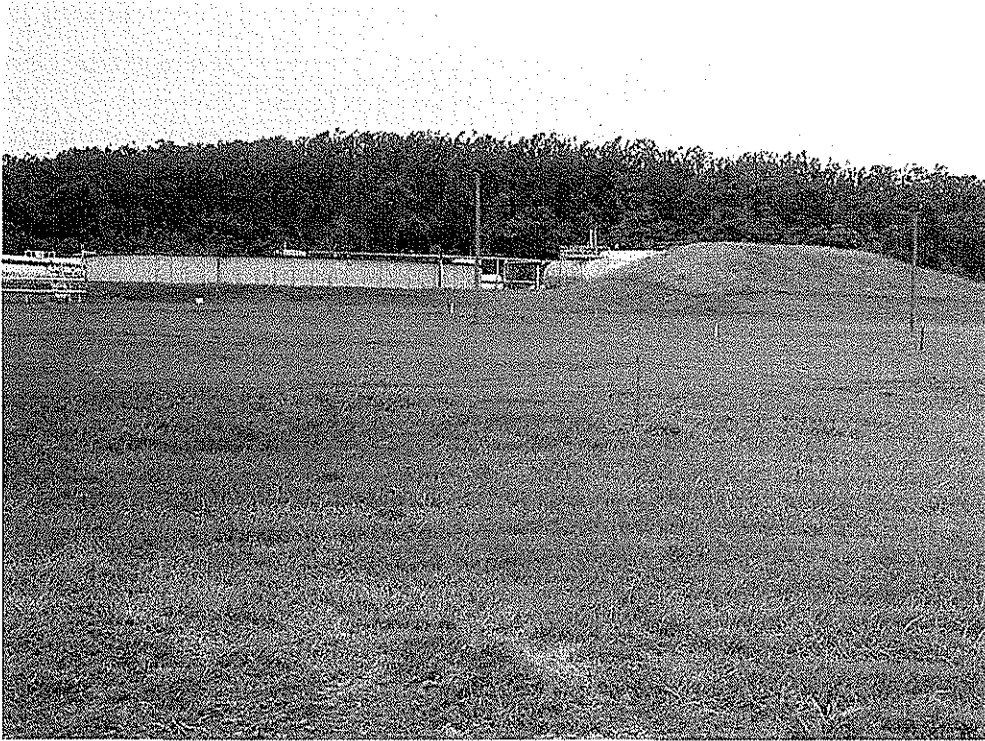
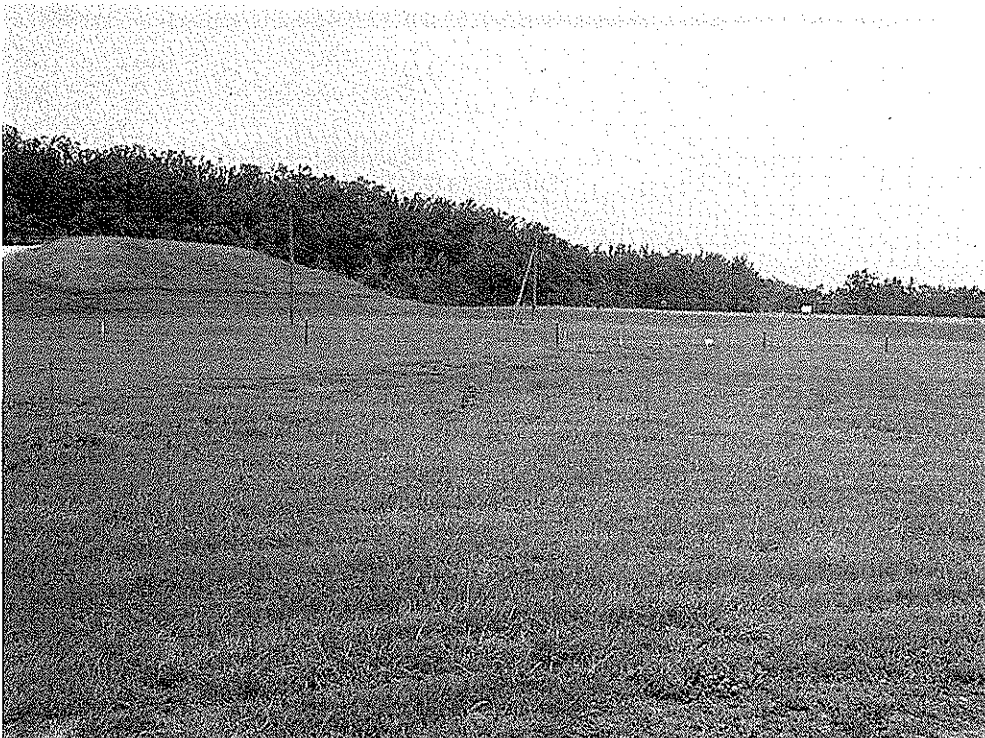
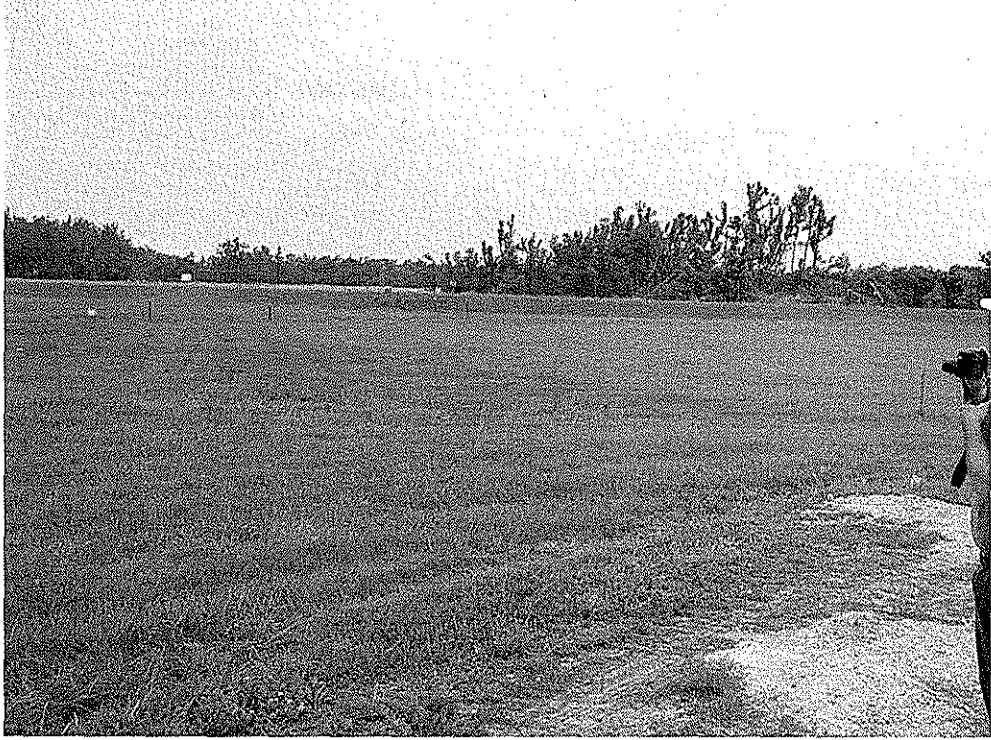
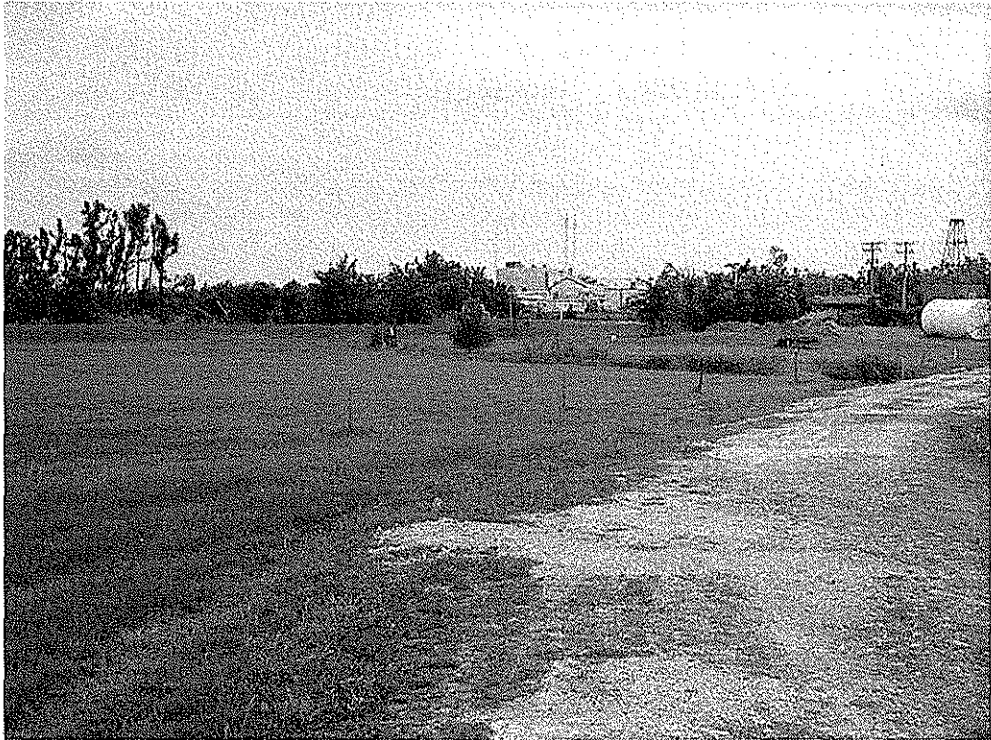
Lagoon Area Vegetative Cap – Picture 1 of 4

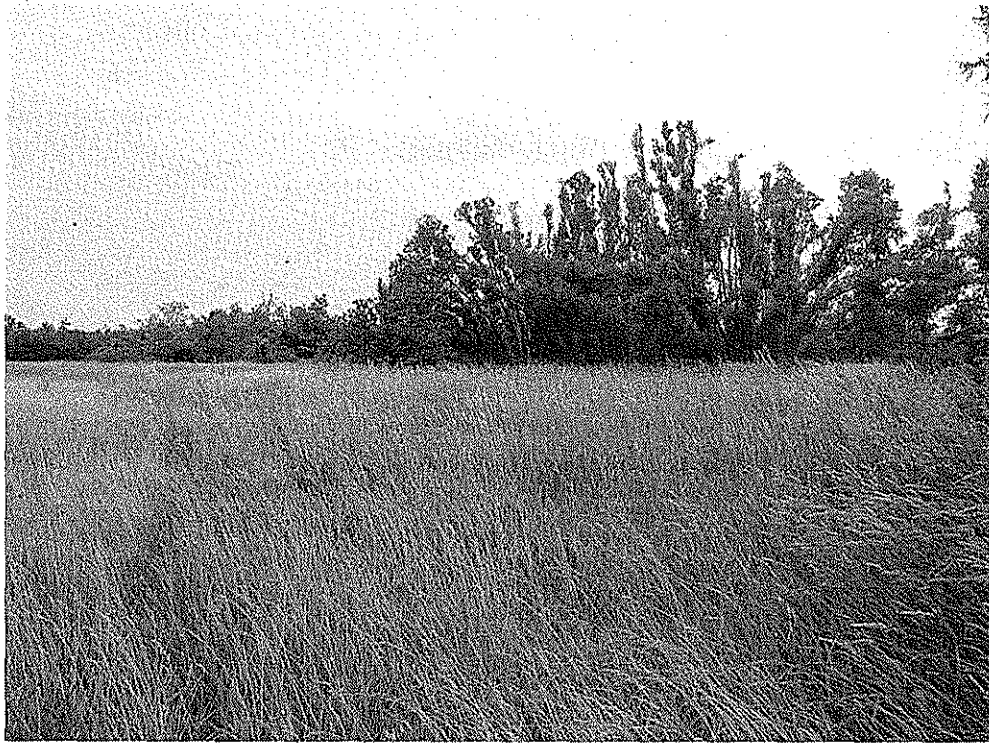
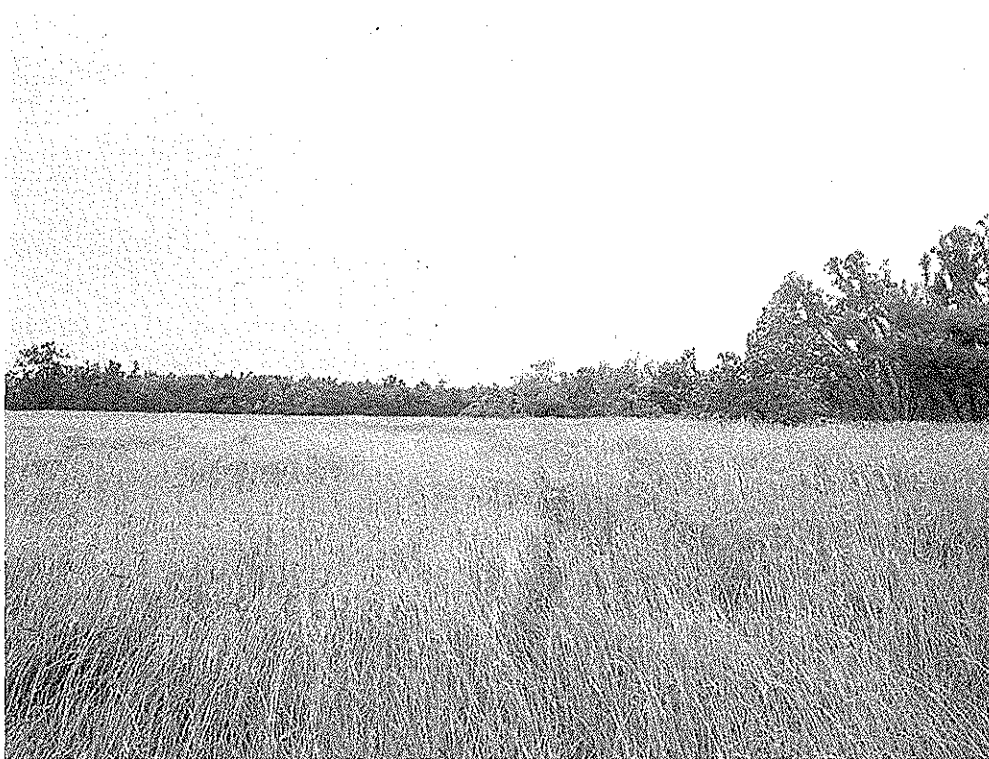
Slough Area – Picture 1 of 2

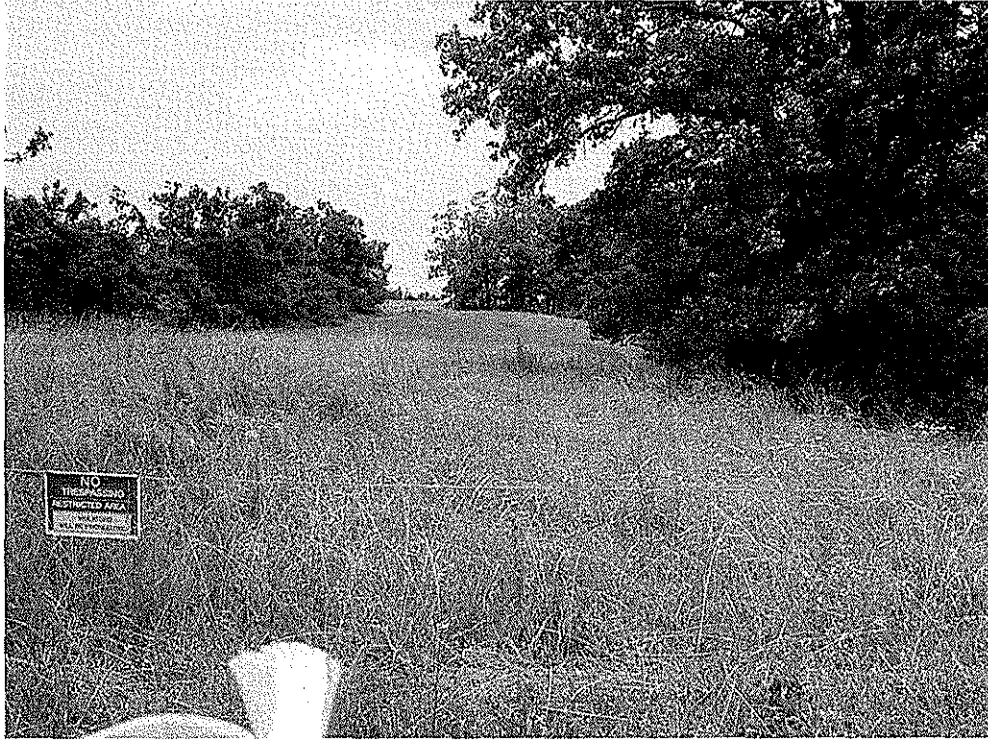
Trench Area Vegetative Cap
