FINAL FIVE-YEAR REVIEW REPORT

INSTALLATION RESTORATION SITE 9 OPERABLE UNIT 1 MARINE CORPS BASE CAMP PENDLETON, CALIFORNIA

September 12, 2007

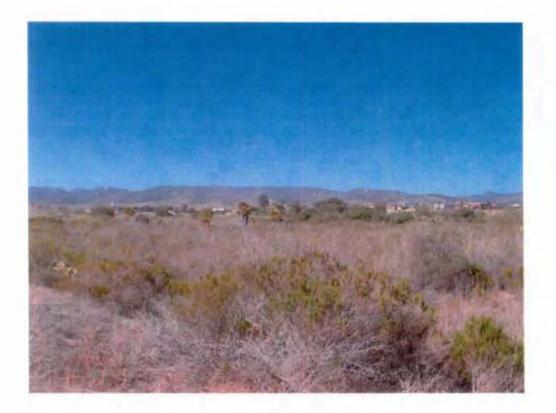
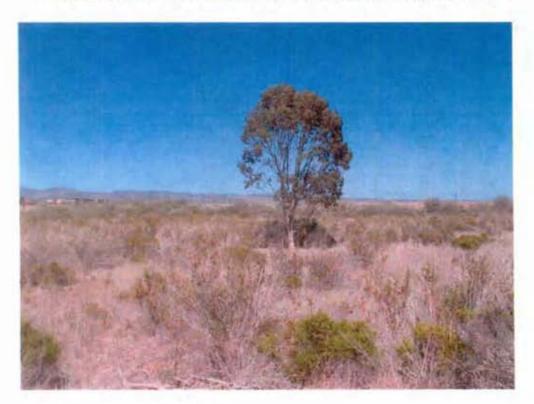
VIEWS TO NORTHEAST AND SOUTHEAST FROM WESTERN EDGE OF SITE
