Five-Year Review Report

**Fourth Five-Year Review Report
for
A.L. Taylor (Valley of Drums)**

**Brooks
Bullitt County, Kentucky**

May 2008

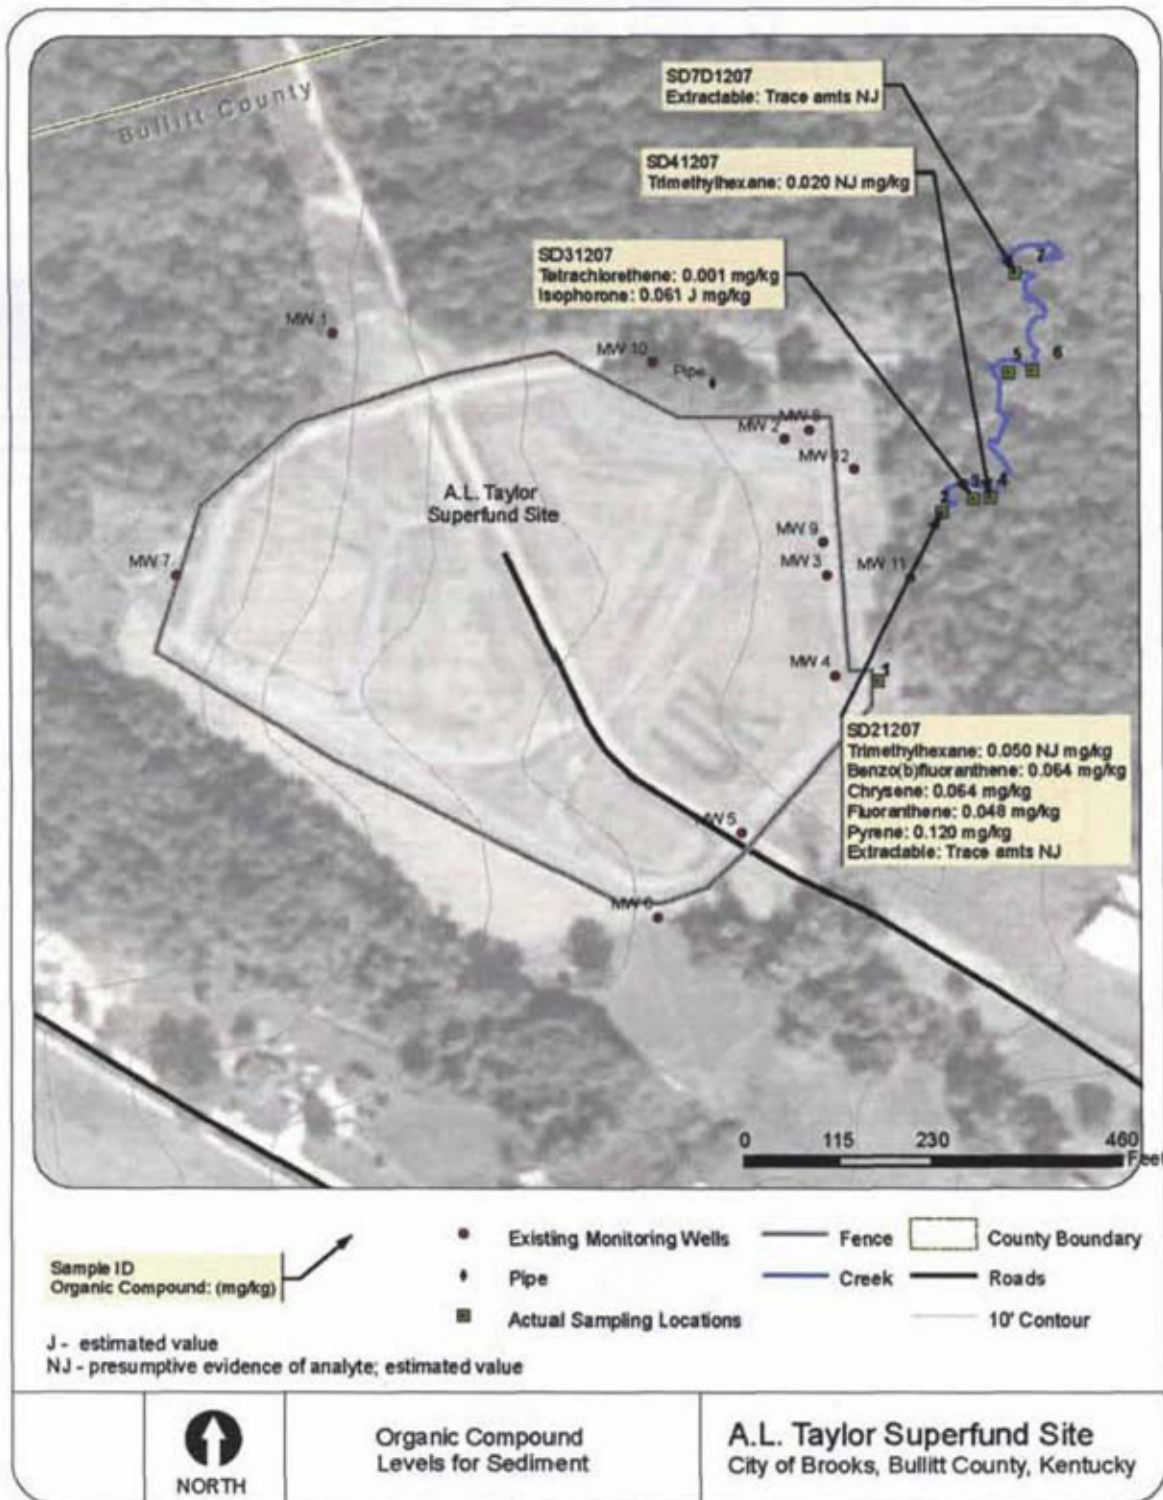
Figure 3: Organic Compound Concentrations at Sediment Sample Locations in Wilson Creek

In December 2007, surface water and sediment samples were collected to inform this FYR about levels of VOCs, PCBs, and extractable organic compounds. The samples were collected in Wilson Creek near hardened sludge and drum carcasses (sample locations 6 and 7) that were found during the site inspection. The contaminants detected in the hardened sludge and drums were compared to downstream surface water and sediments samples. The results of the sampling data indicate that there is no evidence of contaminants in the surface water. Although metals were detected during the previous FYR process, no samples were analyzed for metal in this FYR. Metals were not detected at high levels of concern during historical sampling. The concentration of metals detected in surface water was below the Kentucky water quality standards for Recreational and Warm Water Aquatic Habitat waters or there were no regulatory standards available for the metal. Only contaminants that were listed as COCs were tested during the most recent sampling. Table 6 presents a comparison of the surface water data presented in the 2003 FYR to the surface water data from 2007.

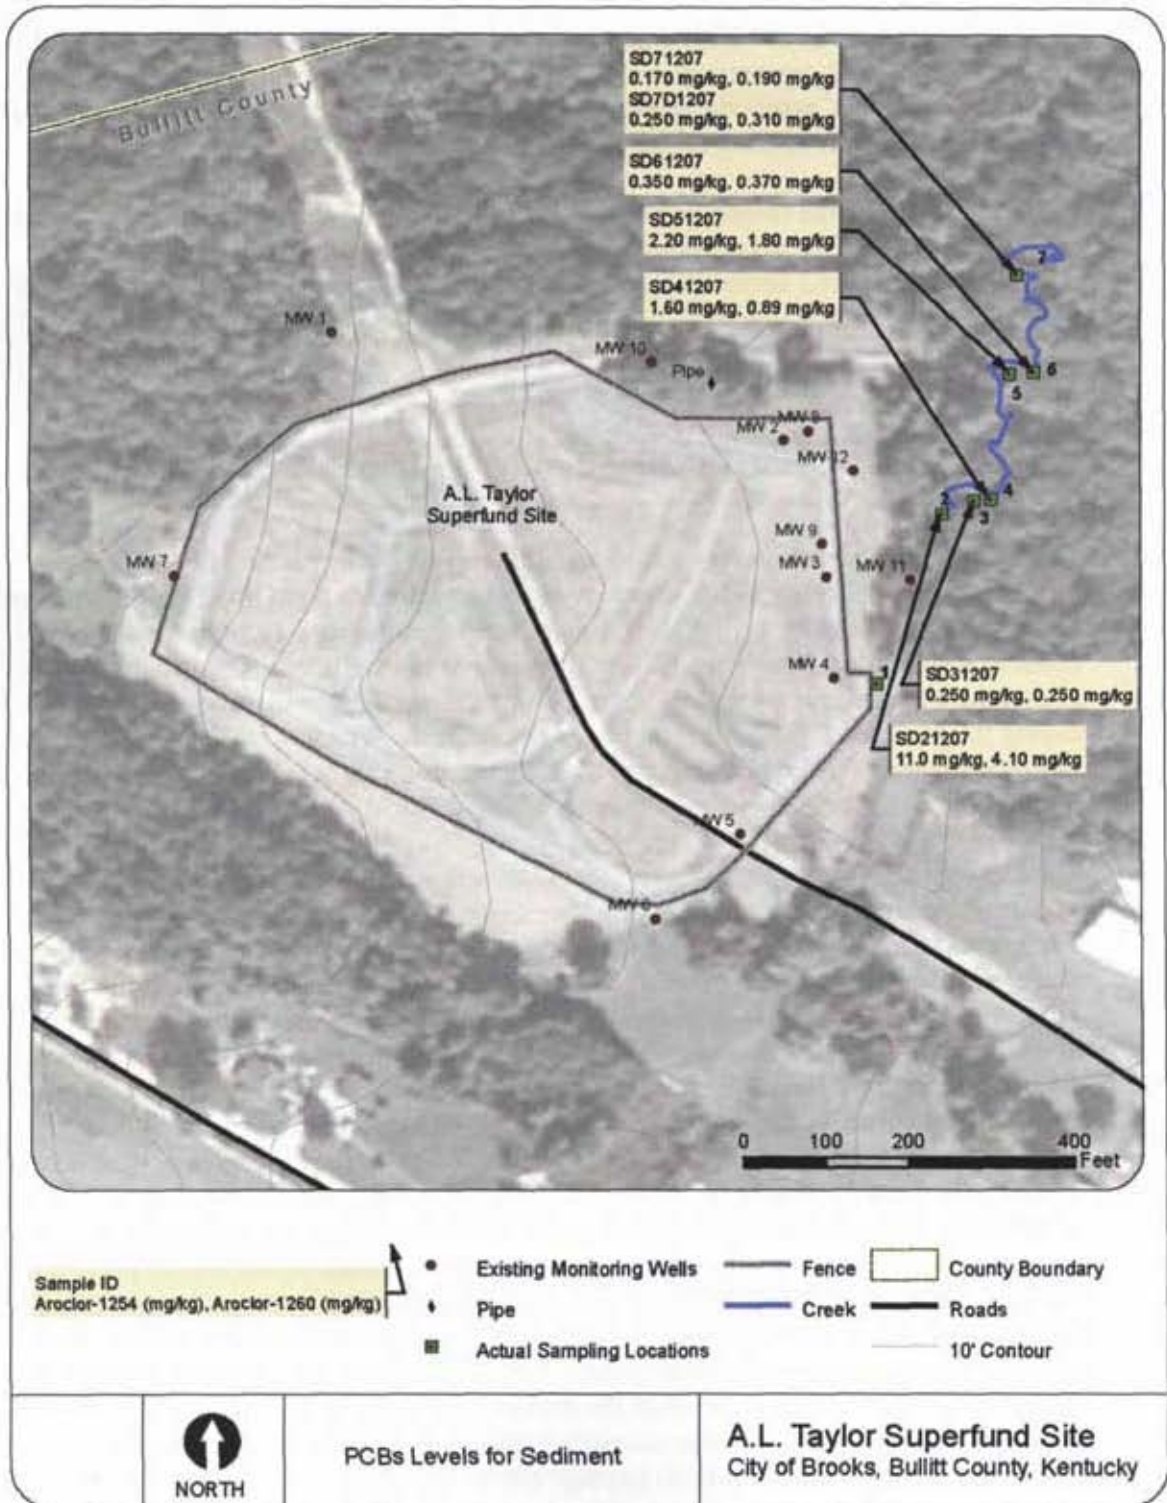
Figure 4: PCB Concentrations at Sediment Sample Locations in Wilson Creek

The previous FYR documented that PCBs were detected in sediment samples from Wilson Creek dating as far back as 1998. During the December 2007 sampling, PCBs were detected at six out of the seven sediment sample locations in Wilson Creek; Aroclor 1254 and Aroclor 1260 were the PCBs detected. The PCB concentrations at sample locations 2, 4, and 5 exceeded PRGs indicated in Table I-2 of Appendix I. While further investigation should take place to determine the source of this contamination, the contamination may be linked to the presence of hardened sludges that were found in Wilson Creek during the previous FYR. One sample of a hardened sludge was taken in January 2003, and was found to contain Aroclor 1254, which was also found in the most recent sediment samples at the Site. Based on observations during the Site inspection, the cap appears to be functioning properly and does not show signs of being compromised.

exceedances. However, PCB concentrations in Wilson Creek sediment samples exceed PRGs. PCBs were found to be a component of a hardened sludge sample. These and drum carcasses in Wilson Creek could be potential sources of PCB contamination in the Creek. Additional actions may be needed to prevent migration.
