BPMO NE/BH
Ser 09-170
June 10, 2009

FIVE YEAR REVIEW
for
Girard Point Management Area
at
Philadelphia Naval Business Center
Philadelphia, Pennsylvania

June 2009

**Naval Facilities Engineering Command
Second Five-Year Review (June 2004 to June 2009)
Girard Point Management Area
Philadelphia, Pennsylvania**

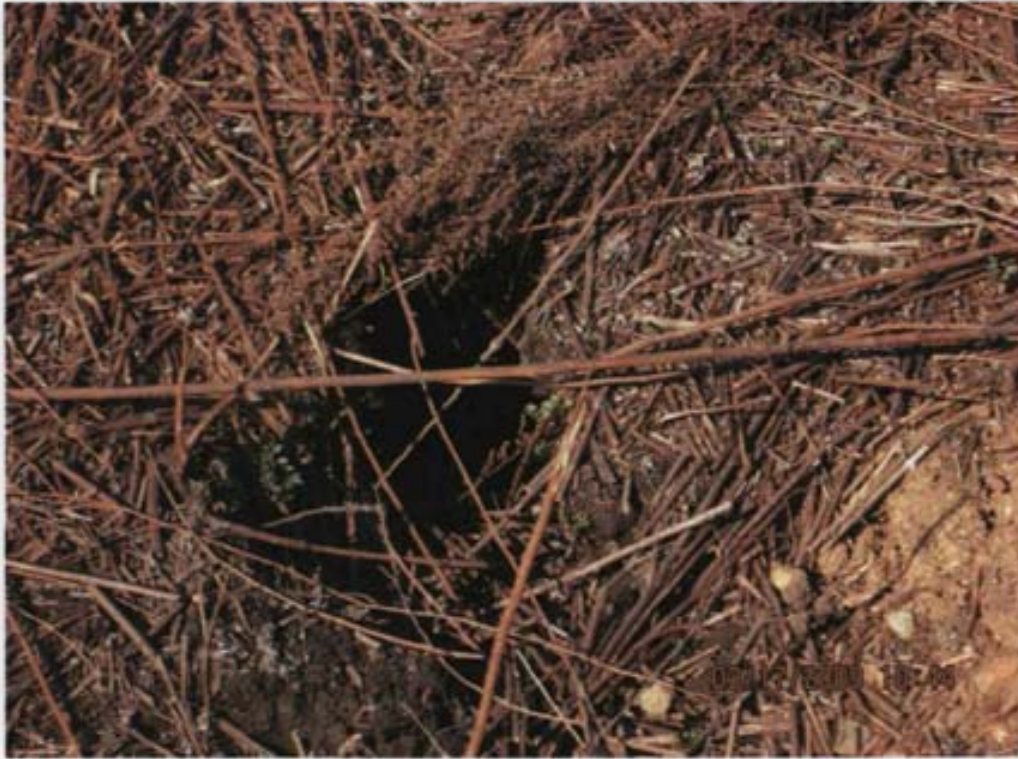
A small burrow hole was noted in the Zone A cap area.

Two burrow holes were noted in the Zone A cap area.

BURROW HOLE IN AREA A CAP

It is recommended that the burrow holes from small animals be repaired during the next O&M activities. The excavation from the water line capping project should be re-graded and reseeded.

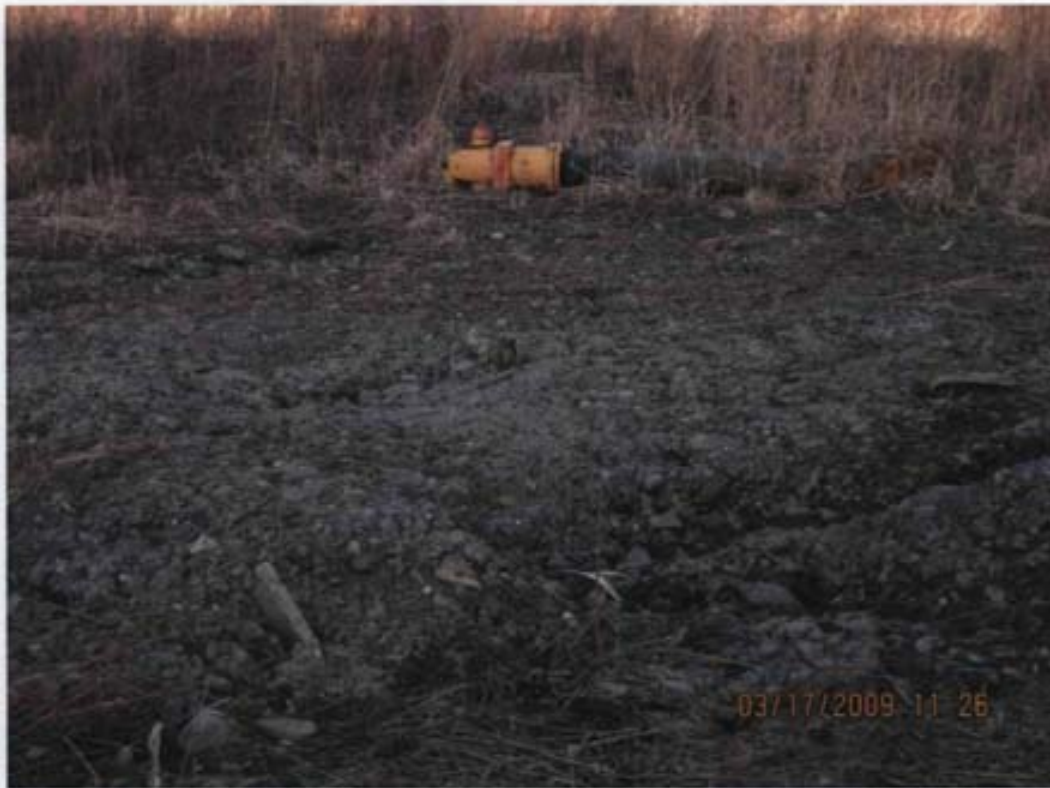
An excavation in Zone A in the right-of-way under the Girard Point Bridge was observed. This excavation was related to a water line capping project being conducted by PIDC. The excavation was backfilled, but not graded or seeded.

An excavation in Zone A in the right-of-way under the Girard Point Bridge was observed. This excavation was related to a water line capping project being conducted by PIDC. The excavation was backfilled, but not re-graded or seeded.

EXCAVATION FROM WATER LINE CAPPING PROJECT

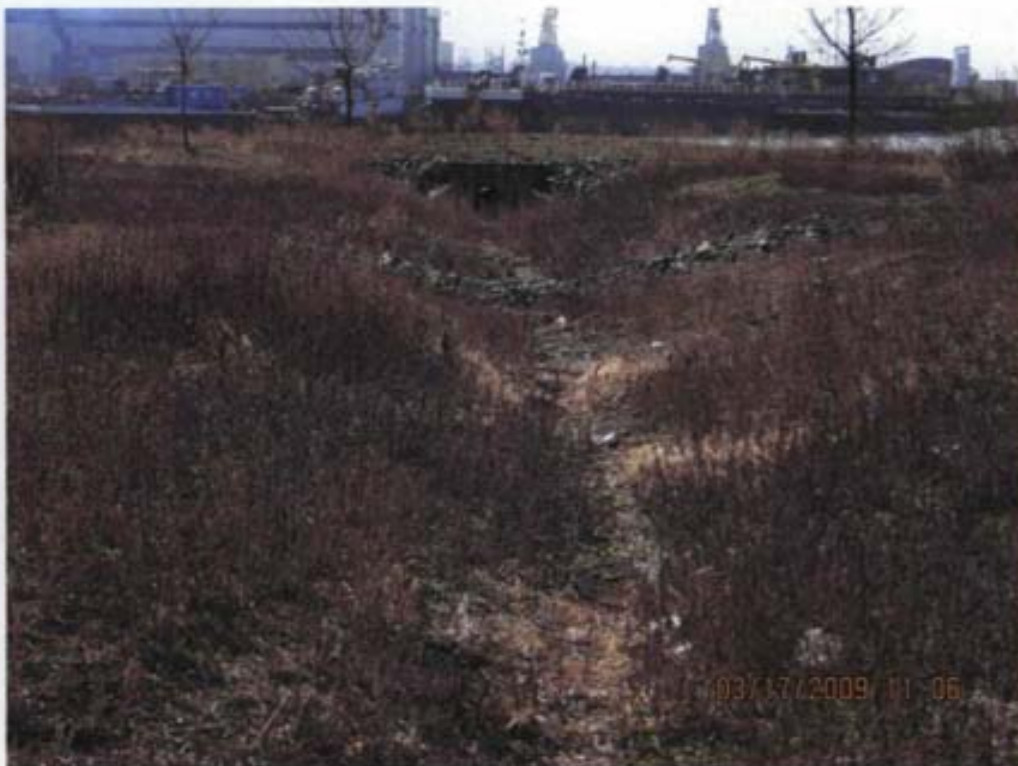
DRAINAGE SWALE IN AREA A

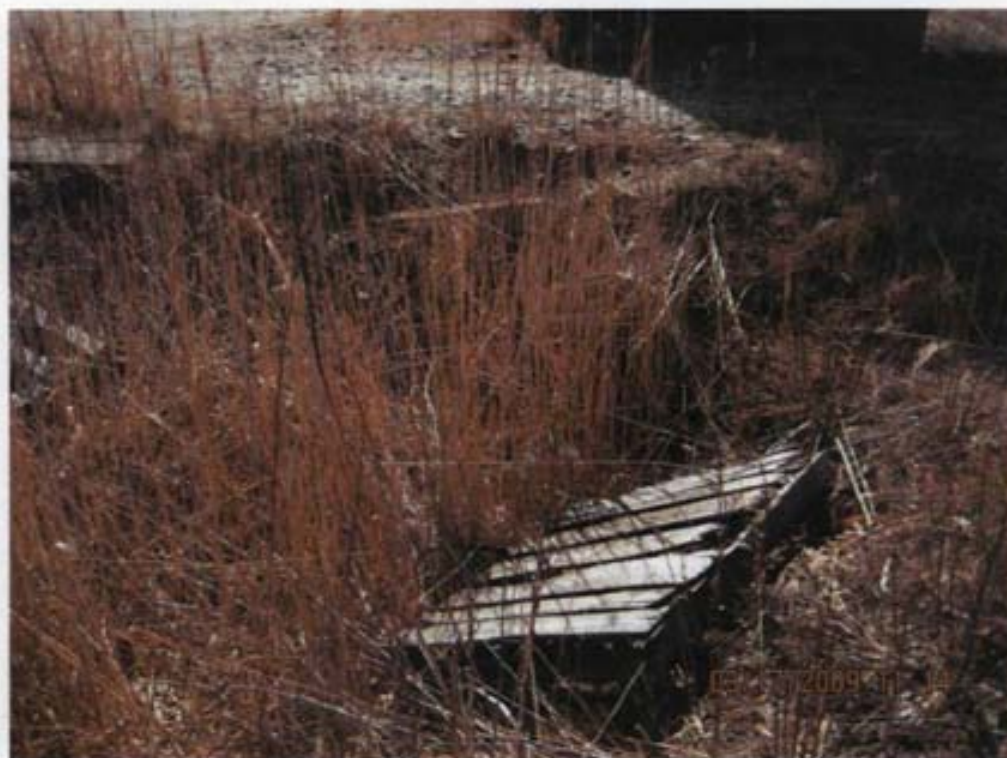
Nuisance dumping of small amounts of debris (e.g., pallets, empty drums) was observed, although the material dumped at the site does not appear to impact the remedy.

Nuisance dumping of small amounts of debris was observed, although the material dumped at the site does not appear to impact the remedy.

DEBRIS IN AREA A

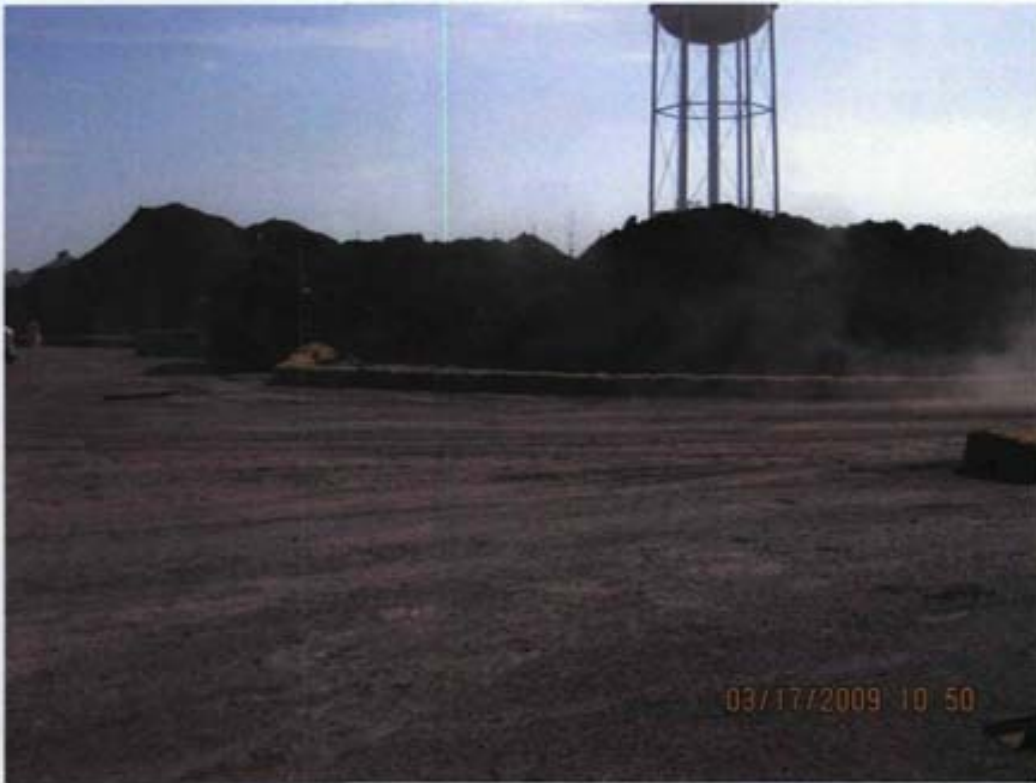
Soil excavated from storm sewer work along the roadway bordering the site was stockpiled on a portion of the asphalt cap in Zone B. The stockpile prevented a 100% inspection of the cap during the Five-Year Review. However, this area was inspected, and repairs made as needed, during O&M activities conducted in 2008.

AREA B CAP WITH SOIL STOCKPILE

It is recommended that the asphalt cap should be inspected after PIDC storm sewer construction activities on adjacent parcels is completed. The entire cap should undergo inspection due to the heavy equipment traffic. The area under the soil stockpiles that could not be observed during the Five-Year Review inspection should also be inspected and repaired as necessary.

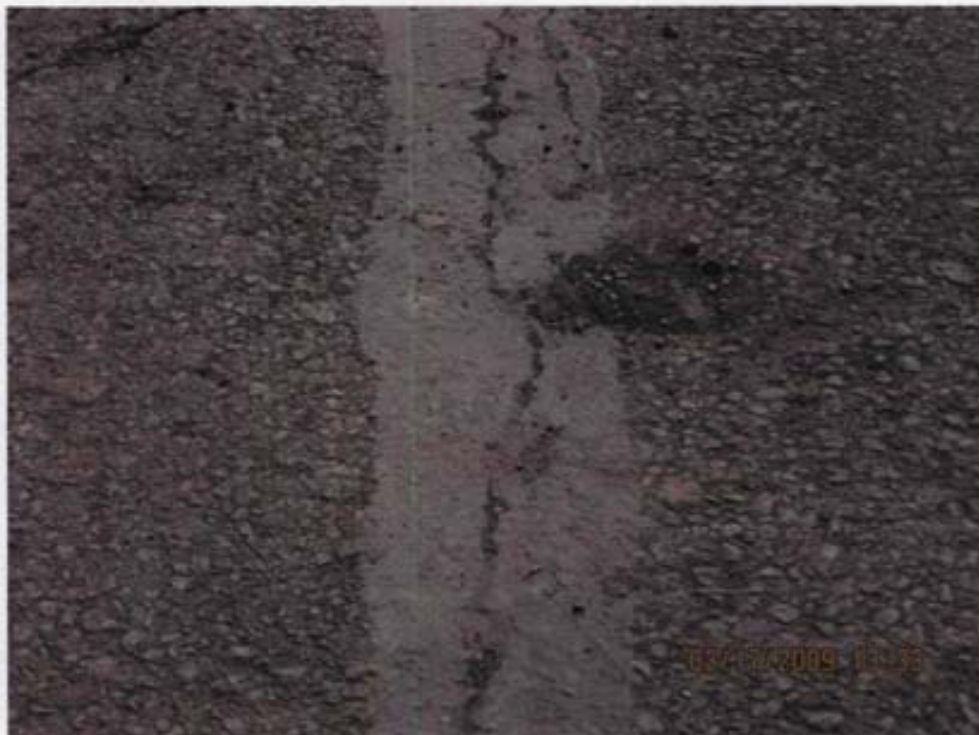
AREA B CAP SHOWING CRACK REPAIR

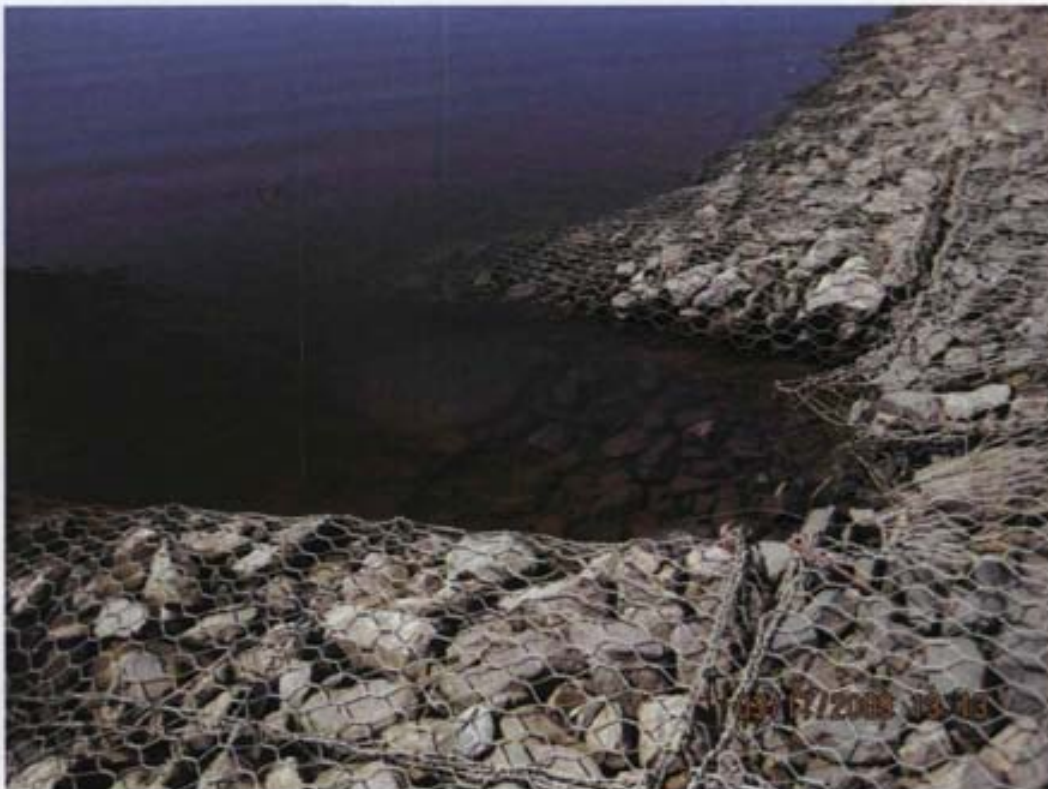
Several (approximately 5) gabion baskets have been dislodged at the toe of the gabion system, particularly in the area under the Girard Point Bridge. In addition, the wire mesh of one basket was torn. The overall integrity of the gabion system and shore stabilization component of the remedy is adequate.

DISPLACED GABION BASKET

It is recommended that the missing gabion baskets be replaced and that the basket with the torn mesh be repaired.

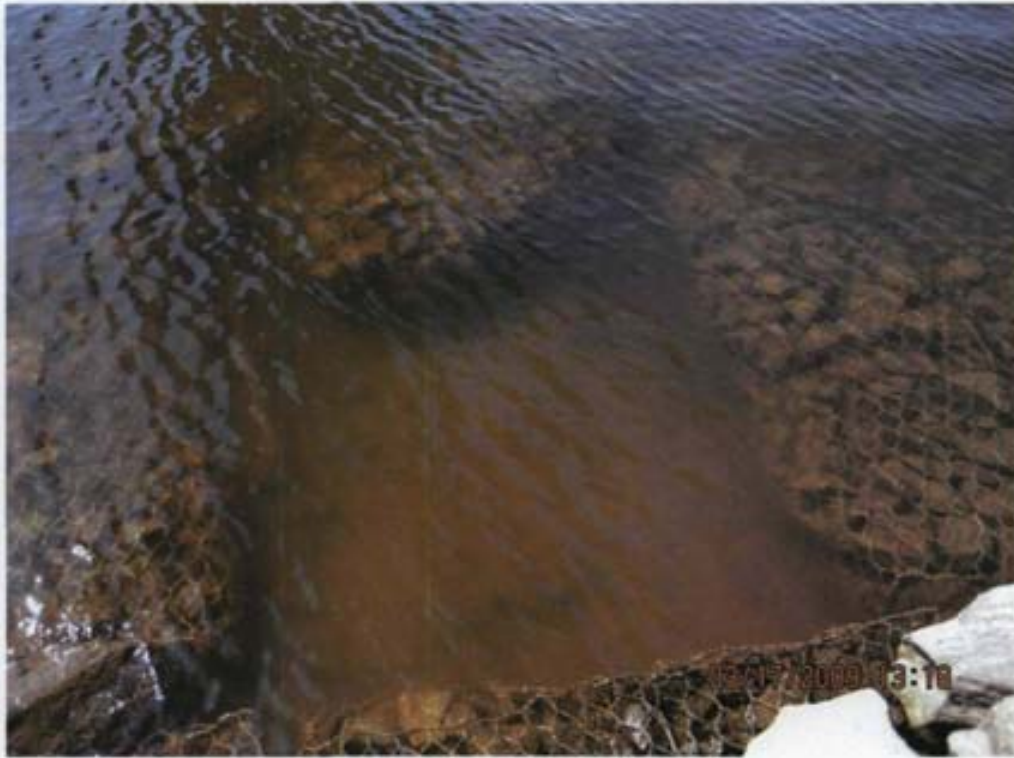
DISLODGED GABION BASKET

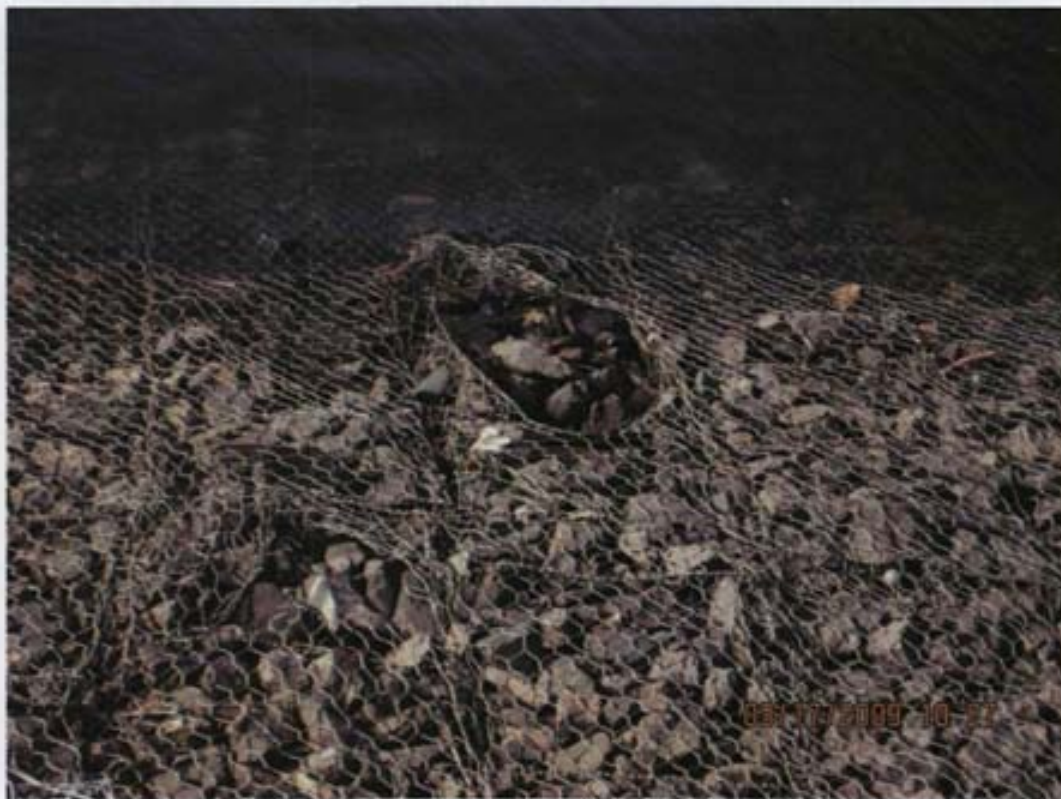
HOLE IN GABION MESH
