Third Five-Year Review Report  
for  
Raymark Industries, Inc. Site  
Stratford, Connecticut

September 2010

The United States Environmental Protection Agency  
Region 1, New England  
Boston, Massachusetts

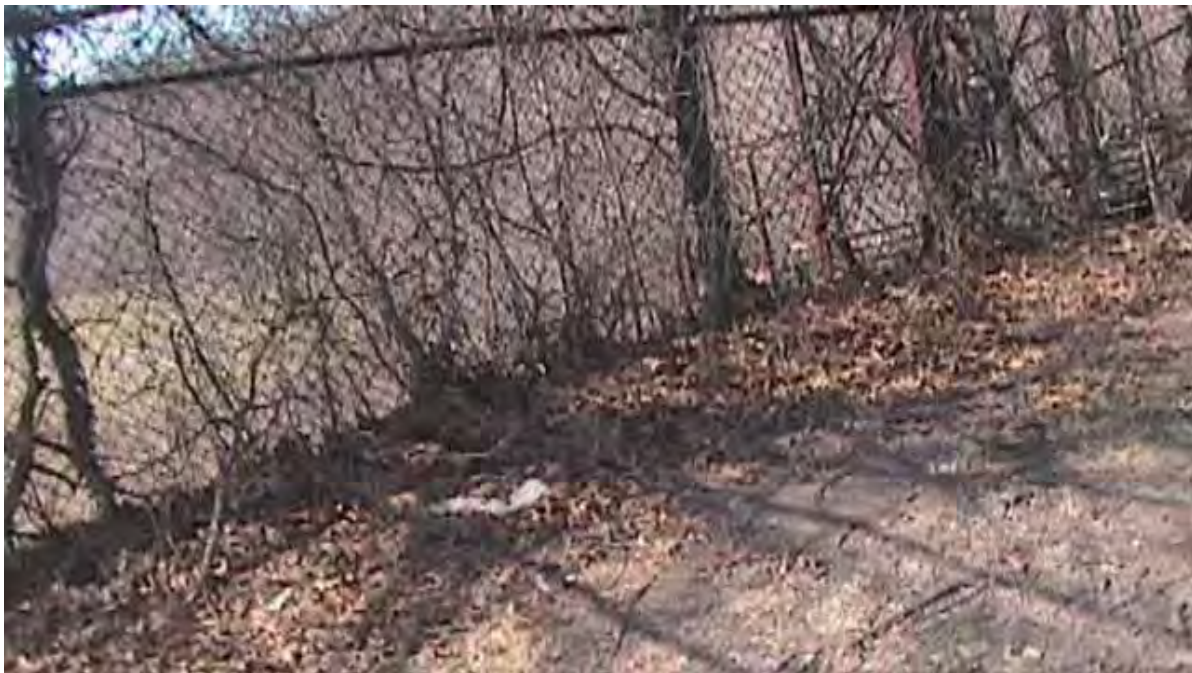
Neighboring the corner of Patterson and Frog Pond. Bleachers visible in background. Please note the lack of signage on fence.

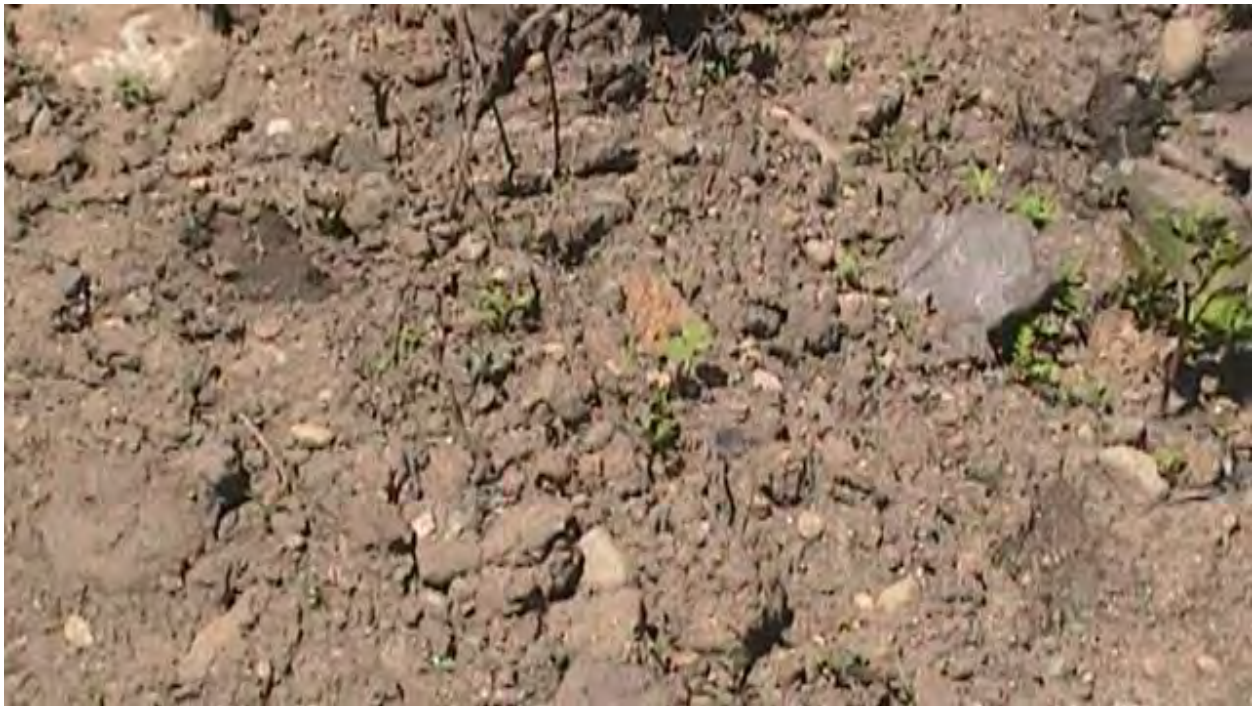
In 2009, 340 East Main Street required emergency response due to the unauthorized excavation of Raymark waste. The property owner excavated Raymark waste that was buried on the property and spread the Raymark waste on the surface of the property. CTDEP responded to the site on May 18, 2009 to evaluate the conditions at the property and on May 19, covered the excavated material with a membrane and clean fill. On May 20, 2009, EPA Emergency Response arrived on-site to secure additional areas where Raymark waste was placed and to decontaminate mechanical equipment used during the unauthorized excavation. The State of Connecticut filed suit for cost recovery of CTDEP's expenditure and a final injunction prohibits any future activity that could release Raymark waste.

Raymark waste disturbed by on-site activities.

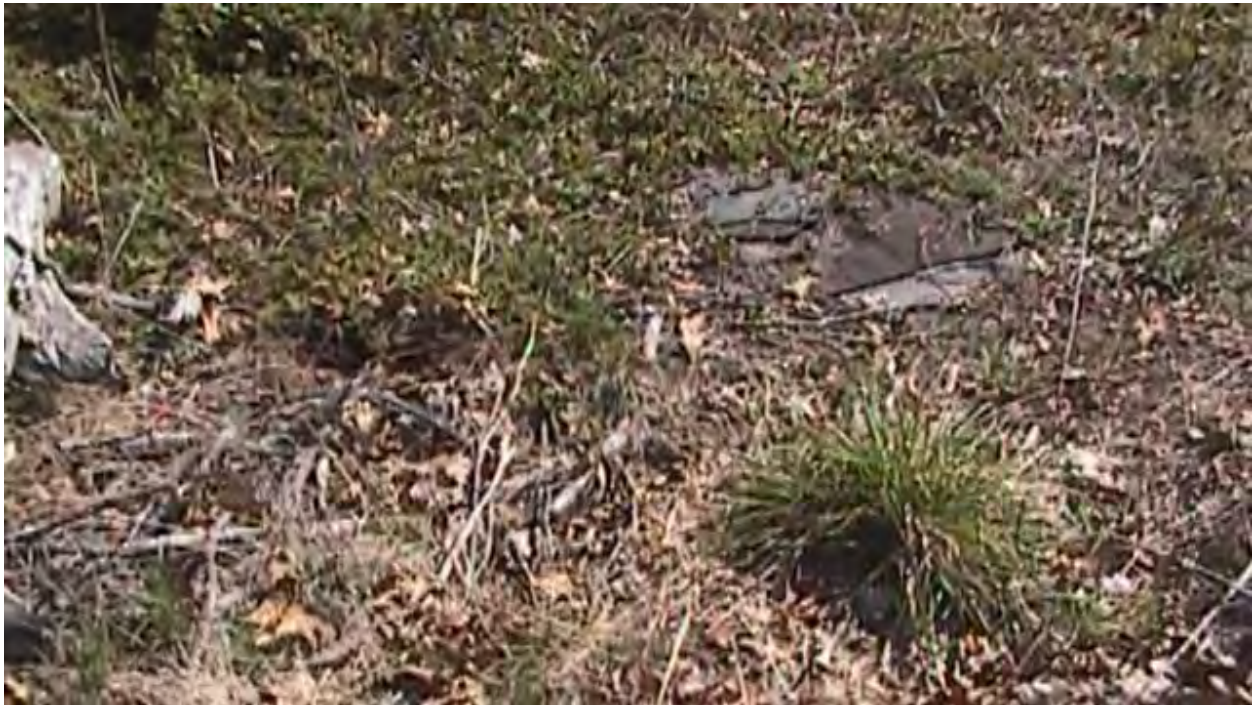
Waste dumping evidence.

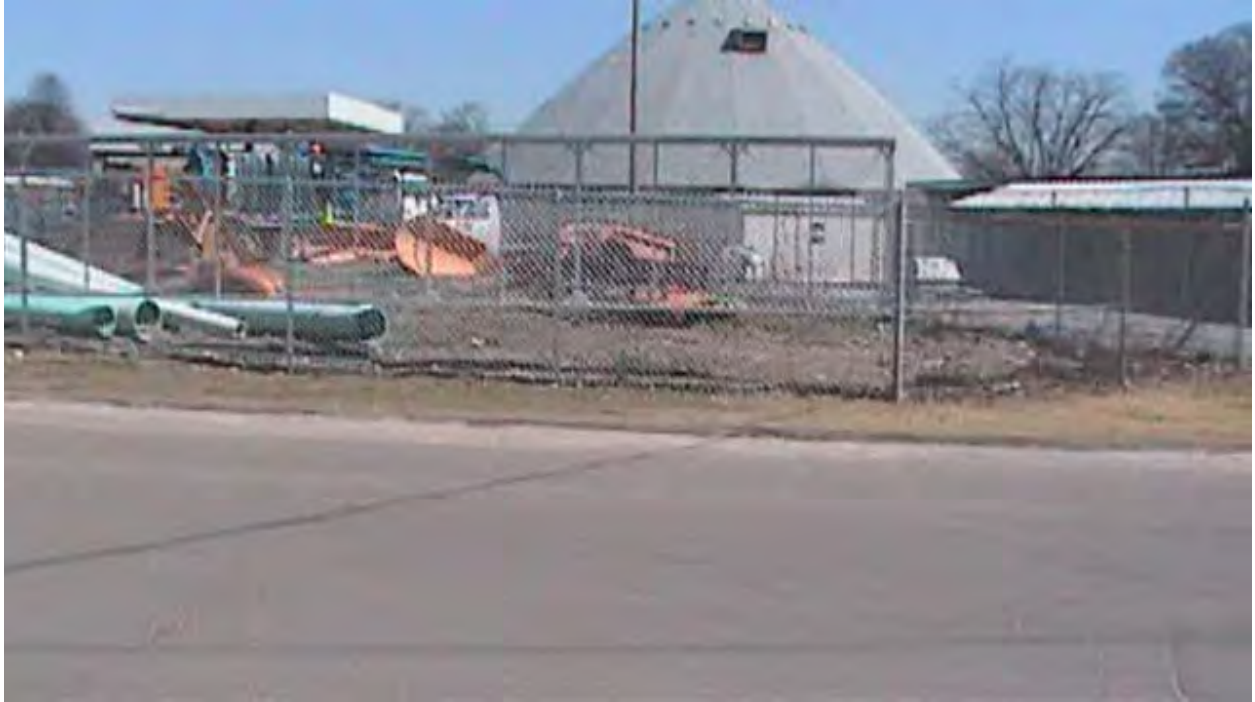
Area where Raymark waste was identified near dog pound.
