**Final**  
**Five-Year Review Report**  
**for**  
**Phoenix-Goodyear Airport (North and South Areas)**  
**Superfund Site**  
**Goodyear, Arizona**

September 2010

Prepared By:  
U.S. Environmental Protection Agency  
Region IX  
75 Hawthorne Street  
San Francisco, California 94105

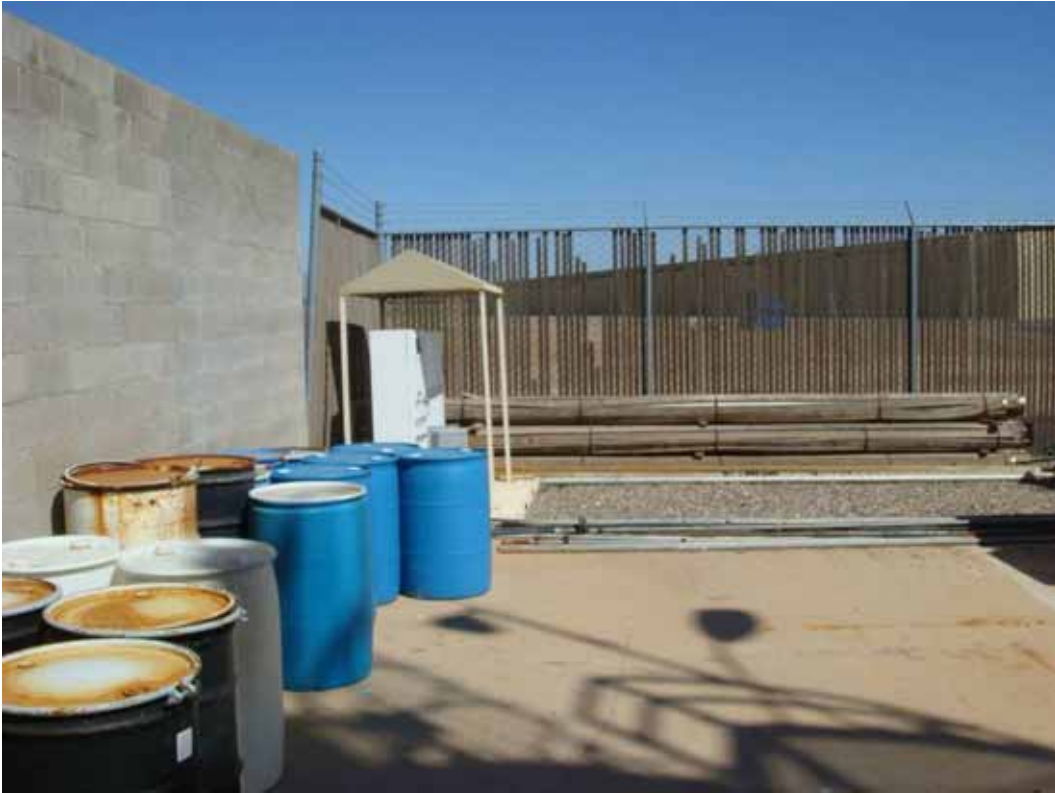
*Photo 10. PGAS Site Visit. Subunit A treatment compound showing unmarked drums, some of which contain material.*

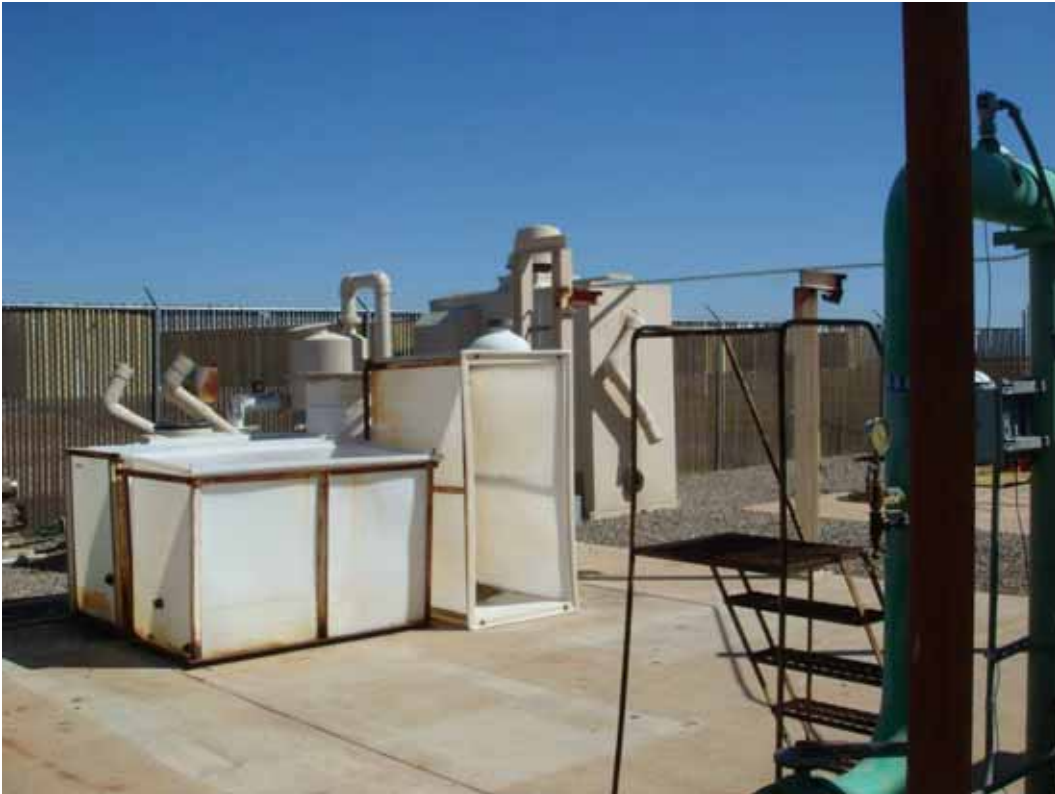
*Photo 11. PGAS Site Visit. Subunit A treatment compound showing decommissioned equipment.*

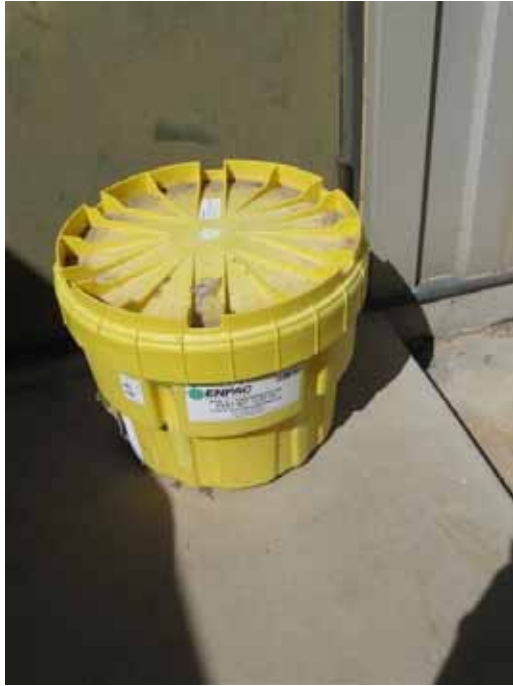
*Photo 24. PGAS Site Visit. Unlabelled container.*

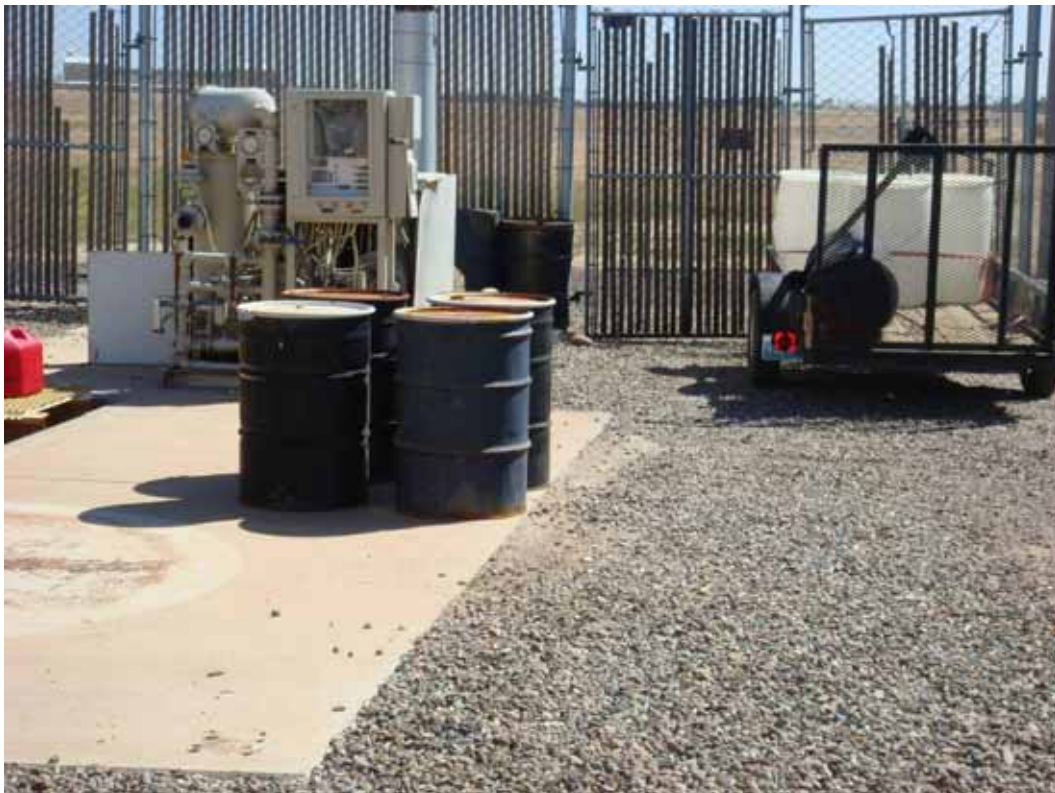
*Photo 27. PGAS Site Visit. Subunit A treatment compound showing unmarked drums and decommissioned SVE system.*
