Five-Year Review Report
Third Five-Year Review Report
for
Airco Plating Co.
FLD004145140

Miami
Miami-Dade County, Florida

September 2011

**Third Five-Year Review Report
for
Airco Plating Co.
3636 NW 46th Street
Miami
Miami-Dade, Florida**

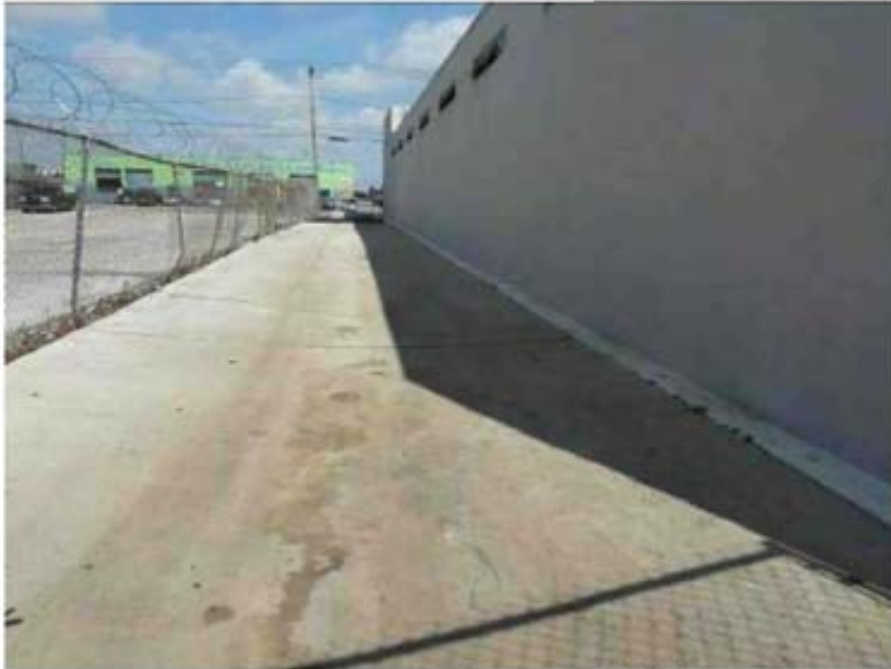
Cap on the west side of the Airco building.

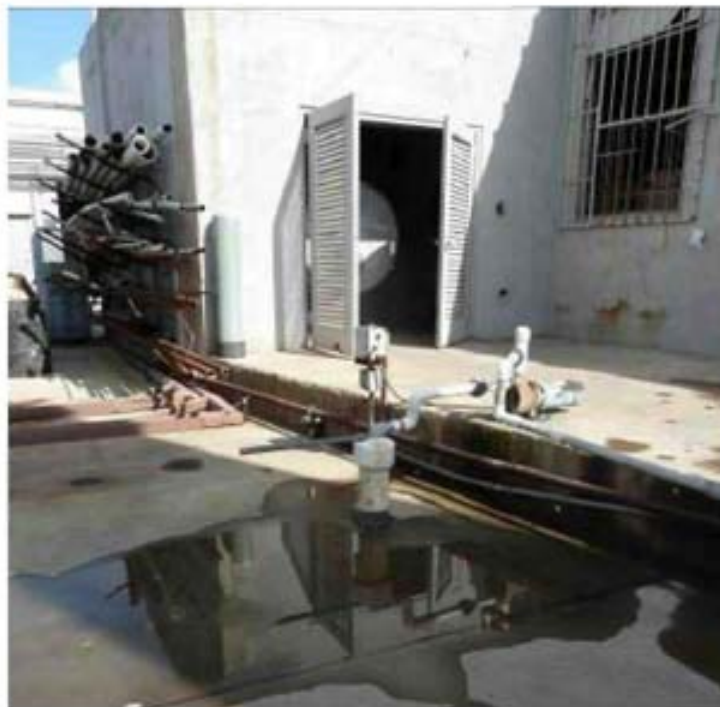
Recovery well (RW-4) within the Airco Plating Facility.

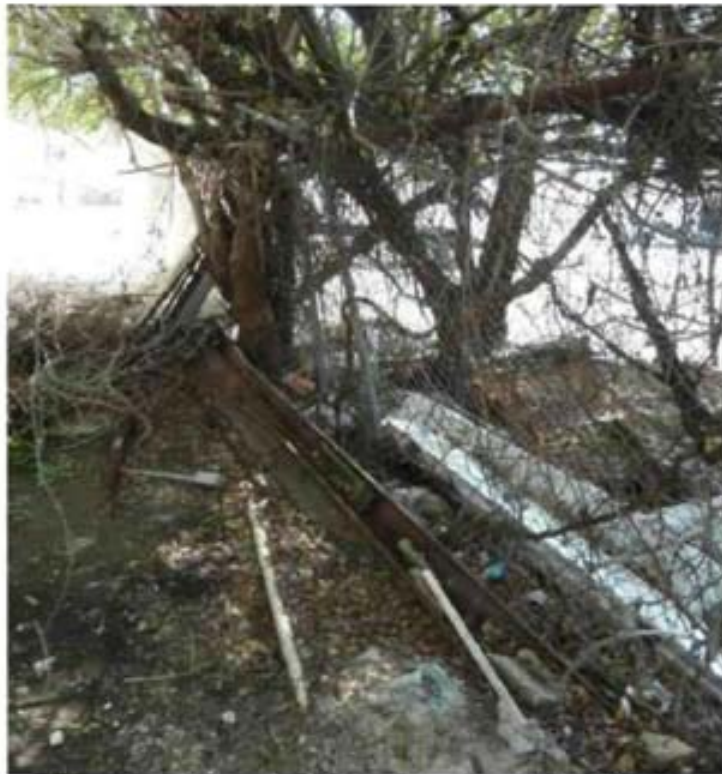
Fence and tree next to monitoring well (APS-5).

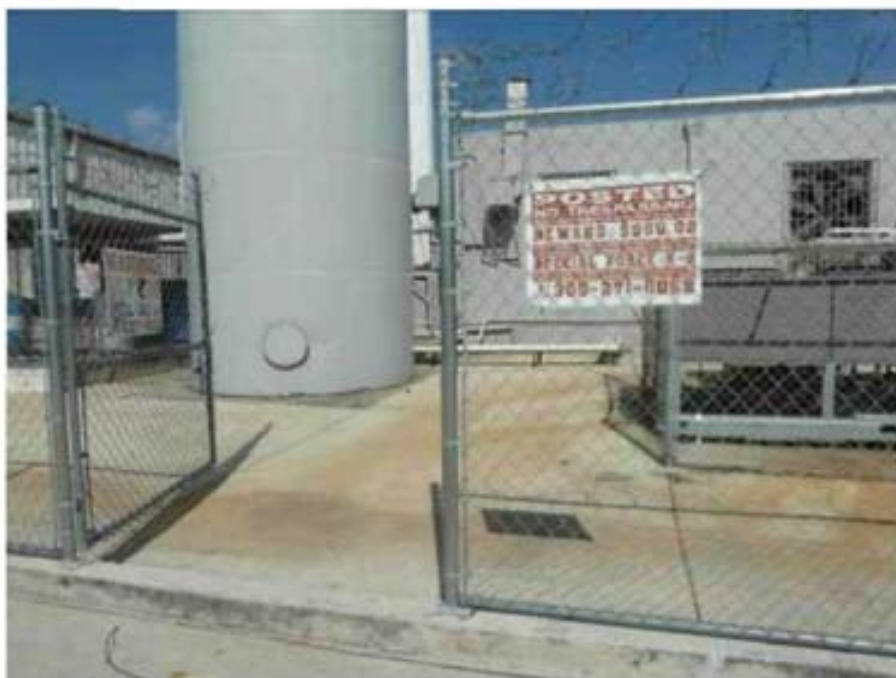
Warning sign and "no trespassing" sign.

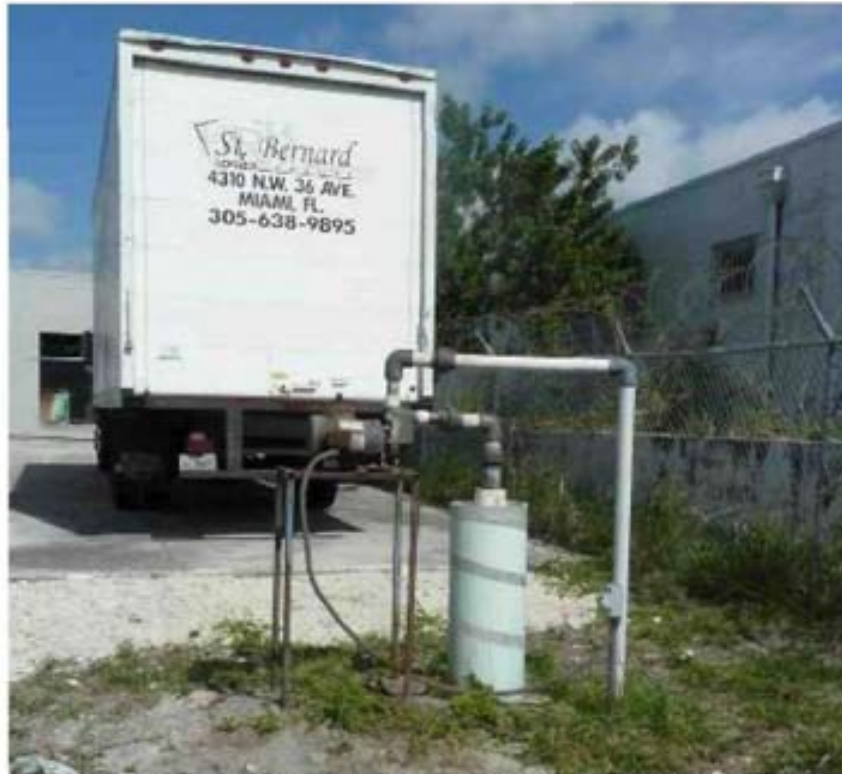
Recovery well (RW-1) and company truck parked on cap.

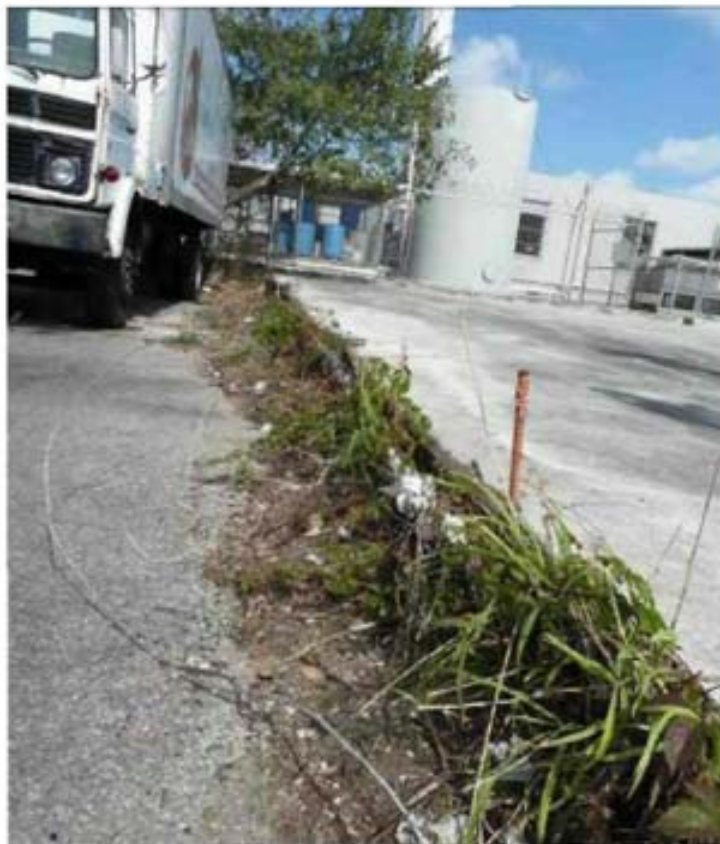
Cap on adjacent property where fence was removed.

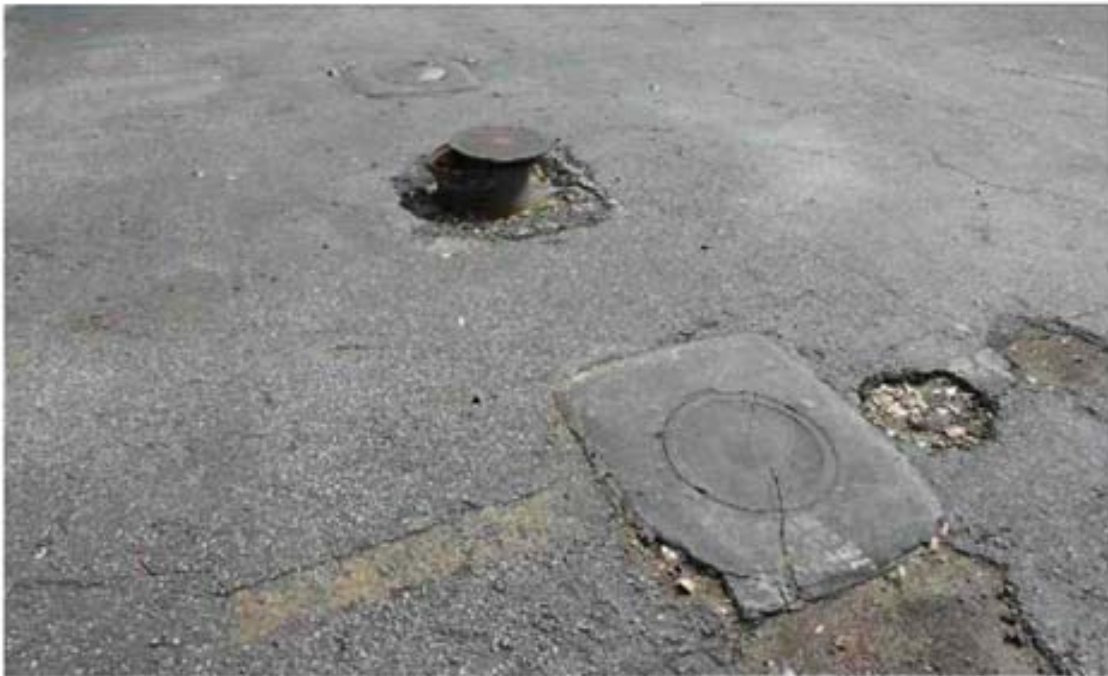
Monitoring wells cluster #2.

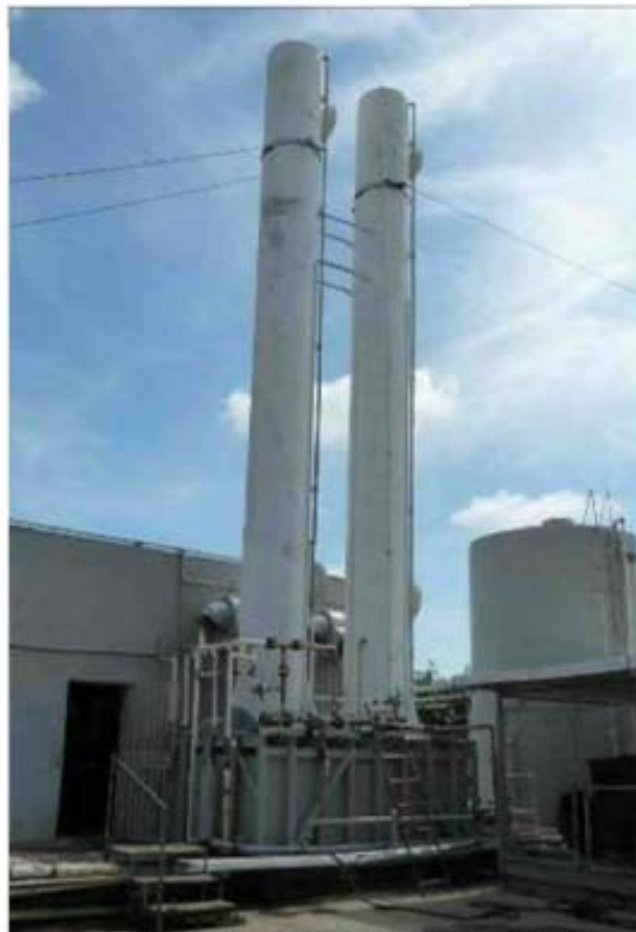
Air strippers at the Airco Plating Co. facility.

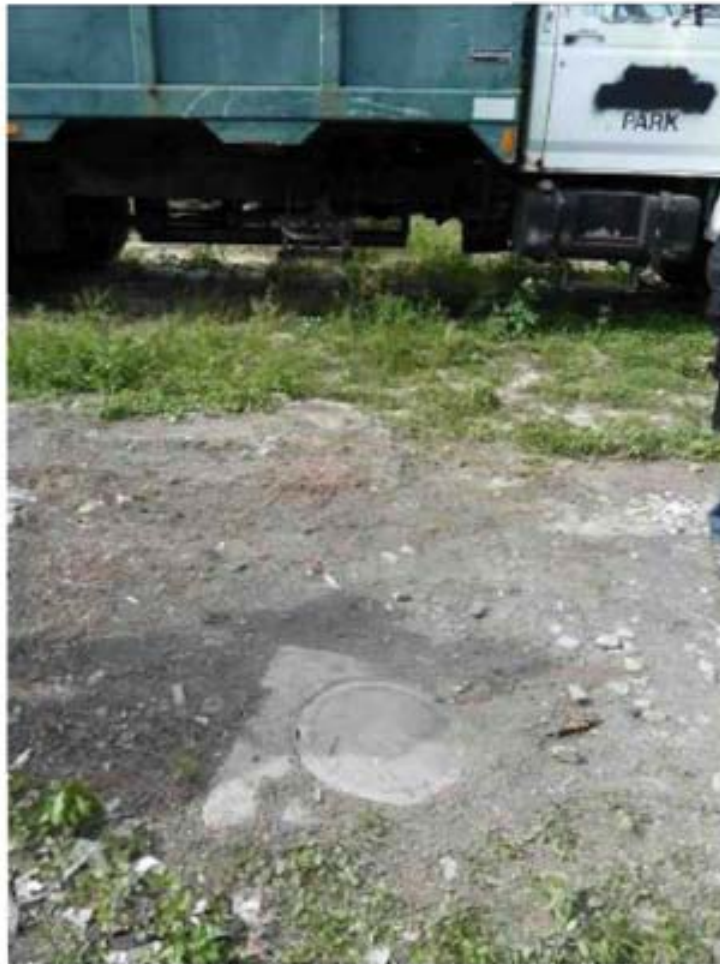
Monitoring wells cluster #1 on the Branif Auto Parts property.

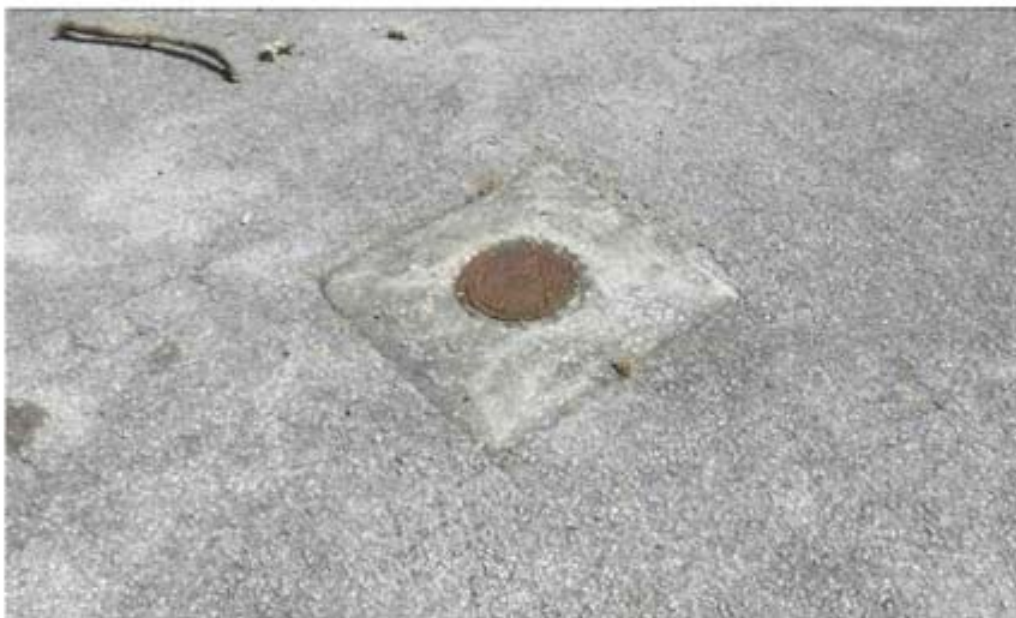
Unmapped monitoring well at neighboring parking lot.
