**SECOND FIVE-YEAR REVIEW REPORT FOR
LEY CREEK PCB DREDGINGS SUBSITE
ONONDAGA LAKE SUPERFUND SITE
ONONDAGA COUNTY, NEW YORK**

**U.S. Environmental Protection Agency
Region 2
New York, New York**

JAN. 17, 2012

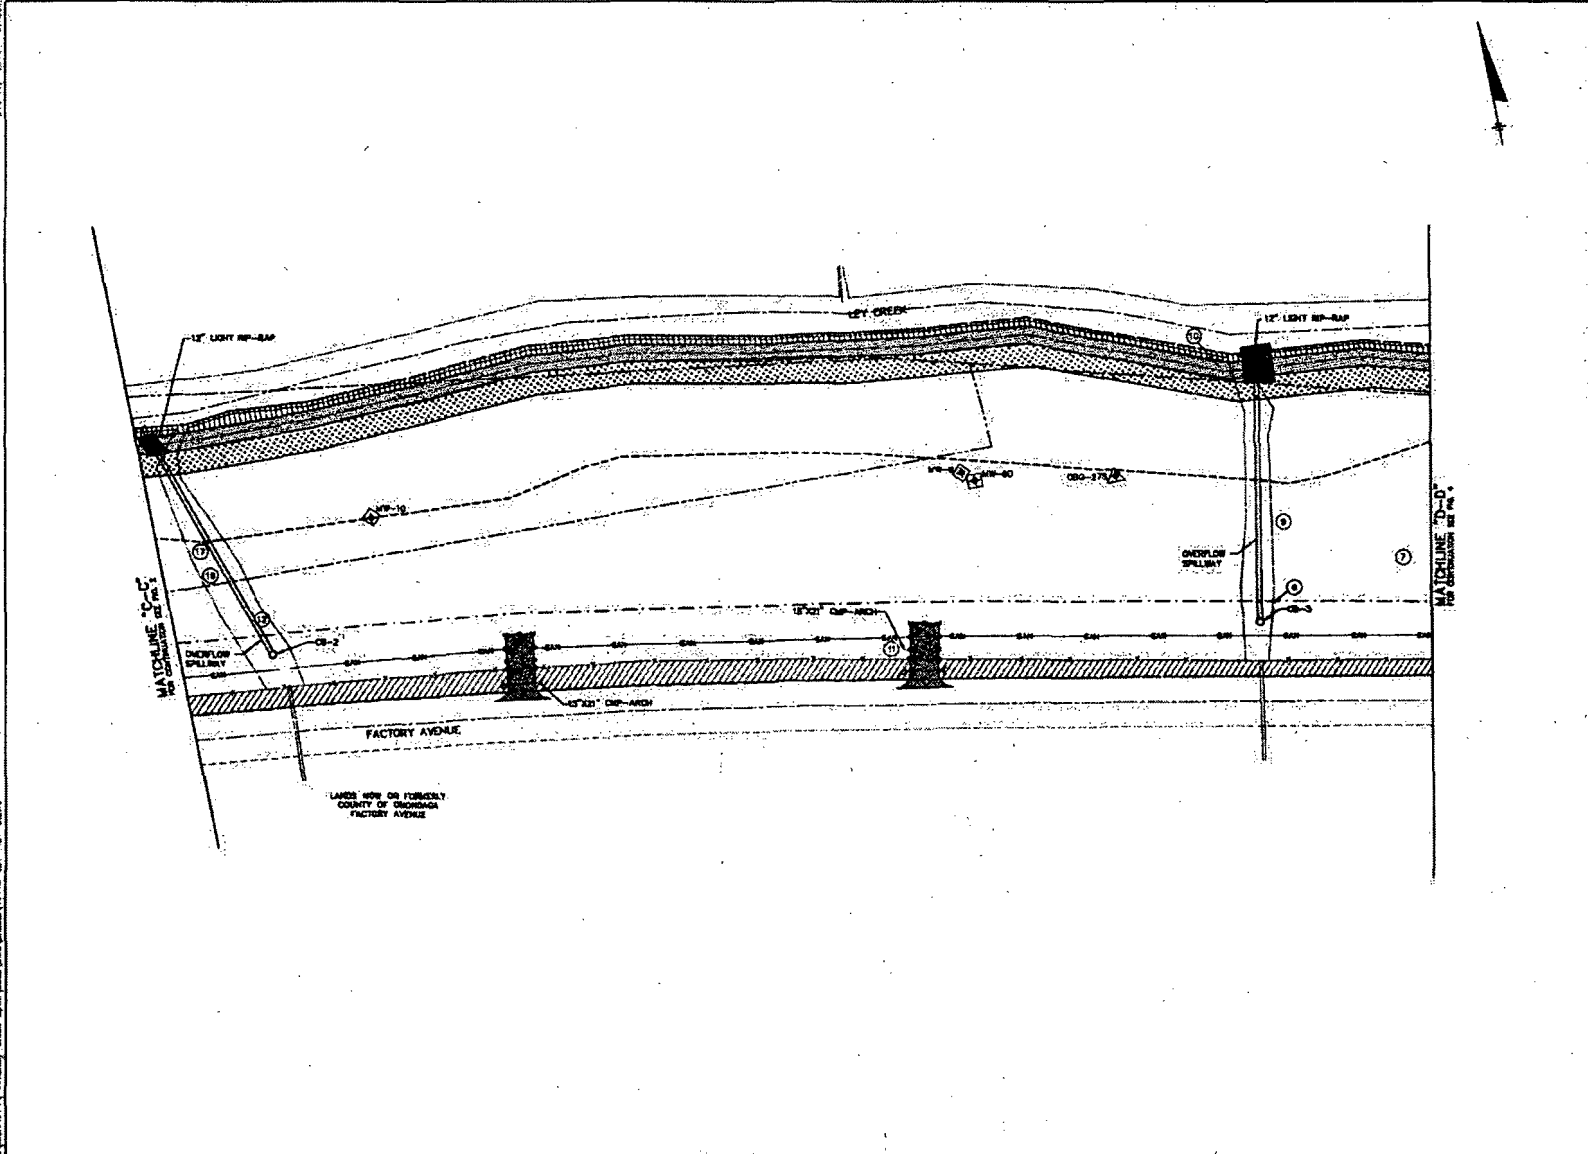
Figure 4

OCTOBER 2010
O&M INSPECTION
PARTIAL SITE PLAN
