**FINAL  
FIRST FIVE-YEAR REVIEW  
FOR THE  
ROCKWOOL INDUSTRIES, INC. SUPERFUND SITE  
BELTON, BELL COUNTY, TEXAS**

September 2012

REGION 6  
UNITED STATES ENVIRONMENTAL PROTECTION AGENCY  
1445 Ross Avenue  
Dallas, TX 75202-2733

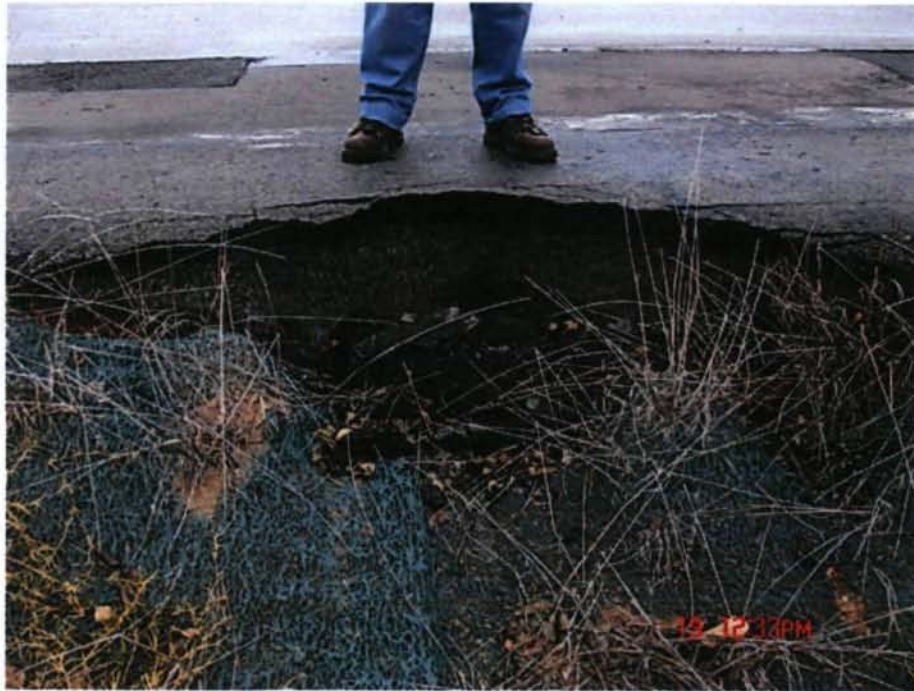
**Undated photograph of erosion damage to the Matcon cap.**

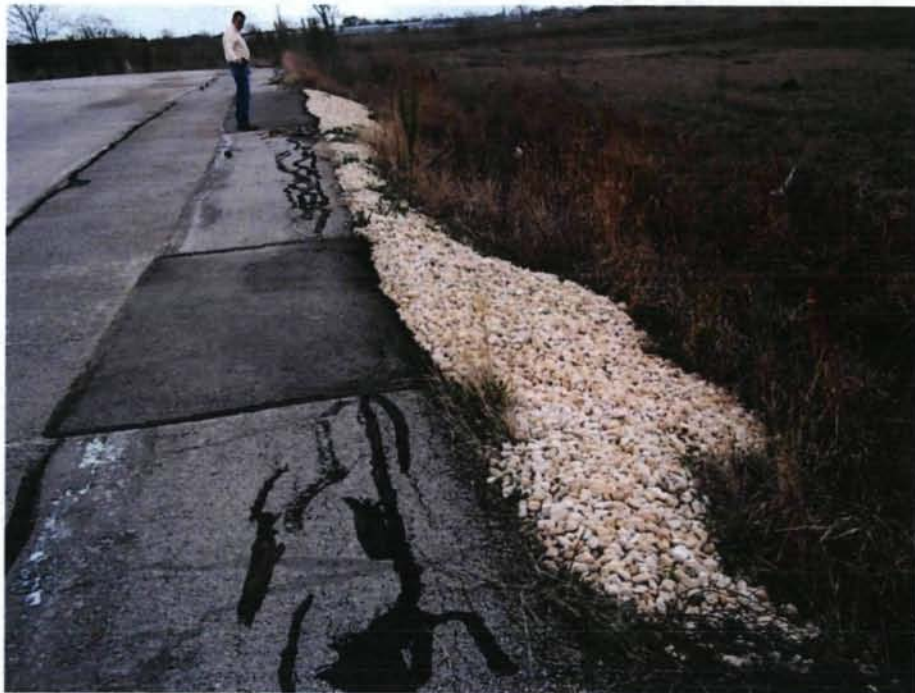
EPA was to conduct the O&M for the first year after completion of the remedial action, and TCEQ was to assume O&M activities after the first year. However, the State (TCEQ) has not yet assumed the O&M phase as TCEQ considered damage on the periphery of the Matcon cap as not acceptable. TCEQ is scheduled to begin conducting O&M at the site later this year, except that EPA will continue O&M of the Matcon cap until the damages to the Matcon cap are addressed and TCEQ assumes O&M for the whole site. The City of Belton mows the property 2-3 times per year. EPA conducted baseline groundwater sampling and groundwater elevation measurements on December 18-20, 2006 and January 9-11, 2007 (EA, 2007). The groundwater analytical data is included in **Table 3**, the groundwater elevation data is given in **Table 6**, and a review of the data is given in **Section 6.3**. EPA has been making periodic repairs of cracks to the Matcon cap, and in September of 2010 EPA completed repairs of the erosion damage of the southern edge of the Matcon cap. **Figure 10** shows an example of the damage and repairs to the Matcon cap.

**Repaired erosion damage to the Matcon cap, March 17, 2011 photograph.**

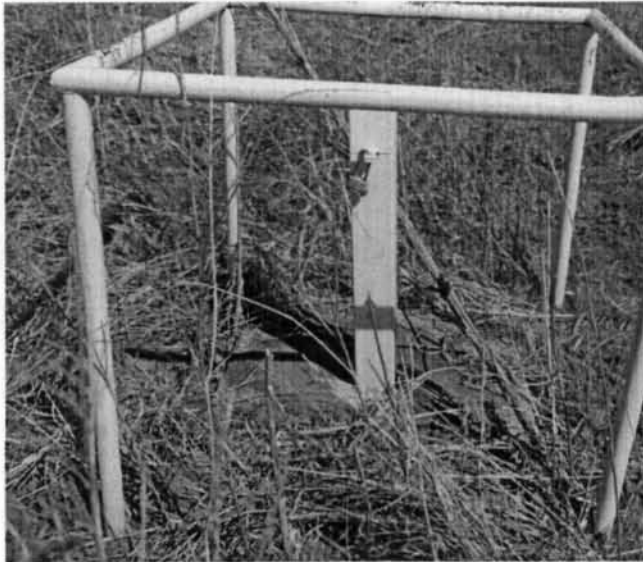
Photo 5. MW-14, has no identification marker

1. All unused monitoring wells should be plugged and abandoned.
2. Install warning signs in the areas where they are missing.
3. Remove the trees growing out of the ACB as specified in the O&M Plan.
4. Monitor the ACB to avoid loss of blocks and erosion of the bank.
5. Clear out all the CMPs at the site.
6. Patch the cracks in the outfall for the CMP in the stabilized LRB.
7. In areas with capped waste and with sparse vegetation the vegetation needs to be re-established to provide erosion protection.
8. The erosion near the edge of the capped EVL should be repaired and addressed in a manner to reduce or prevent future erosion.
9. Site inspections should be conducted as specified in the Operations and Maintenance Plan and as specified in the institutional controls documents.

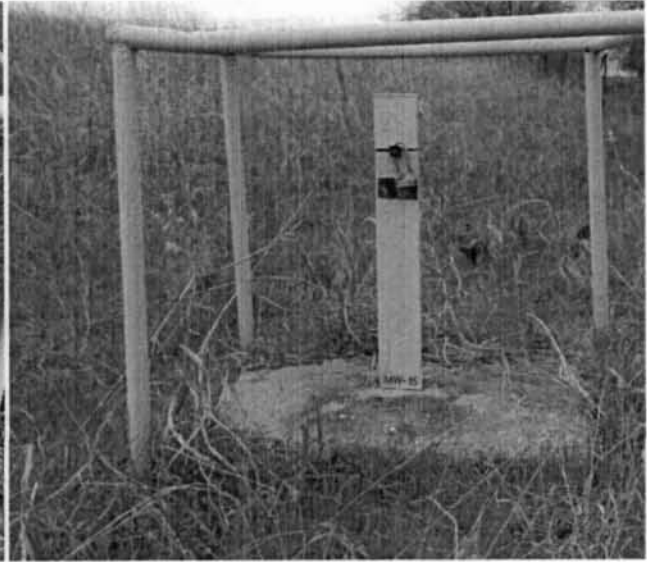
Photo 6. MW-15, identification marker has fallen off

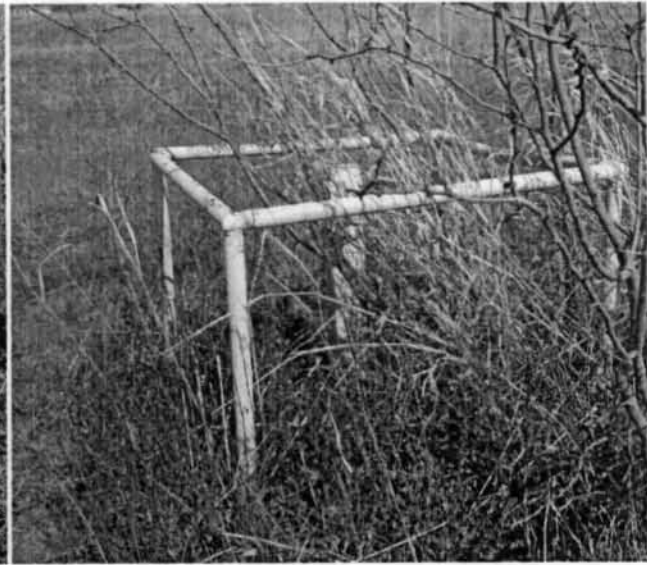
Photo 8. MW-17, has no identification marker,  
overgrown

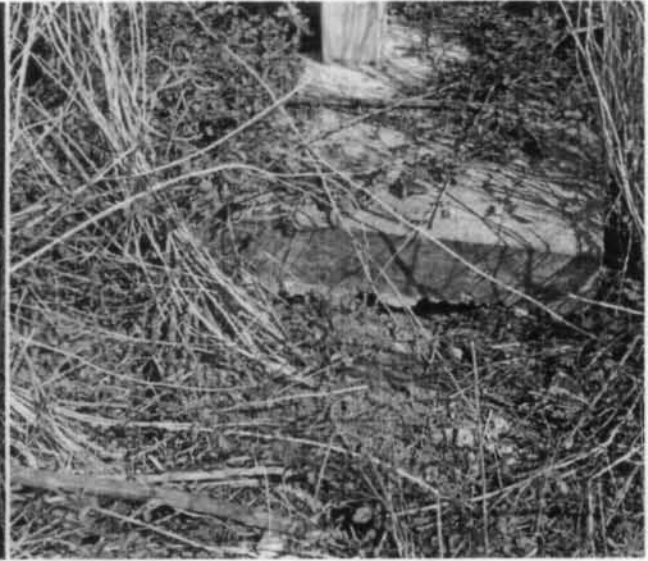
Photo 18. MW-28-90, soil has eroded out beneath the well pad.

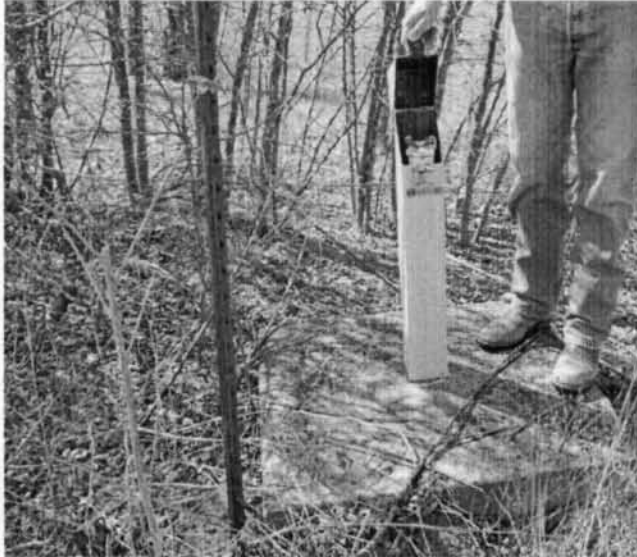
Photo 21. MW-33-90, well is missing the lock

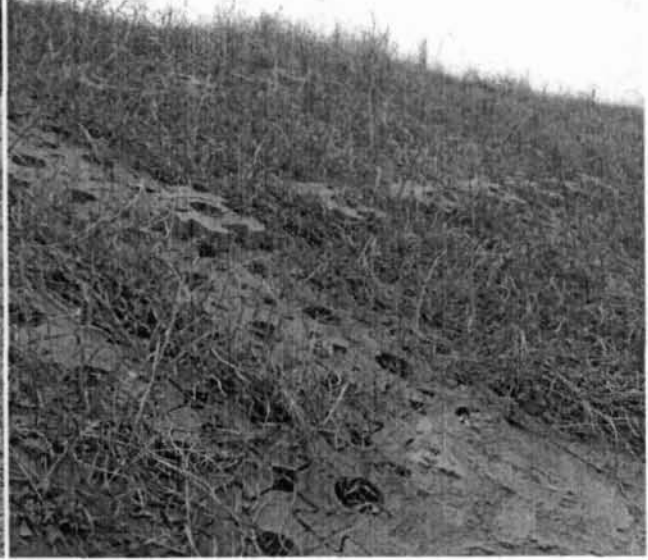
Photo 28. Looking west at ACB from the eastern edge.  
Note the raised concrete blocks.

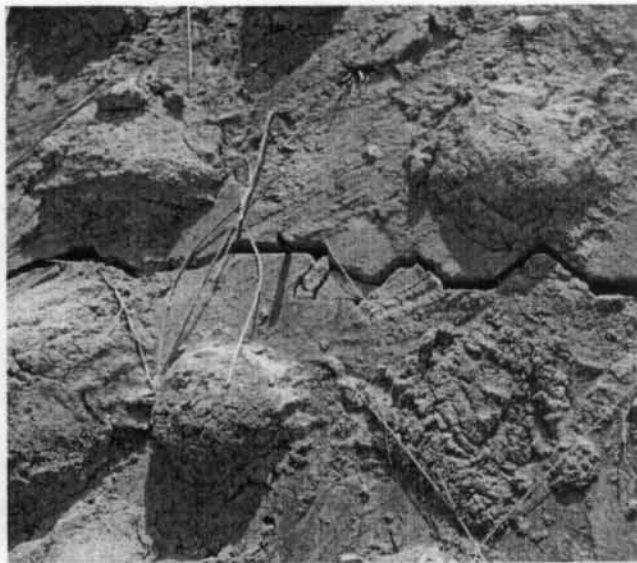
6. The concrete outfall to the CMP in the stabilized LRB is cracked. The cracks are sufficiently large to possibly allow water to erode and undermine the outfall.

Photo 33. Crack in concrete CMP outfall, the writing pen placed in the crack indicates the depth of the crack.

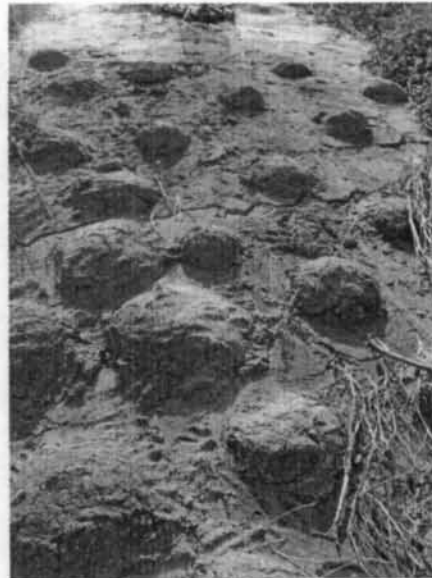
Photo 34. Crack in concrete CMP outfall.

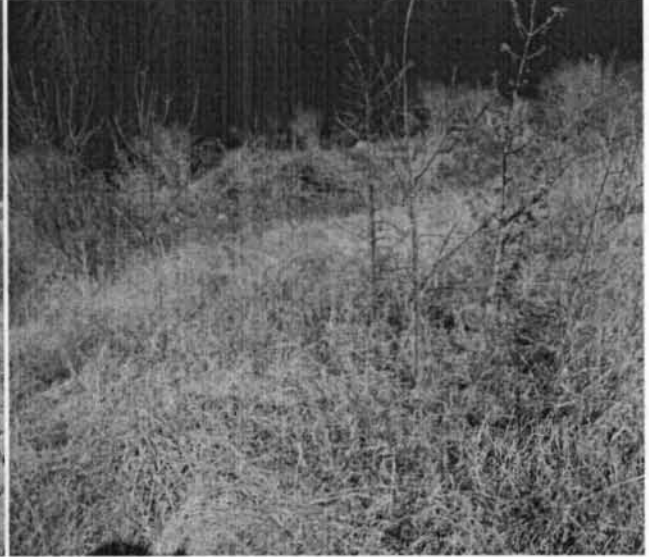
Photo 36. Small trees growing out of the ACB.

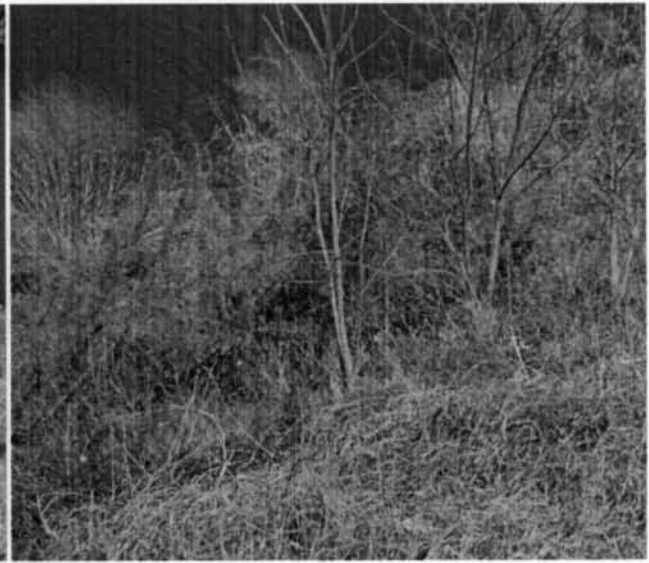
Photo 38. Small trees growing out of the ACB.

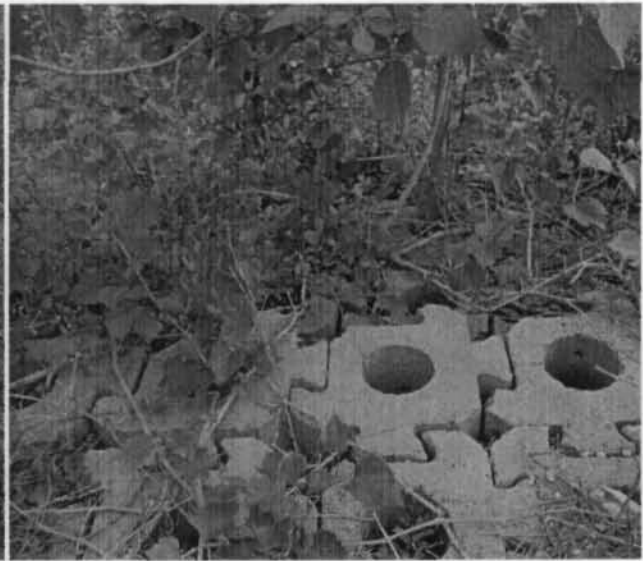
Photo 42. Instability and loss of continuity in the ACB at the toe of the LRB.

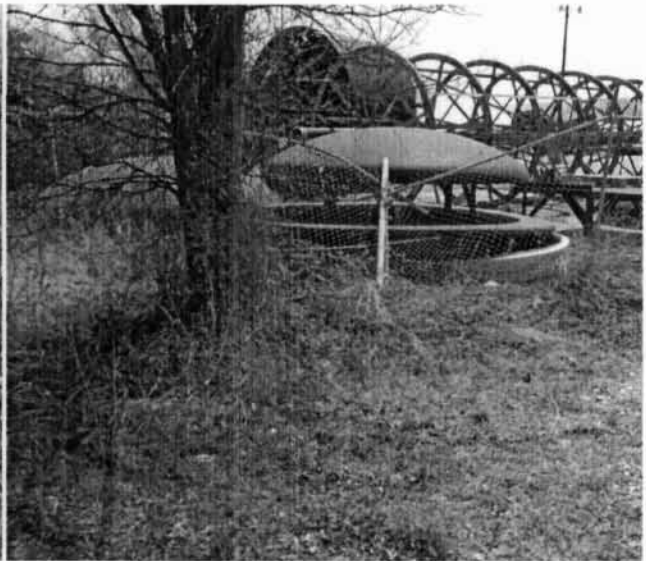
Photo 46. Damaged fence at the northwest corner of the paved parking area.

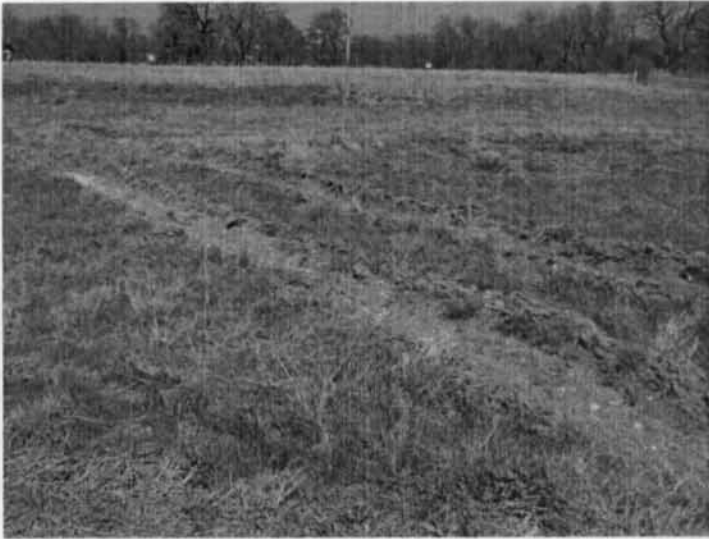
Photo 47. Wheel ruts and grass cover damage in the area between the paved parking area and the EVL in the background.

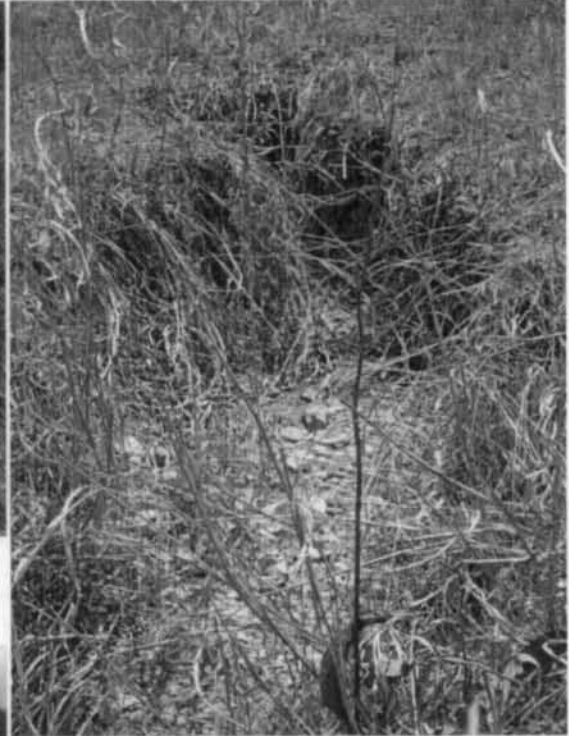
Photo 48. Erosion in EVL area about 25 feet west of well MW-35-90.

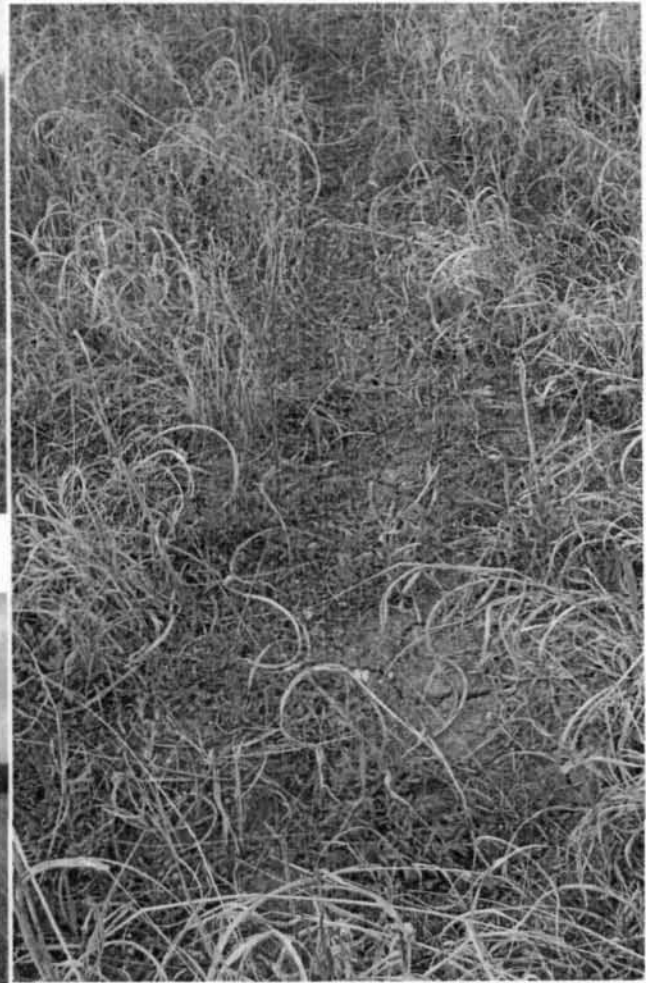
Photo 51. Small cracks in the cover on the top of NSP.

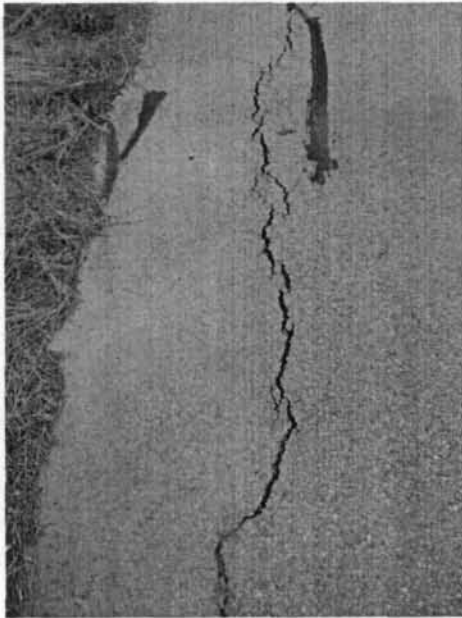
Photo 58. Unpatched cracks.

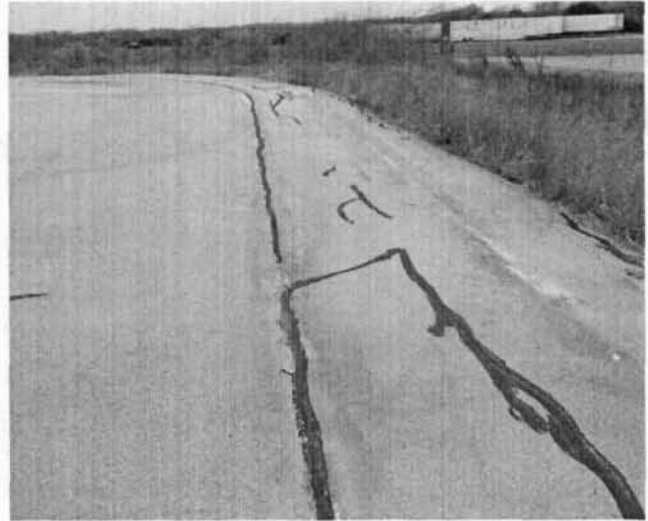
Photo 59. Patched cracks and asphalt repair area.

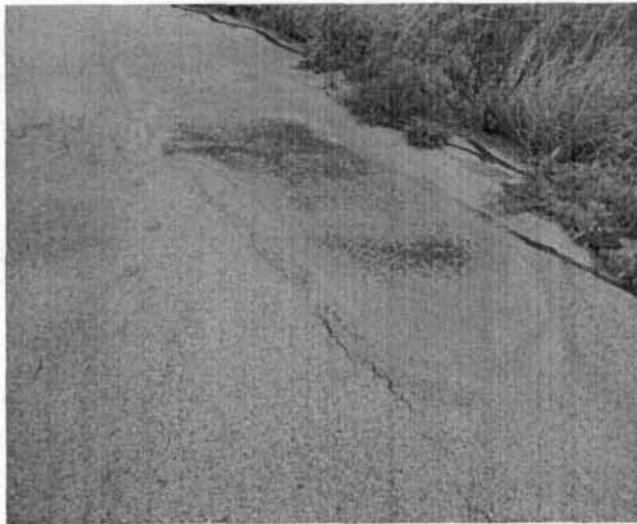
Photo 60. Area where water stands near the edge.

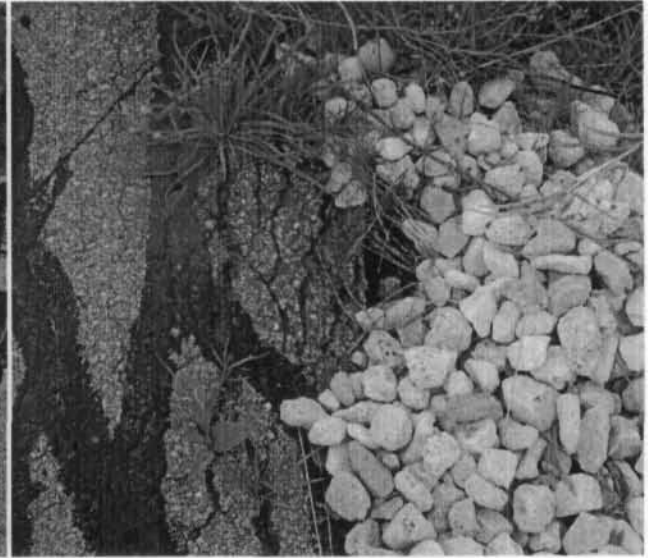
Photo 63. Rip rap along the southern edge of the CC. The hole in the rip rap indicates that erosion may still be occurring.

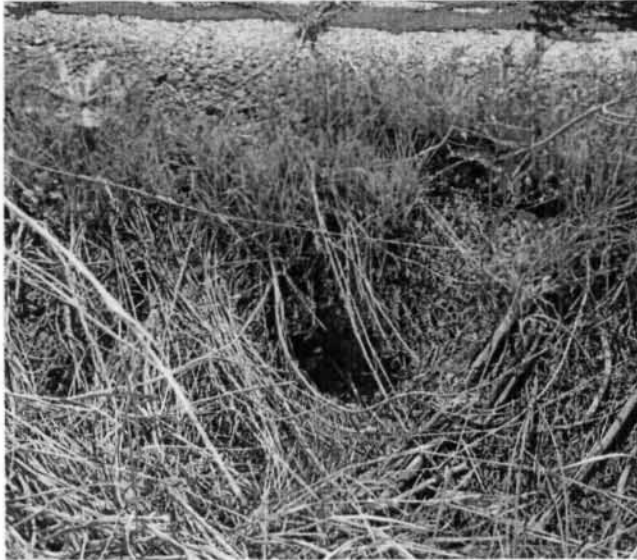
Photo 66. Possible minor erosion at the northern edge of the CC cap.

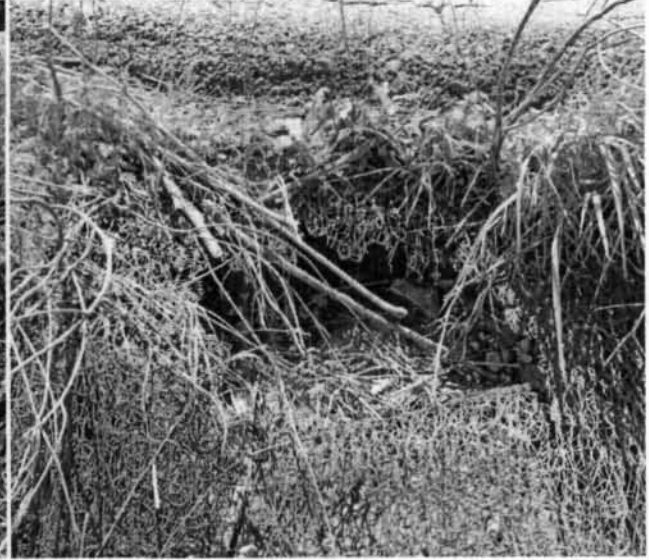
Photo 67. Possible minor erosion at the northern edge of the CC cap.

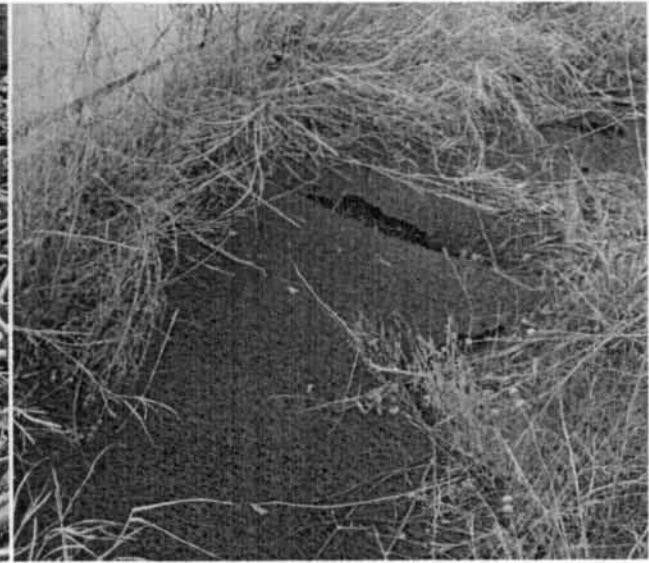
Photo 69. Erosion protection mat has separated from the ground and is several inches above the bottom of the drainage ditch.

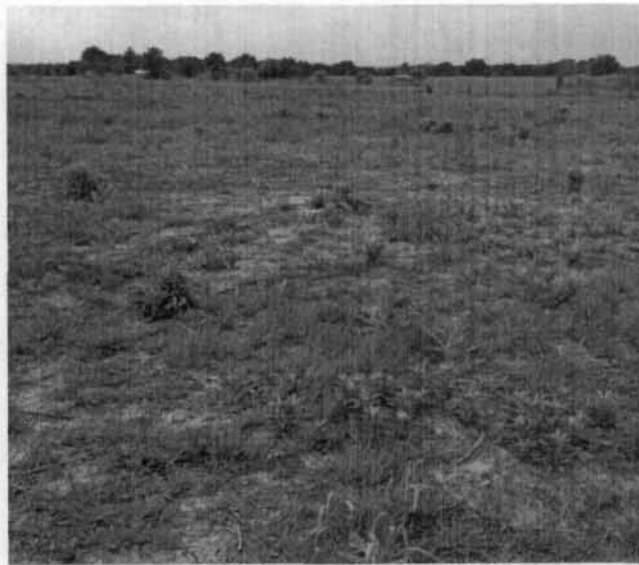
Photo 72. Sparse vegetation cover over SSP waste capped in place.

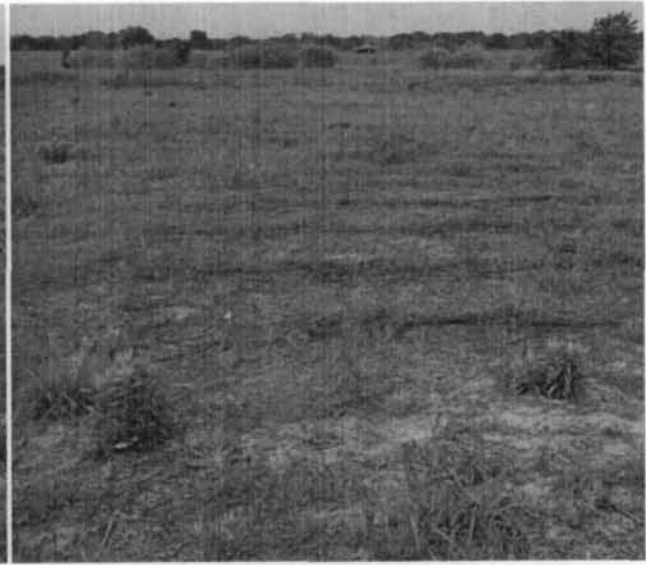
Photo 73. Sparse vegetation cover over SSP waste capped in place.

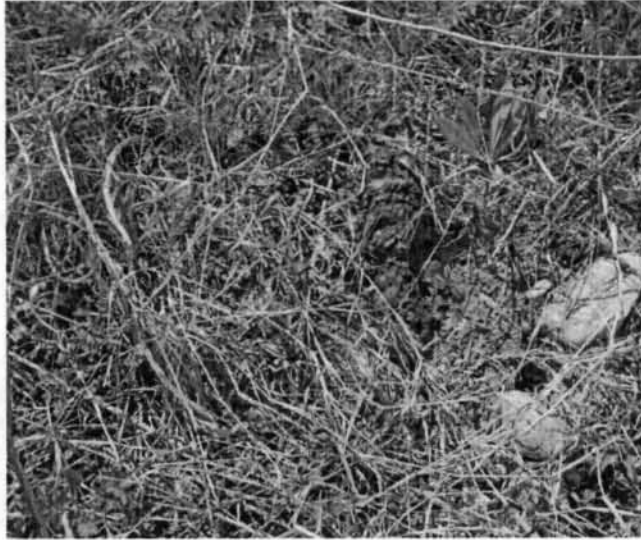
Photo 74. Possible slag/spent shot found northeast of the EVL.

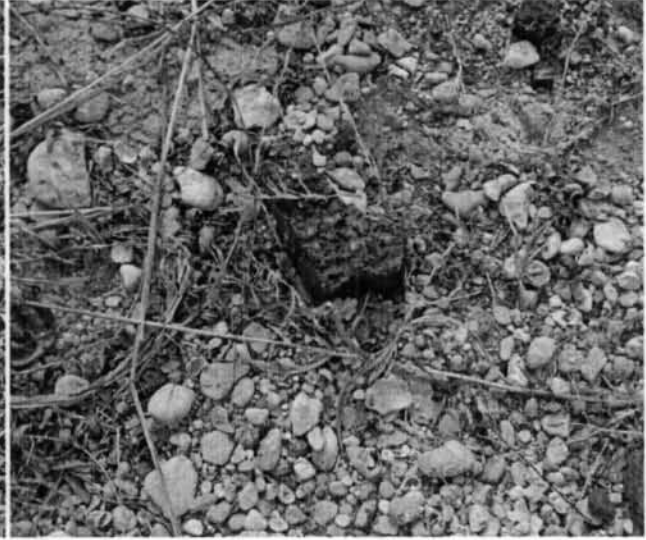
Photo 75. Possible slag/spent shot found northeast of the EVL.

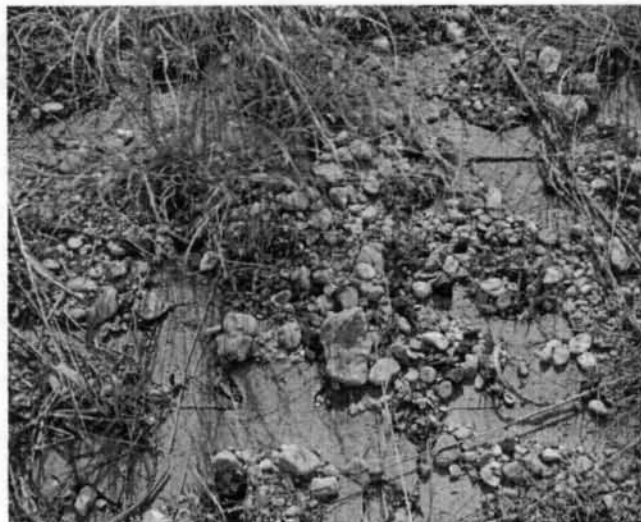
Photo 76. Possible slag/spent shot found on the ACB.

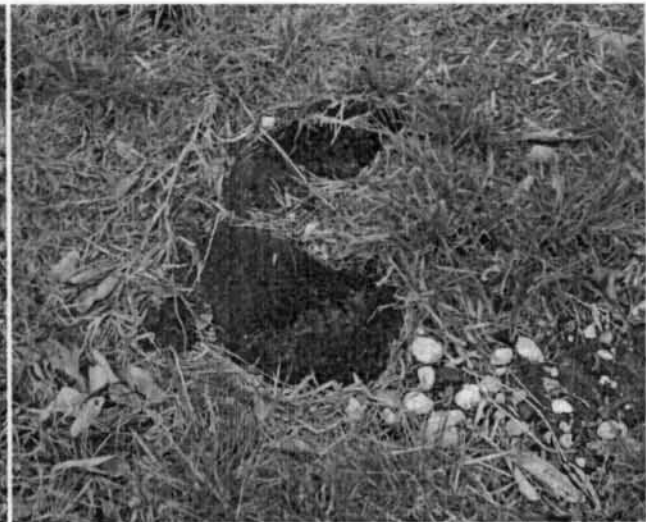
Photo 77. Possible slag/spent shot found in the cemetery.
