**THIRD FIVE-YEAR REVIEW REPORT FOR
BUCKINGHAM COUNTY LANDFILL SUPERFUND SITE
BUCKINGHAM COUNTY, VIRGINIA**

August 2013

**U.S. Environmental Protection Agency
Region 3
Philadelphia, Pennsylvania**

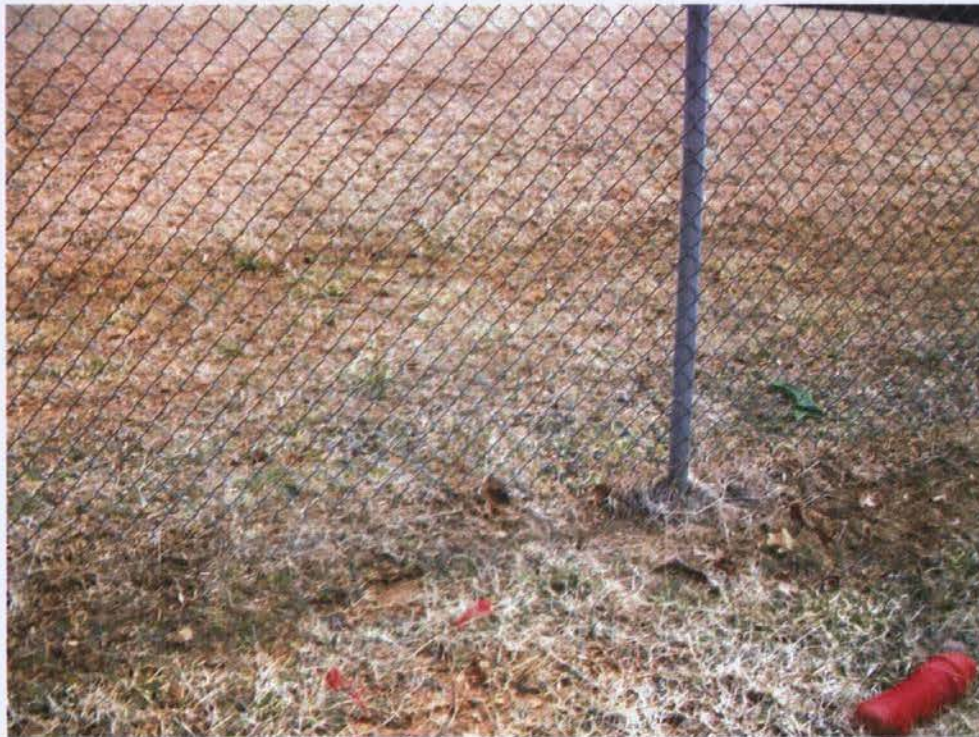
Photo: 182 Date: 02/28/13 Description: Facing east near back Landfill gate and fence. Waste yarn and gap at bottom of fence. **Photographer:** Rich Opem

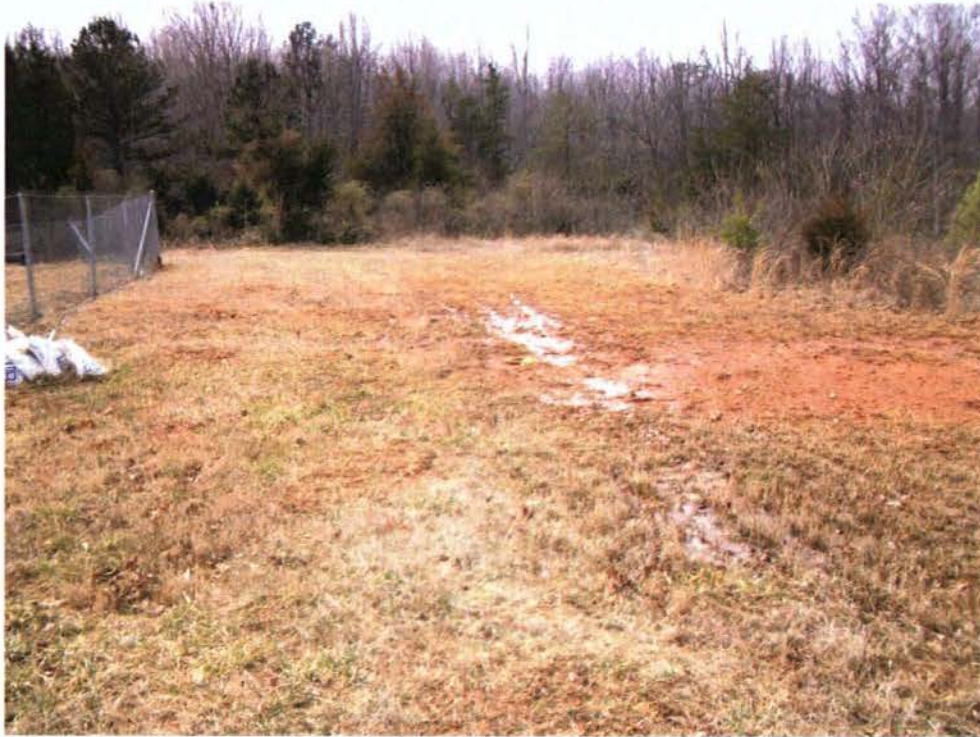
Photo: 184 **Date:** 02/28/13 **Description:** Facing southwest near back Landfill gate and beyond fence. Left over bags of sand; bare grass spots in need of reseeding; low spot with standing water.
Photographer: Rich Opem

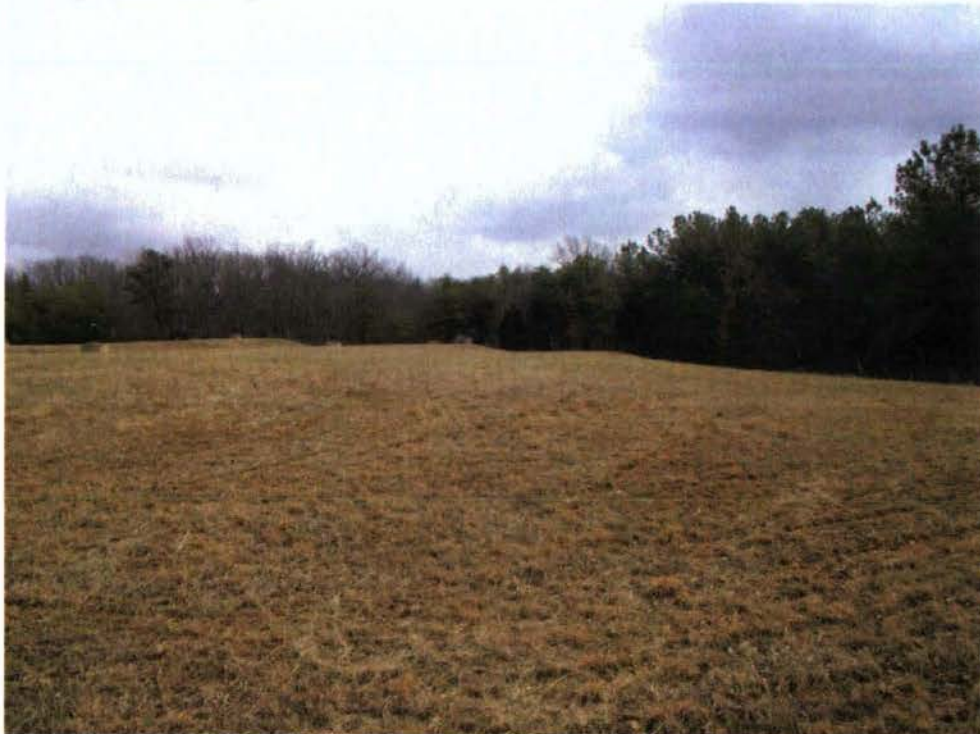
Photo: 187 **Date:** 02/28/13 **Description:** Facing east at Landfill. Landfill grass cover.
Photographer: Rich Opem

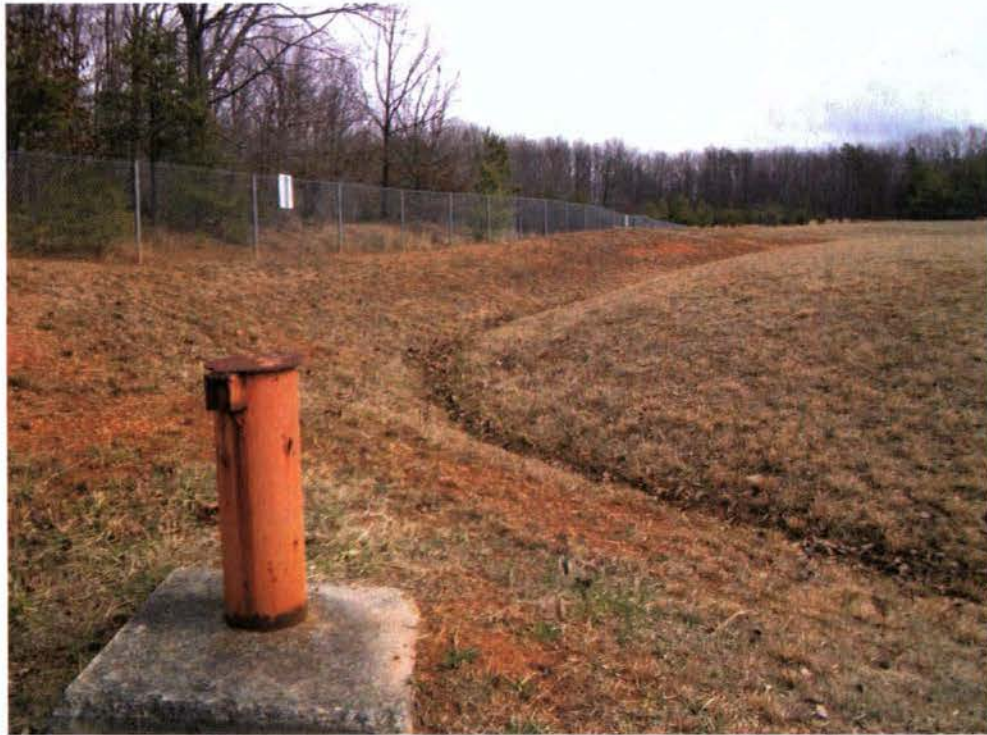
Photo: 189 Date: 02/28/13 Description: Facing northeast at Landfill near back gate fence. Monitoring well MW-3B. Well has no lock and well cap. **Photographer:** Rich Opem

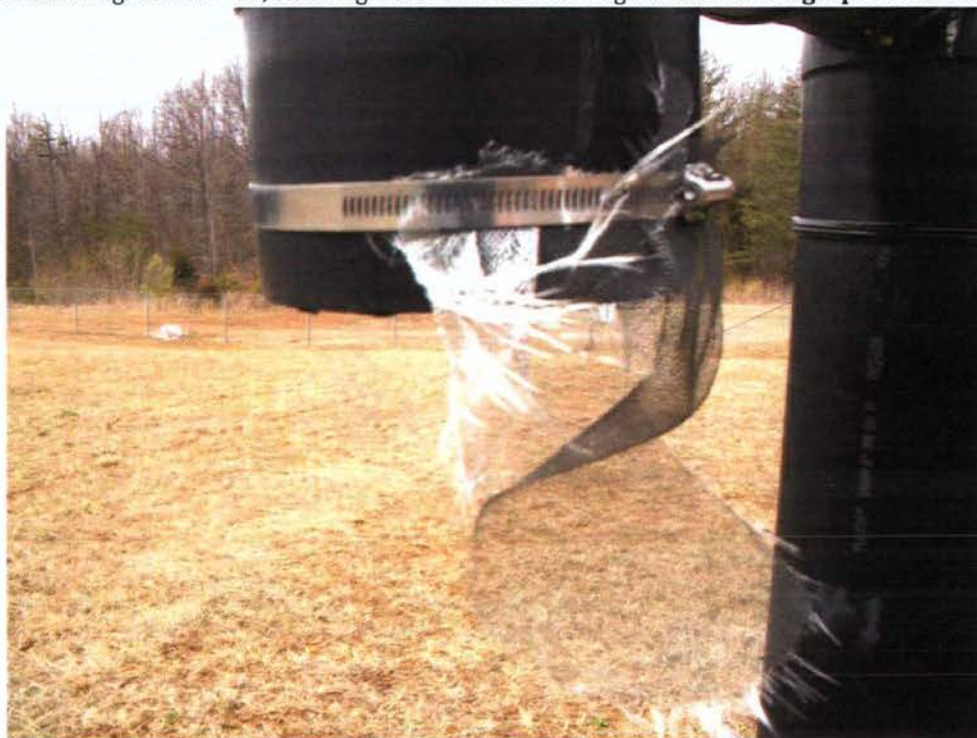
Photo: 192 **Date:** 02/28/13 **Description:** Facing northwest at Landfill. Damaged vent screen at gas vent, GV-1. **Photographer:** Rich Opem

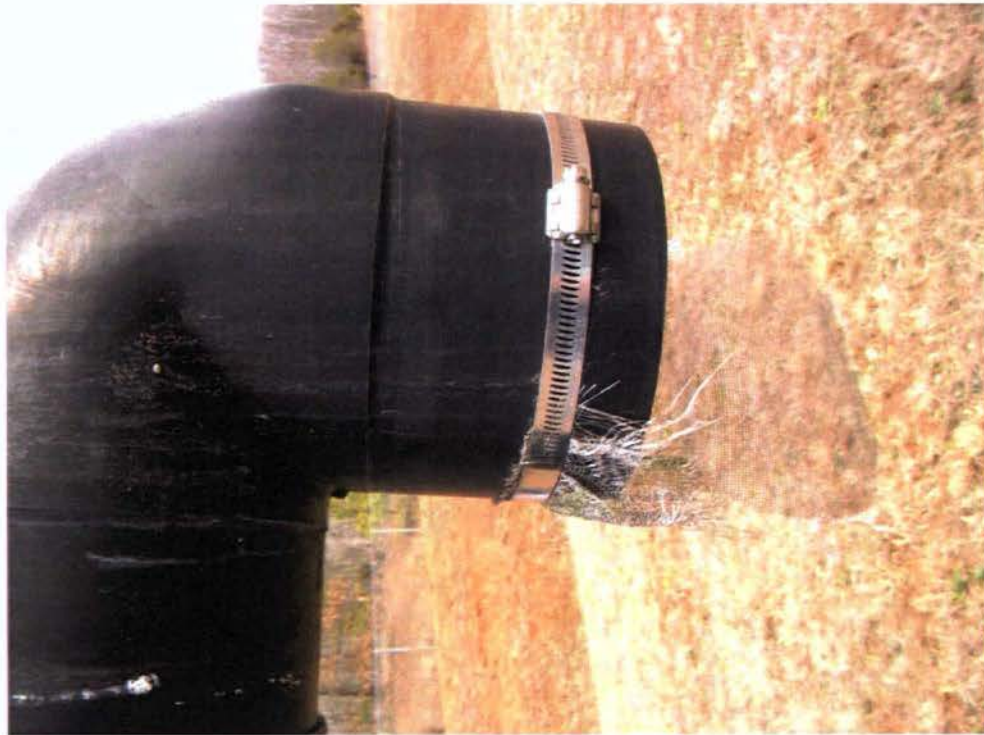
Photo: 193 Date: 02/28/13 Description: Damaged vent screen at gas vent, GV-1.
Photographer: Rich Opem

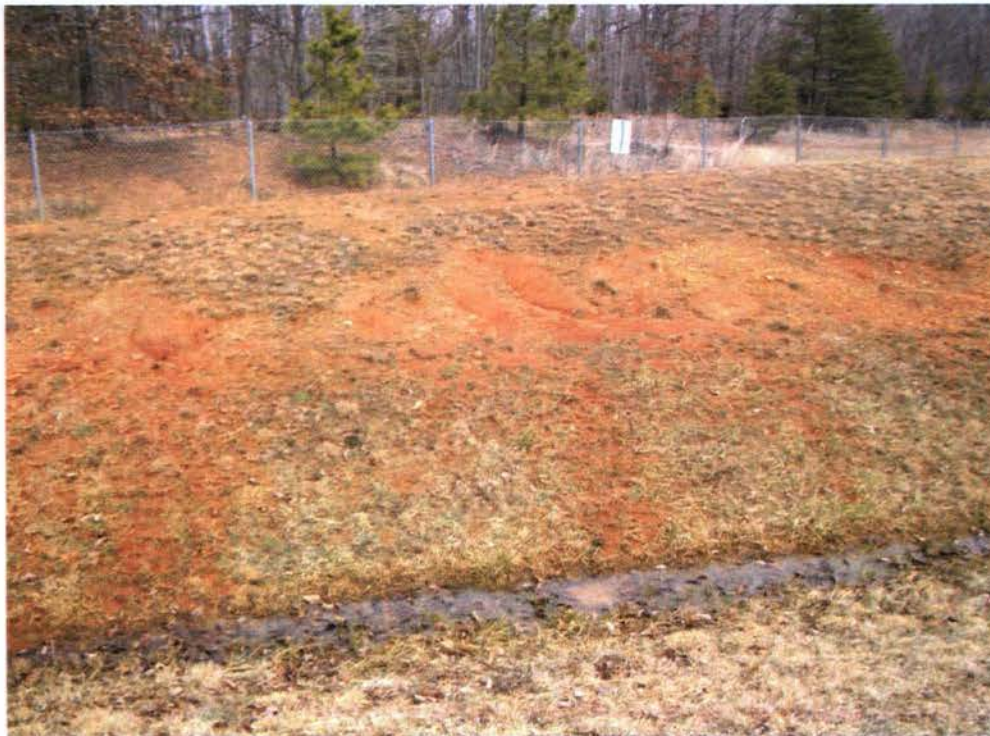
Photo: 194 Date: 02/28/13 Description: Facing north at Landfill near GV-1. Bare grass spots in need of reseeding and standing water. **Photographer:** Rich Opem

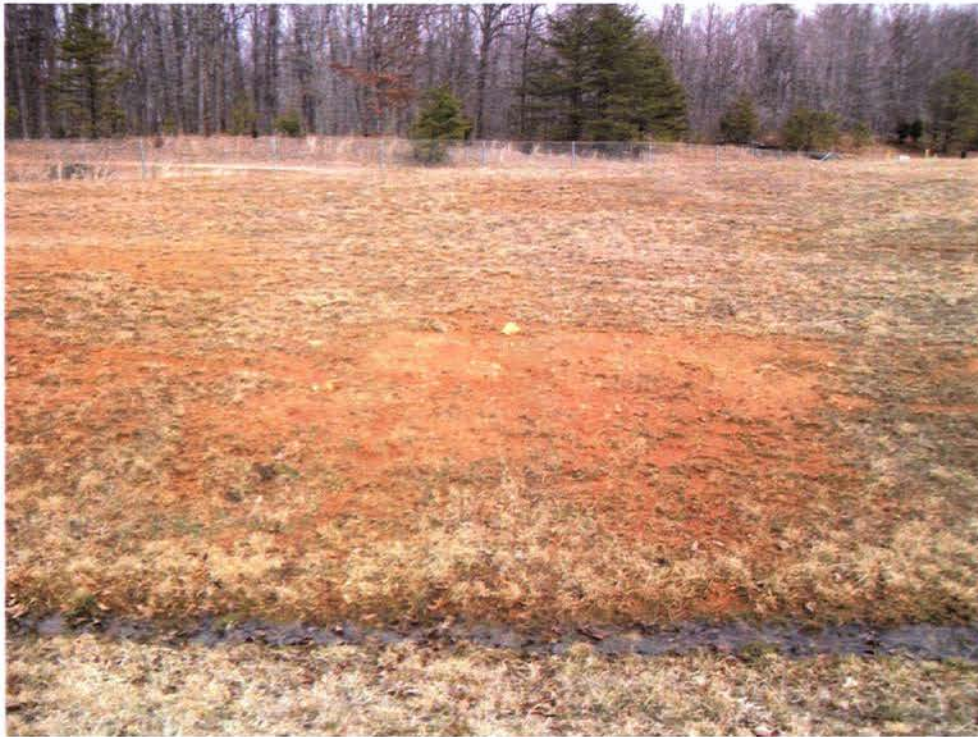
Photo: 195 **Date:** 02/28/13 **Description:** Facing north at Landfill. Bare grass spots in need of reseeding. Standing water. **Photographer:** Rich Opem

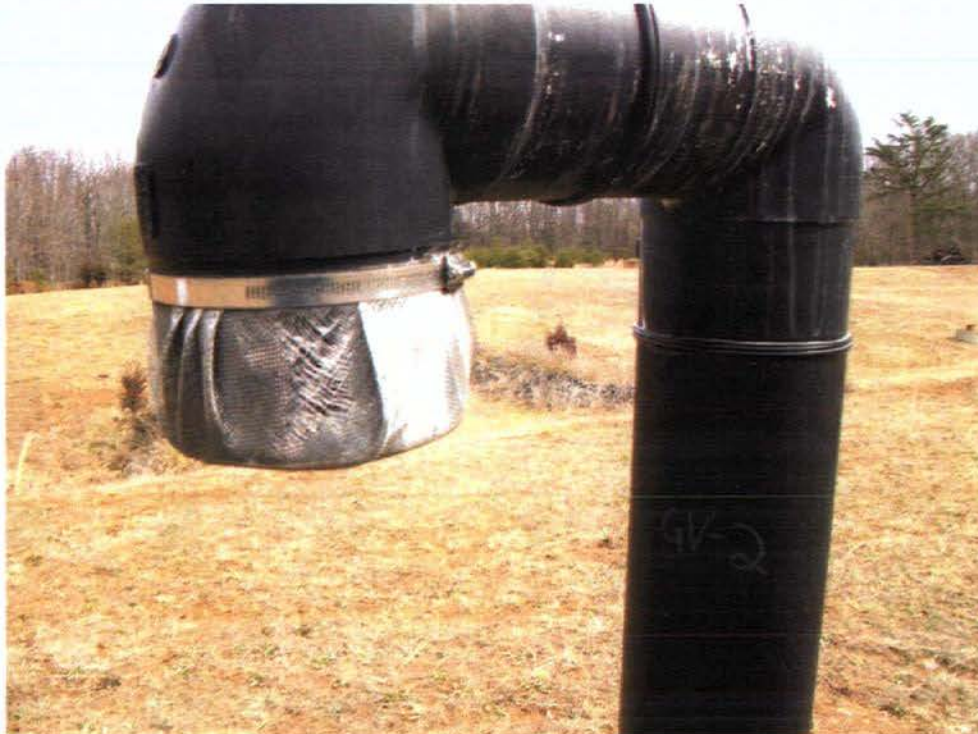
Photo: 196 **Date:** 02/28/13 **Description:** Facing north at Landfill. Gas vent, GV-2, with damage to vent screen. Over grown vegetation in drainage swale in background. **Photographer:** Rich Opem

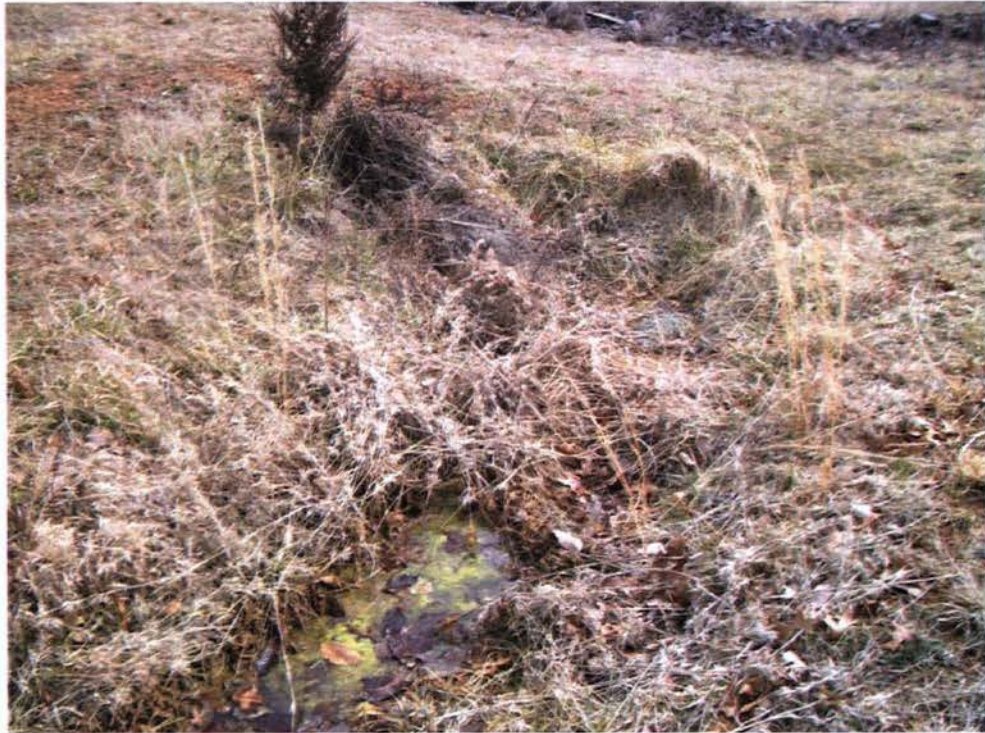
Photo: 197 Date: 02/28/13 Description: Over grown vegetation in drainage swale and rock dam near GV-2. Standing water and algae in drainage swale. **Photographer:** Rich Opem

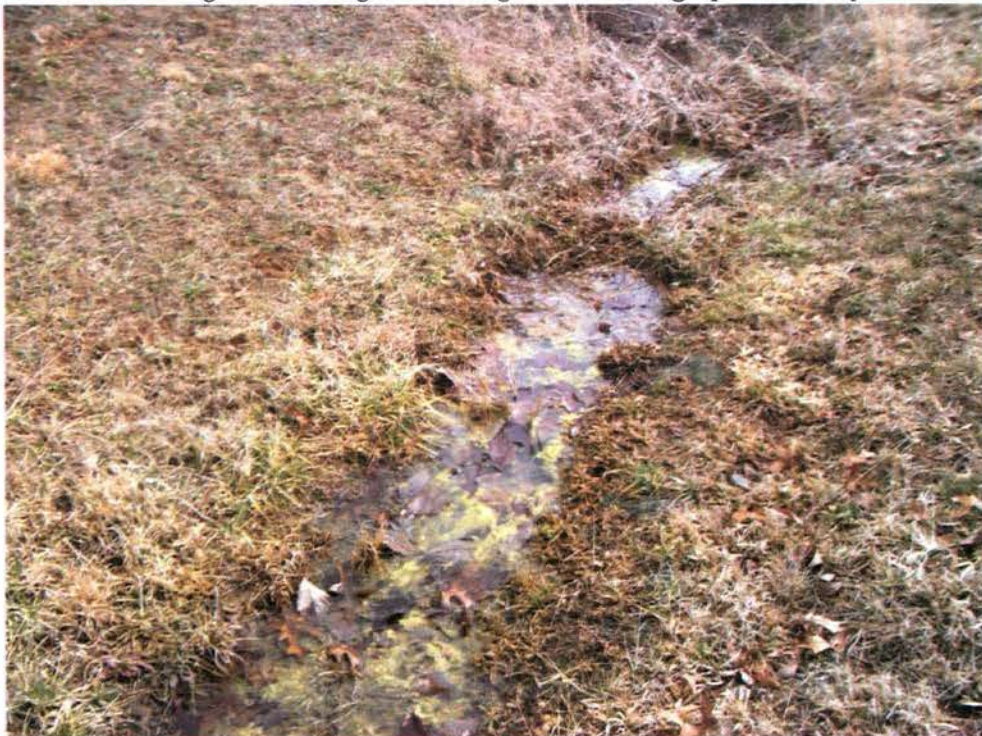
Photo: 198 Date: 02/28/13 Description: Near GV-2 at Landfill. Standing water and algae in drainage swale. **Photographer:** Rich Opem

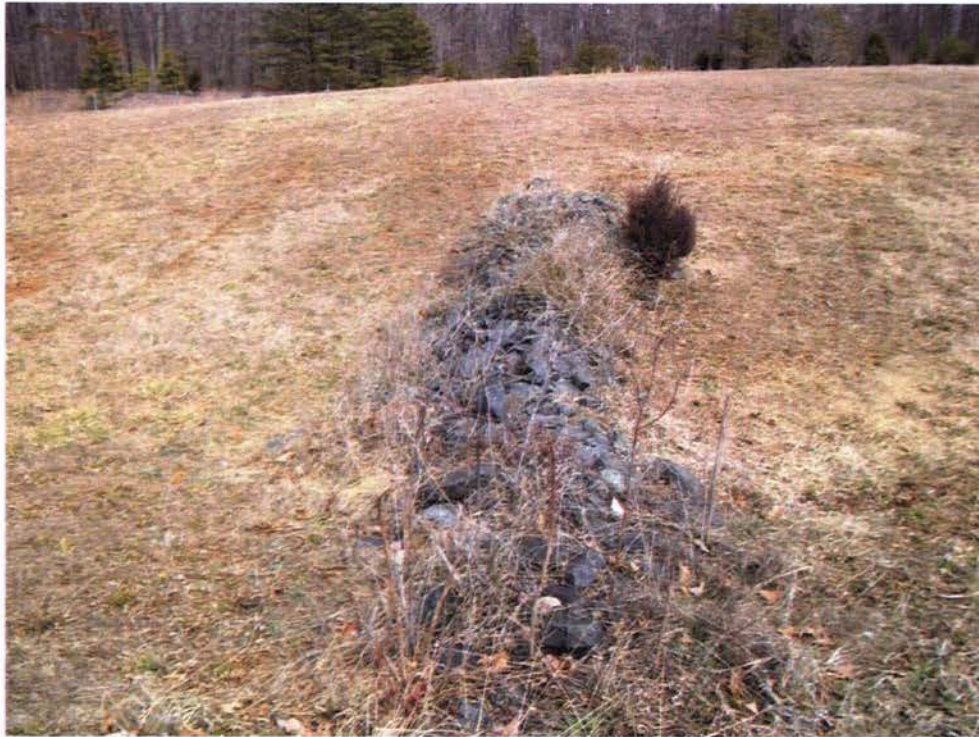
Photo: 199 Date: 02/28/13 Description: Near GV-2 at Landfill. Over grown vegetation within rock dam. **Photographer:** Rich Opem

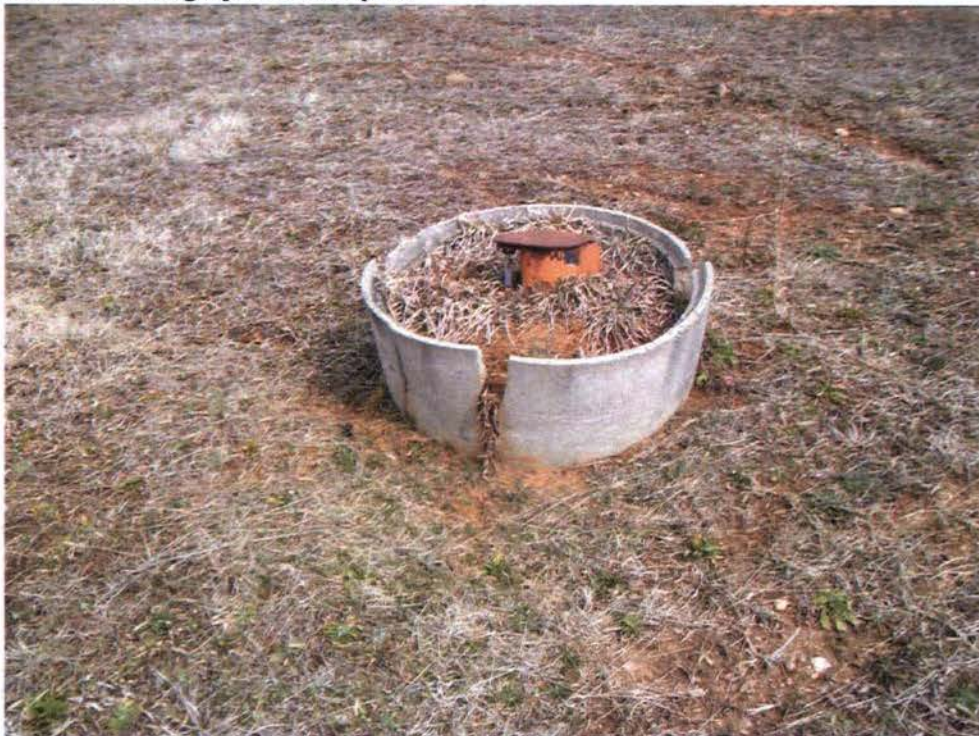
Photo: 200 Date: 02/28/13 Description: On Landfill. Monitoring well, MW-2SU, damaged protective concrete ring around well. **Photographer:** Rich Opem

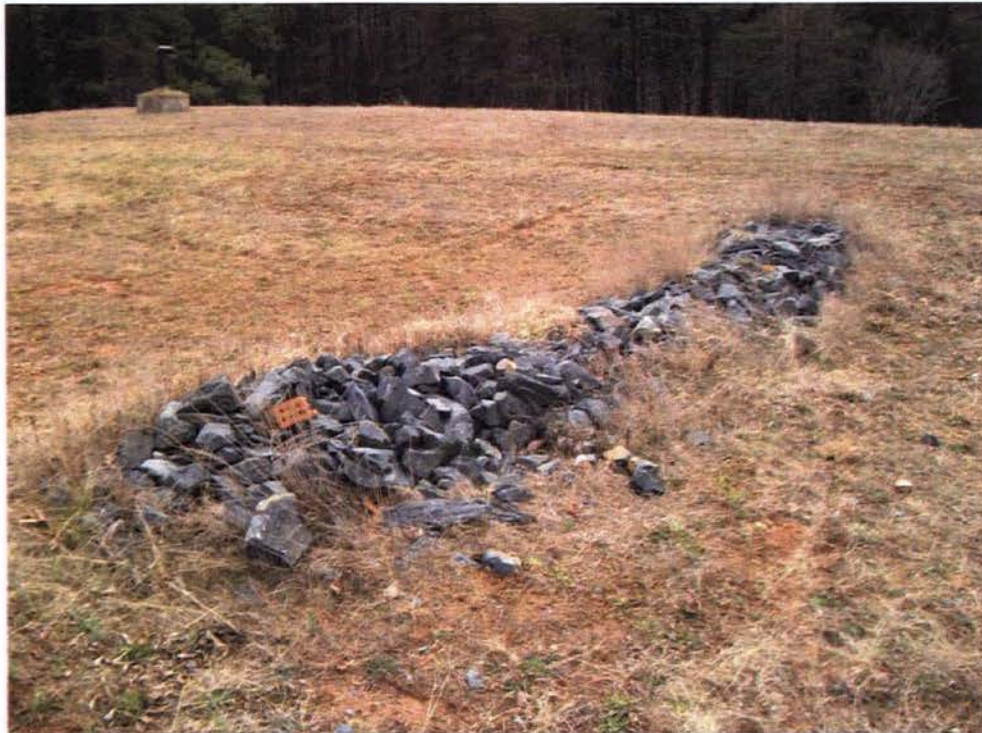
Photo: 202 Date: 02/28/13 Description: Near GV-2 at Landfill. Over grown vegetation within rock dam. **Photographer:** Rich Opem

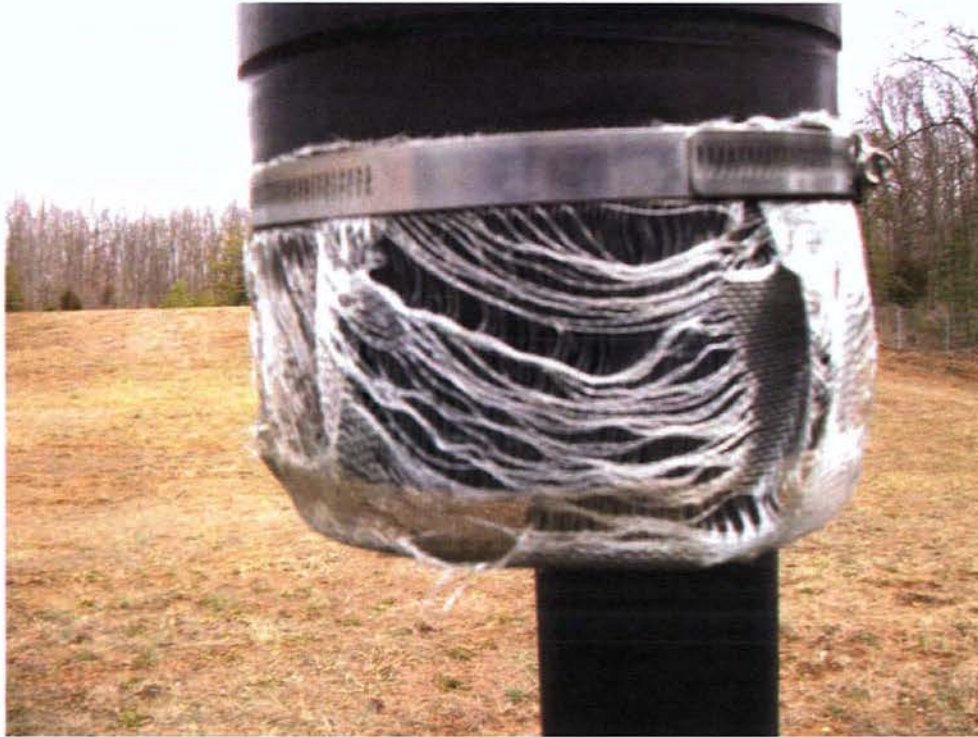
Photo: 205 **Date:** 02/28/13 **Description:** On Landfill. Gas vent, GV-4, with damaged vent screen. **Photographer:** Rich Opem

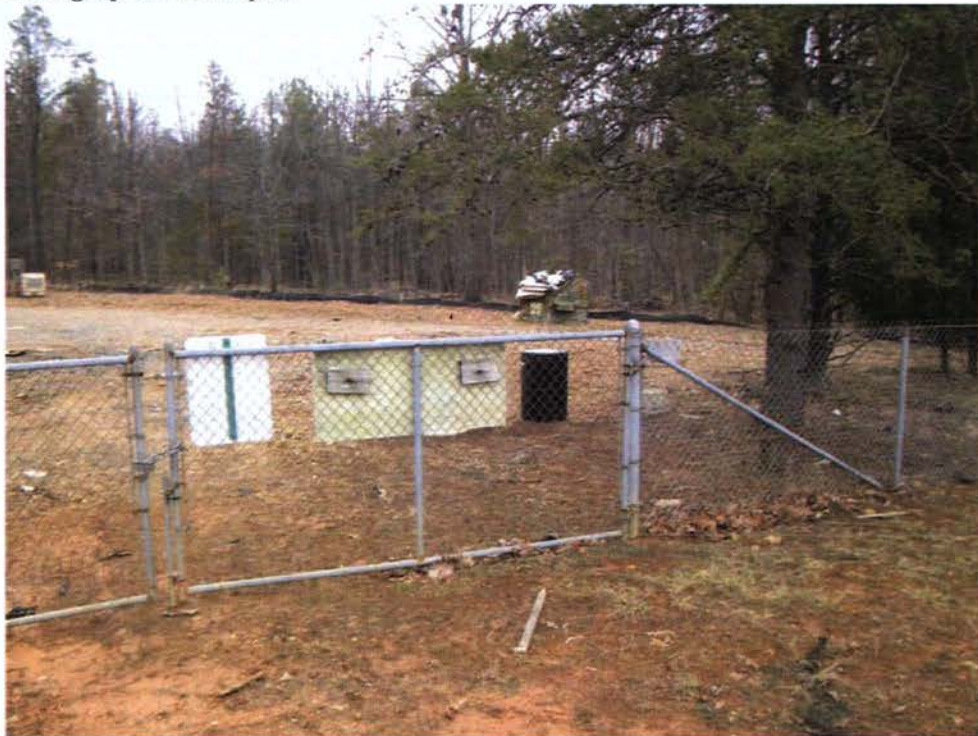
Photo: 206 **Date:** 02/28/13 **Description:** Facing southeast within Landfill entrance gate. Bare grass spots in need of reseeding, 55-gallon IDW drum and trash-filled dumpster. **Photographer:** Rich Opem

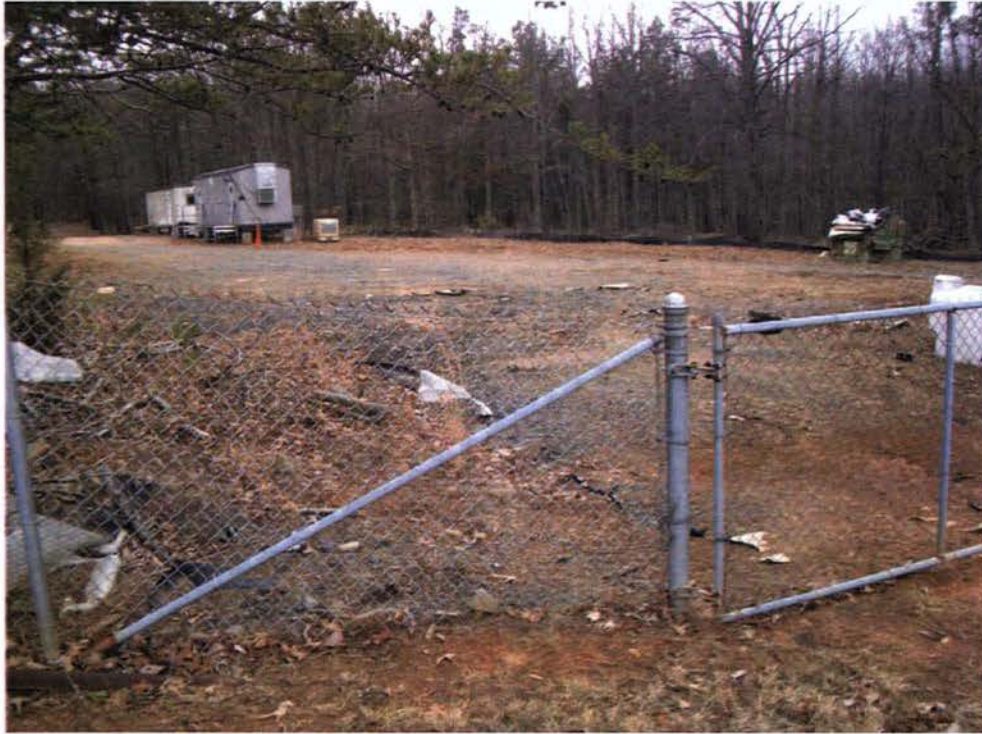
Photo: 208 Date: 02/28/13 Description: Facing southeast within Landfill entrance gate. Bare grass spots in need of reseeding and trash-filled dumpster. **Photographer:** Rich Opem

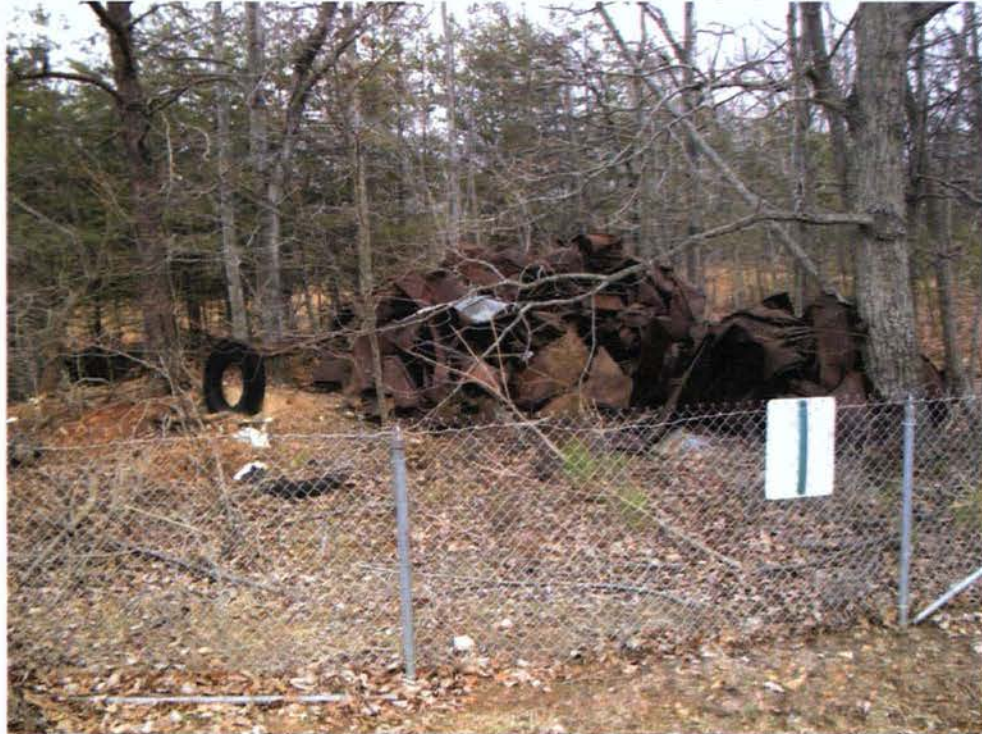
Photo: 209 Date: 02/28/13 Description: Facing east within Landfill fence. Big pile of metal scraps and tire in woods beyond fenced area. **Photographer:** Rich Opem

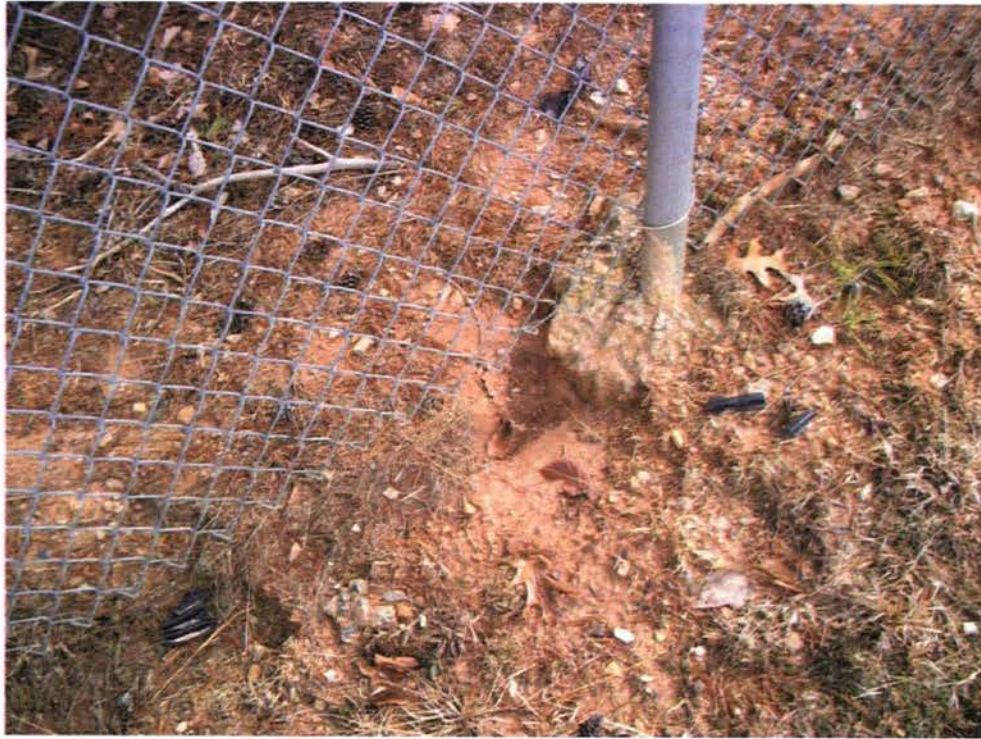
Photo: 210 Date: 02/28/13 Description: Facing northeast at Landfill fence near GV-6. Gap at bottom of fence and bare grass spot. **Photographer:** Rich Opem

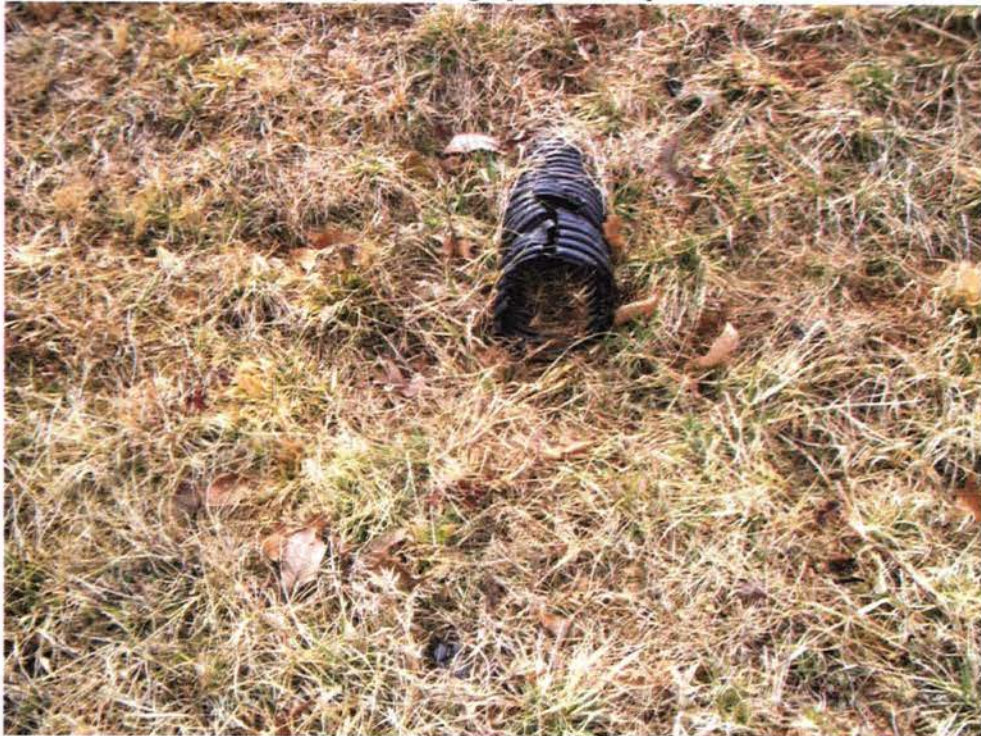
Photo: 211 Date: 02/28/13 Description: Facing northeast at landfill near GV-6. damaged drainage pipe. **Photographer:** Rich Opem

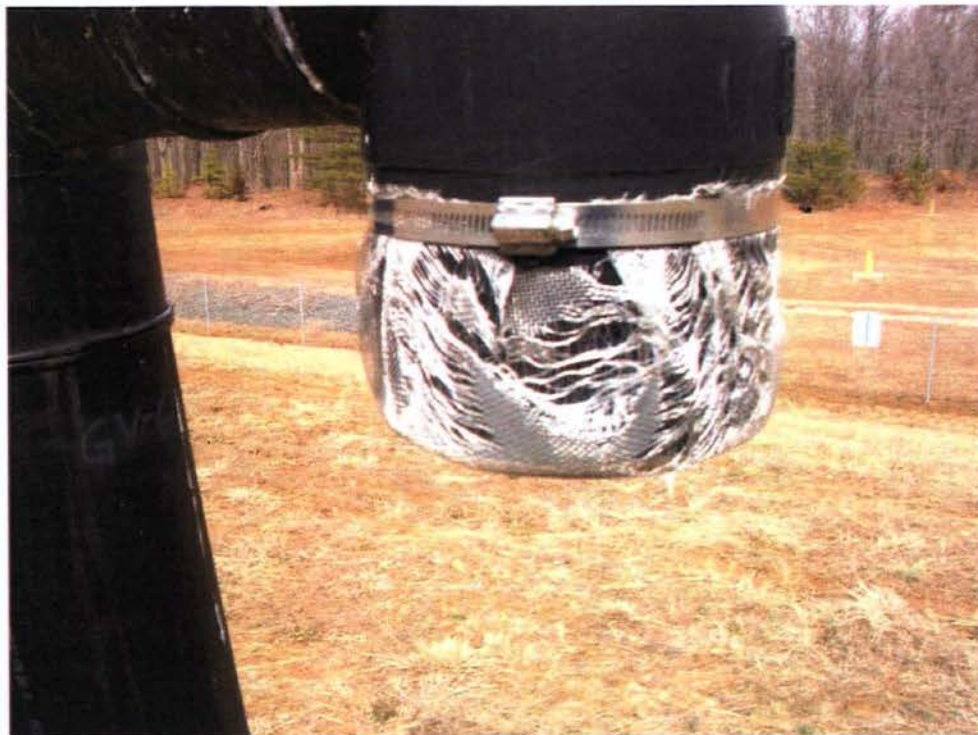
Photo: 212 Date: 02/28/13 Description: On Landfill. Gas vent, GV-6, with damaged vent screen.
Photographer: Rich Opem

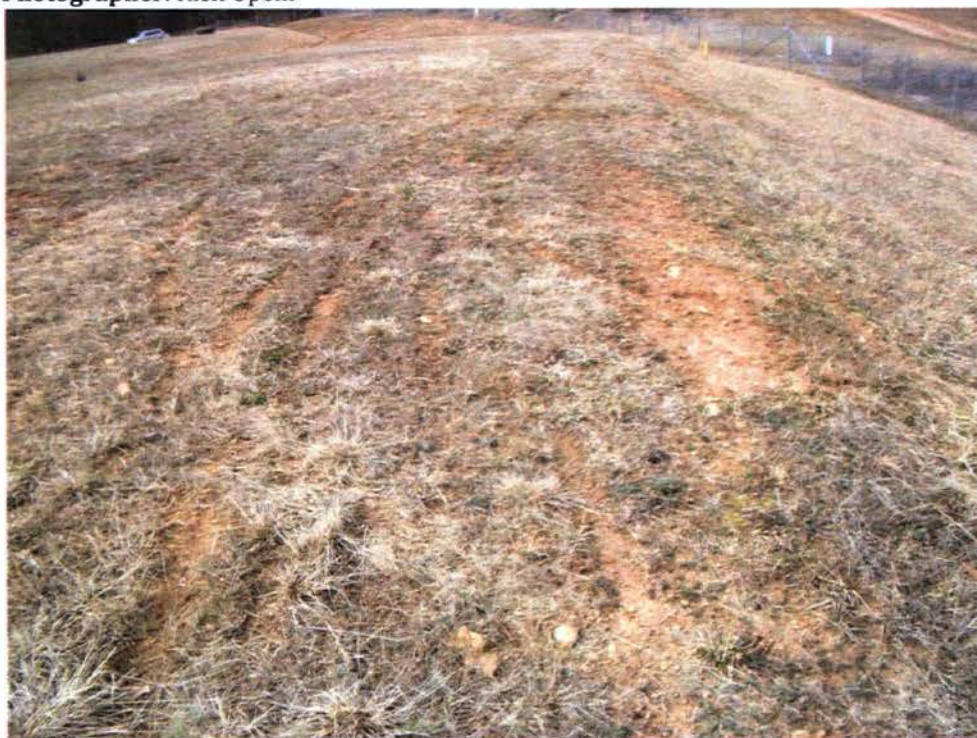
Photo: 213 Date: 02/28/13 Description: Facing northwest at Landfill near GV-6. Bare grass spots on Landfill cover in need of reseeding. **Photographer:** Rich Opem

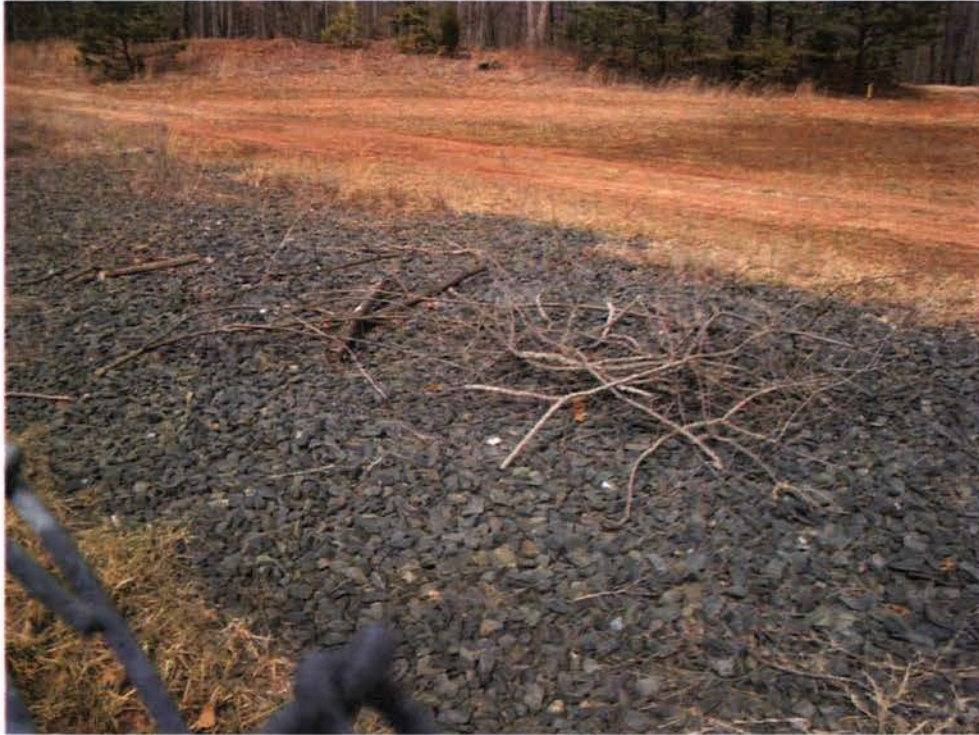
Photo: 216 Date: 02/28/13 Description: Facing north near fence line. Riprap area in good condition with shrub growth. **Photographer:** Rich Opem

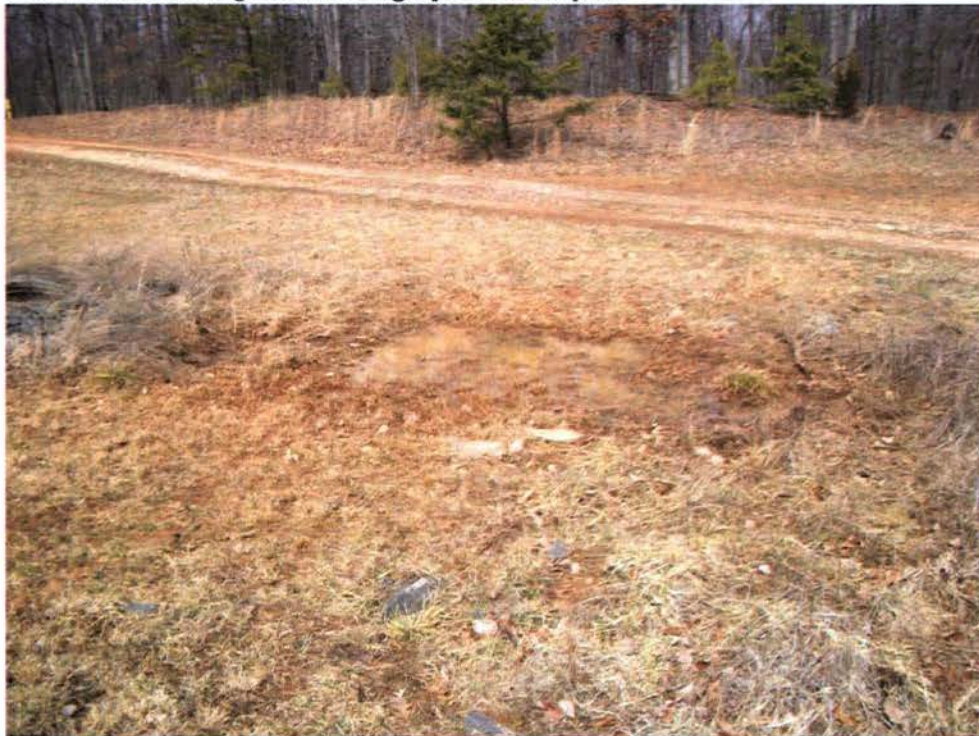
Photo: 217 Date: 02/28/13 Description: Facing north near fence line. East edge of riprap area with shrub growth and low spot with standing water. **Photographer:** Rich Opem

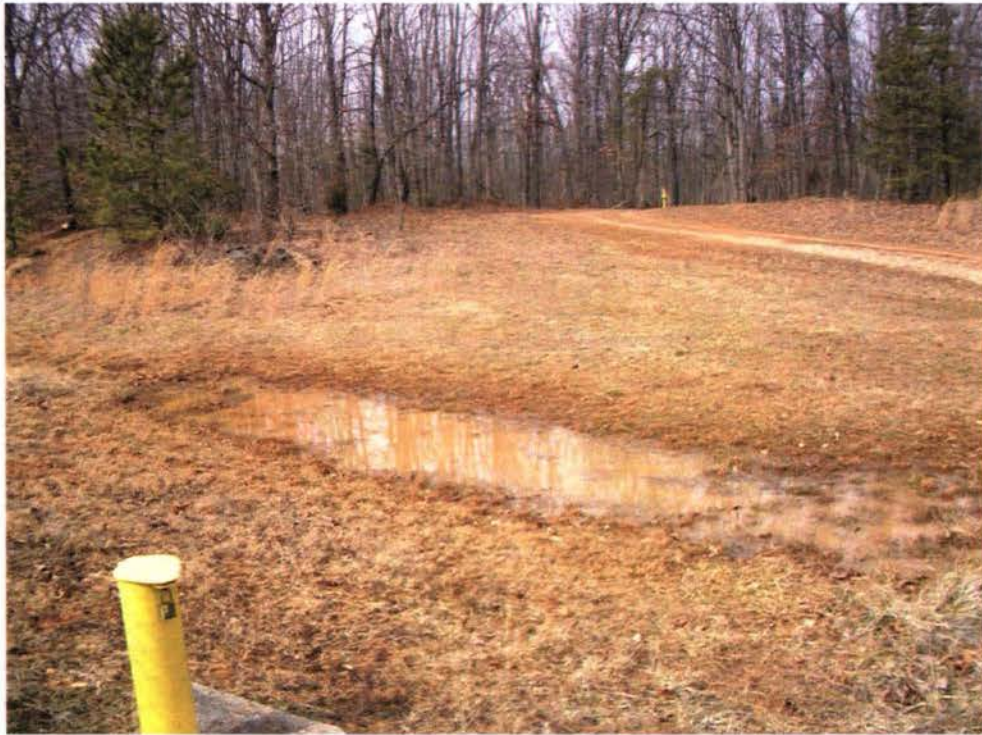
Photo: 218 Date: 02/28/13 Description: Facing north near fence line and MW-6S. West edge of riprap area, drainage swale with standing water. **Photographer:** Rich Opem

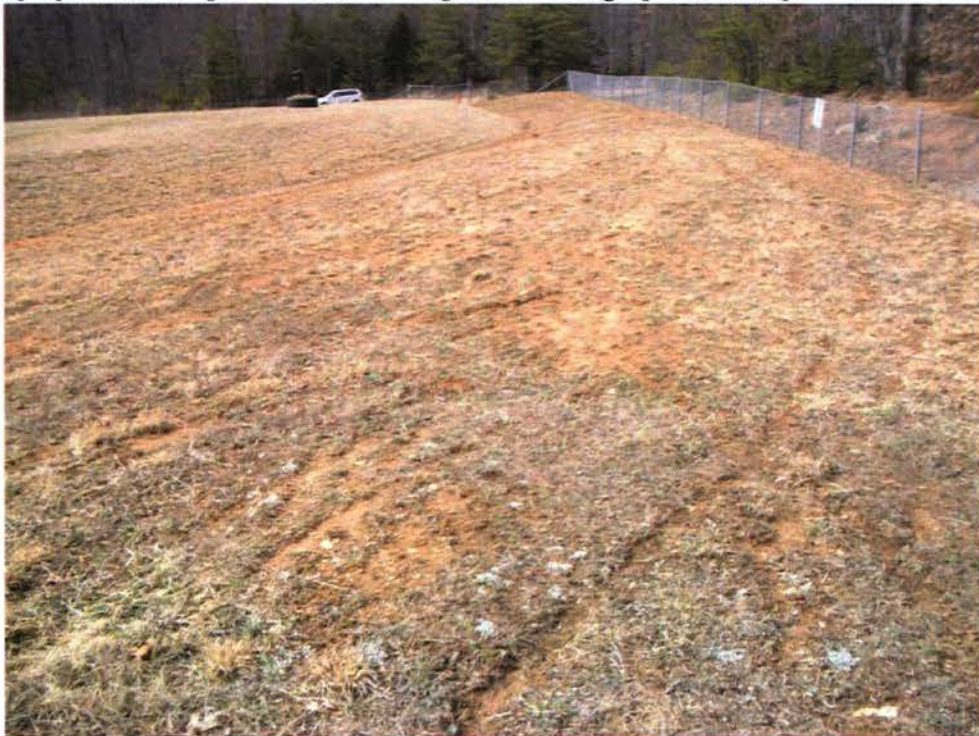
Photo: 220 Date: 02/28/13 Description: Facing west at Landfill near northeast fence line. Bare grass spots in need of reseeding. **Photographer:** Rich Opem

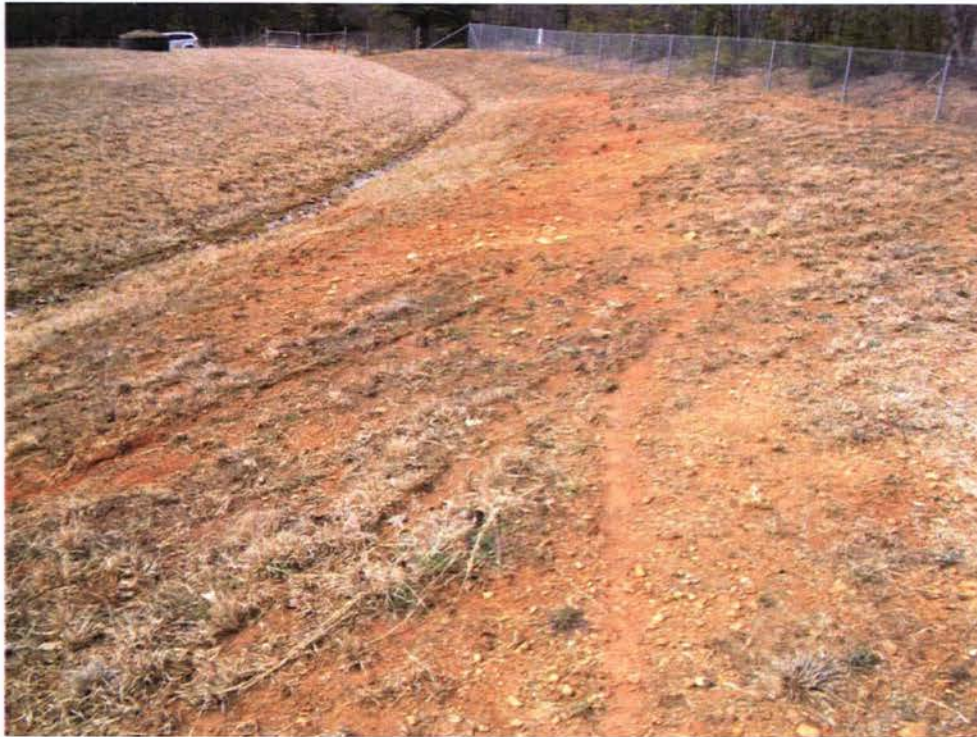
Photo: 221 Date: 02/28/13 Description: Facing northwest at Landfill near north fence line. Bare grass spots in need of reseeding and standing water in drainage swale. **Photographer:** Rich Opem

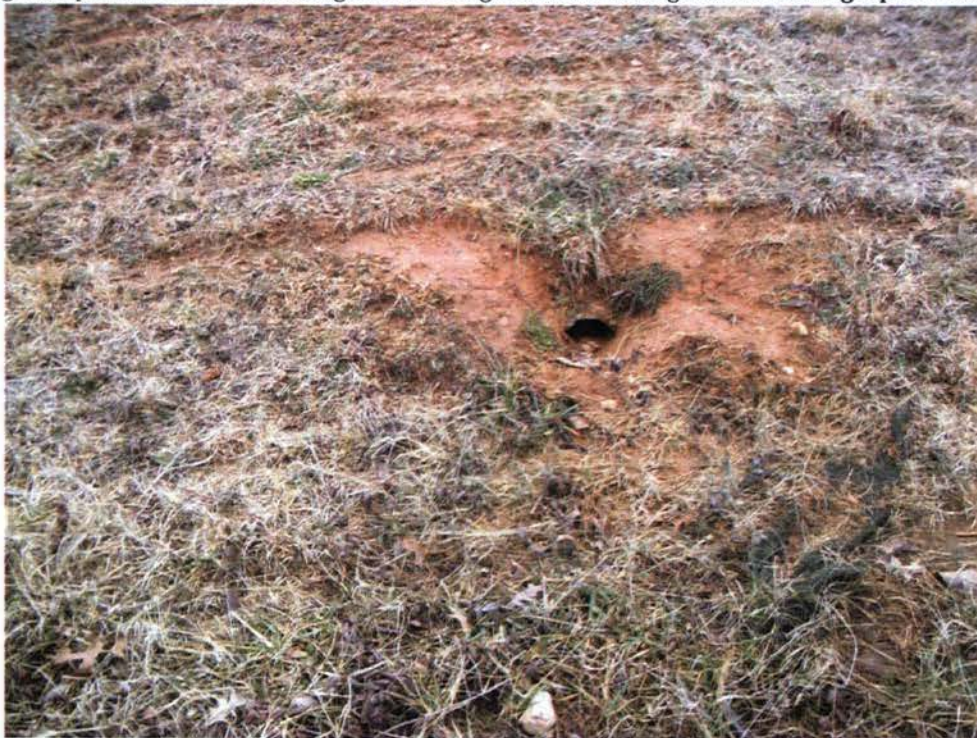
Photo: 223 Date: 02/28/13 Description: Bare grass spot around clogged drainage pipe. Located at northwest corner of Landfill. **Photographer:** Rich Opem

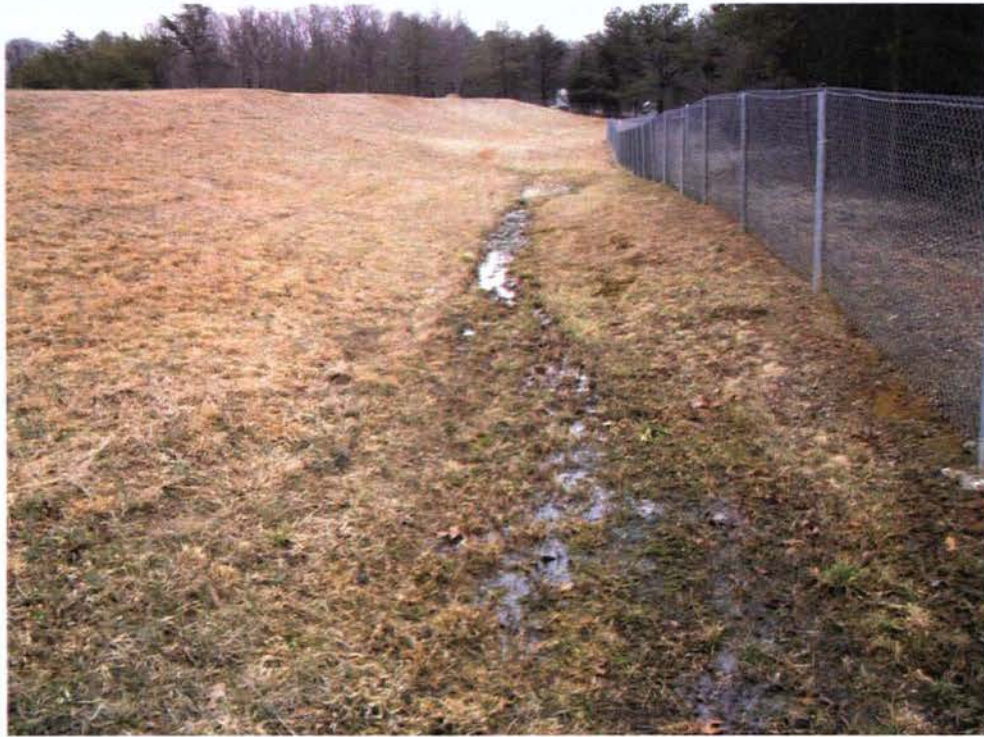
Photo: 224 Date: 02/28/13 Description: Facing east of Landfill near south fence line. Standing water with algae in drainage swale. **Photographer:** Rich Opem

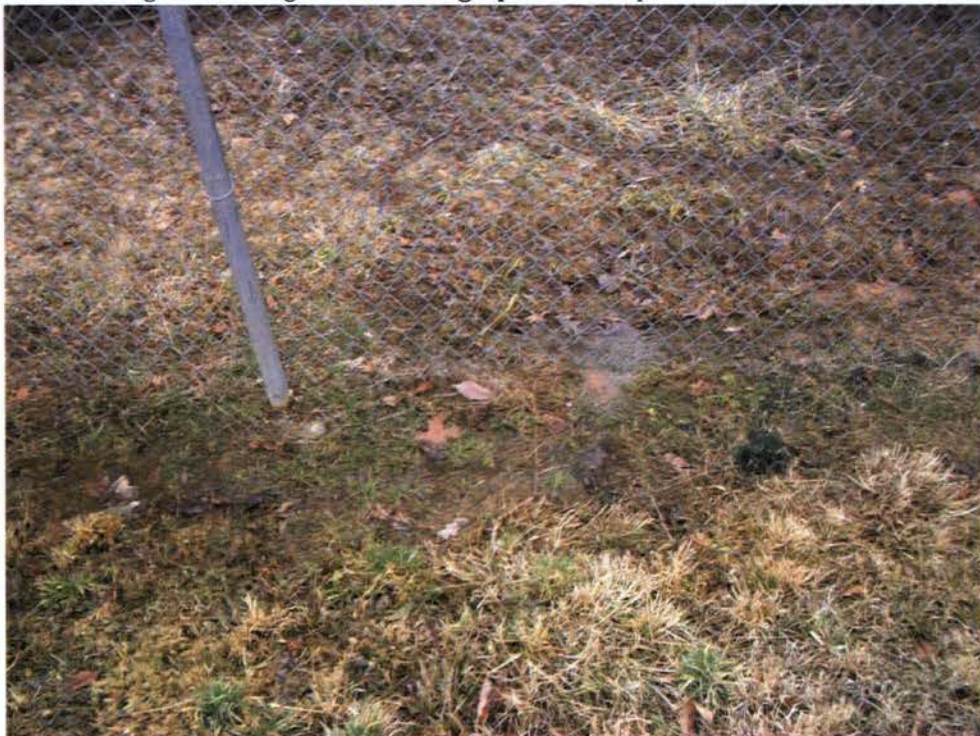
Photo: 225 Date: 02/28/13 Description: Southwest area of Landfill long south fence line. Standing water and gap at bottom of fence. **Photographer:** Rich Opem
