**THIRD FIVE-YEAR REVIEW REPORT FOR
BUCKINGHAM COUNTY LANDFILL SUPERFUND SITE
BUCKINGHAM COUNTY, VIRGINIA**

August 2013

**U.S. Environmental Protection Agency
Region 3
Philadelphia, Pennsylvania**

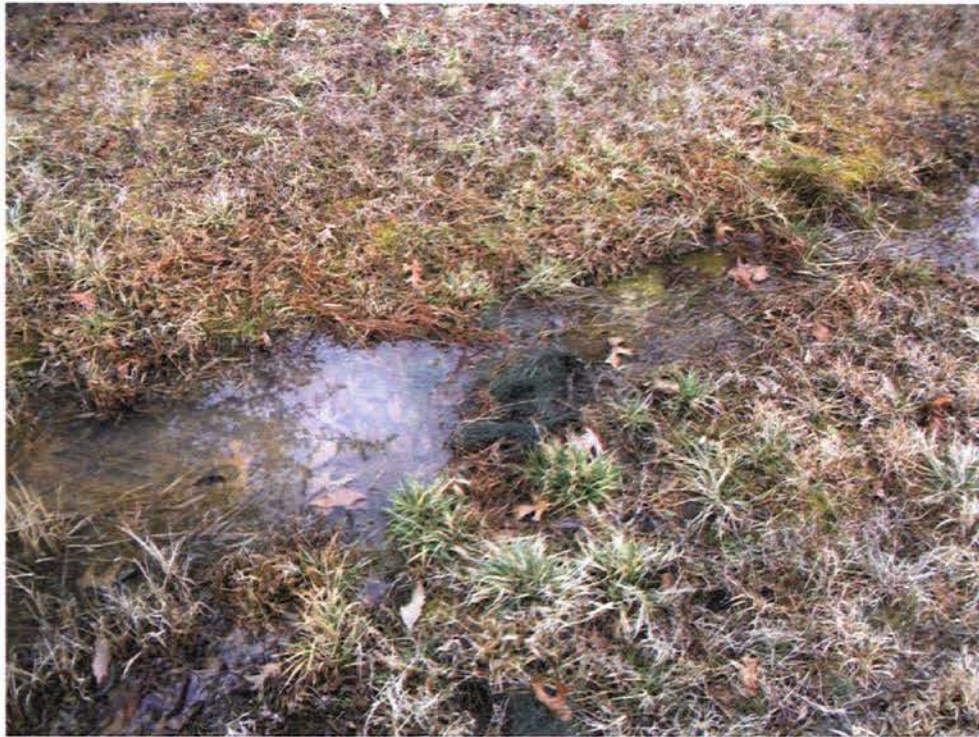
Photo: 226 Date: 02/28/13 Description: Looking down near south fence line. Standing water with algae in drainage swale. **Photographer:** Rich Opem

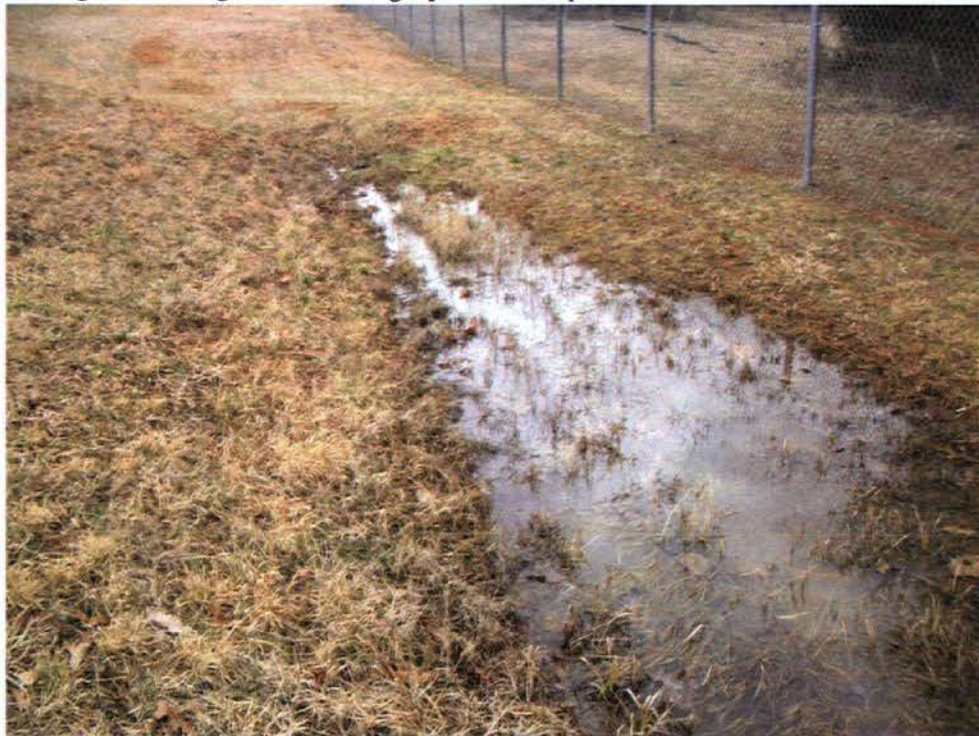
Photo: 227 Date: 02/28/13 Description: Facing southeast of Landfill near south fence line. Standing water in drainage swale. **Photographer:** Rich Opem

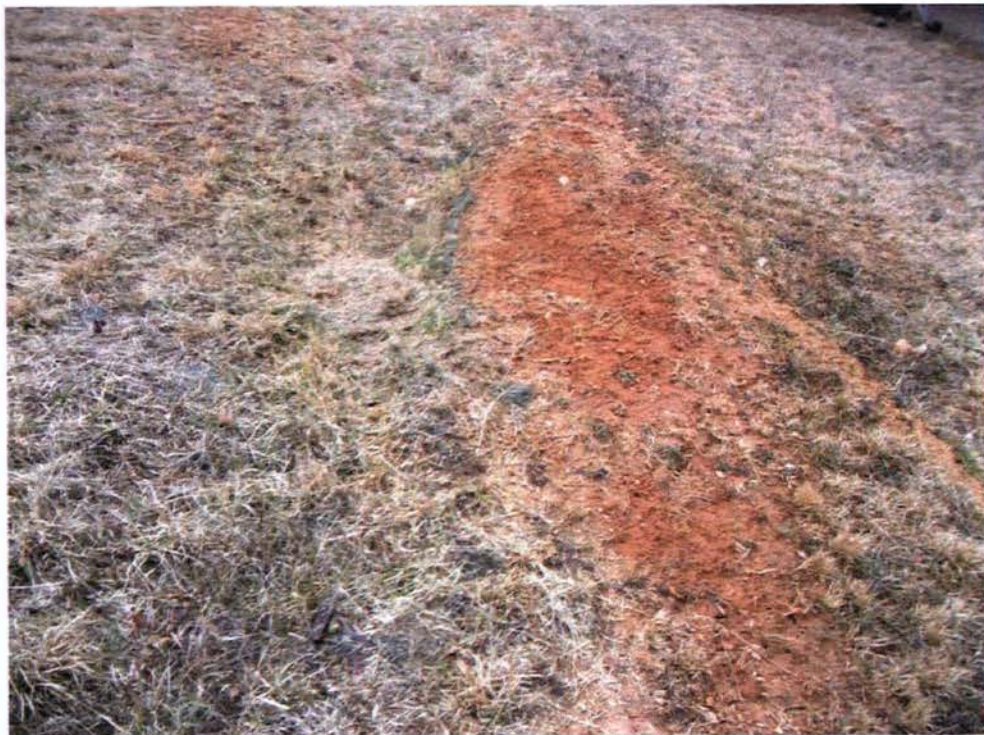
Photo: 229 Date: 02/28/13 Description: Looking down near south fence area of Landfill. Bare grass spot in need of reseeded. **Photographer:** Rich Opem

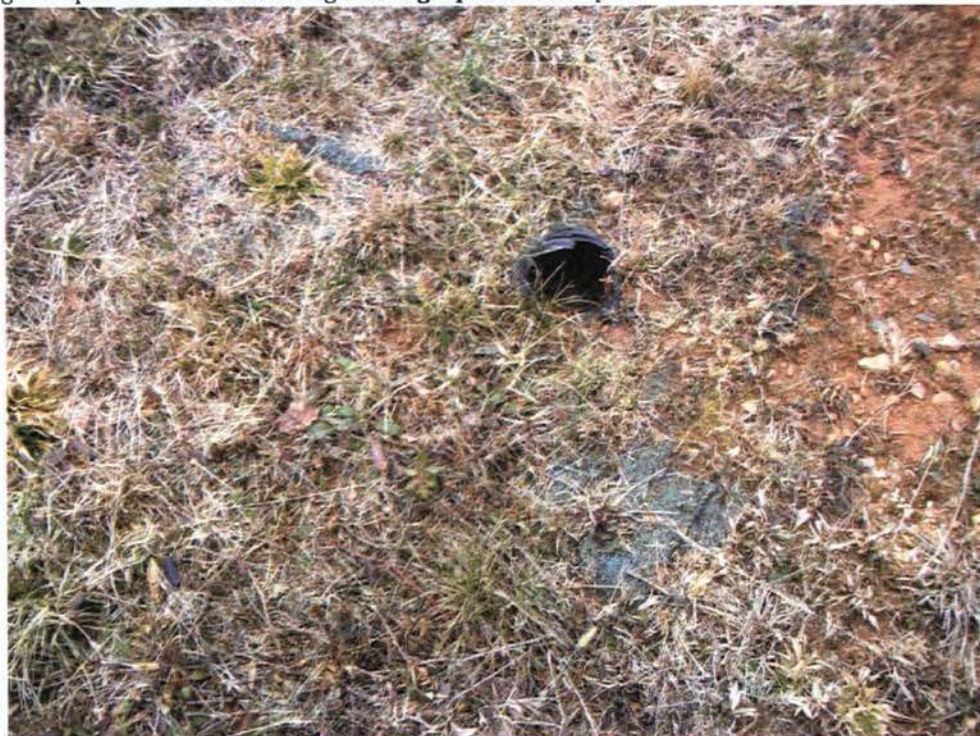
Photo: 230 Date: 02/28/13 Description: Inverted drainage pipe near bare grass spot in need of reseeded. Located at southeast corner of Landfill. **Photographer:** Rich Opem

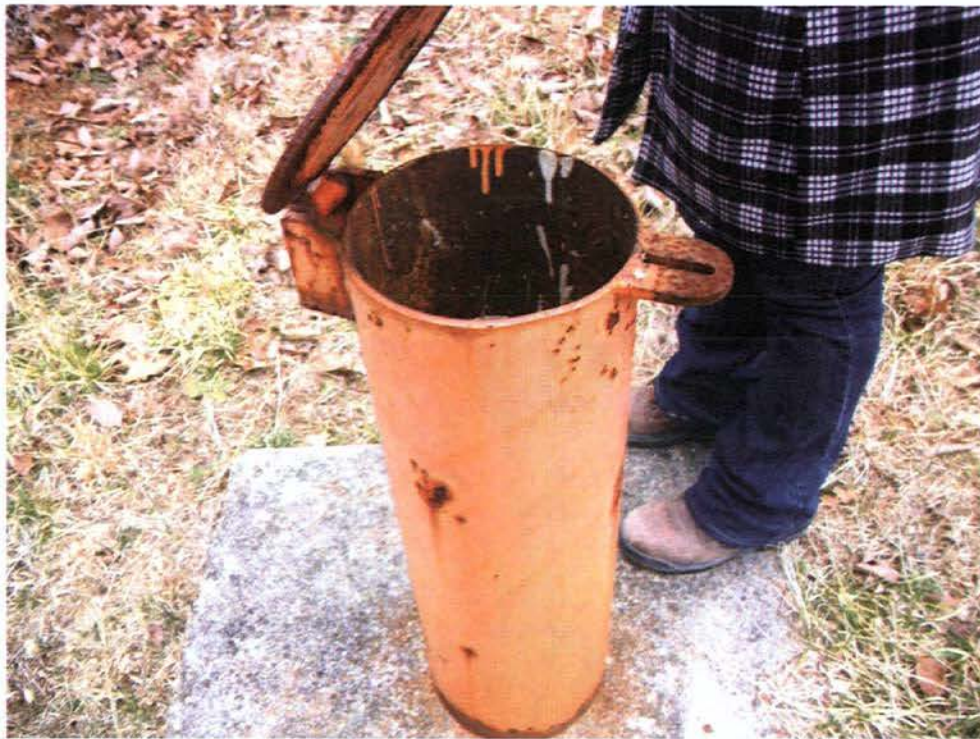
Photo: 231 Date: 02/28/13 Description: At monitoring well, MW-3B. Well protective casing missing lock. **Photographer:** Rich Opem

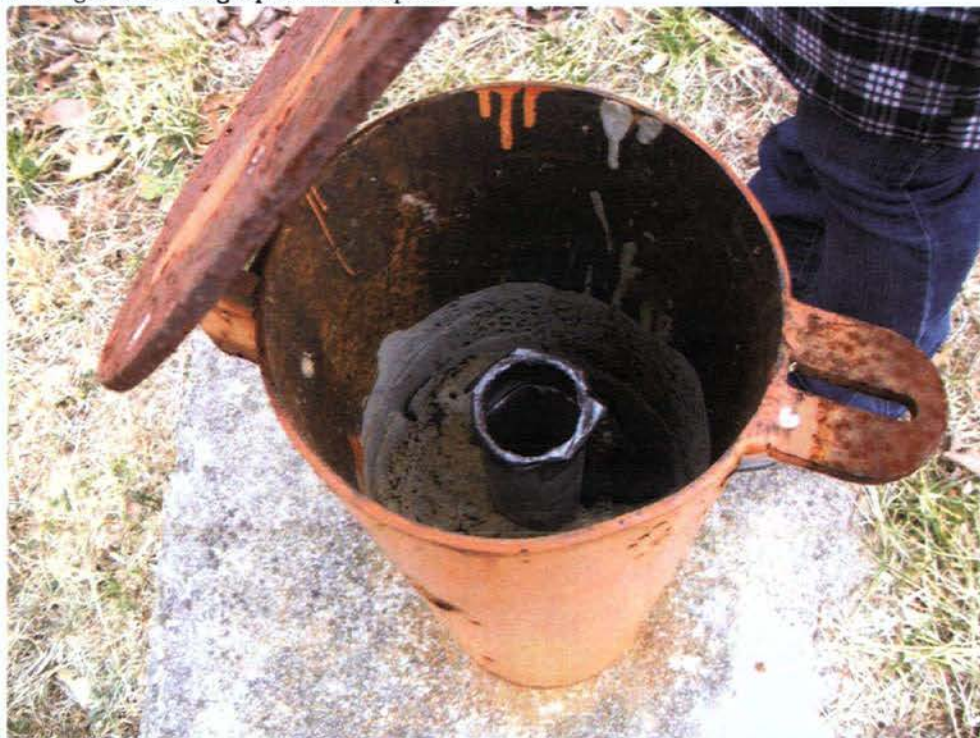
Photo: 232 Date: 02/28/13 Description: At monitoring well, MW-3B. Well pipe missing cap. **Photographer:** Rich Opem
