FINAL REPORT

Marine Archaeological Investigation

Removal and Documentation of the New Bedford Harbor Superfund Site Unanticipated Discovery Shipwreck #2 from the 2015 Task 2 (Submarine Cable Crossing) Study Area

Acushnet River, New Bedford, Massachusetts

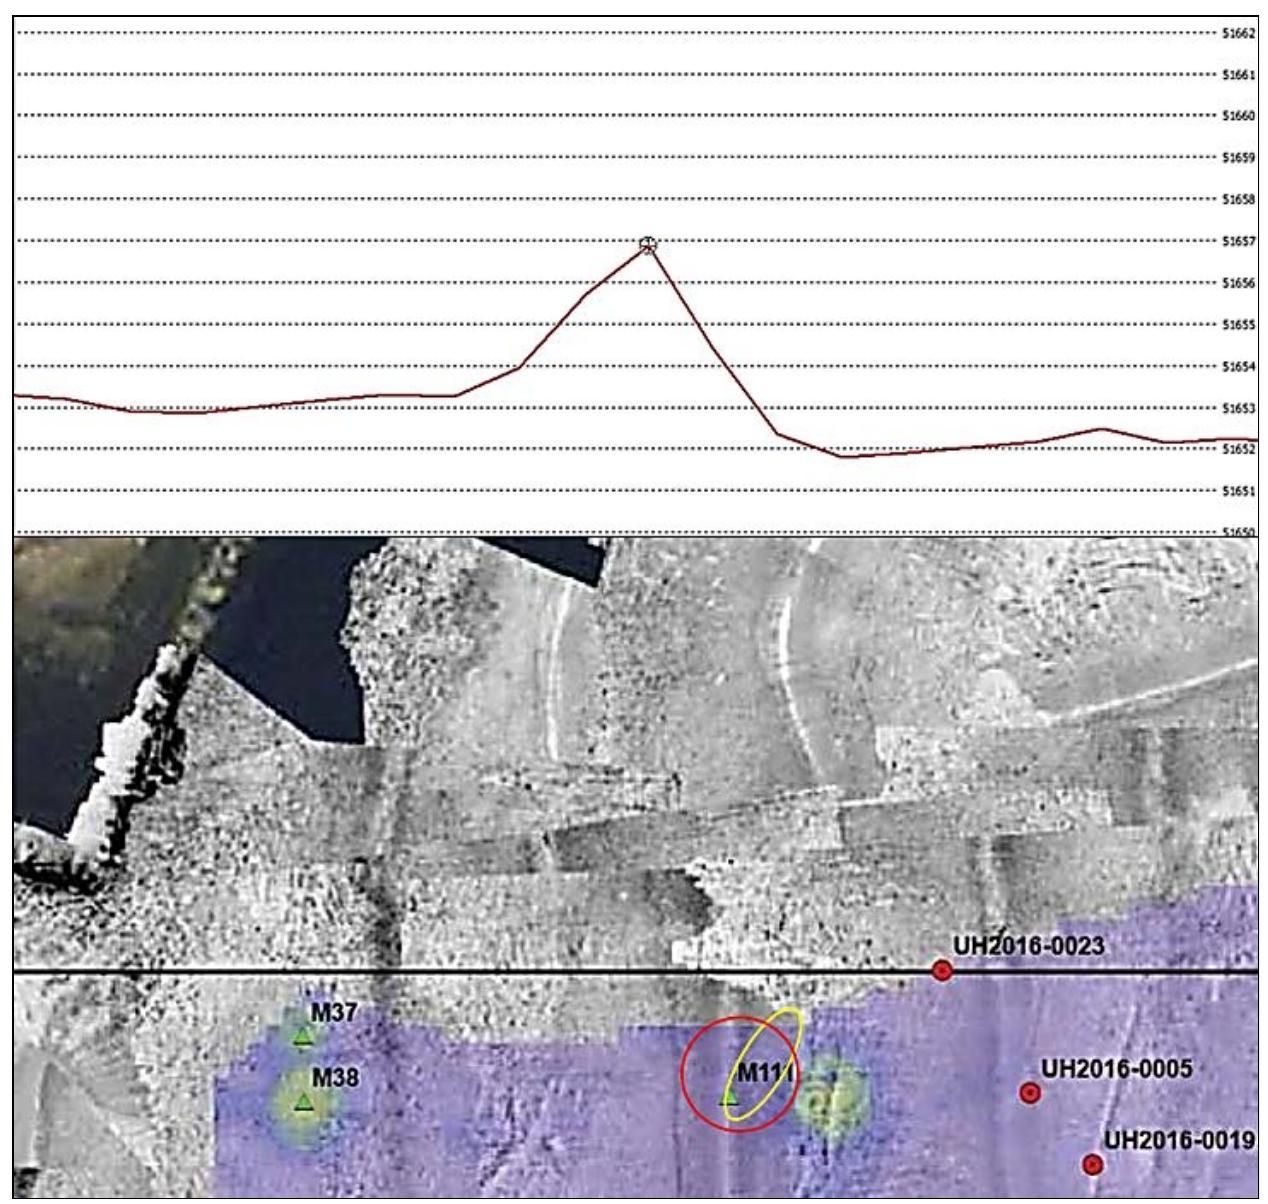
Figure 3. Raw magnetic data from the 2015 Task 2 (Submarine Cable Crossing) Area detailed re-survey showing (top image) the single isolated low-amplitude (4.5 gammas), short-duration (10 feet [3 meter]), monopolar magnetic anomaly (M111), and (bottom image) an excerpted plot of a sidescan sonar mosaic base-map with an overlying magnetic color-contour and point-plot of magnetic anomalies in the area of the NBHSS UAD SW#2 find (outlined in yellow). The combined sidescan sonar and magnetic data depicted in the lower image were recorded <u>prior</u> to NBHSS UAD SW#2's unanticipated discovery. The data shows no visible sidescan sonar contact at its location (source: base images for figure provided by CR).

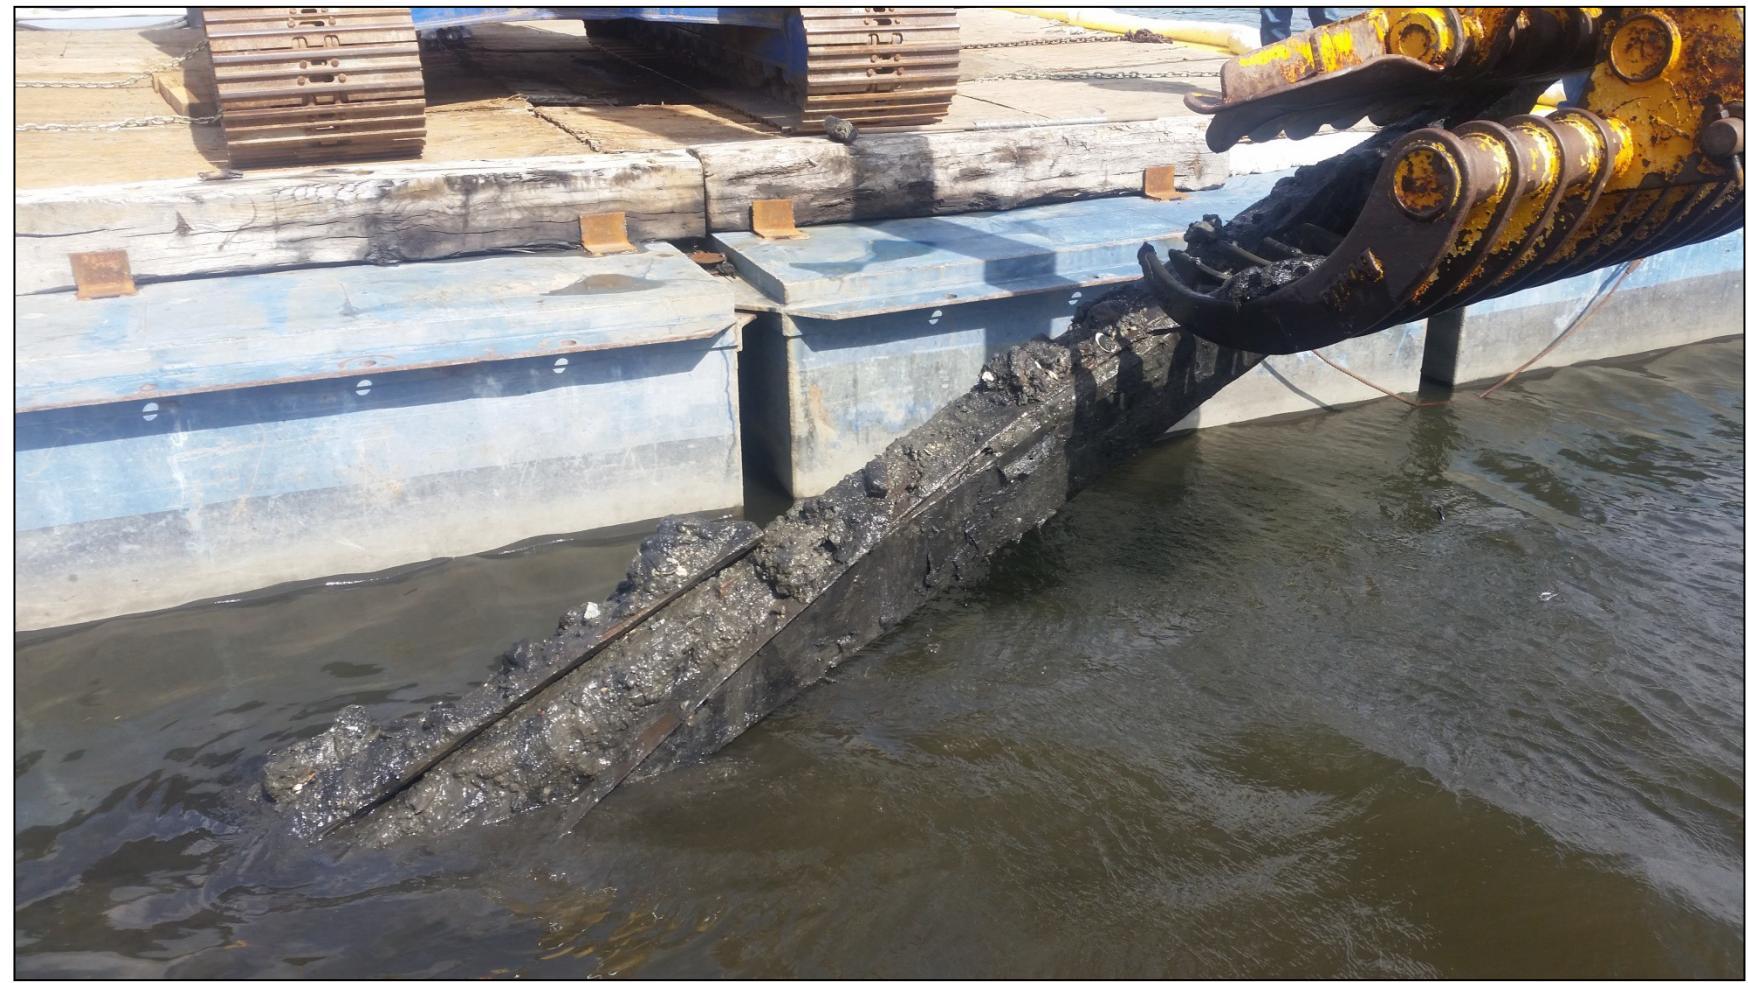
Figure 4. The keel of NBHSS UAD SW#2 exposed at the surface at the time of its unanticipated discovery in July of 2016 during remediation activities within the 2015 Task 2 (Submarine Cable Crossing) Study Area of the NBHSS Upper Harbor area (photograph by Joshua Cummings, Jacobs).

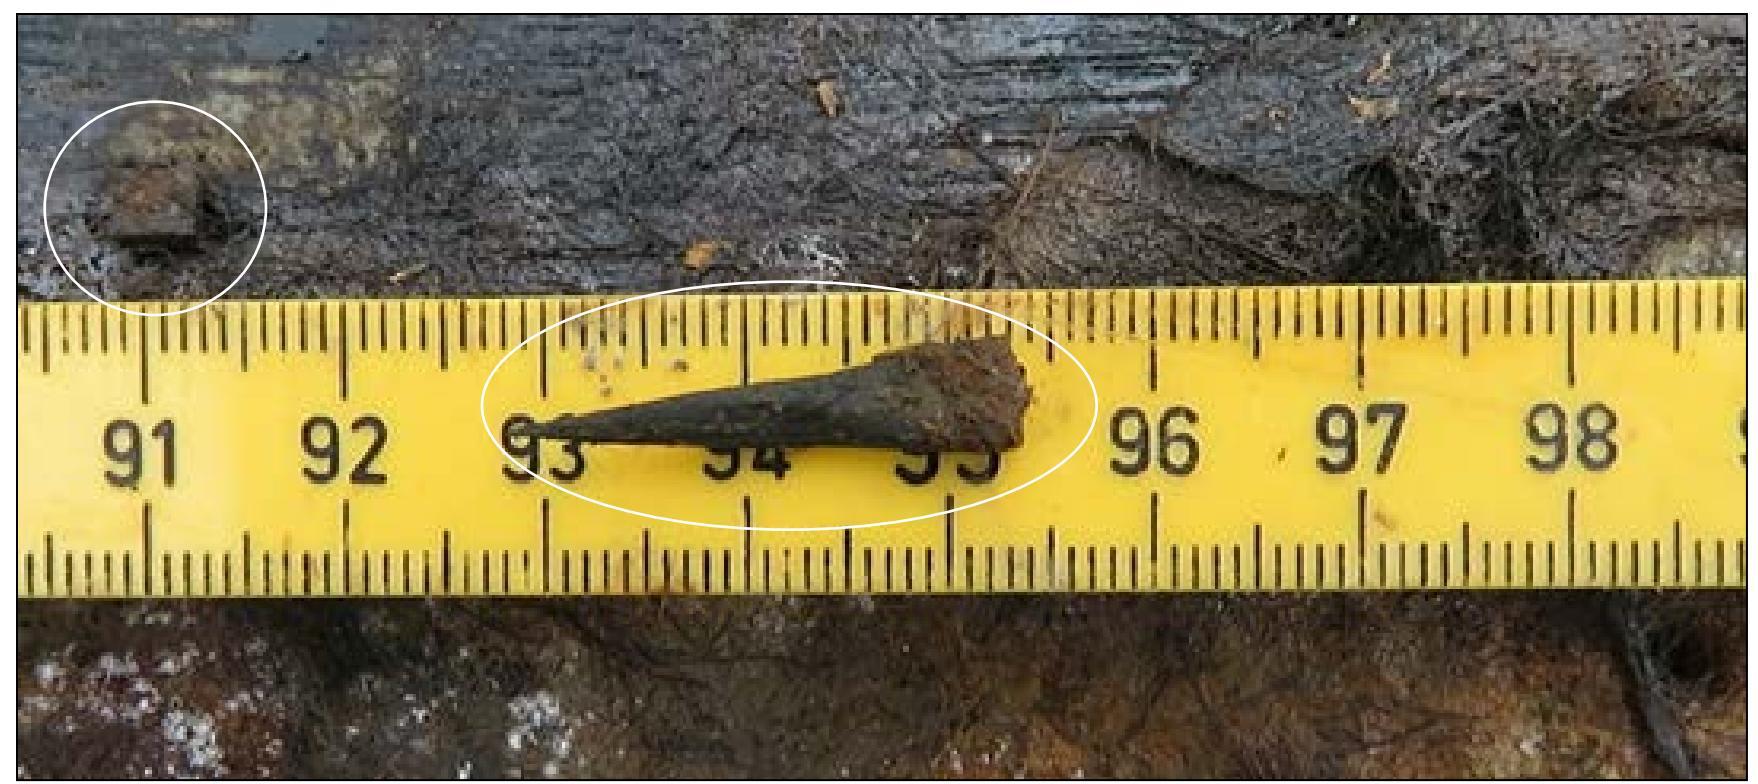
Figure 12. In addition to iron sheathing nails, wooden sheathing nails (circled above) were also used to fasten NBHSS UAD SW#2's sacrificial wooden hull sheathing on the exterior of its hull (photograph by David S. Robinson, DSRA).

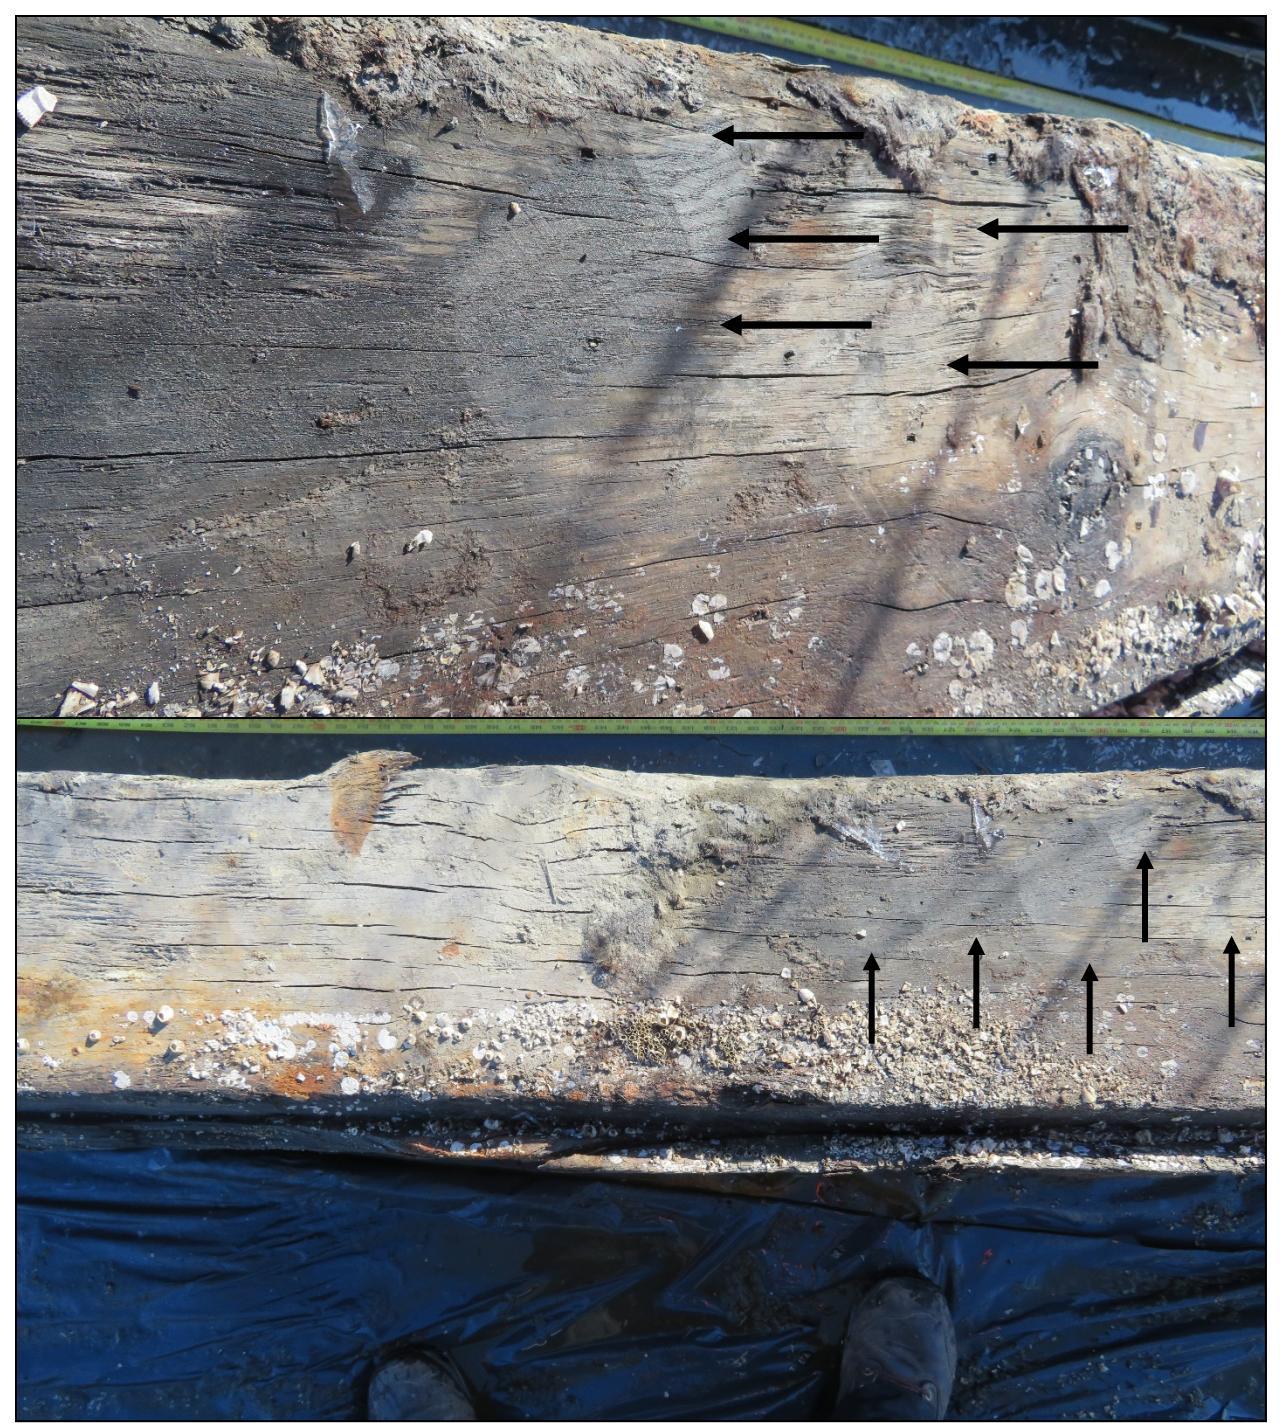
Figure 13. Shallow "scalloping" visible in the well-preserved surface of one of the sides of NBHSS UAD SW#2's keel (indicated by the arrows) resulting from the use of an adze to shape the large timber (photographs by David S. Robinson, DSRA).

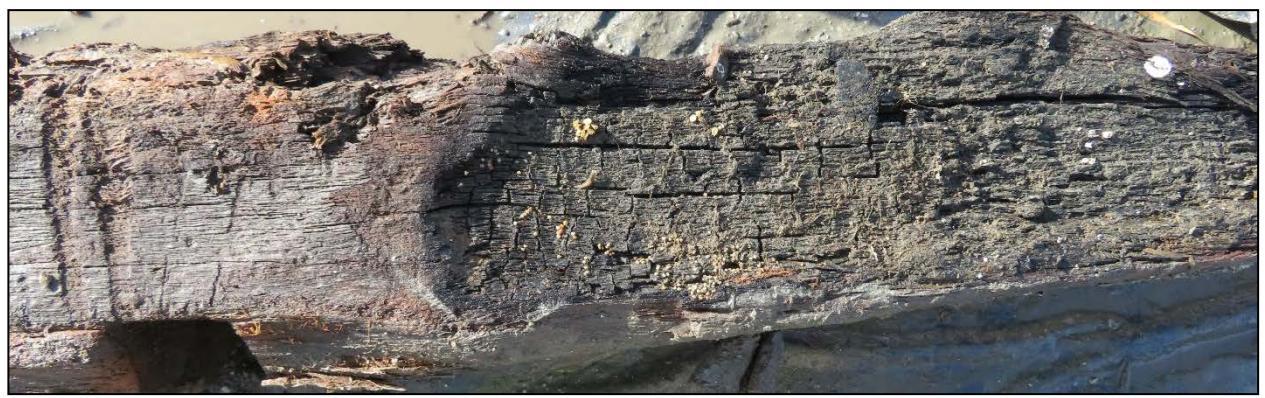
Slightly less than half (i.e., 10) of NBHSS UAD SW#2's estimated 23 floors (a total indicated by bolt holes in the top of the keel) (plus two "half-floors") was found preserved in the recovered hull remains. All 10 of the recovered floors were shaped primarily from compass timbers using an adze, and appeared to derive from the aft half of the hull (see Appendices C and D). All of the floors exhibited charring and damage from burning on their upper surfaces and sides (**Figure 17**). Based on the measured locations of the bolt holes distributed along the length of the keel, floors were fastened to the keel at an average, on-center spacing of 22 in (56 cm). Spacing between the floors and the adjoining next element of the frames, termed "first futtocks," could be inferred from measurements of fastener hole patterns and preferentially preserved raised areas corresponding to where floors and futtocks were in contact with the inboard surfaces of the garboard and first planking strakes. This patterning suggested that a tight (in places), although somewhat variable, spacing between the floors and first futtocks had existed before these components were separated at the time of NBHSS UAD SW#2's discovery and during the recovery of its hull remains.

Figure 17. A total of 10 of NBHSS UAD SW#2's floors were among the recovered hull remains. This representative example exhibits charring (lower image) and damage from burning that was present on all of the recovered floors' upper surfaces and sides (photographs by David S. Robinson, DSRA).

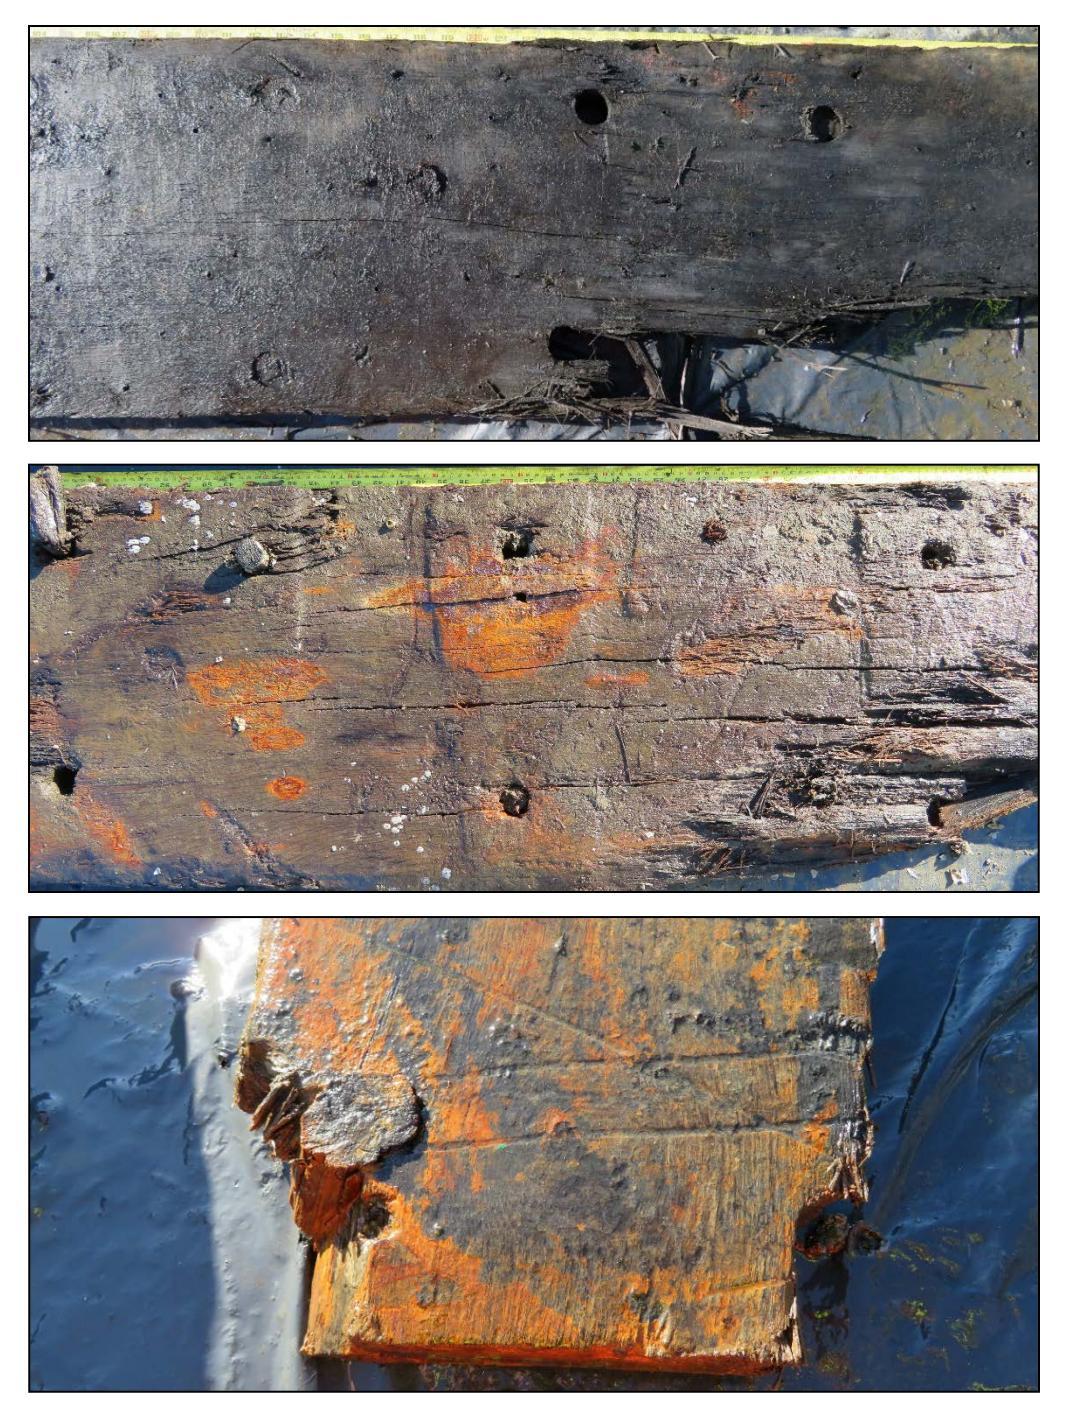
Figure 18. NBHSS UAD SW#2 hull planking (note: a. the excellent condition and saw marks in the planking's exterior [top image] formerly protected by tarred felt and wood sheathing; b. the preferential preservation of the planking's interior surface where it was in contact with floors and futtocks [middle image]; and c. the "XX" scribe mark at a frame location (indicated by the presence of treenails) (photos by David S. Robinson, DSRA).

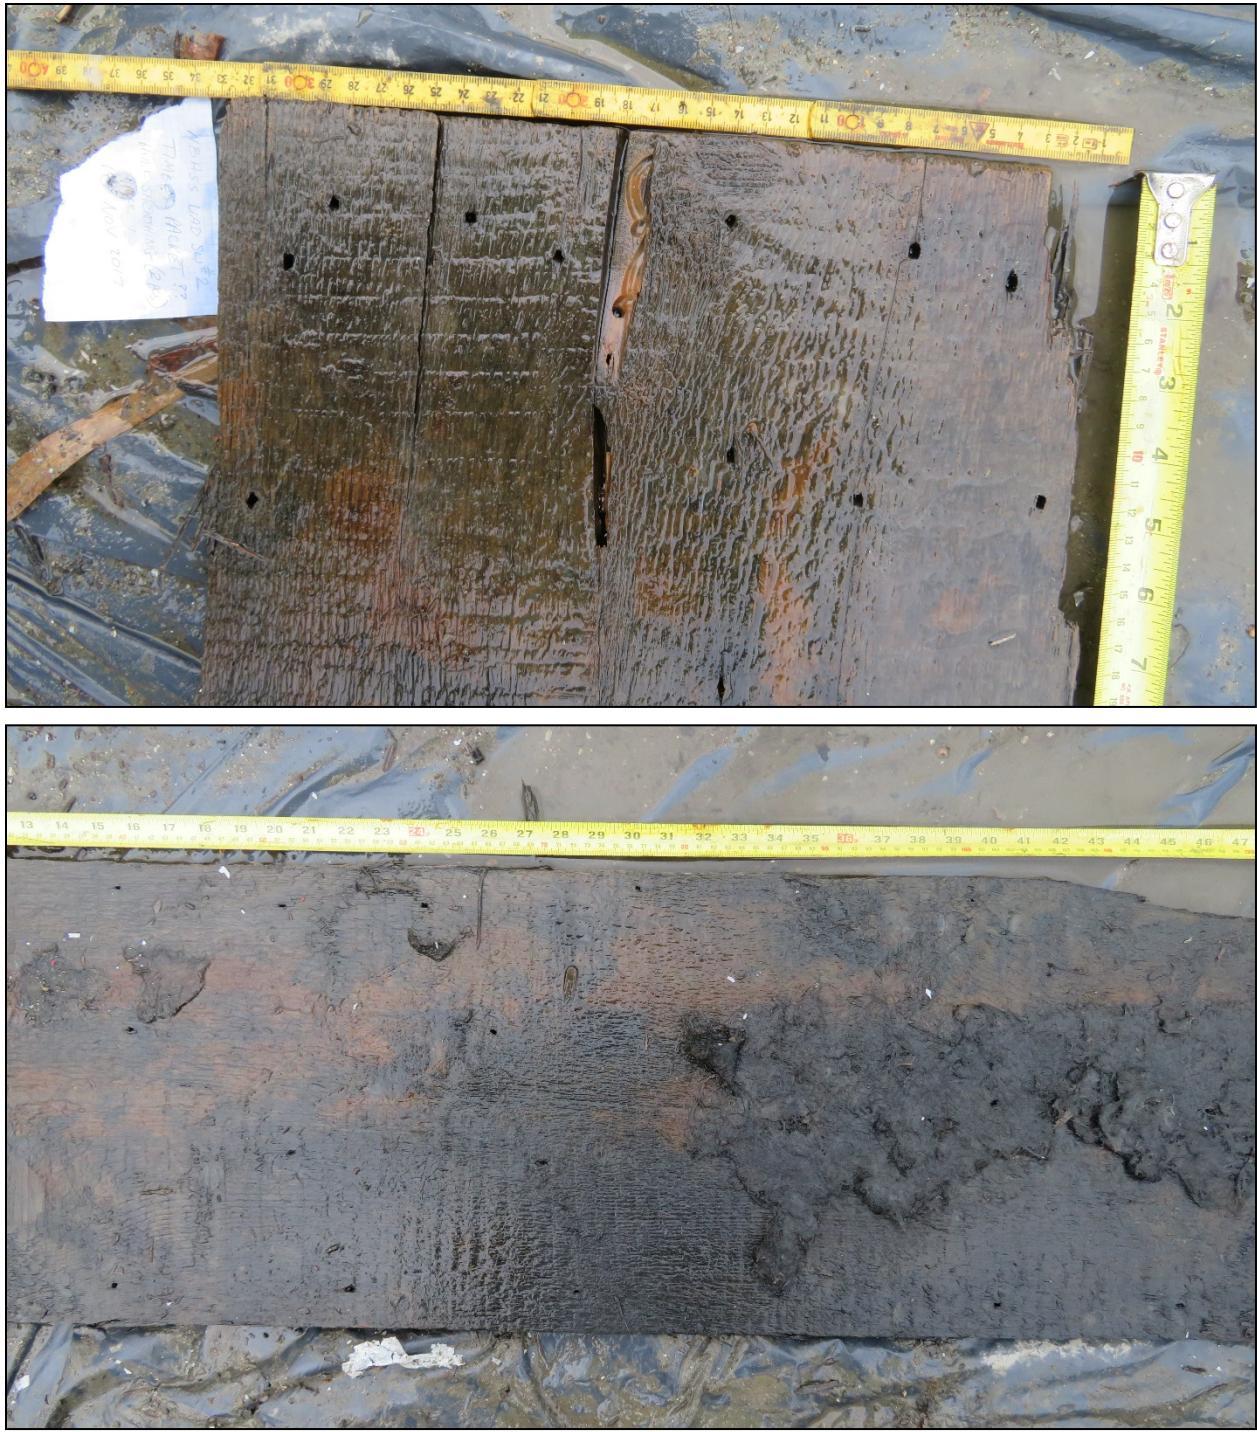
Figure 19. Irregularly angled, widely-spaced, saw kerf marks were visible on both sides of the sheathing (top and bottom images), and were consistent with hand-cut "pit-" or "platform-" sawn lumber. Large areas of intact tarred felting were also still visible adhering to the inboard surfaces of the wood hull sheathing (photographs by David S. Robinson, DSRA).
