Re: GE-Pittsfield/Housatonic River Site Rest of River (GECD850) Rising Pond Dam - 2024 Penstock Investigations – Material Identification Testing

MicroVision Labs Project #: 17006 GZA GeoEnvironmental Project #: 19896.50 GZA GeoEnvironmental Project Name: Rising Pond Dam Penstock Report Analyst: T. Wozmak

This report covers the methods and findings of the unknown material identification that MicroVision Laboratories, Inc. conducted on two (2) samples from project number 19896.50. The purpose of the analysis was to examine the sample material by SEM/EDS to identify the elemental composition of the solids. The results presented in this report relate only to the samples examined and as received.

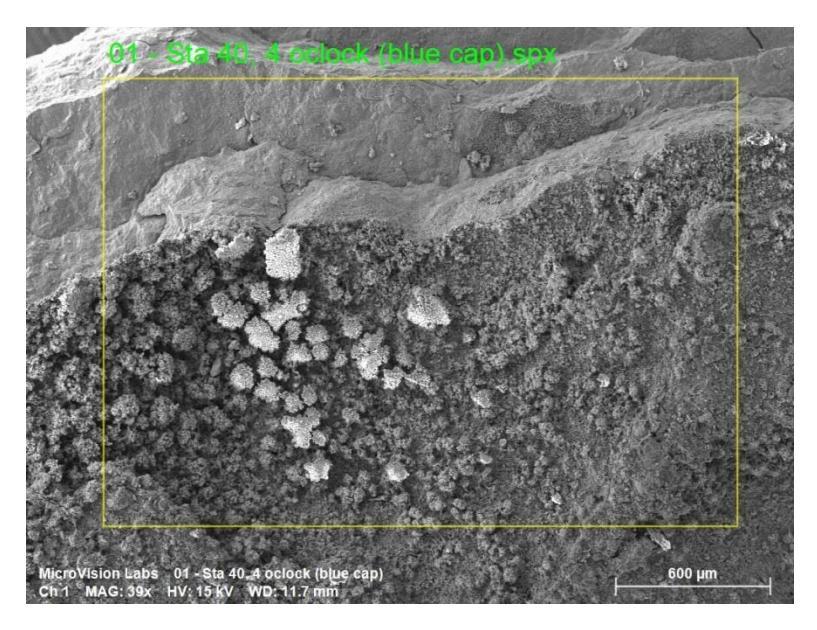
Sample: 01 – Sta. 40, 4 o'clock (blue cap)

The SEM image above shows the sample material and the location where the EDS data was collected (yellow box). The elemental composition was predominantly iron and oxygen with lower to trace concentrations of carbon, manganese, silicon, calcium, nitrogen, aluminum, magnesium, potassium, sulfur, phosphorus, and sodium. The material was brittle, multilayered, flakey, and had a reddish color to it. These properties along with the elemental composition detected in the material suggests that this sample is composed of rust flakes, presumably from a mild steel due to the presence of manganese and no chromium, nickel, or other type of steel additive.

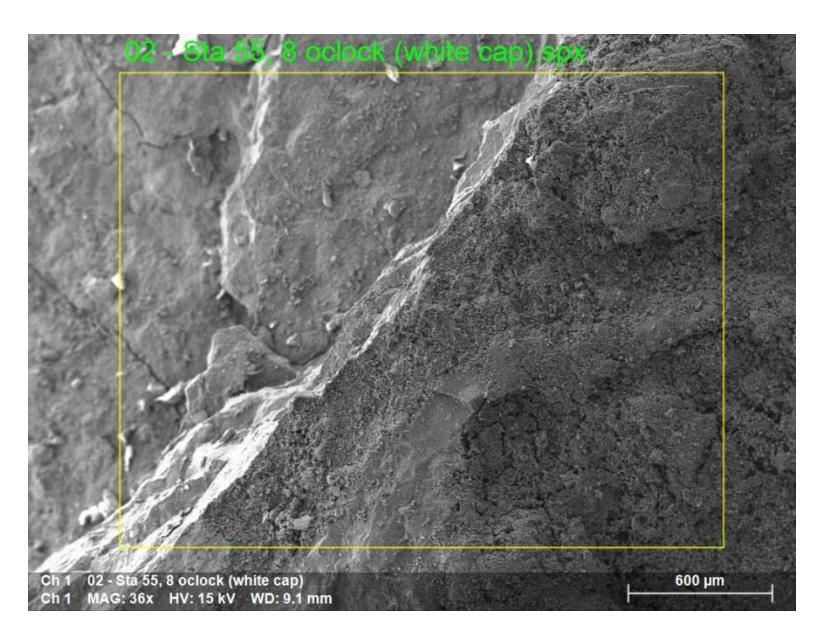
The SEM image above shows the sample material and the location where the EDS data was collected (yellow box). The elemental composition was also predominantly iron and oxygen with lower to trace concentrations of carbon, manganese, silicon, calcium, aluminum, magnesium, potassium, sodium, titanium, sulfur, and phosphorus. The material was brittle, multilayered, flakey, and had a reddish color to it. These properties along with the elemental composition detected in the material suggests that this sample is composed of rust flakes, presumably from a mild steel due to the presence of manganese and no chromium, nickel, or other type of steel additive.
