**Re: GE-Pittsfield/Housatonic River Site
Rest of River (GECD850)
Revised Operation, Monitoring, and Maintenance Plan for Rising Pond Dam**

OPERATION, MONITORING, AND MAINTENANCE PLAN RISING POND DAM – MA00250

Revised December 2025
GZA File No.: 01.0019896.81

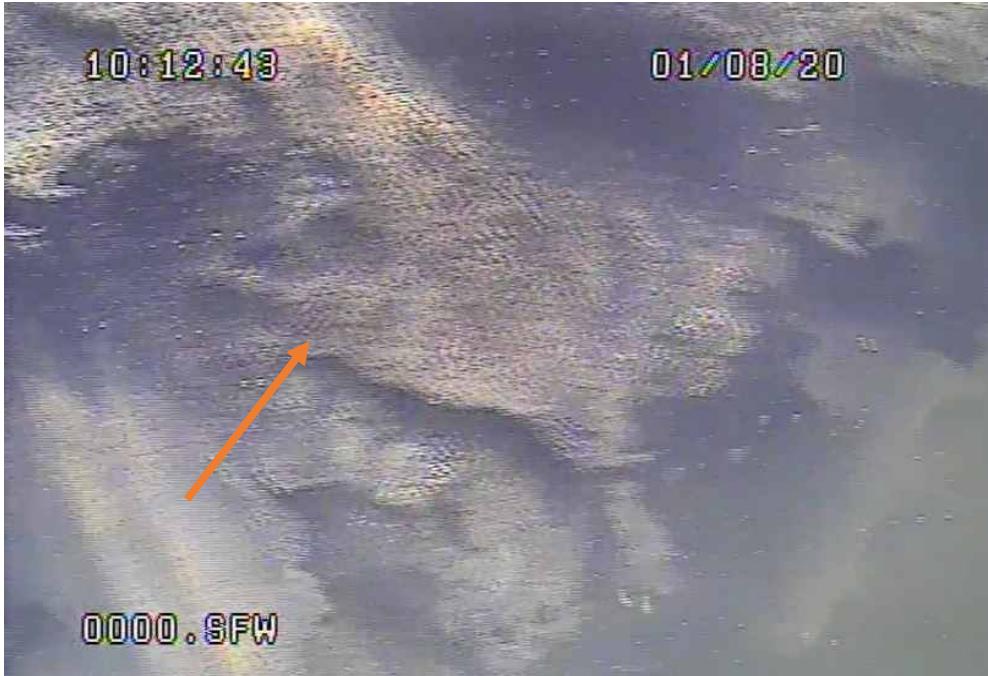
Photo 1	Date: 1/8/2020

Direction Photo Taken: Left		
Description: Filter fabric under downstream riprap (placed as part of 1992 repairs).

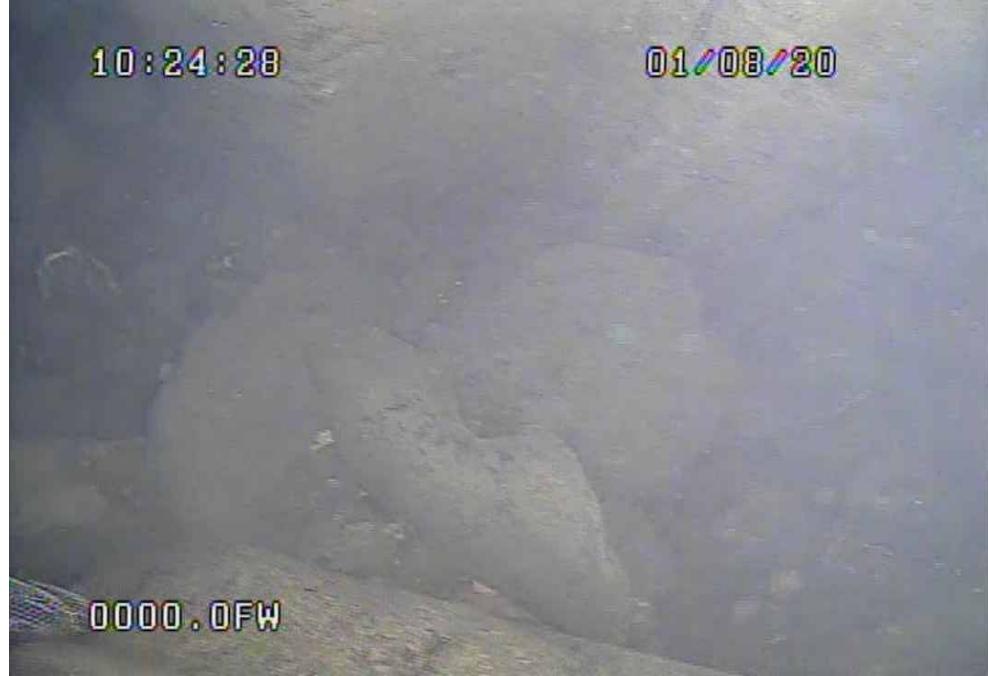
Photo 2	Date: 1/8/2020

Direction Photo Taken: Left		
Description: At downstream left training wall base. Slight pitting observed. Bottom material is rip rap with debris/logs.

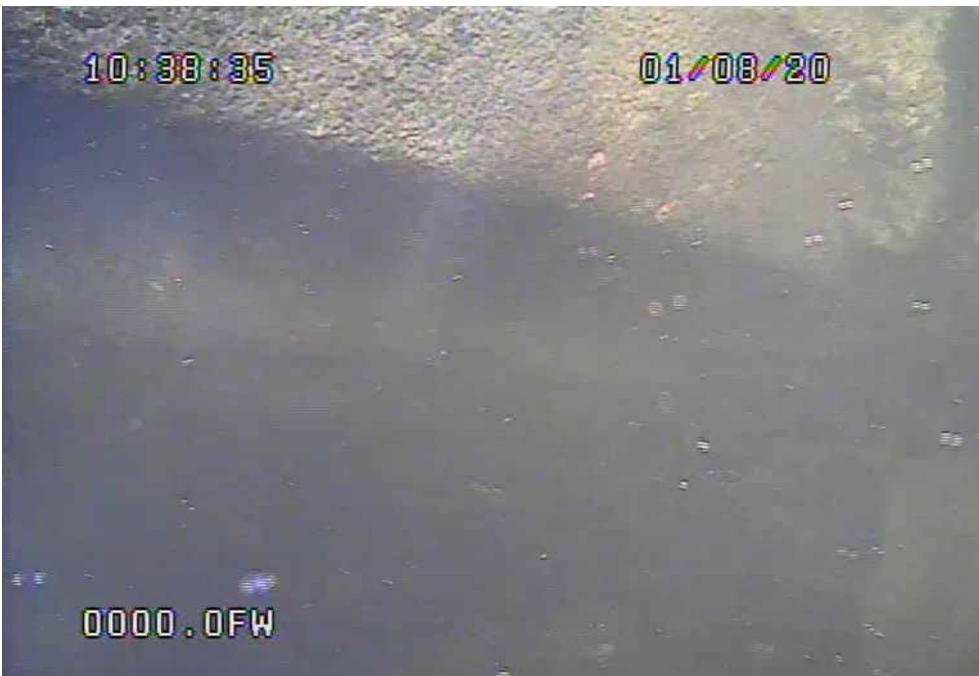
Photo 3	Date: 1/8/2020

Direction Photo Taken: Upstream		
Description: Sheet pile downstream of spillway.

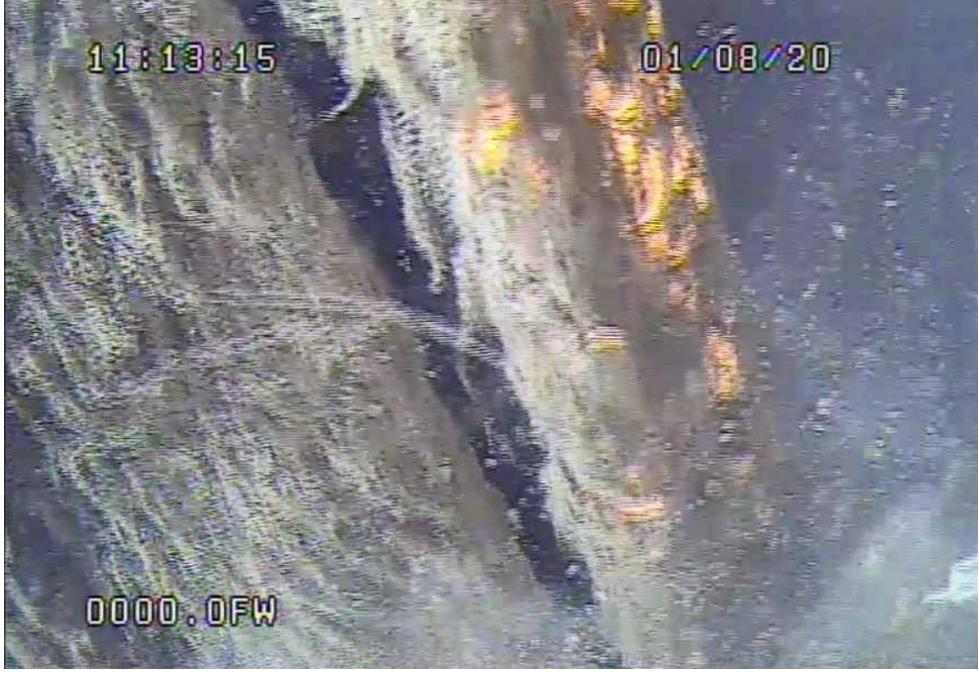
Photo 4	Date: 1/8/2020

Direction Photo Taken: Right		
Description: Corner of upstream sheet pile below instrumentation shed.

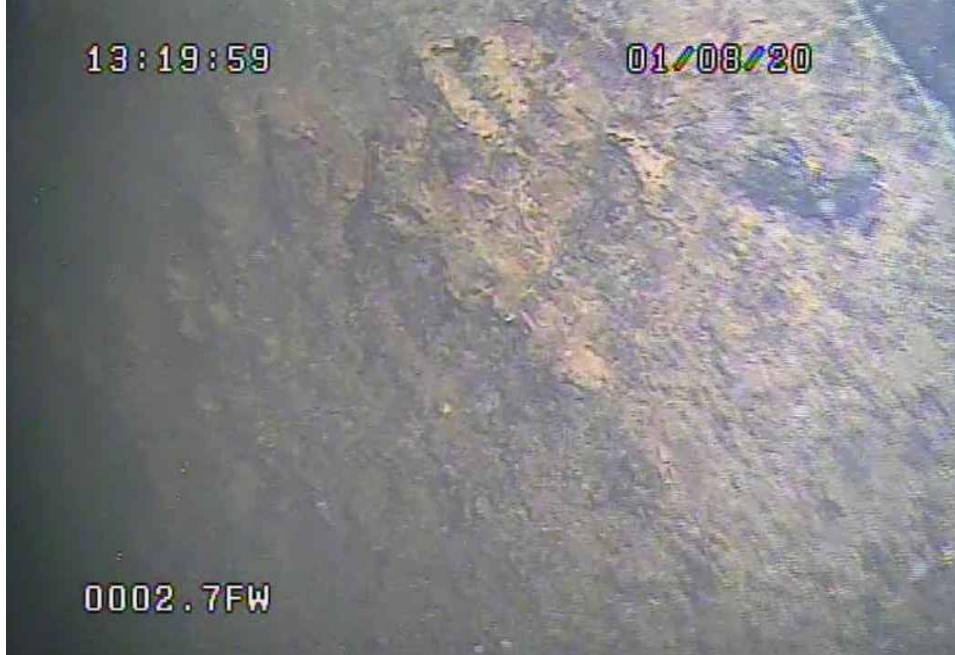
Client Name: General Electric Company		Site Location: Rising Pond Dam Great Barrington, MA	Project No.: 01.0019896.50
Photo 9	Date: 1/8/2020

Direction Photo Taken: Downstream			
Description: Upstream side of the trash rack.			
Photo 10	Date: 1/8/2020

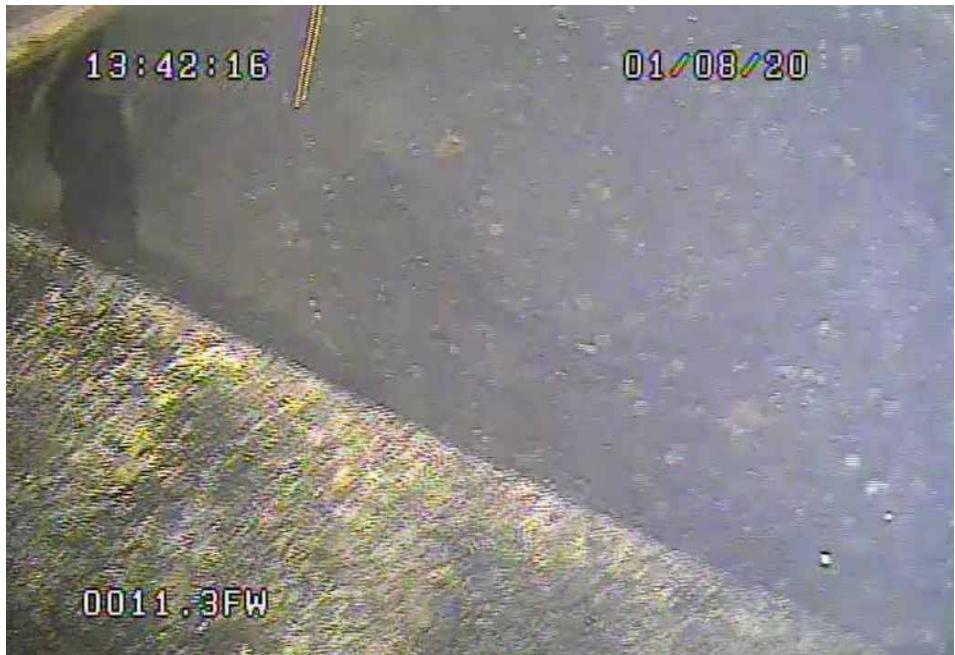
Direction Photo Taken: Upstream/Right			
Description: Downstream side of the trash rack.

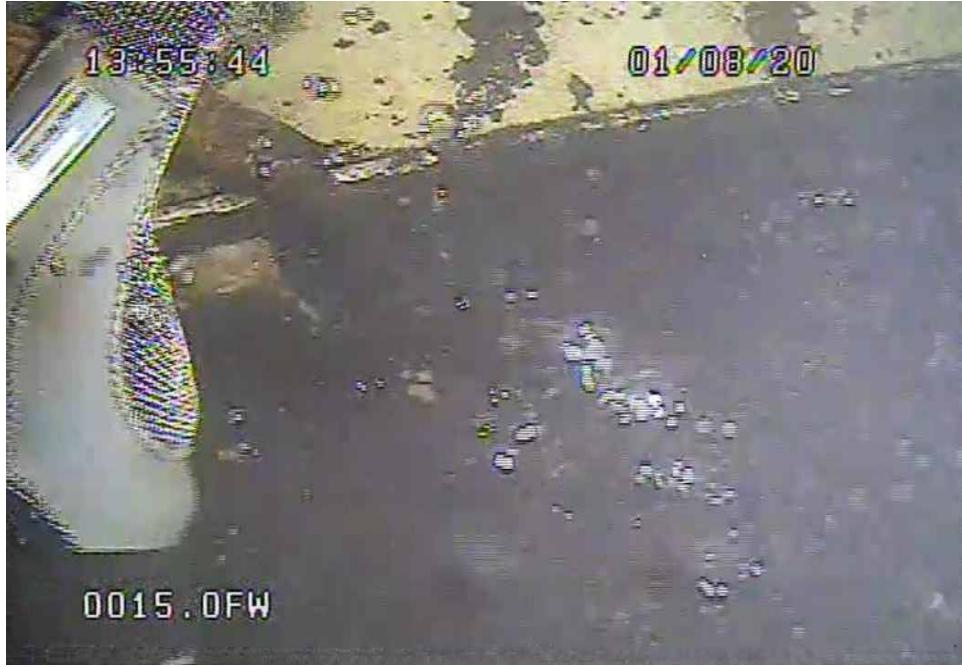
Client Name: General Electric Company		Site Location: Rising Pond Dam Great Barrington, MA	Project No.: 01.0019896.50
Photo 11	Date: 1/8/2020	Direction Photo Taken: Downstream

Description: Left side of low level outlet gate.			
Photo 12	Date: 1/8/2020	Direction Photo Taken: Left

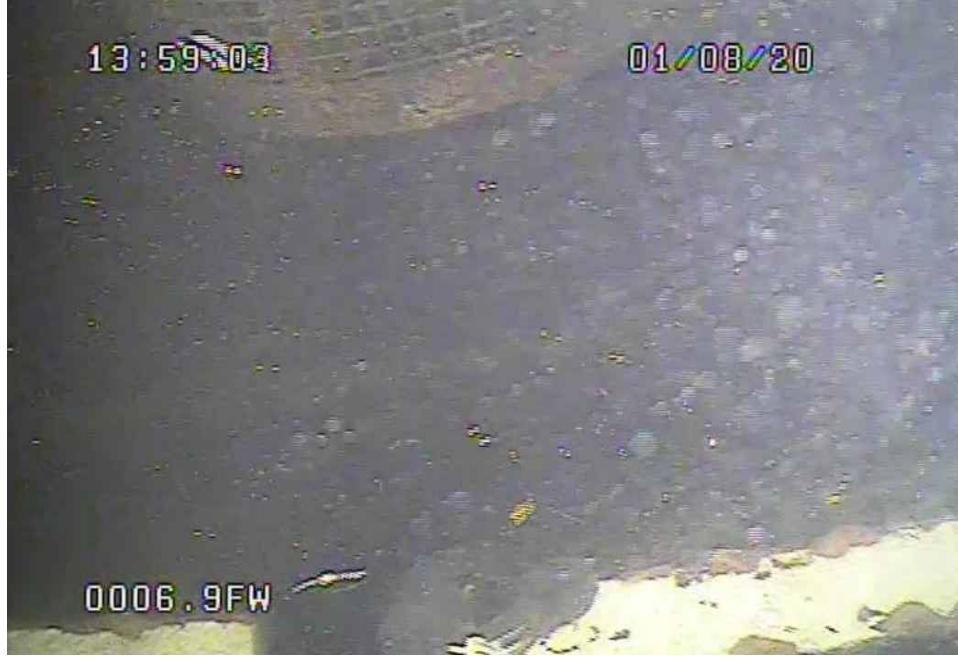
Description: Former fire pump intake at left wall of forebay.
