Superfund Five-Year Review Report Syncon Resins Superfund Site Kearny, Hudson County, New Jersey

August 2011

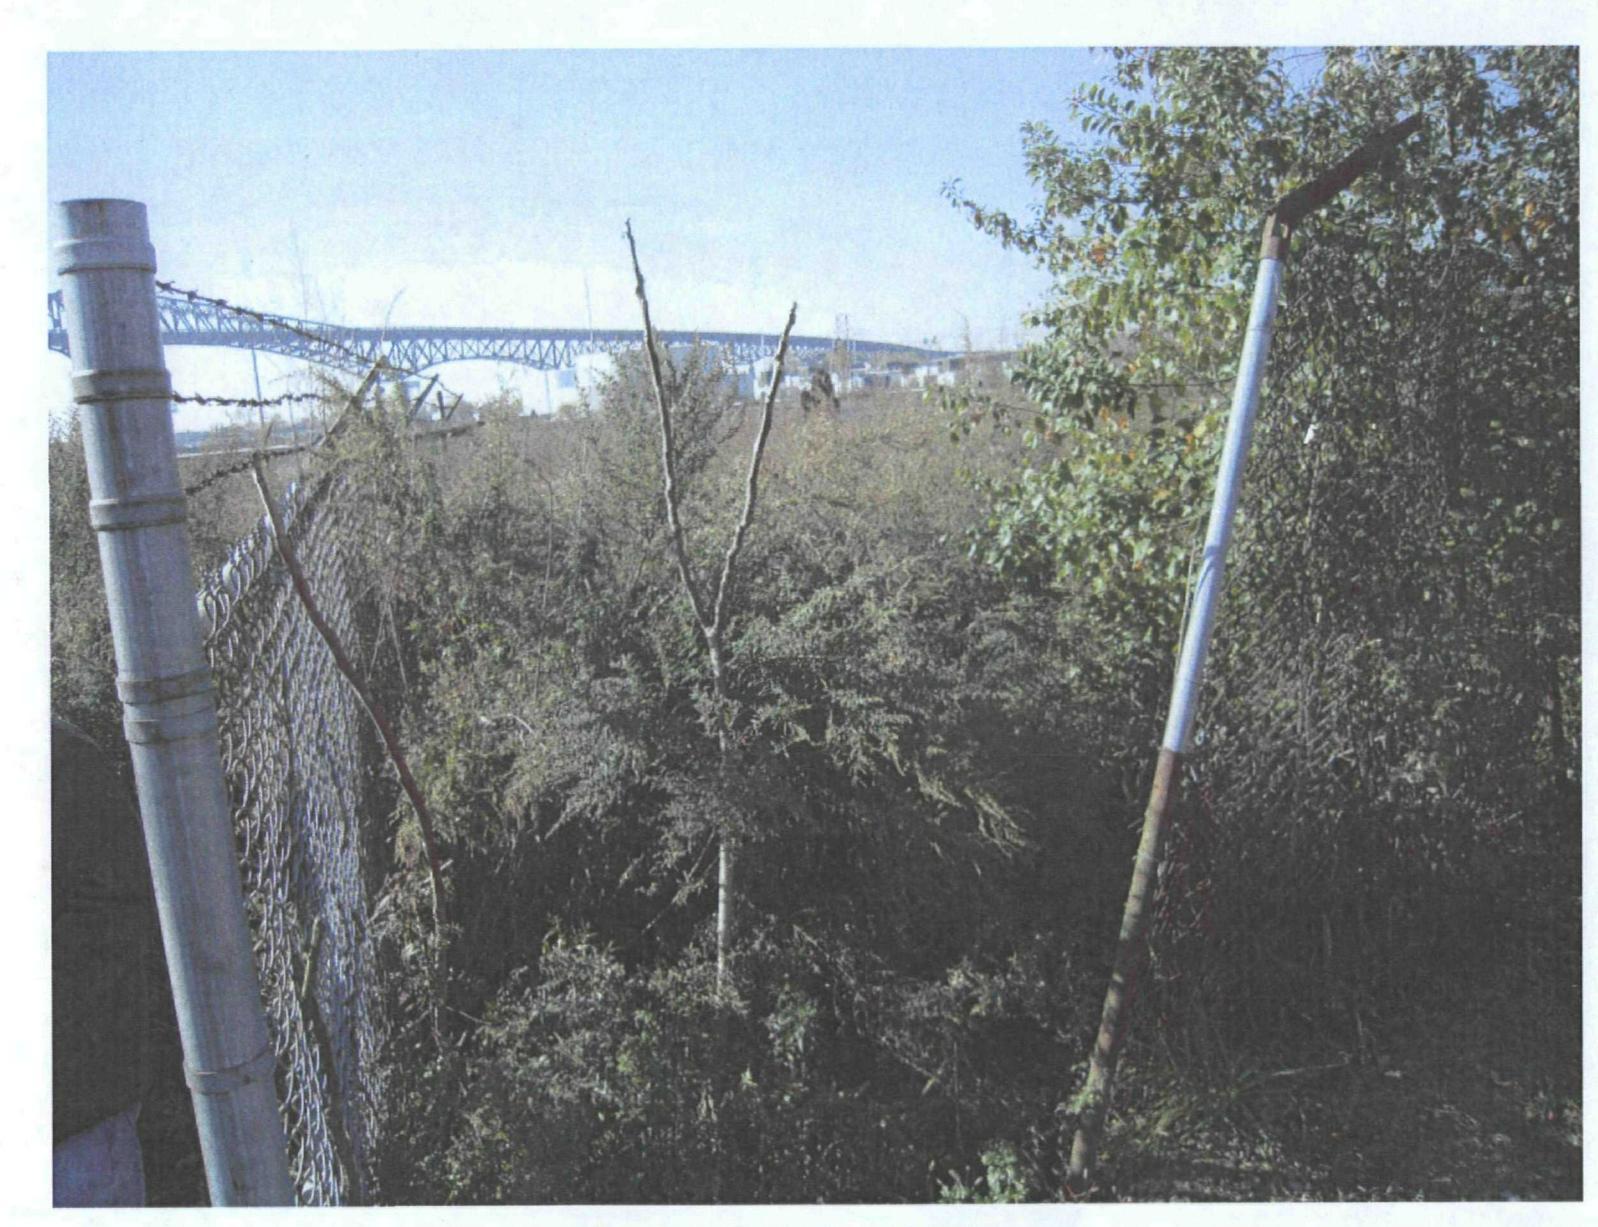
Currently, the Site is mostly fenced. However, trespassers have had access to the Site as evidence such as graffiti on Site buildings has been observed. Since contaminated above-ground structures were decontaminated and/or disposed of off-site, lagoon sediments and highly contaminated soils were removed and disposed of off-site, a permeable cover layer was placed over the ground surface, and groundwater is not currently used or expected to be used for drinking water in the future, the direct contact exposure to contaminated surface soils and groundwater at the Site have been interrupted. Additionally, with regard to direct contact exposure to subsurface soils and groundwater, no construction/utility work is anticipated in the next five years, the timeframe considered in this review; therefore, the current remedy is considered protective.

Figure 5 - Gap in Fence

NJDEP needs to continue the operation, maintenance and monitoring of the OU1 remedy. Access controls need to be improved and continued to be maintained and the Site use must remain restricted to ensure that the public is not exposed to site-related contaminants.
