Subject: Delineation of Lemon Lane Perimeter Security Fence

FIELD OVERSIGHT SUMMARY FOR JANUARY 30, 2001 LEMON LANE LANDFILL SITE BLOOMINGTON, INDIANA

FIELD OVERSIGHT SUMMARY LEMON LANE LANDFILL SITE BLOOMINGTON, INDIANA

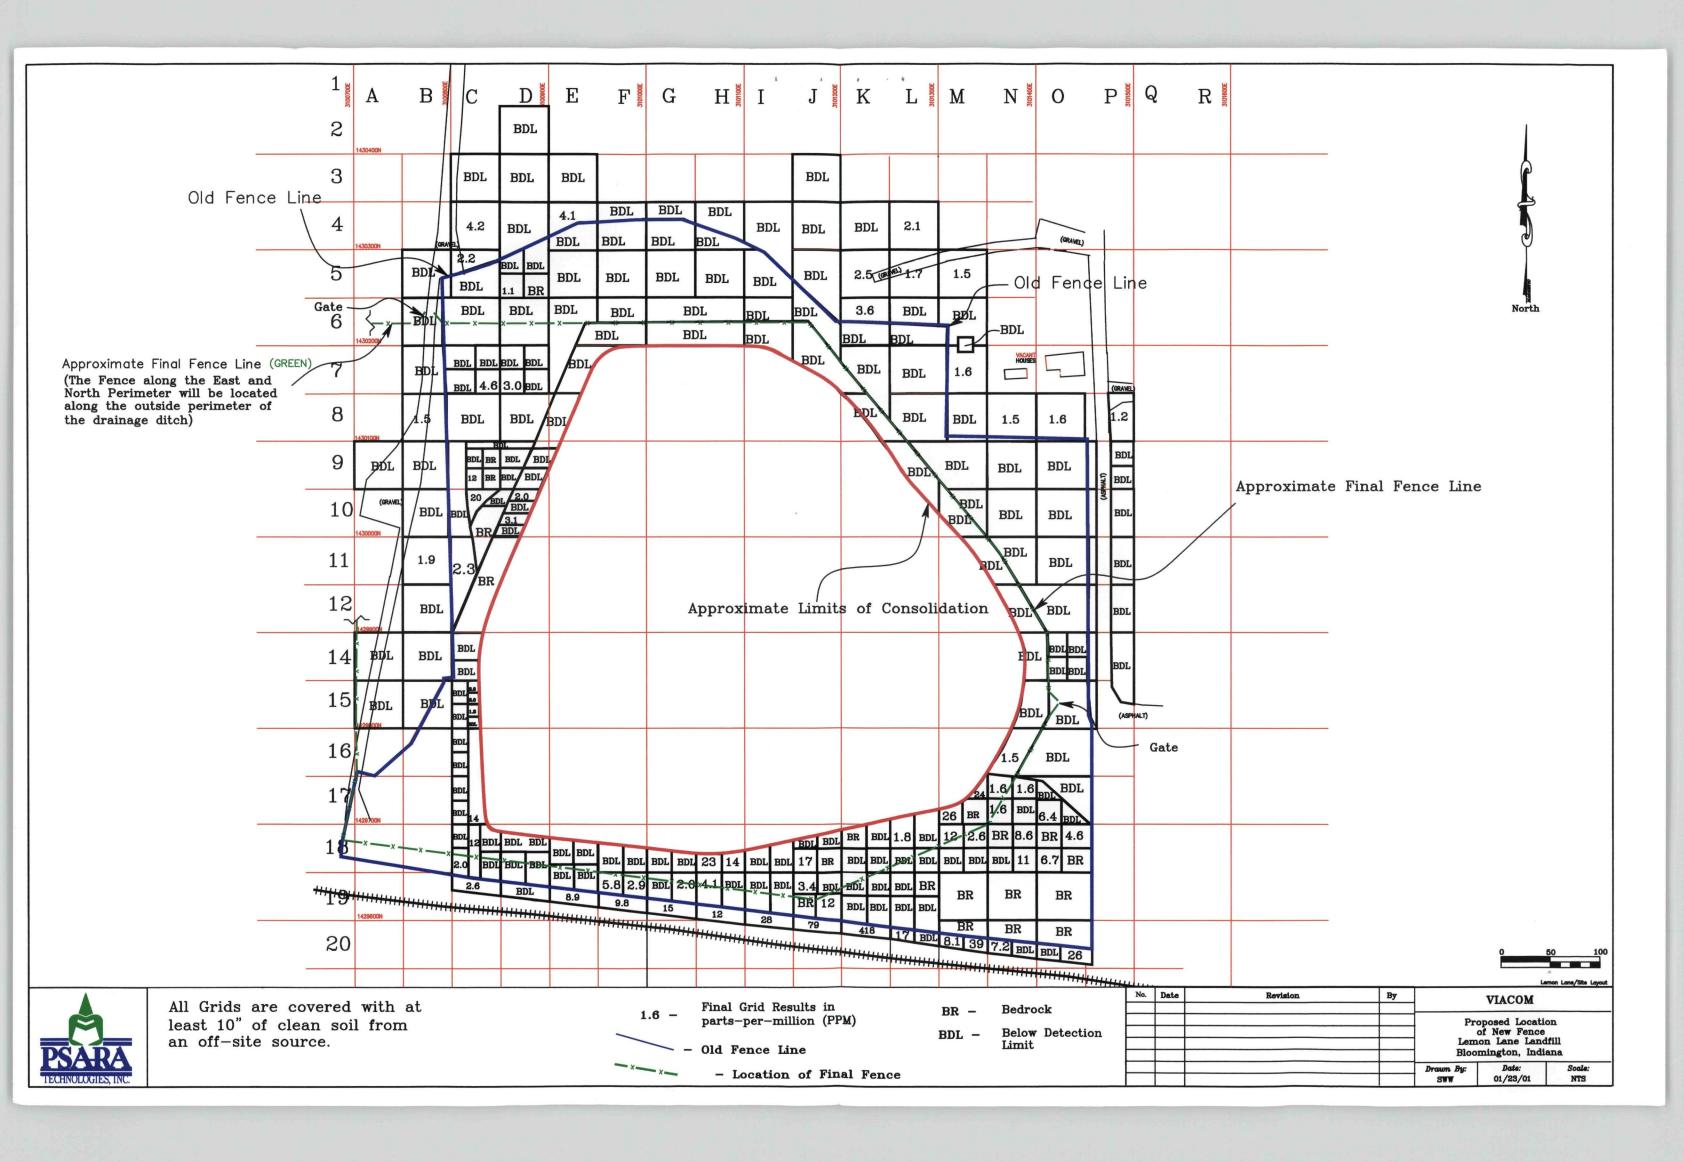
Attachment: Proposed Site Fence Location dated 1/3/01

I have attached a sketch of the approximate fence location around the landfill. The fence has been overlaid on the excavated grids. The numerical value or BDL for a grid depicts the final verification sample result for that grid. The grids outside the perimeter fence meet the applicable cleanup criteria.

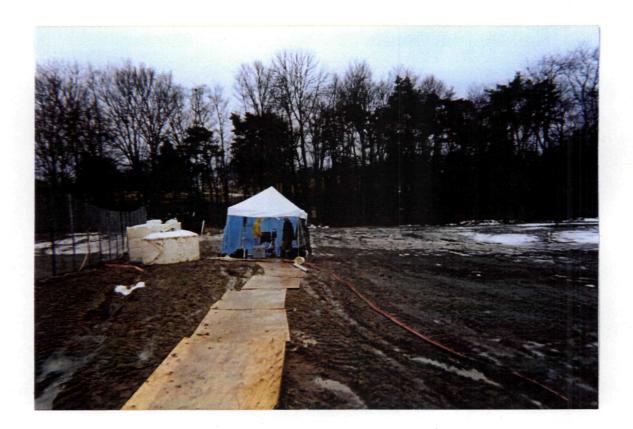
Photograph No. 1 Orientation: South Location: Lemon Lane Landfill

Description: PSARA Technologies, Inc. (PSARA), inside protective tent around monitoring well MW-16

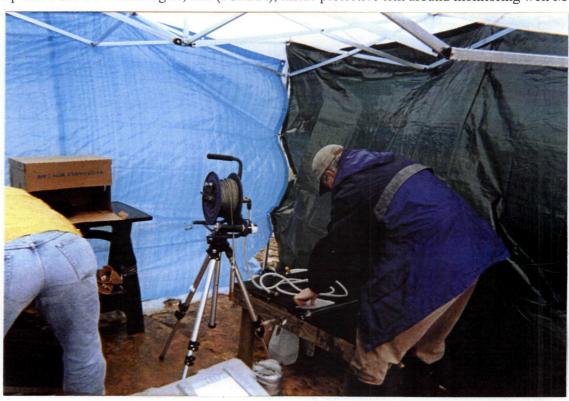
Photograph No. 2 Orientation: Southwest

Description: PSARA setting up video-logging equipment

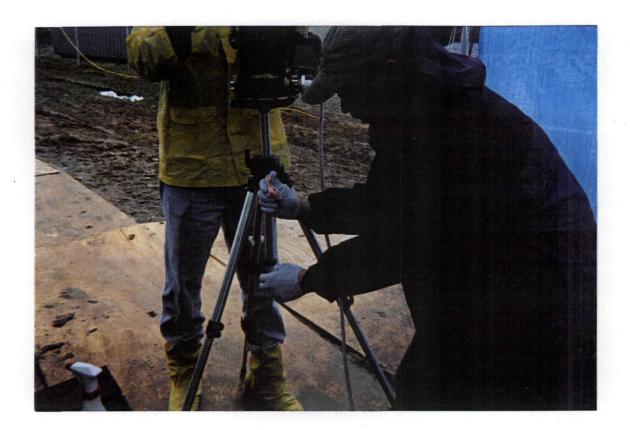
Photograph No. 3 Orientation: Northeast Location: Lemon Lane Landfill

Description: PSARA retracting the video camera and decontaminating deployment wire

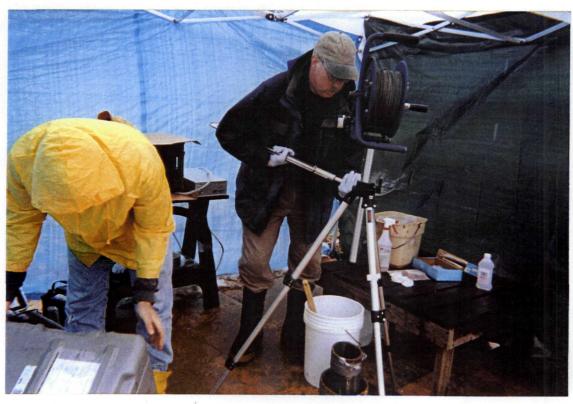
Photograph No. 4 Orientation: Southwest

Description: PSARA disassembling video-logging equipment

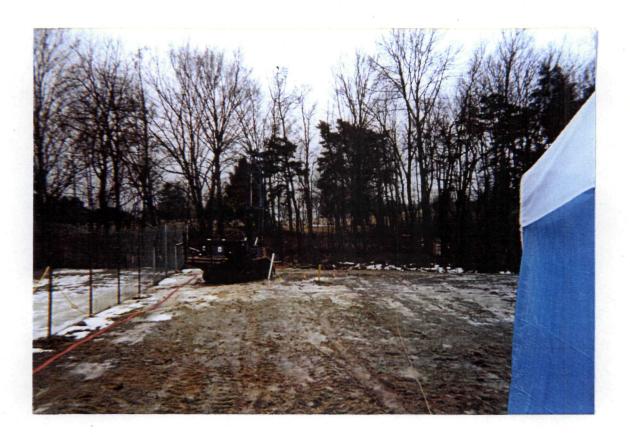
Photograph No. 5 Orientation: South Location: Lemon Lane Landfill

PSARA reported that soft soil conditions were limiting movement of the ADS drill rig. As a result, rock drilling for piezometer PZ-G on the northwest side of the landfill cap would be delayed.

Description: American Drilling Services drill rig stationed in southeast corner of site
