Callahan Mine Superfund Site Monthly Update May 2021

The United States Environmental Protection Agency (EPA) and Maine Department of Environmental Protection (MEDEP) continue their efforts to complete the cleanup of the Callahan Mine Superfund Site. The United States Army Corps of Engineers (USACE) was retained by EPA to implement the cleanup work and to provide technical and administrative management of the contract and contractor. The work is being performed by Environmental Quality Management, Inc. (EQM) and their subcontractor TetraTech EC, Inc. (wholly referred to in this document as the EQM Team). Current effort focuses on stabilization of the Tailings Dam, Waste Rock Pile #3 (WRP#3), and installation of cover system on the Tailings Impoundment.

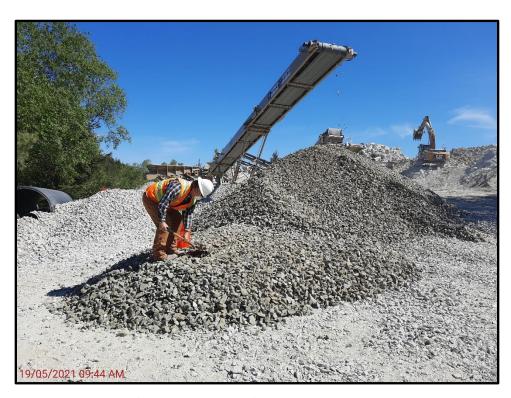
Photo 1. View of sample collection for testing at the rock processing plant. (see attached Figure E-1 for location of processing area)

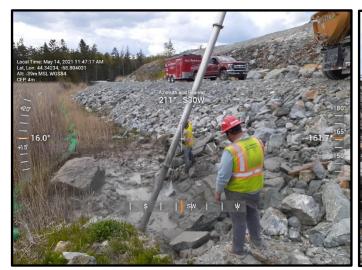
Photo 2 (group). Views of RF Jordan removing tailings sediment from toe of the East access road and along access road drainage features.

- Inspected the interim erosion and sediment controls on the Tailings Impoundment.
- Repaired/maintained the controls that sustained erosion damage during the 2020/2021 winter shutdown.
- Enhanced stormwater conveyance channels and upgraded/repaired the erosion controls.
- Continued crest main drainage swale work, and road repairs throughout the site using 3/4" reject fines.
- RF Jordan vactor truck team completed the tailings sediment removal.
- Gorilla-Snot (synthetic copolymer dispersion) applied to control dust and prevent erosion.

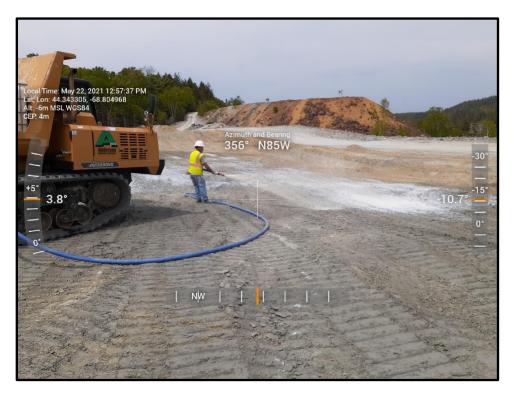
Photo 3. EQM team regraded tailings materials and applied Gorilla-Snot to control future erosion.

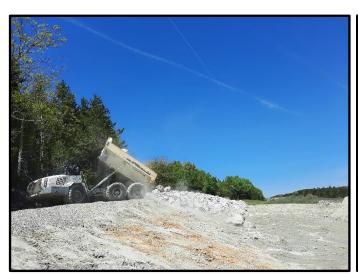
Photo 4 (group). Views of Western Ore Pad slope during 36" rock placement.

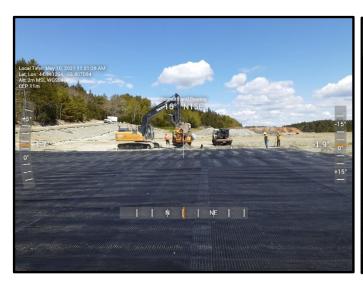
Photo 5 (group). Views of Southwest corner geo-grid and fines placement as surface stabilization.

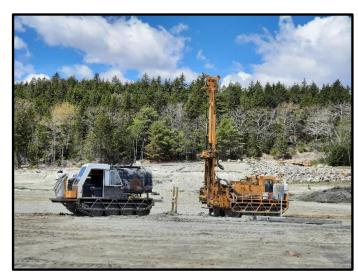
Photo 6. Views of geotechnical and well abandonment on top of the Tailings Impoundment with New England Boring Contractors.
