FIVE-YEAR REVIEW REPORT FOR WESTINGHOUSE ELECTRIC CORP. (SHARON PLANT) SUPERFUND SITE MERCER COUNTY, PENNSYLVANIA

September 2016

Prepared By: United States Environmental Protection Agency Region 3 Philadelphia, Pennsylvania

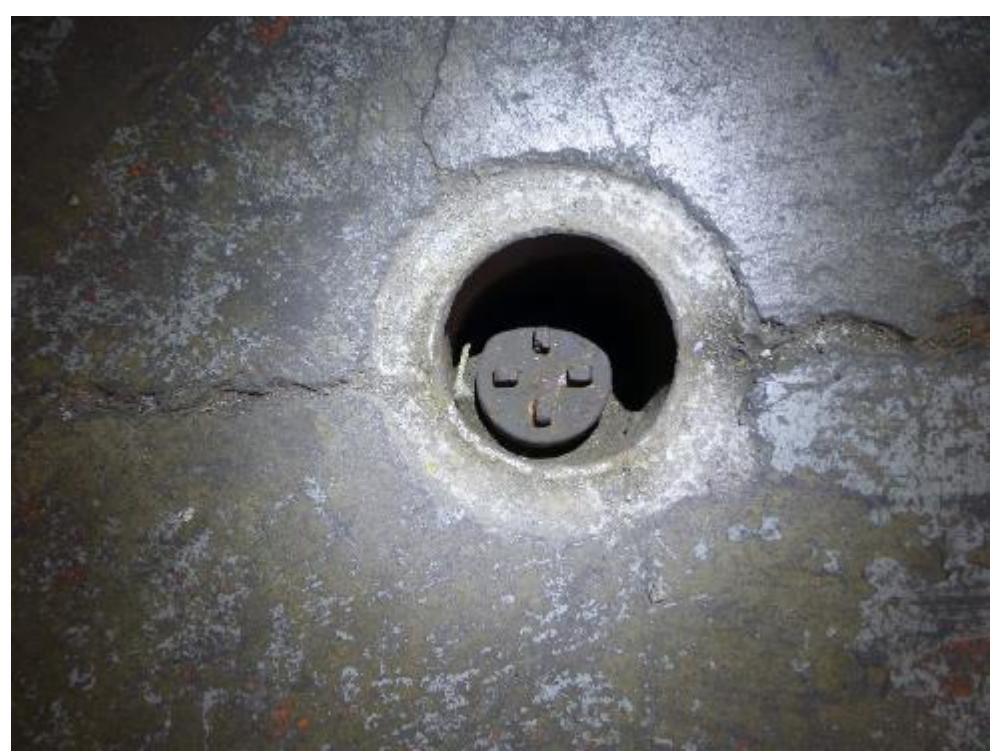
Unmarked monitoring well S-4 inside South Sector Building.

- During the FYR site visit, several wells needed maintenance, these wells should be repaired.
- Documents at the Site's repository only included an Administrative Record up until the ROD. Important site documents (RODs and FYRs) should be sent to the repository.
- Subslab concentrations of 1,2,4-trimethylbenzene in the South Sector increased from 2014 to 2015, additional sampling for vapor intrusion is warranted.
- The Davis Alloys buildings is currently vacant. If it becomes occupied, additional sampling for vapor intrusion is warranted and mitigation should be considered prior to re-use of the building.

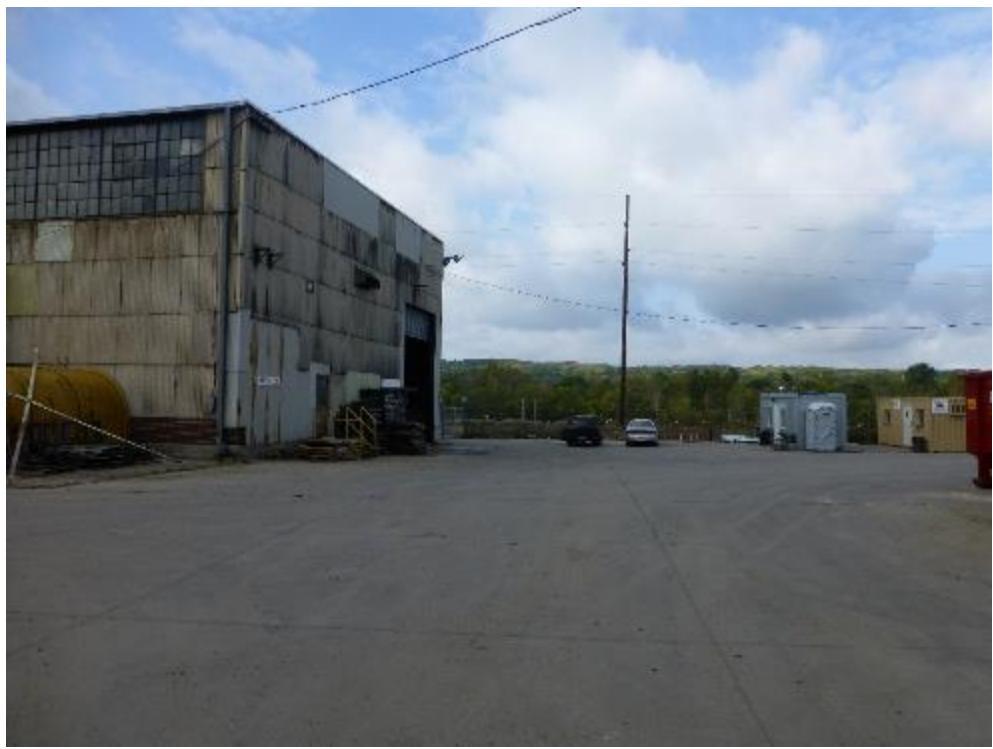
The most recent cover inspections occurred in October 2015. During the site inspection, it was noted all covers were intact as intended.

Asphalt cap area in North Sector on Ellwood Crankshaft property. (Picture taken facing west.)

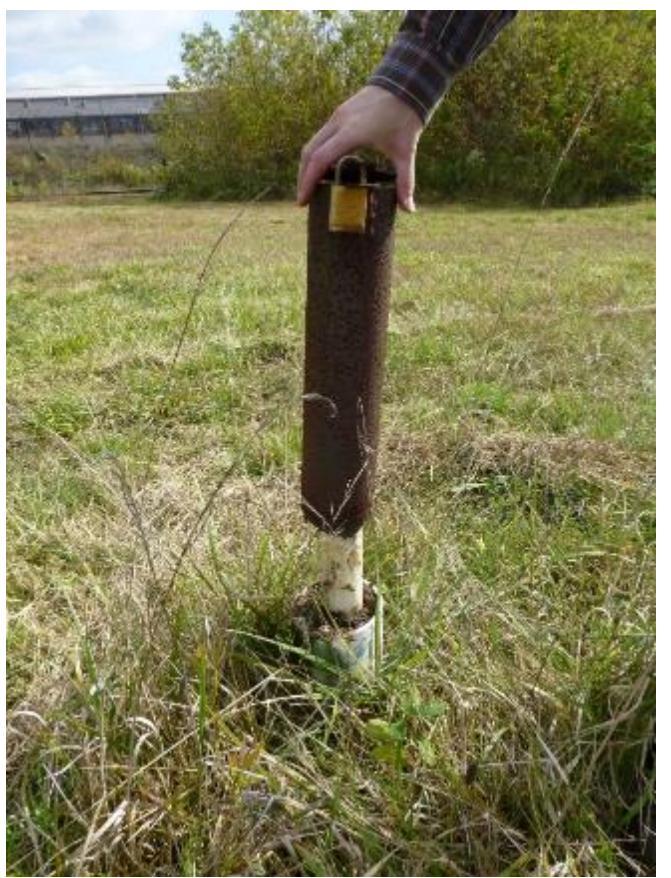
Rusted cap of monitoring well R-1

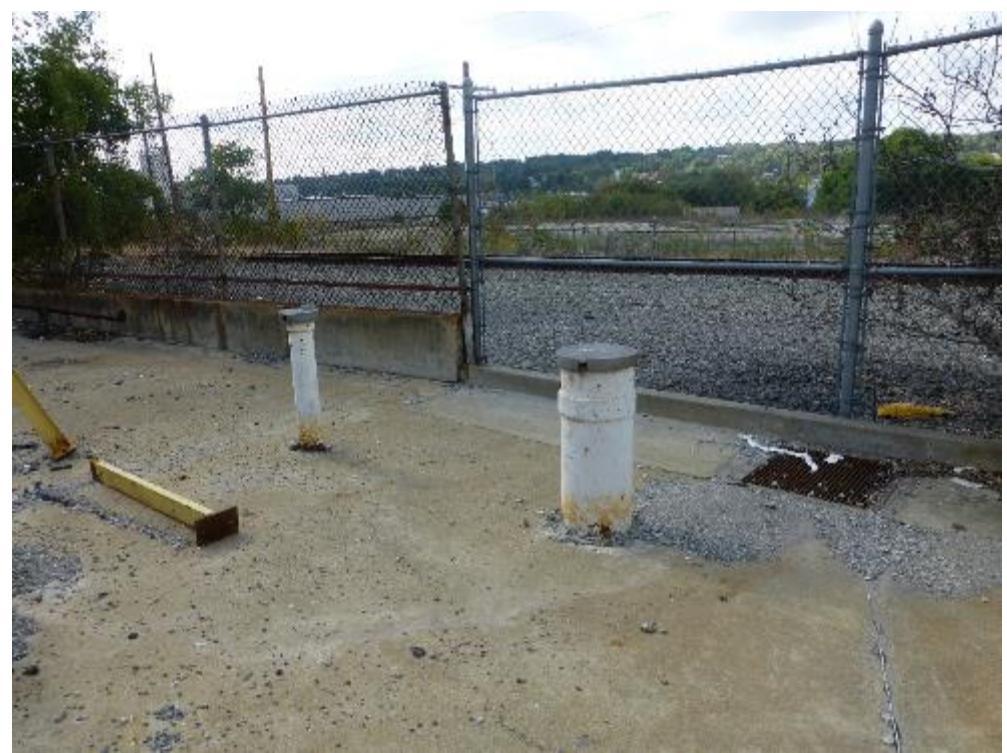
Unlocked monitoring wells GM-5A and GM-5B Middle Sector. (Picture taken facing southwest.)

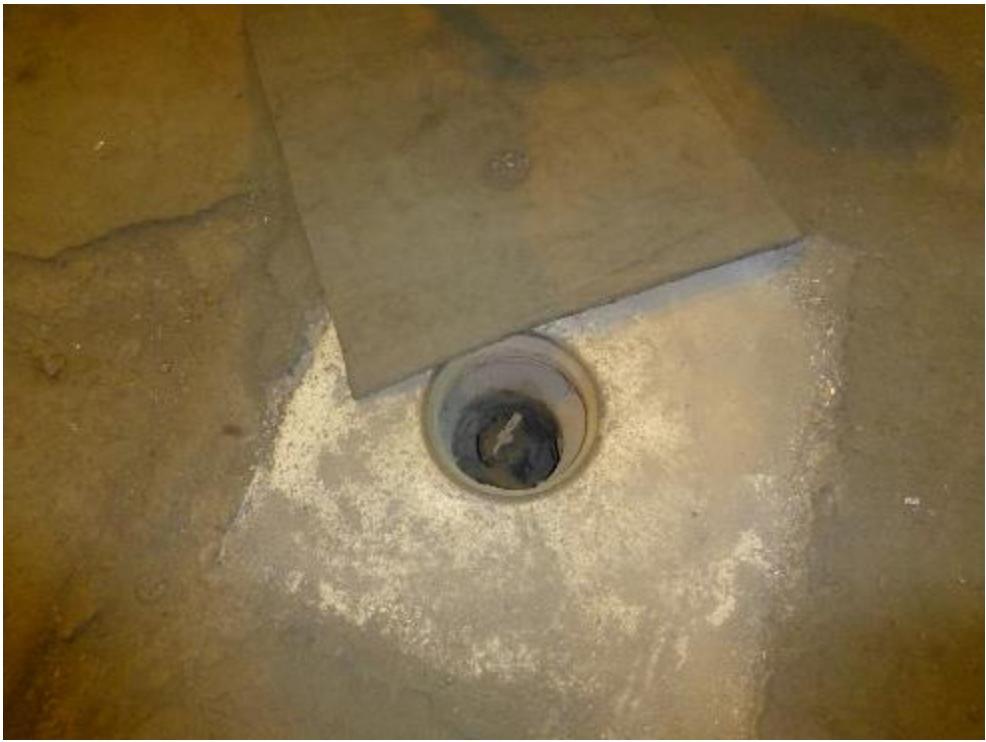
An adsorbent sock was used to remove LNAPL in S-4; the sock is replaced as needed. Results are summarized in Appendix G. In general, the quantity of LNAPL recovered has declined in GM-5A and slightly declined in M-2. The last two times the S-4 sock was inspected it did not need to be replaced, which also indicates reduction of recovered LNAPL.

Monitoring well M-2, lacking proper cover Middle Sector.

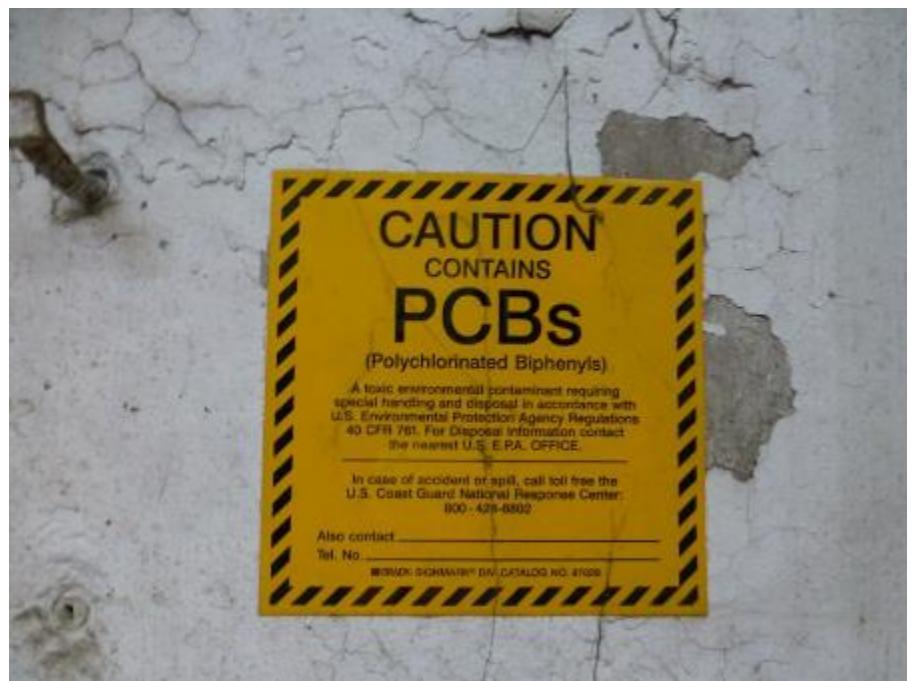
International building (Middle Sector). The PCB warning signage in the Winner International building was legible and in good condition. The group also inspected the Site's monitoring wells; some were locked and marked, while others were unmarked, unlocked, had rusted locks or caps, or no caps at all. The asphalt caps outside the buildings were well maintained. The group went to the River to observe fish tissue sampling. The group saw the Shenango River, areas where sediments and riparian soils were removed, and the Aqua America water treatment plant. The team then visited and photographed commercial properties on the western side of the railroad tracks.

PCB warning sign in unoccupied area of Winner International building in Middle Sector

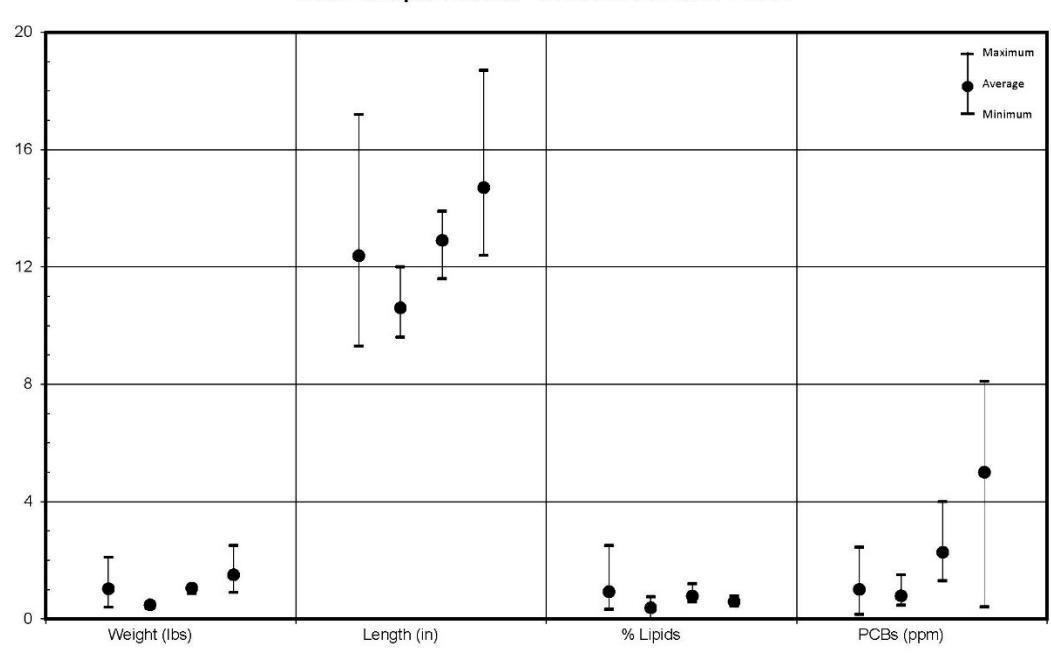
FIGURE 1 Bass Sample Results - 2003 / 2005 / 2010 / 2015

OU(s): 2	Issue Category: Monitoring			
	Issue: Polychlorinated biphenyl (PCB) concentrations in 2015 fish tissues were higher than previous samples.			
	Recommendation: Develop a sampling plan to determine if there is an on-going release from the Site to the Shenango River.			
Affect Current Protectiveness	Affect Future Protectiveness	Implementing Party	Oversight Party	Milestone Date
No	Yes	PRP	EPA	9/22/2017
