# FOURTH FIVE-YEAR REVIEW REPORT FOR TYBOUTS CORNER LANDFILL SUPERFUND SITE NEW CASTLE COUNTY, DELAWARE

## July 2015

Prepared By: United States Environmental Protection Agency Region 3 Philadelphia, Pennsylvania

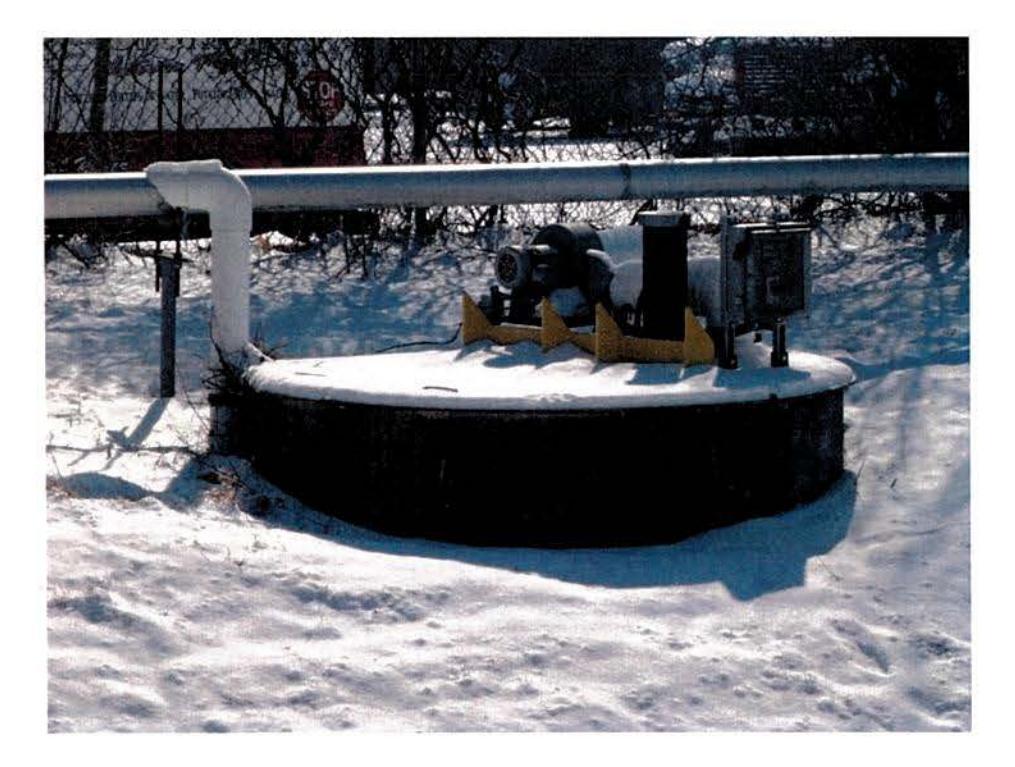
IW-8, located near the blower building, is one of the several interceptor wells around the Site that are no longer in operation.

- While the interceptor well system is not currently in operation, the system should be maintained in case the need arises to put it back into operation. A system inspection in 2010 indicated that there is a strong possibility that the interceptor wells may have filled in with silt. Further investigate the condition of the interceptor well system and perform any maintenance or repairs needed to ensure the system can be made operational if necessary.

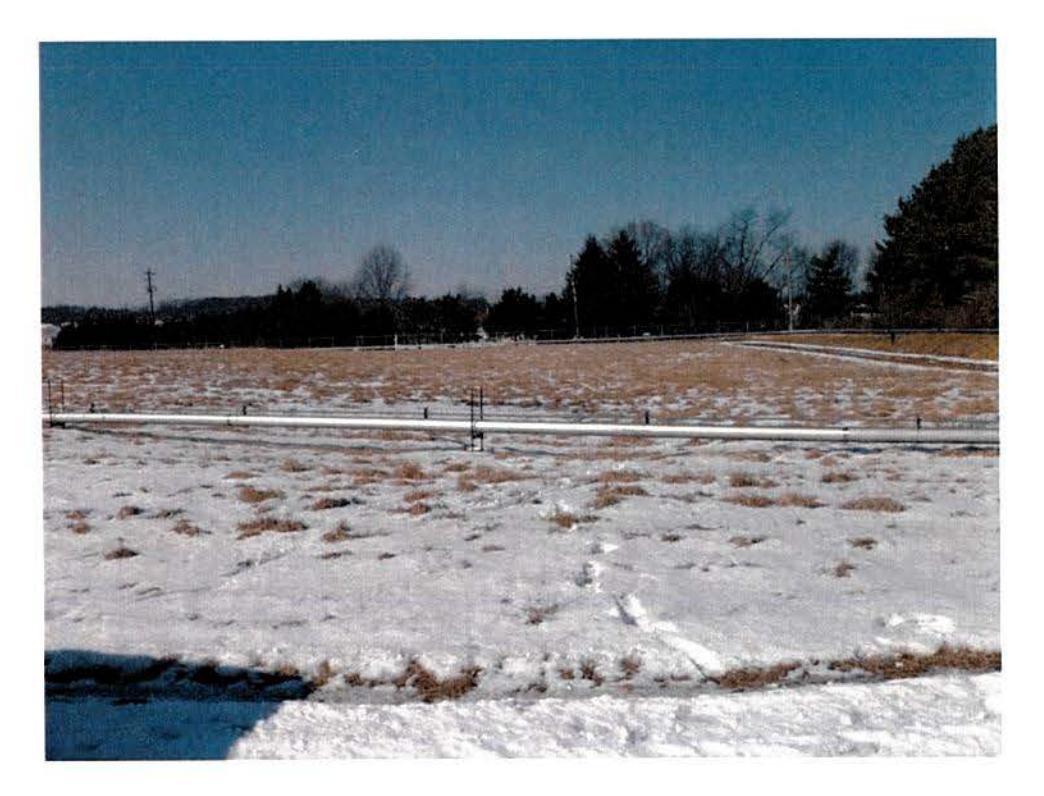
An area of subsidence is located immediately west of the blower building, at the far northern end of the landfill.

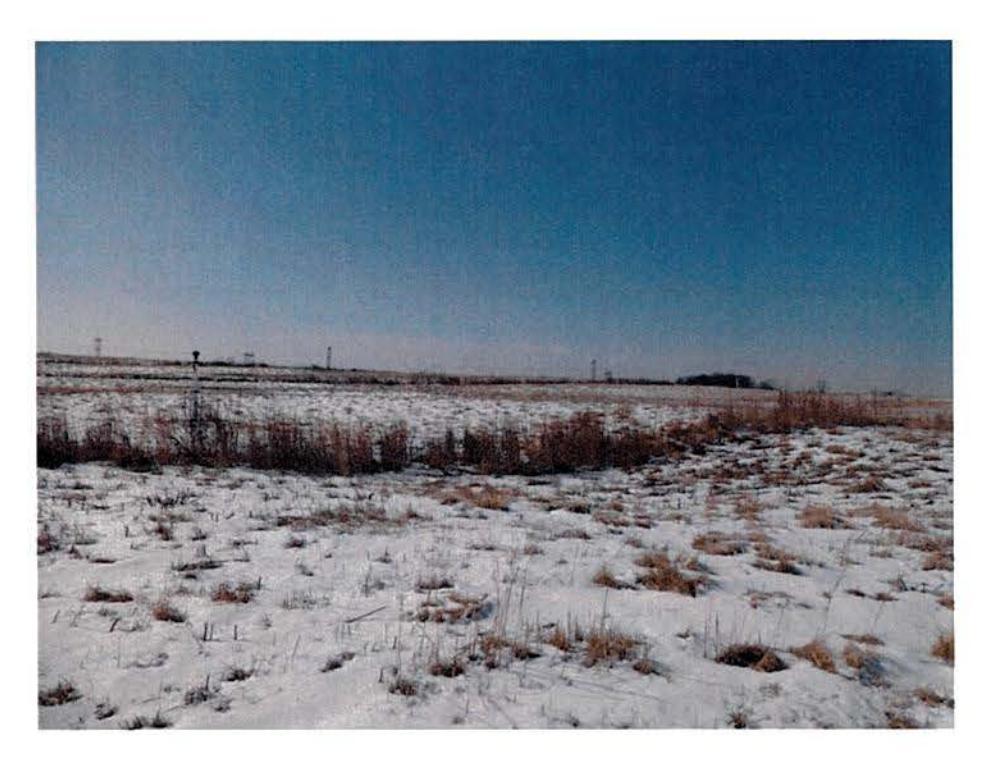
Another area of cap settlement was observed along the landfill's southeastern edge.

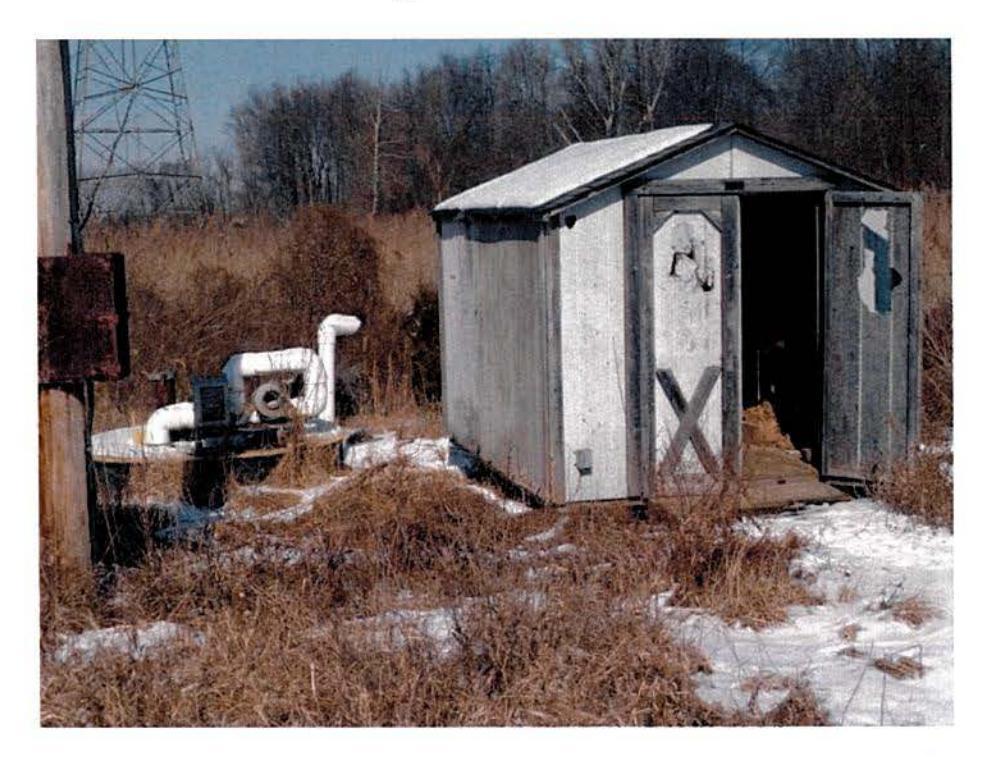
This shed (previously used as a chemical feed building for IW-7) and IW-7 are located on the West Fill area property behind the gate. Trespassers have accessed the area by foot and broken into the shed. The PRP has removed all materials from the shed.

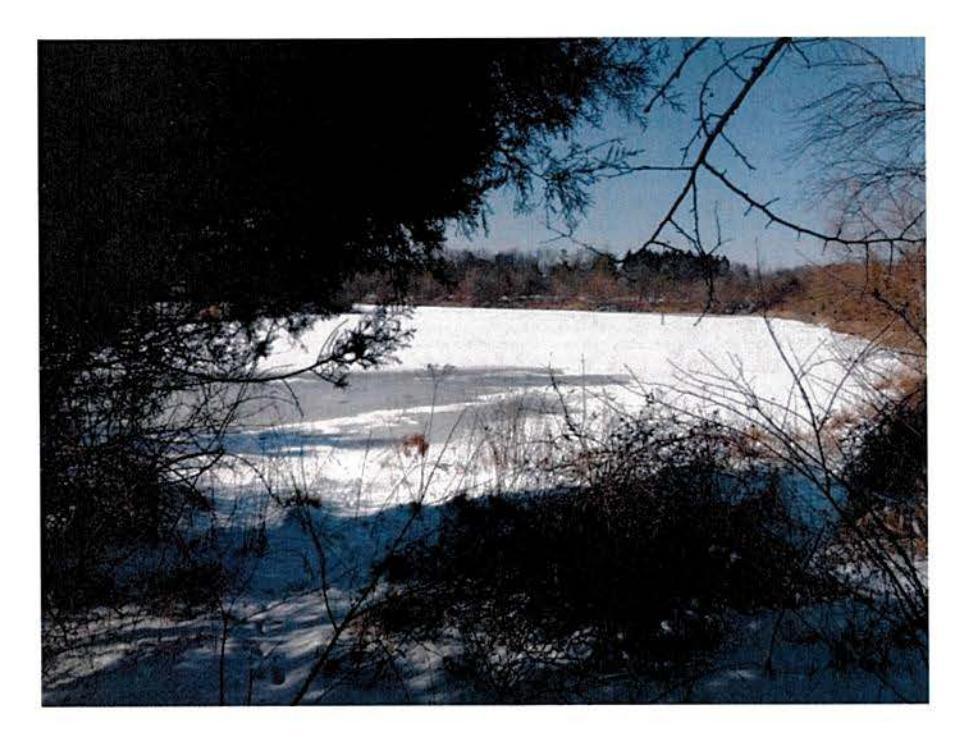
View of the west fill area. The fill area is full of water and is a wetland.

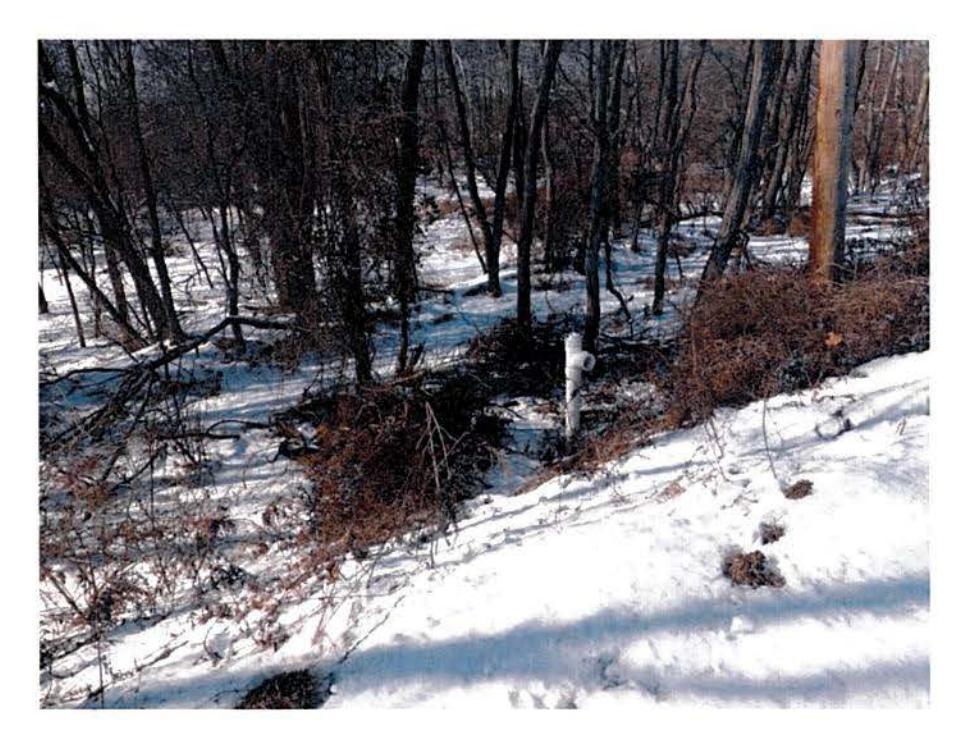
Perimeter landfill gas monitoring well PGMW-7 is located outside of the southwest edge of the main landfill. The well shows the highest methane concentrations of any of the perimeter landfill gas wells. The well's low elevation and location in a marshy area may attribute to the elevated gas concentrations.

- Update the monitoring schedule to include quarterly monitoring of PGMW-7.
- Groundhogs burrow into the surface of the landfill cap. Inspections have determined that the burrowing has not damaged the cap's top impervious layer. However, the groundhogs are not actively managed. Implement a management plan to help actively prevent burrowing animals from damaging the landfill cap. Incorporate the management plan into the Site's O&M Plan.

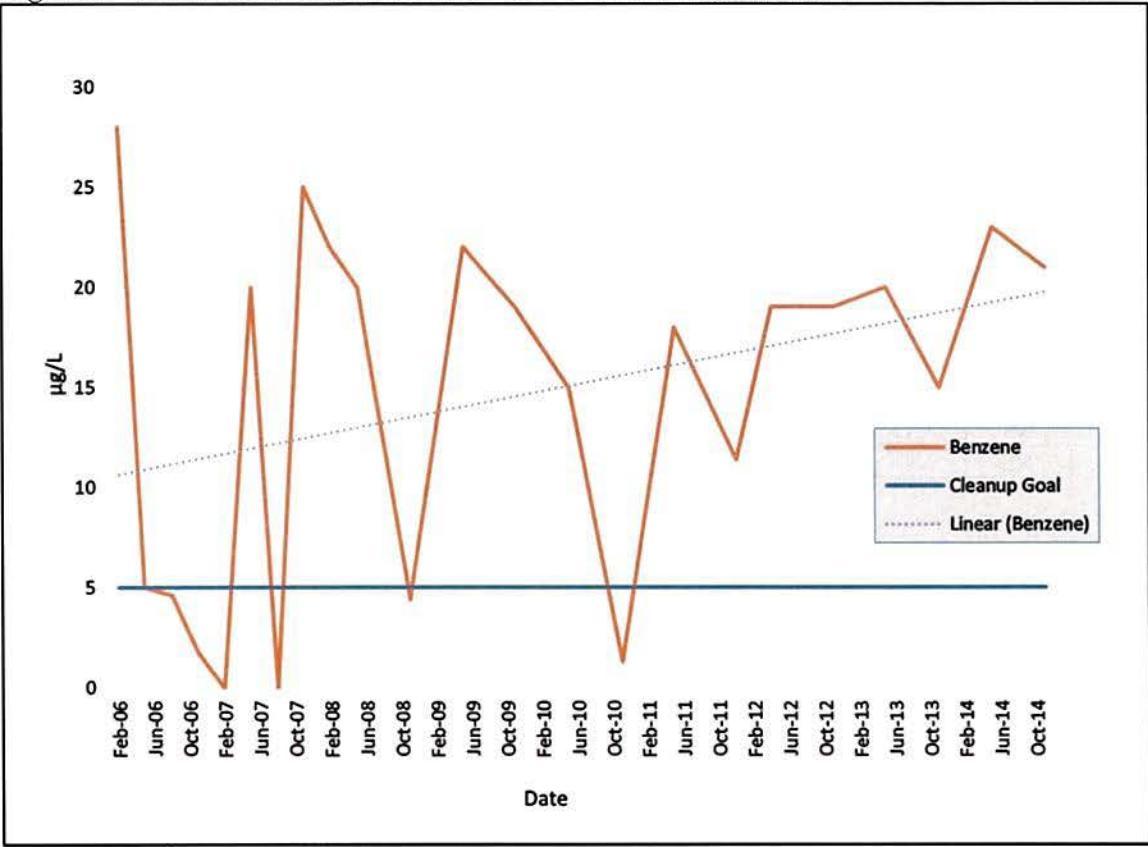
Figure F-1: Benzene Concentrations at TY-119B, 2006 to 2014

An evaluation of the vertical gradient between the P1 and P2 Sands should be conducted if increasing contaminant concentrations are observed in a P1 well. Since 2006, benzene concentrations have increased slightly at TY-119B (screened in the P1 Sand). In 2012 and 2013, data verified a downward gradient at TY-119B. Based on this information, sampling of well TY-119A (screened in the P2 Sand) may be warranted to determine if contamination has migrated to the P2 Sand at the TY-119 well pair.

Two off-property wells (TY-204 and TY-119B) and one well just outside of the main landfill (TY-205) routinely exhibit VOC concentrations above cleanup goals. COC concentrations at other off-property wells are routinely below cleanup goals or not detected. Benzene is the only COC that exceeds the 5  $\mu$ g/L cleanup goal at TY-205 and TY-119B. TY-119B is the furthest downgradient well currently monitored. Benzene concentrations at well TY-119B are higher than at any other on-Site or off-Site monitoring well. Based on this information, this data review examined benzene concentrations at TY-119B from 2006 through 2014 (Figure F-1 and Table F-2). Based on the location of TY-119B, and the elevated benzene concentrations at that location, the current southeastern (leading edge) extent of the groundwater plume may not be fully defined. While these conditions suggest that the leading edge of the groundwater plume may not be fully defined, there is no complete exposure pathway because the downgradient wells that

OU(s): OU1	Issue Category: Monitoring				
	<b>Issue:</b> Benzene concentrations remain elevated in the furthest downgradient well that is sampled, TY-119B.				
<b>Recommendation:</b> Conduct an evaluation of groundwater further downgradient of TY-119B to better define the leading edge of the groundwater plume and determine if additional actions are necess					
Affect Current Protectiveness	Affect Future ProtectivenessImplementing PartyOversight PartyMilestone Date				
No	Yes	PRP	EPA	9/29/2017

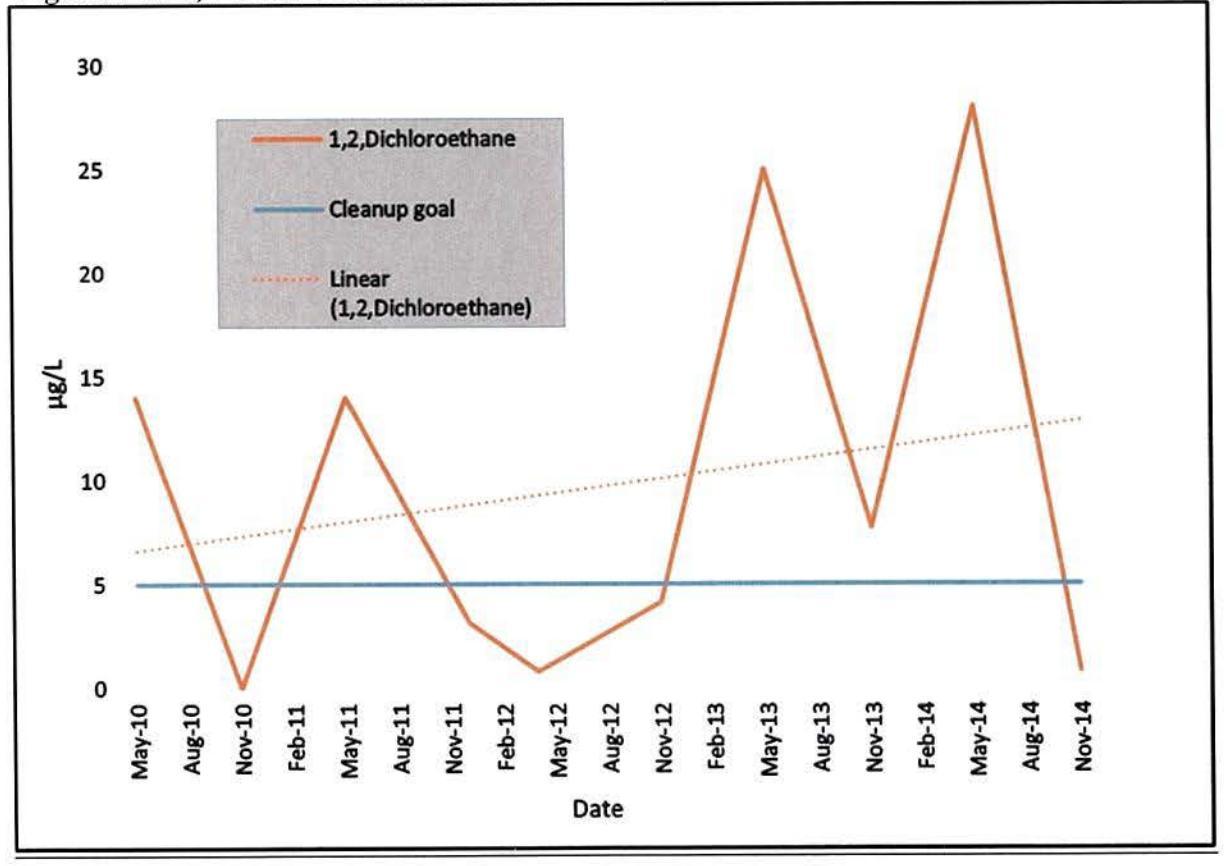
Figure F-2: 1,2-DCA Concentrations at TY-204, 2010 to 2014

Monitoring well TY-204 is located just outside of the southeastern edge of the main landfill, between the landfill and well TY-119B (Figure 4). In the month of May in 2010, 2011, 2013 and 2014, 1,2-DCA exceeded its cleanup goal of 5  $\mu$ g/L at TY-204. Between 2010 and 2014, 1,2-DCA concentrations have gradually increased at TY-204 (Figure F-2). Concentrations of 1,2-DCA at TY-204 between 2010 and 2014 ranged from non-detectable concentrations in November 2010 to a high of 28  $\mu$ g/L in November 2014.

OU(s): OU1	Issue Category: Monitoring				
	<b>Issue:</b> 1,2-dichloroethane concentrations have gradually increased in well TY-204.				
	<b>Recommendation:</b> Determine if the concentration of 1,2-dichloroethane in TY-204 is attributable to the main landfill.				
Affect Current Protectiveness	Affect FutureImplementingOversightMilestone DateProtectivenessPartyParty				
No	Yes	PRP	EPA	9/29/2017
