SECOND FIVE-YEAR REVIEW REPORT FOR PRICE BATTERY LEAD SMELTER SUPERFUND SITE BERKS COUNTY, PENNSYLVANIA

AUGUST 2020

U.S. Environmental Protection Agency Region 3 Philadelphia, Pennsylvania

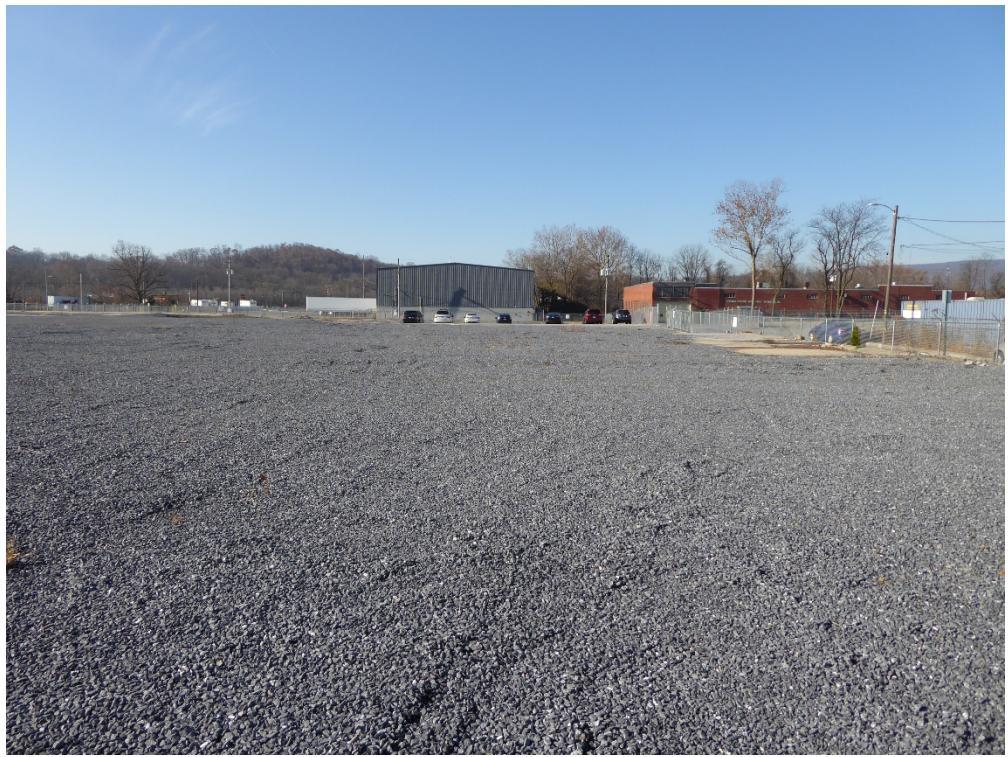
View across Main Parcel of OU2 looking toward Warehouse Parcel

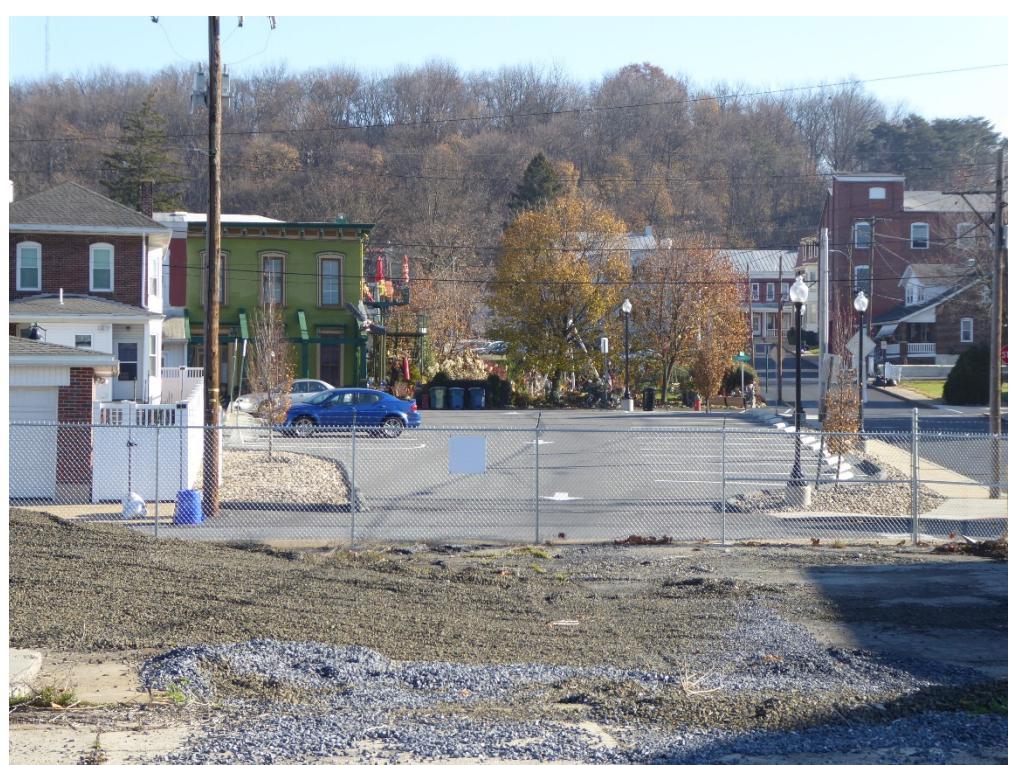
View across Main Parcel of OU2 looking at the Parking Lot Parcel

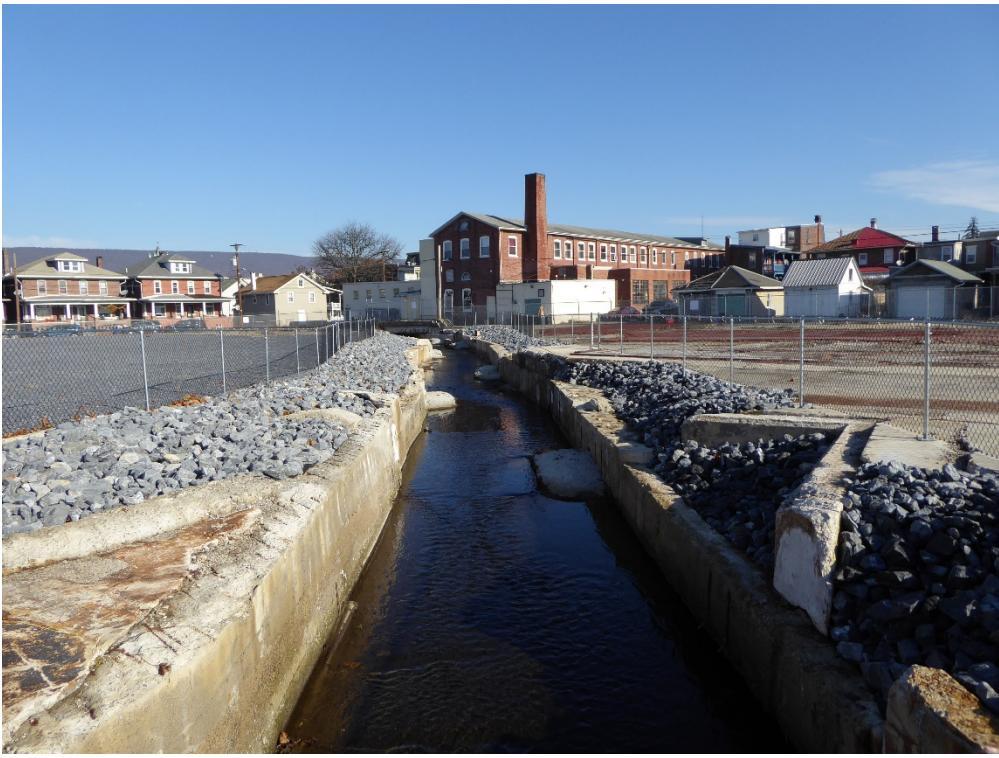
Kaercher Creek in OU2

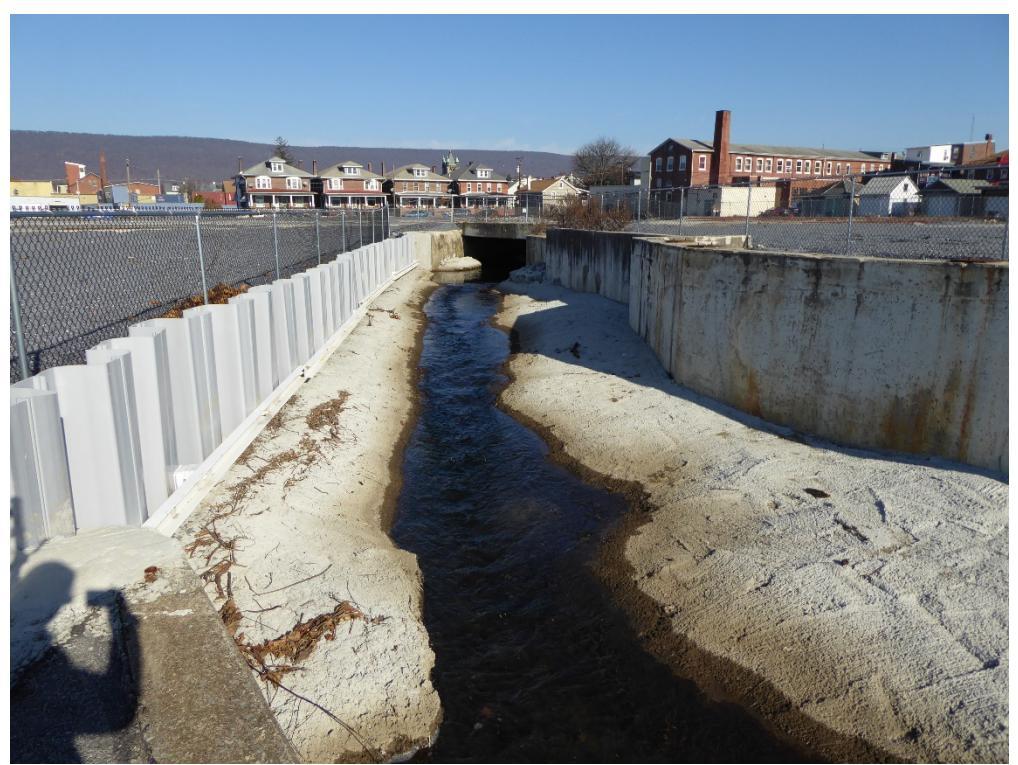
Kaercher Creek running through OU2, sheet pile wall to left

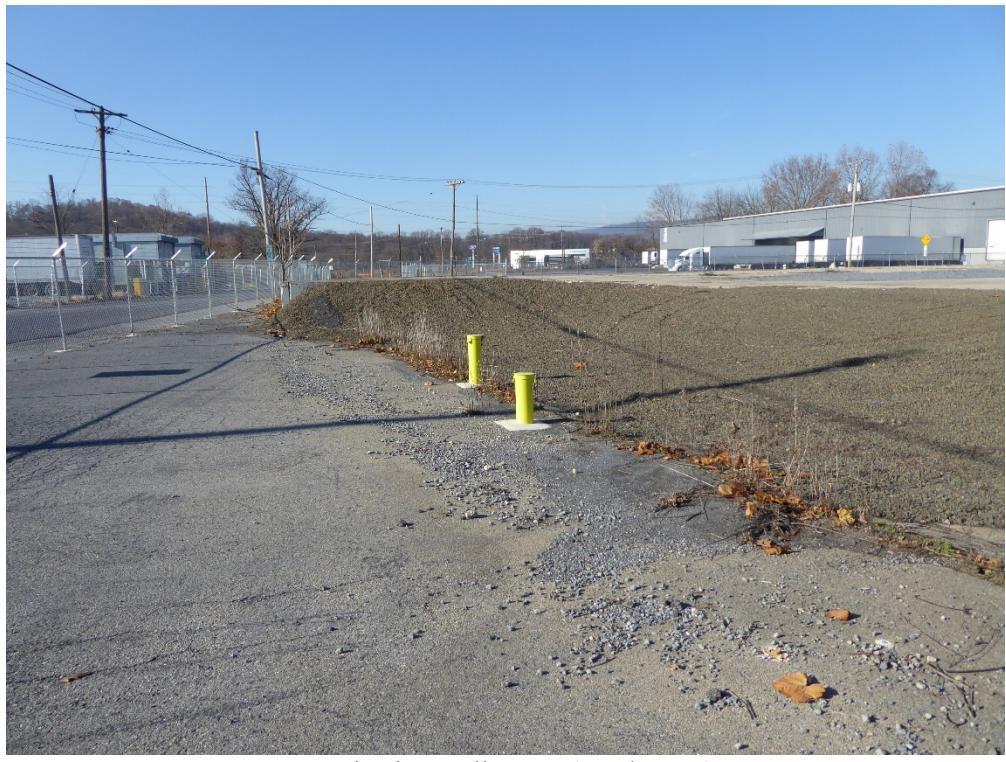
Monitoring wells MW-3 and BW-3

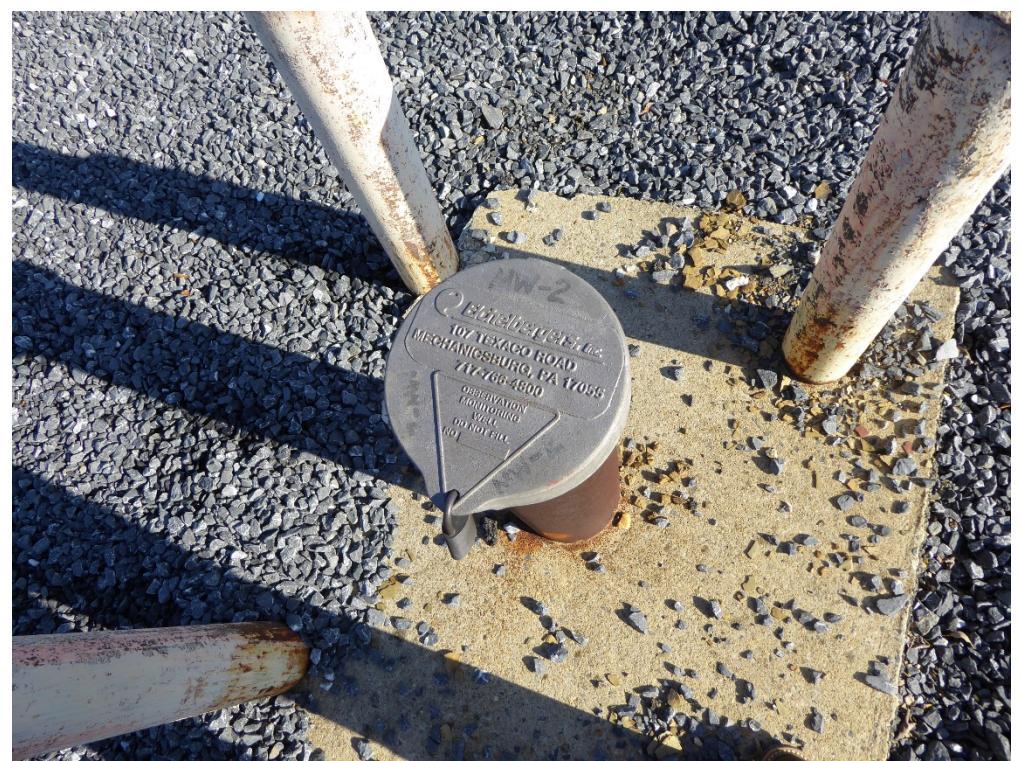
Monitoring well MW-2

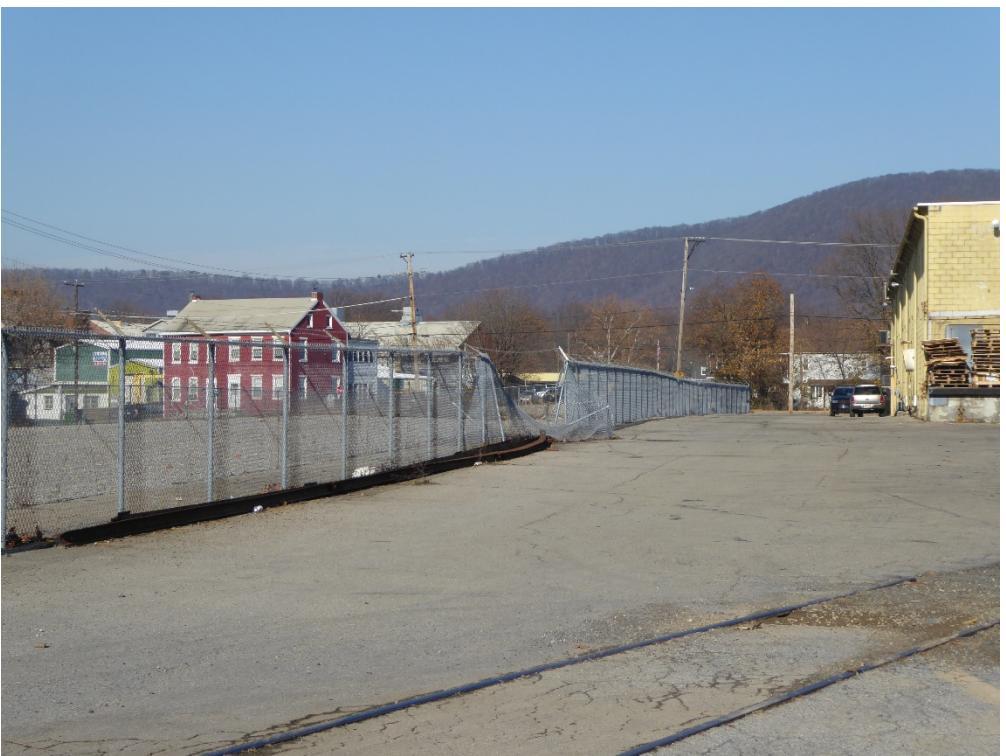
During the first year of the inspections in 2019, no significant issues were identified for the concrete and sheet pile creek walls. During the third quarter 2019 inspection, approximately 20 feet of perimeter fencing was observed to be damaged due to a car accident. Exide subsequently repaired the fencing to secure the Site. Some settlement of the backfill soil and asphalt was also observed in an area of approximately 3 feet wide by 5 feet long on the south side of the excavation area on the Warehouse Parcel. A small void appeared to be forming below the asphalt, but no soil was exposed. Exide worked with the Warehouse Owner to perform a temporary repair to the asphalt surface and plans to evaluate the settlement and need for a more involved repair over the next 12 months.

A. Fe	encing			
1.	Fencing Damaged	Location shown	on site map	Gates secured N/A
	Remarks: <u>Damage to fence at Broom Works Parcel. PRP noted that it would be fixed prior to FYR</u> signature. Update: Fence repaired in December 2019

Fence along Broom Works Parcel, OU1 in background (Update: Fence repaired December 2019)

- Update the Site repository with current Site documents.
- Installation of vinyl sheet pile in the creek was not a ROD requirement; however, EPA approved the vinyl sheet pile wall in the remedial design. Consider formalizing the sheet pile wall as an OU2 remedy component in a Memorandum of Insignificant Changes.
- Continue to monitor for settlement of the asphalt surface on the Warehouse Parcel and evaluate need for a more involved repair over the next 12 months.

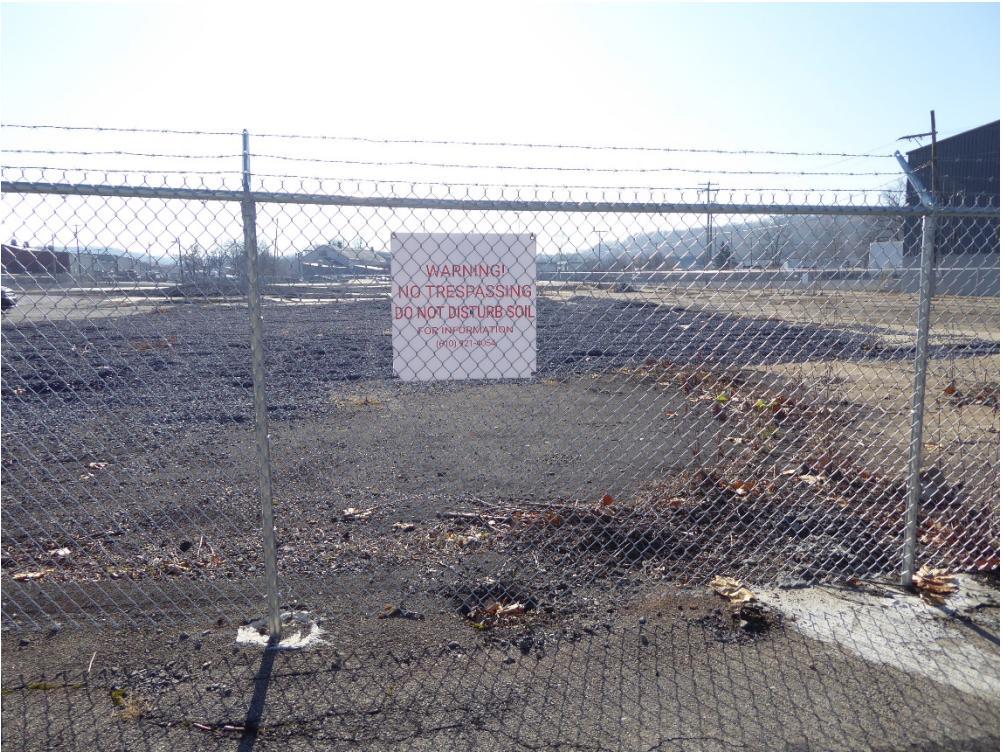
Signage on OU2 fence
