Five-Year Review Report

Third Five-Year Review Report for Piper Aircraft Corp./Vero Beach Water and Sewer Department Site FLD004054284

> > May 2014

United States Environmental Protection Agency Region 4 Atlanta, Georgia

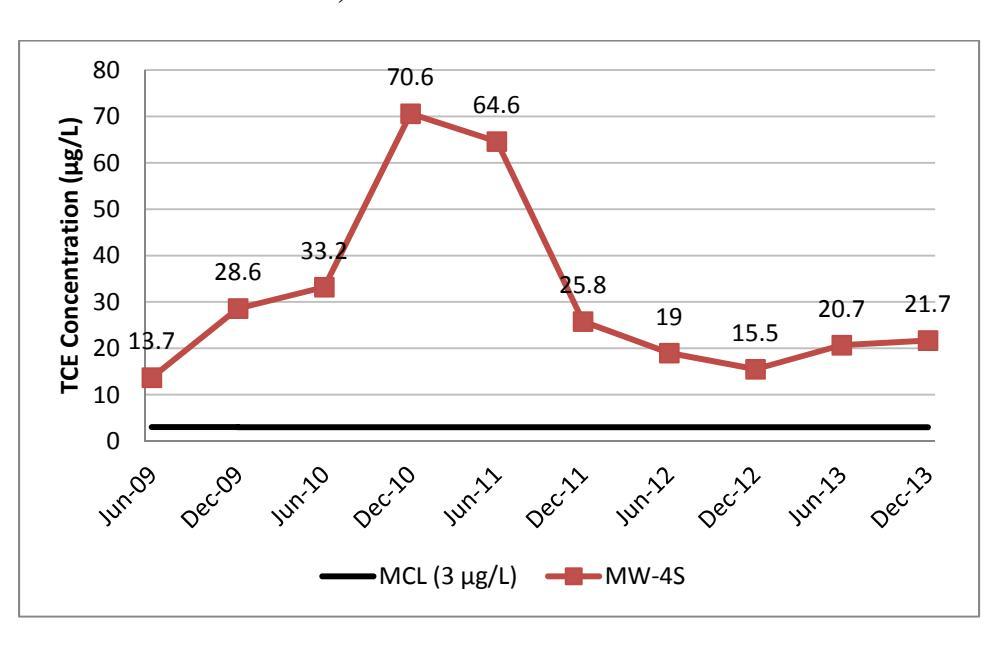
Figure 4. TCE Concentrations, Well MW-4S

During the evaluation period, only one monitoring well (MW-4S) contained TCE at or above the cleanup goal of 3 μ g/L. TCE concentrations in MW-4S exceeded the cleanup goal in every sampling event during the evaluation period. MW-4S is located in the outer maintenance yard, approximately 250 feet downgradient of the former underground storage tank that historically contained TCE. Figure 4 illustrates the concentrations of TCE in MW-4S.

The cause of the increase in TCE concentrations in MW-4S in December 2010 and June 2011 is unknown; however, it does appear to correlate with the lowest recorded ground water levels during the evaluation period. It should also be noted that pumping well

UVB-1, which is located in close proximity to MW-4S, did not operate during the third and fourth quarter of 2010 due to blower unit replacement. MW-4S may have been experiencing rebound conditions during December 2010 and June 2011. TCE was not detected in any of the influent samples (UVB-1A or UVB-2) during the evaluation period.

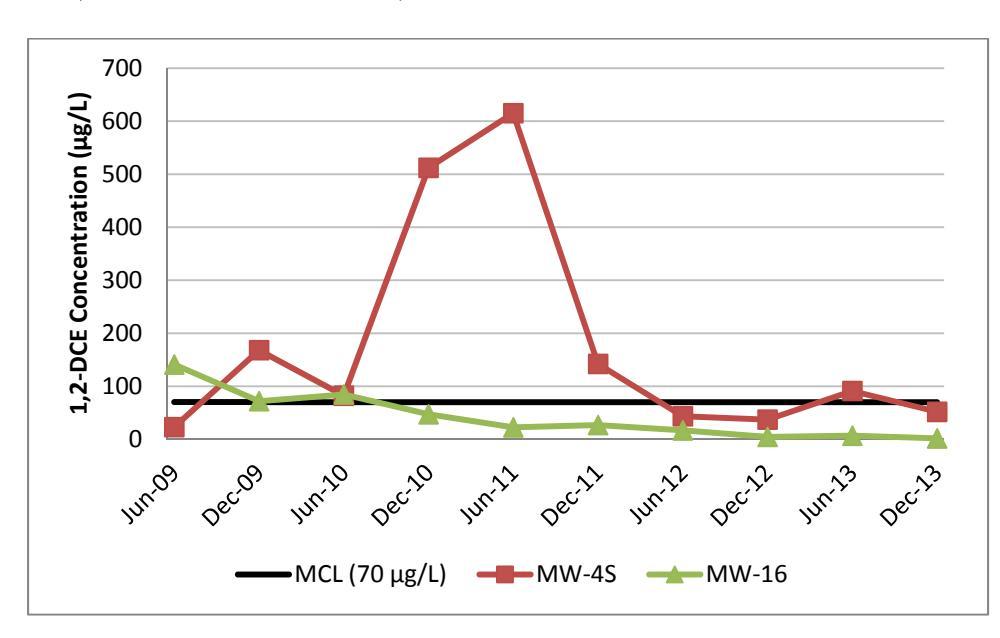
Figure 5. 1,2-DCE Concentrations, Wells MW-4S and MW-16

During the evaluation period, two monitoring wells (MW-4S and MW-16) had 1,2-DCE concentrations at or above the cleanup goal of 70 μ g/L. MW-4S is located in the outer maintenance yard, approximately 250 feet downgradient of the former UST that historically contained TCE. MW-16 is located within Building 5, downgradient of MW-4S. Figure 5 illustrates the concentrations of 1,2-DCE in MW-4S and MW-16 during the evaluation period. Concentrations of 1,2-DCE in MW-4S spiked in 2010 and 2011 and have since declined in the past four sampling evens.

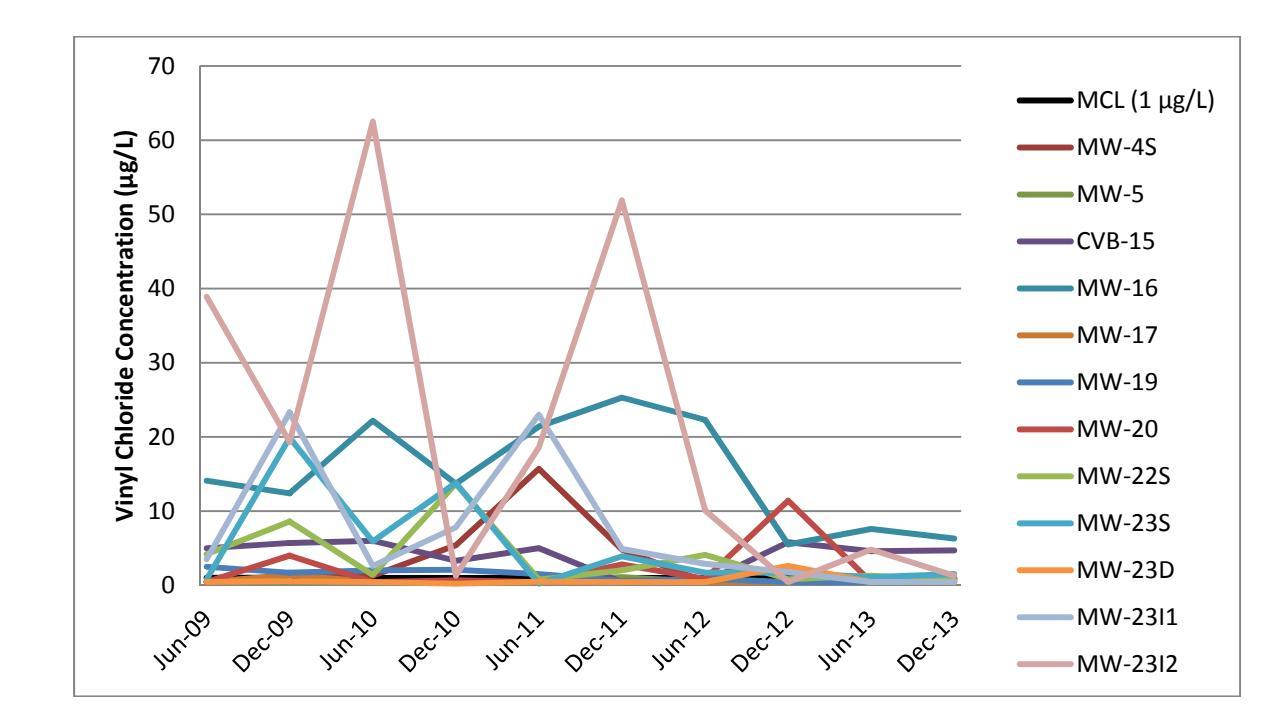
Figure 6. Vinyl Chloride Concentrations in Wells with MCL Exceedances

During the evaluation period, vinyl chloride was detected above the cleanup goal of 1 μ g/L in twelve different wells. Figure 6 illustrates the concentrations of vinyl chloride in those wells where concentrations exceeded the cleanup goal at least once during the evaluation period. The maximum detected concentration of vinyl chloride was 62.5 μ g/L in MW-23-I2 in June 2010. Vinyl chloride was also detected above the cleanup goal for the first time in deeper well MW-23D at a concentration of 2.6 μ g/L during the December 2012 sampling event. In general, vinyl chloride concentrations at the Site have fluctuated over time with no apparent trends.

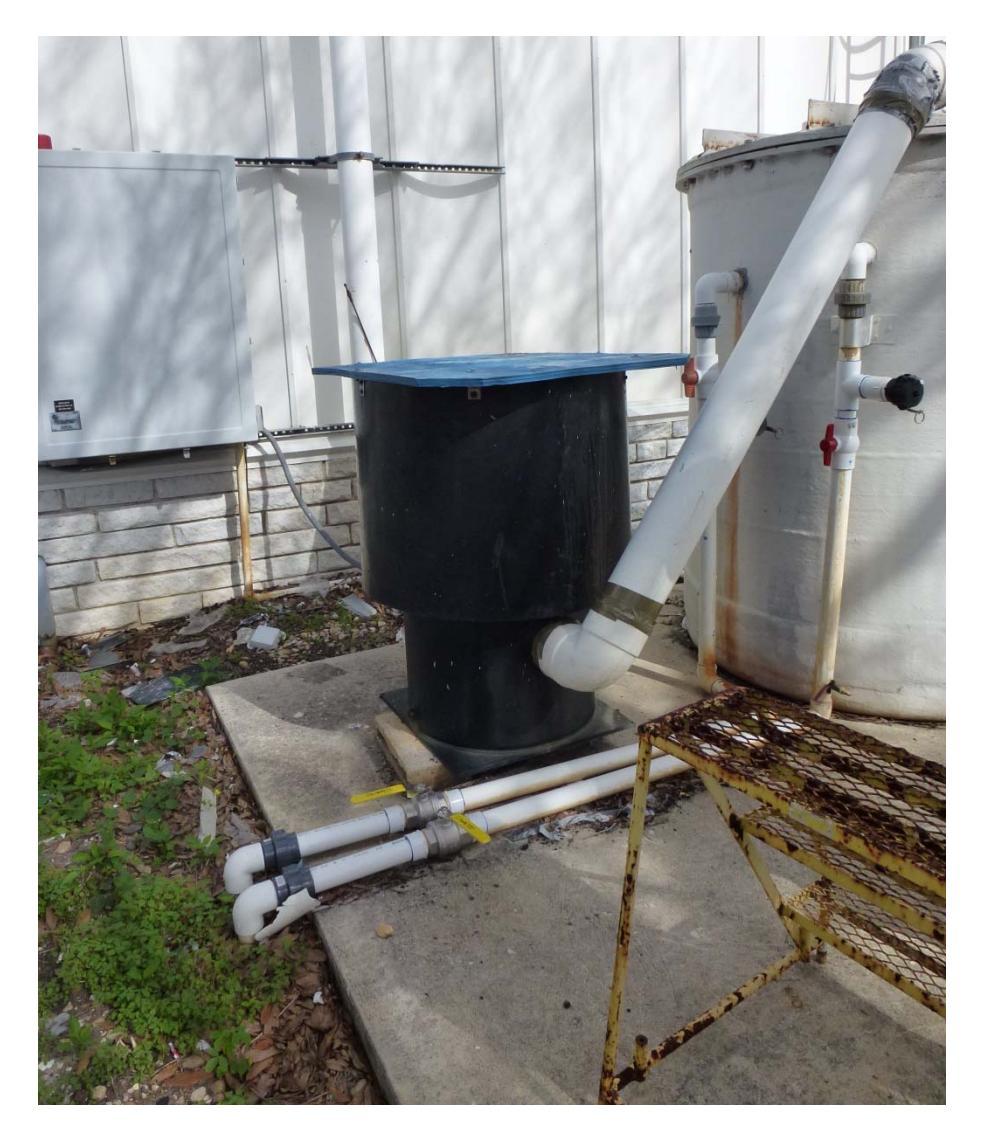
UVB-2 and sump pump to monitoring well outside of Piper Aircraft facility

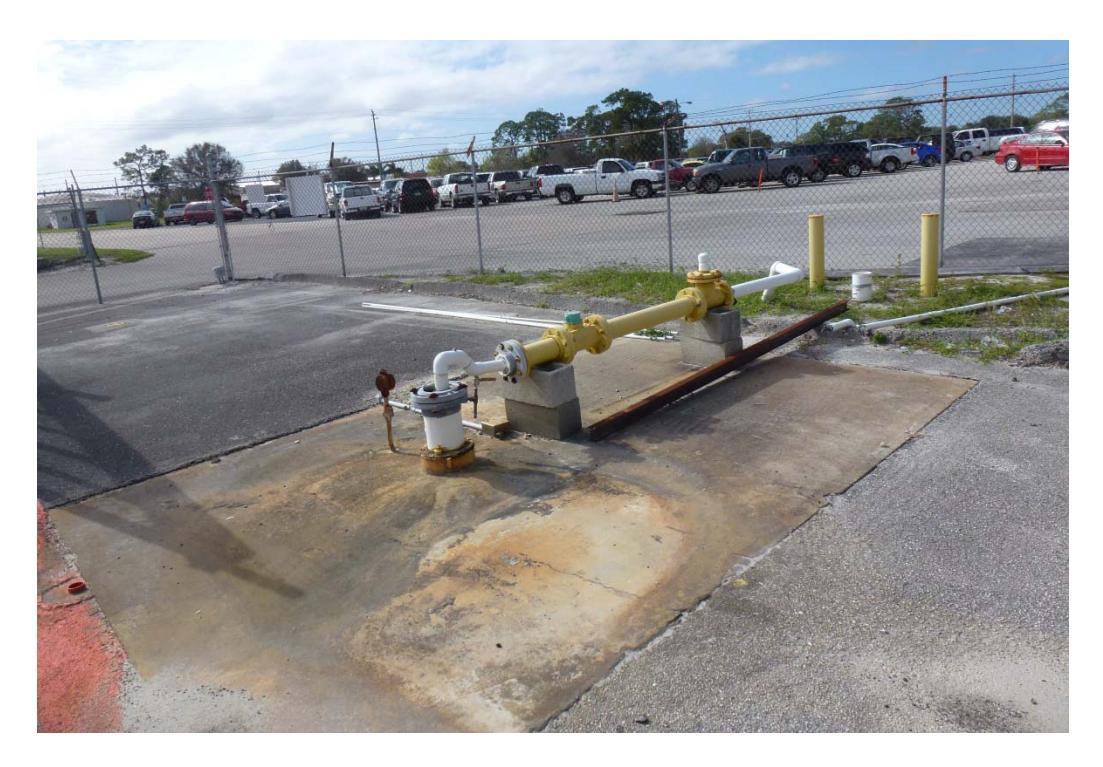
Former location of TCE storage tank, current injection point for UVB-2

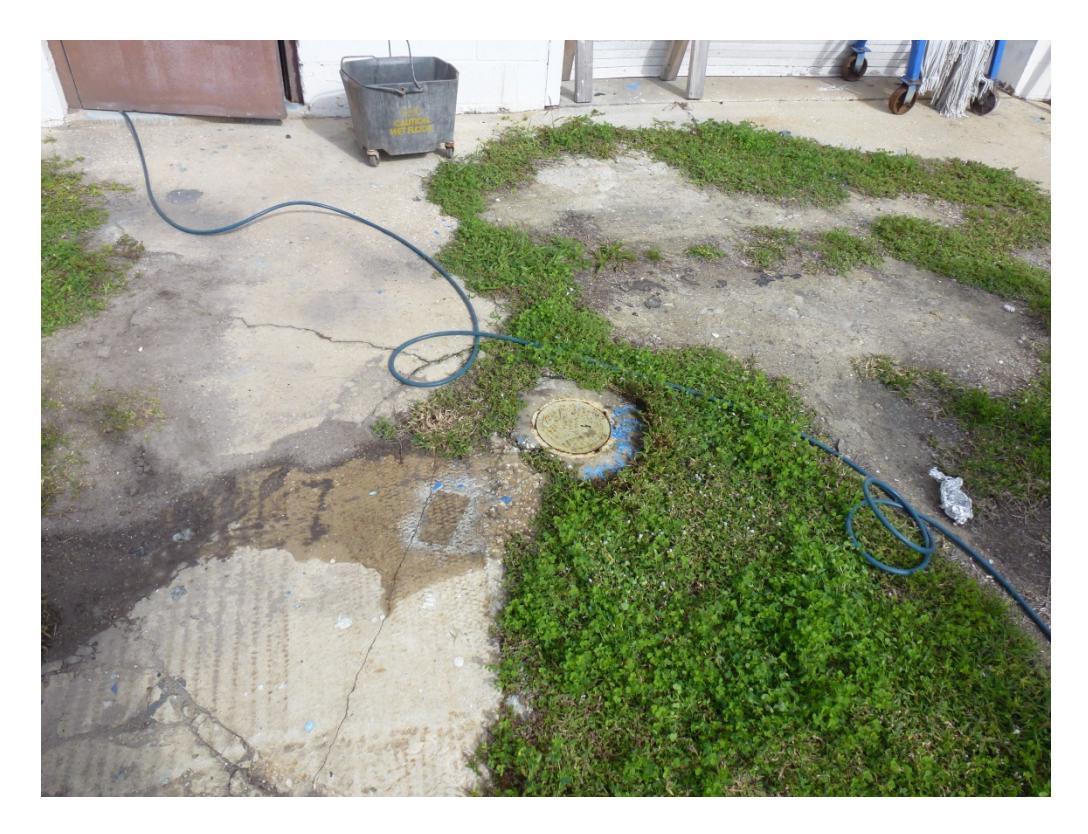
MW-2 within the inner maintenance area

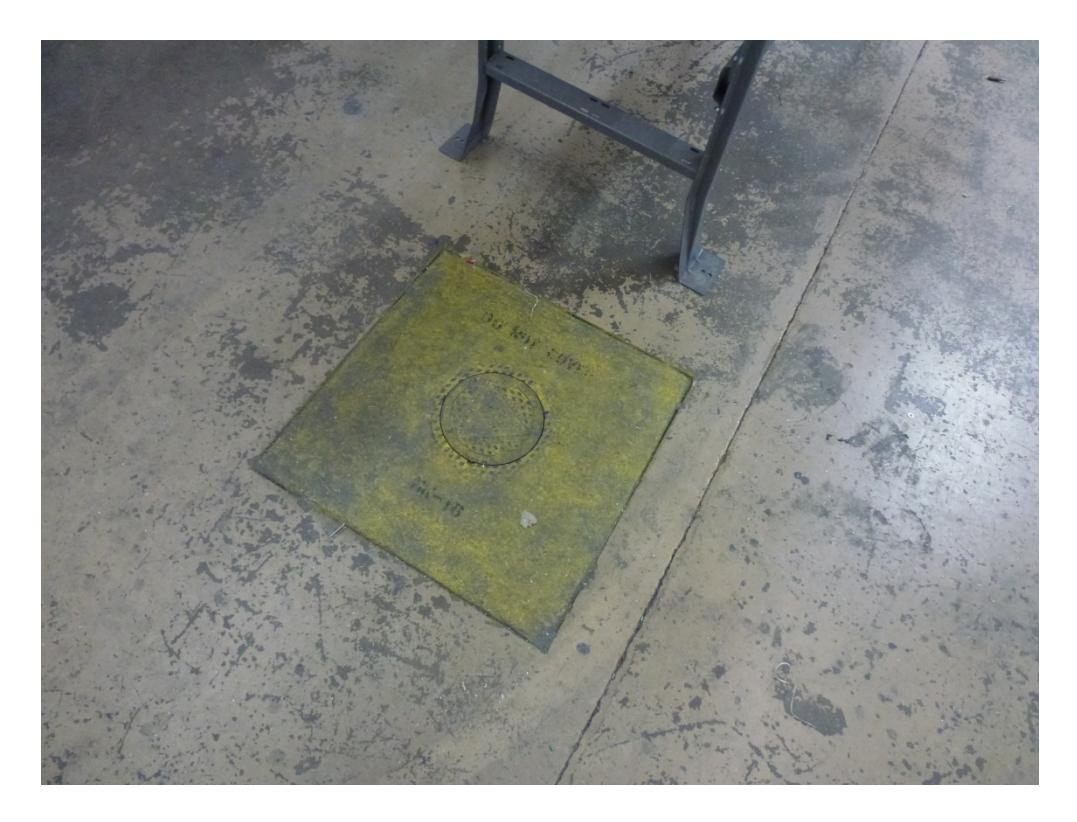
Indoor MW-16

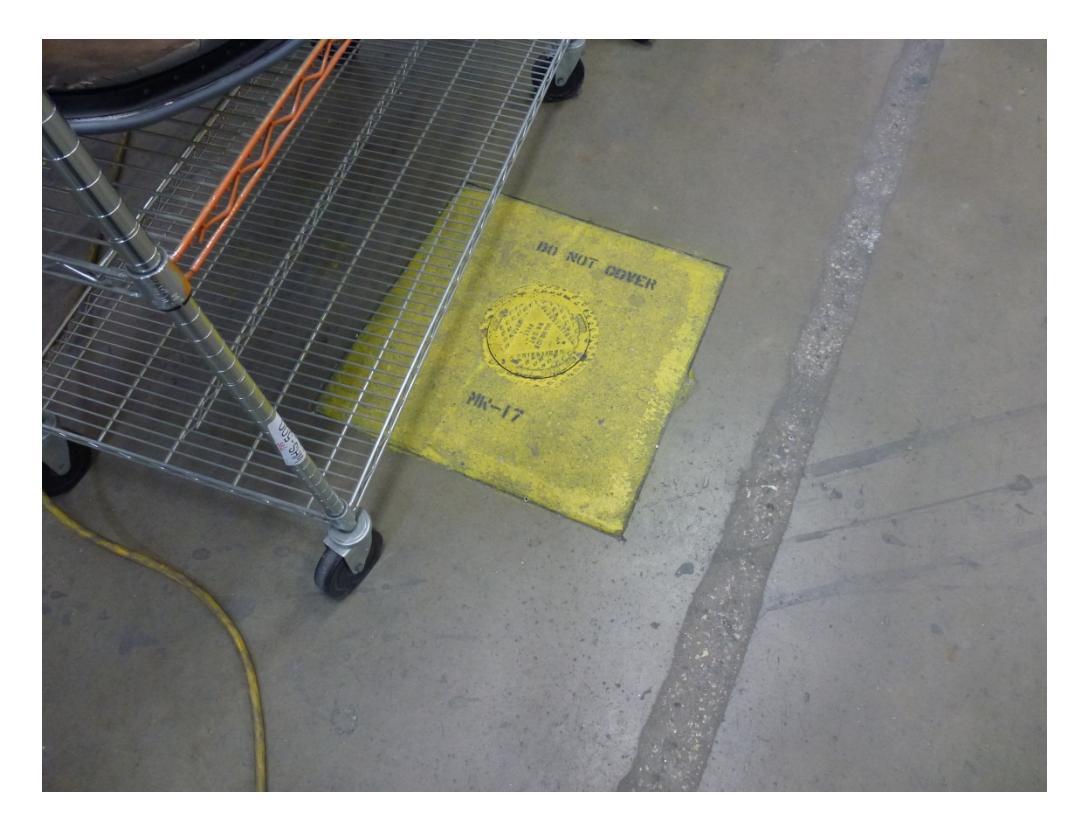
Indoor MW-17

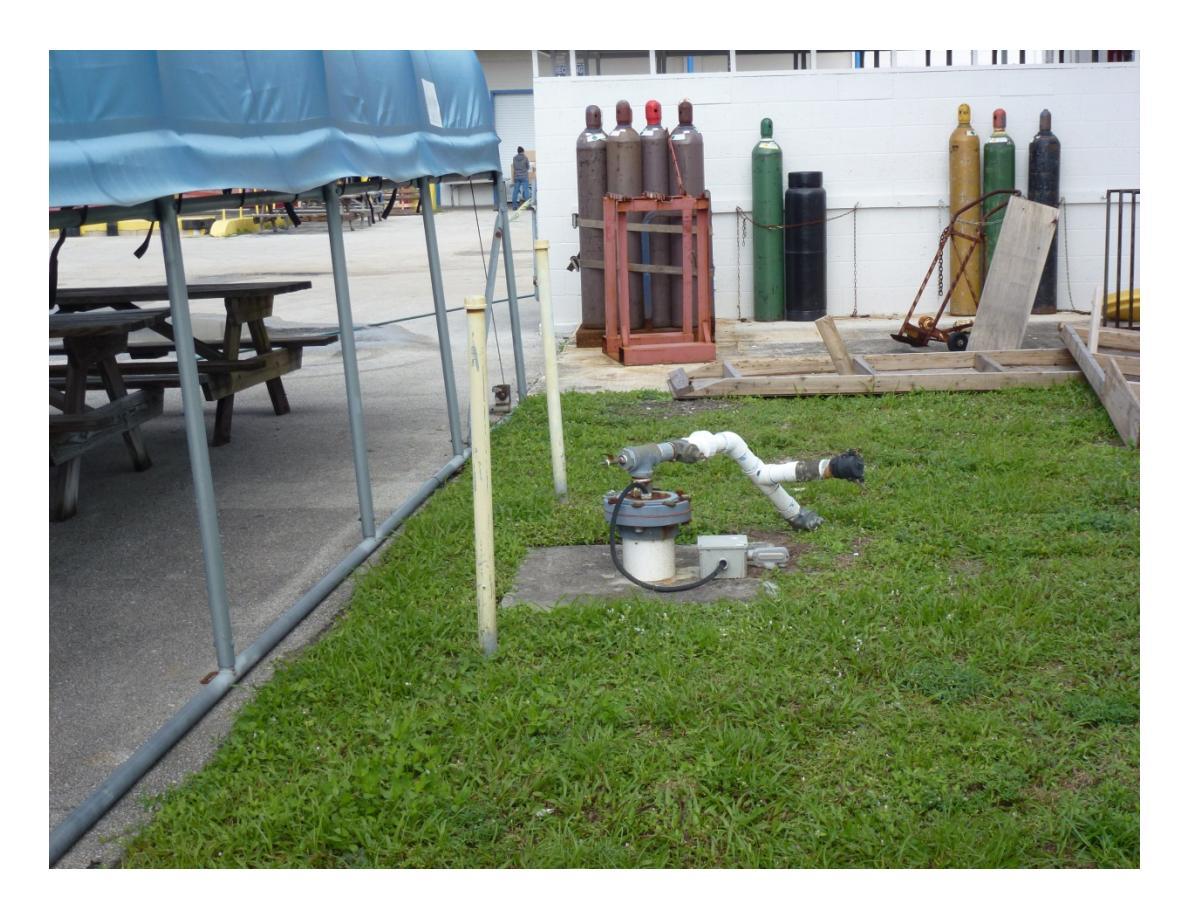
Outdoor UVB-1A
