FOURTH FIVE-YEAR REVIEW REPORT FOR THE AIRCO SUPERFUND SITE MARSHALL COUNTY, KENTUCKY

U.S. Environmental Protection Agency Region 4 Atlanta, Georgia

Superfund Fourth Five-Year Review Report

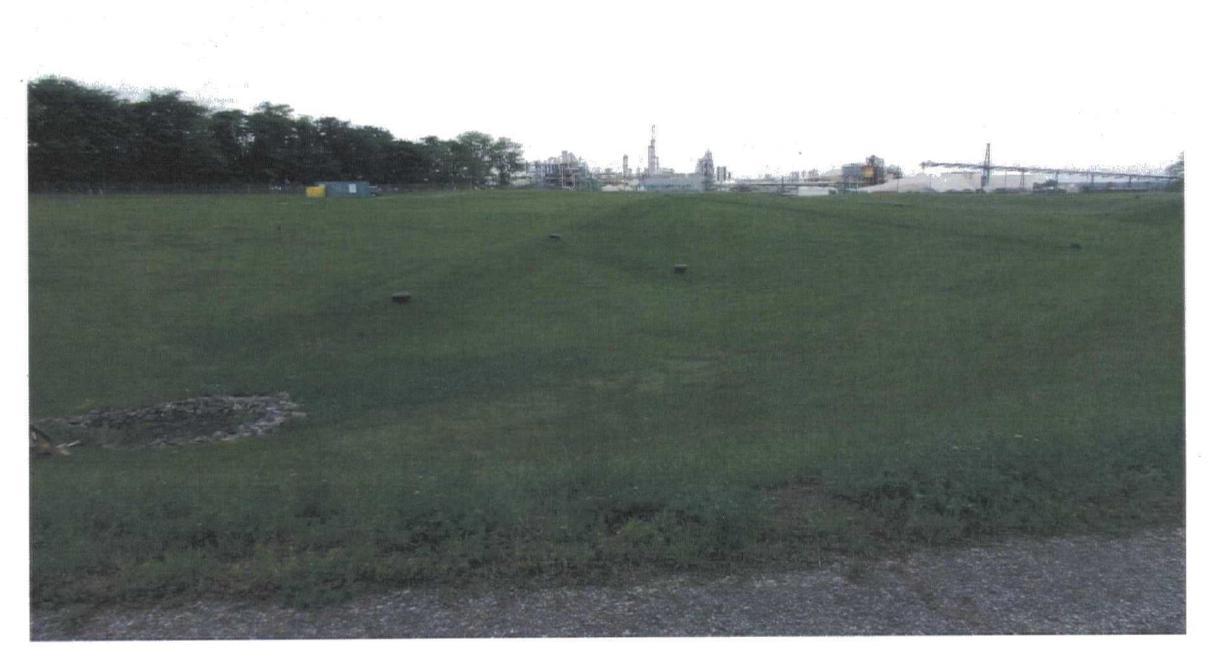
Photo 1 - View of Airco Landfill looking north from road along flood protection dike. Photos taken May 4, 2016 during Five Year Review site inspection.

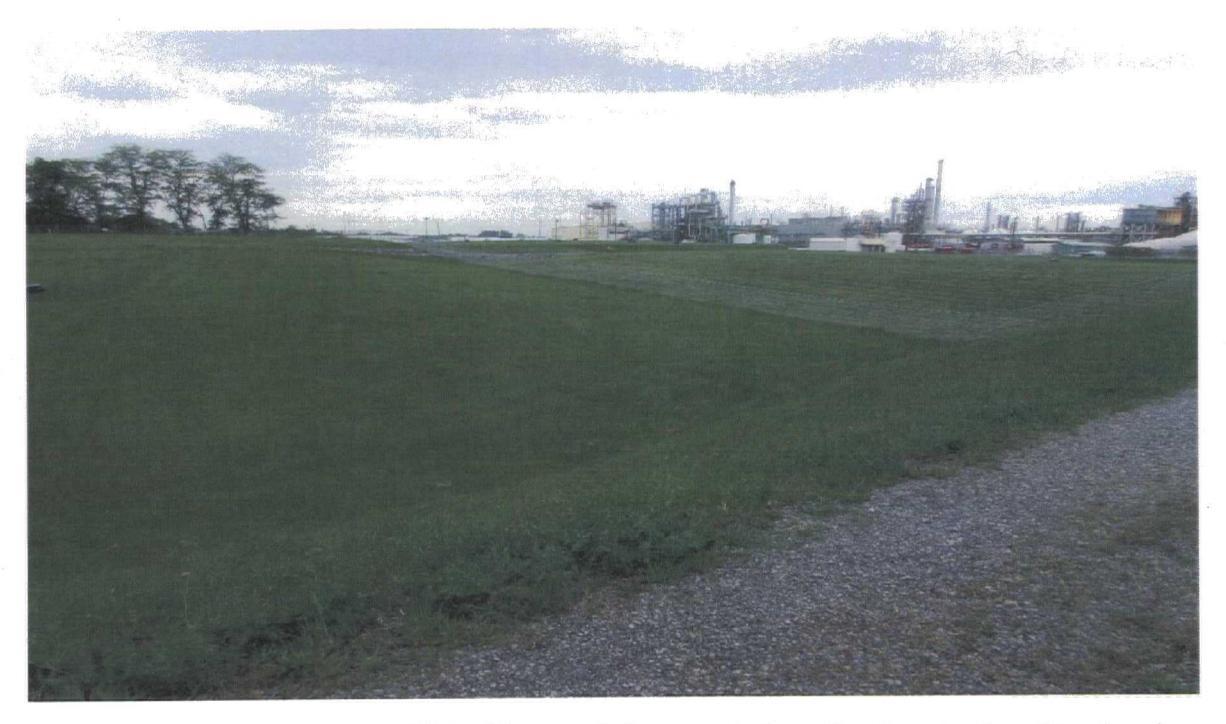
Photo 2 - View of Airco Landfill looking north from road along flood protection dike showing BF Goodrich Landfill in background.

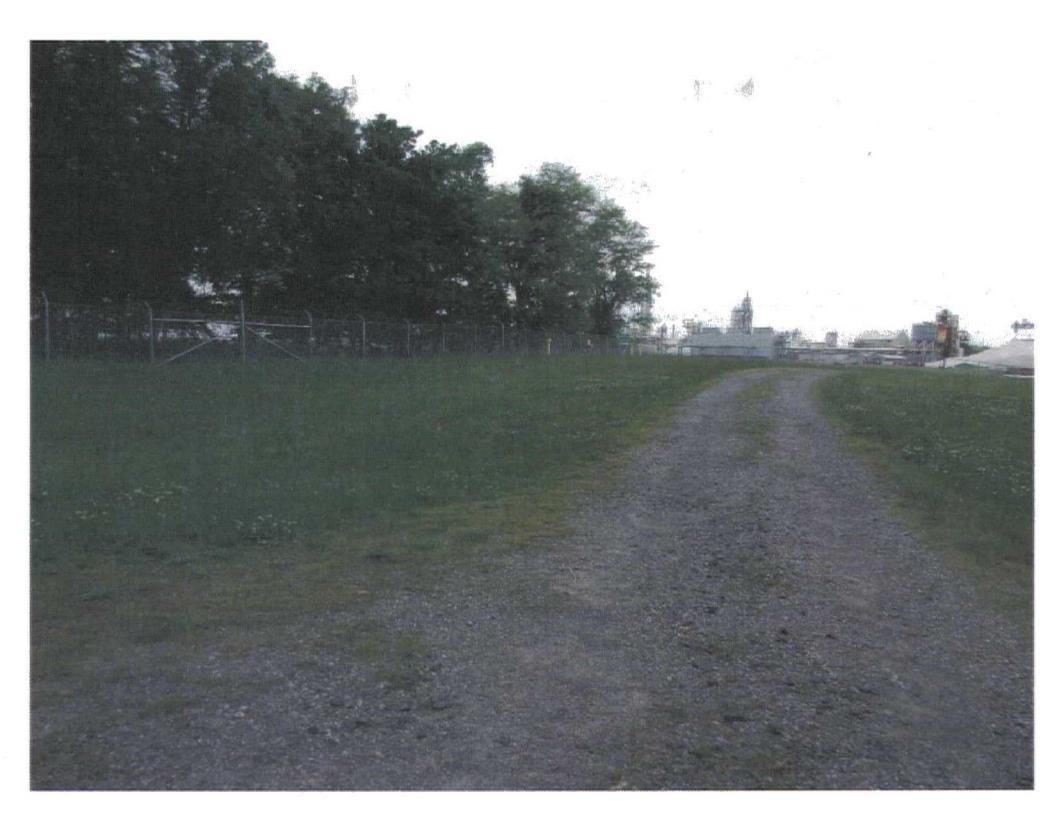
Photo 3 - Monitoring wells GA-13, GA-14A and GA-14 along western fence line.

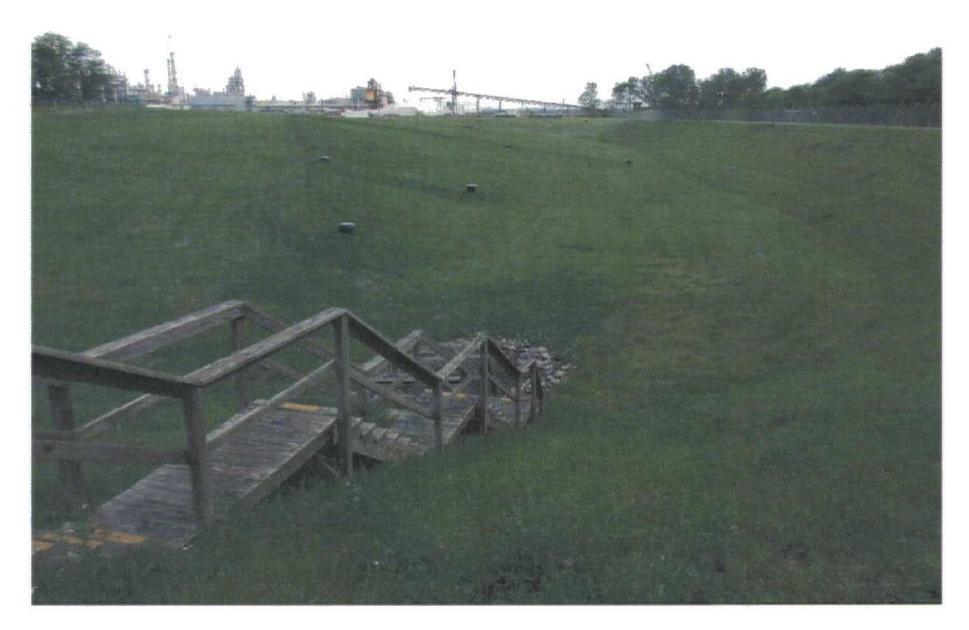
4.	Leachate Extraction Wells Properly secured/locked Functioning Routinely sampled Good condition Evidence of leakage at penetration Needs Maintenance N/A Remarks Three of four leachate sumps not operating due to pump malfunction. Termination of Pumping from LS-3 to LS-6 requested from EPA in May 2016.

Figure 4 – Storm water collection area and leachate sumps LS-05 and LS-06.

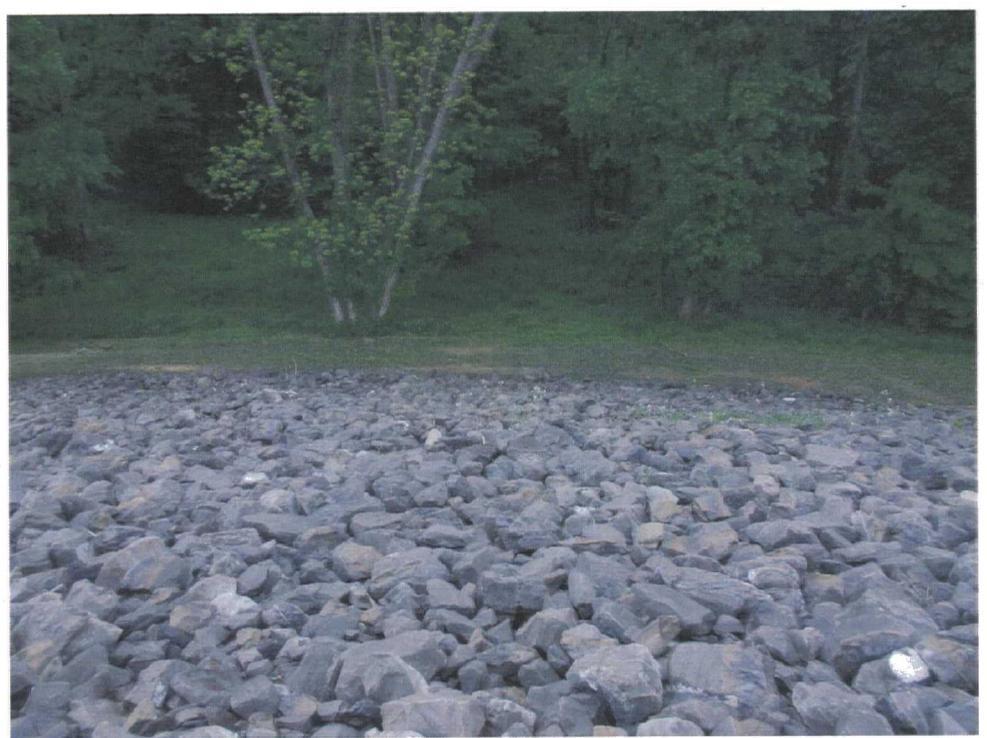
Photo 5 - Flood protection dike showing dike condition and lack of rooted vegetation.

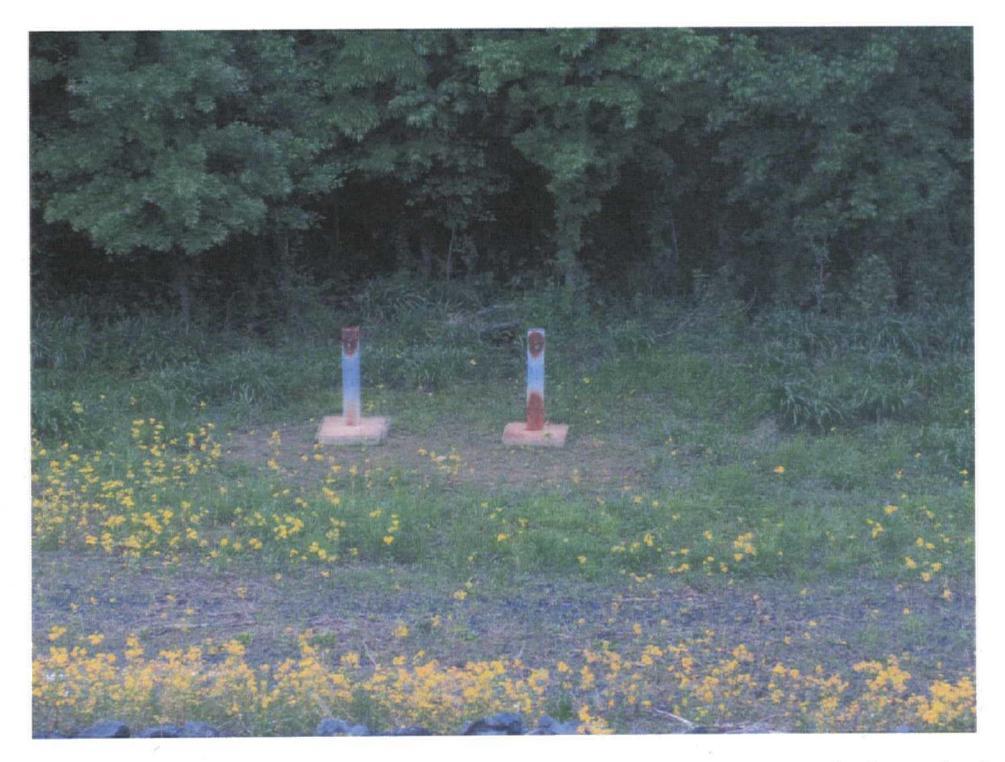
Figure 6 - Monitoring wells AL-MW-04A and AL-MW-04B showing typical monitoring well construction.
