Re: Internet/Wagner Castings  
LPC# 1150155186 – Macon County  
SF/Tech

DRAWING:  
APPENDIX 1 SITE PLAN

**RE: Preliminary Phase I Environmental Site Assessment Findings  
Former Wagner Castings Company / Internet Foundry  
825 - 830 N. Lowber Street / 700 N. Jasper Street / 1275 E. Sangamon Street  
Decatur, Illinois 62521  
LPC No. 1150155186  
USEPA ID No. ILD000814699**

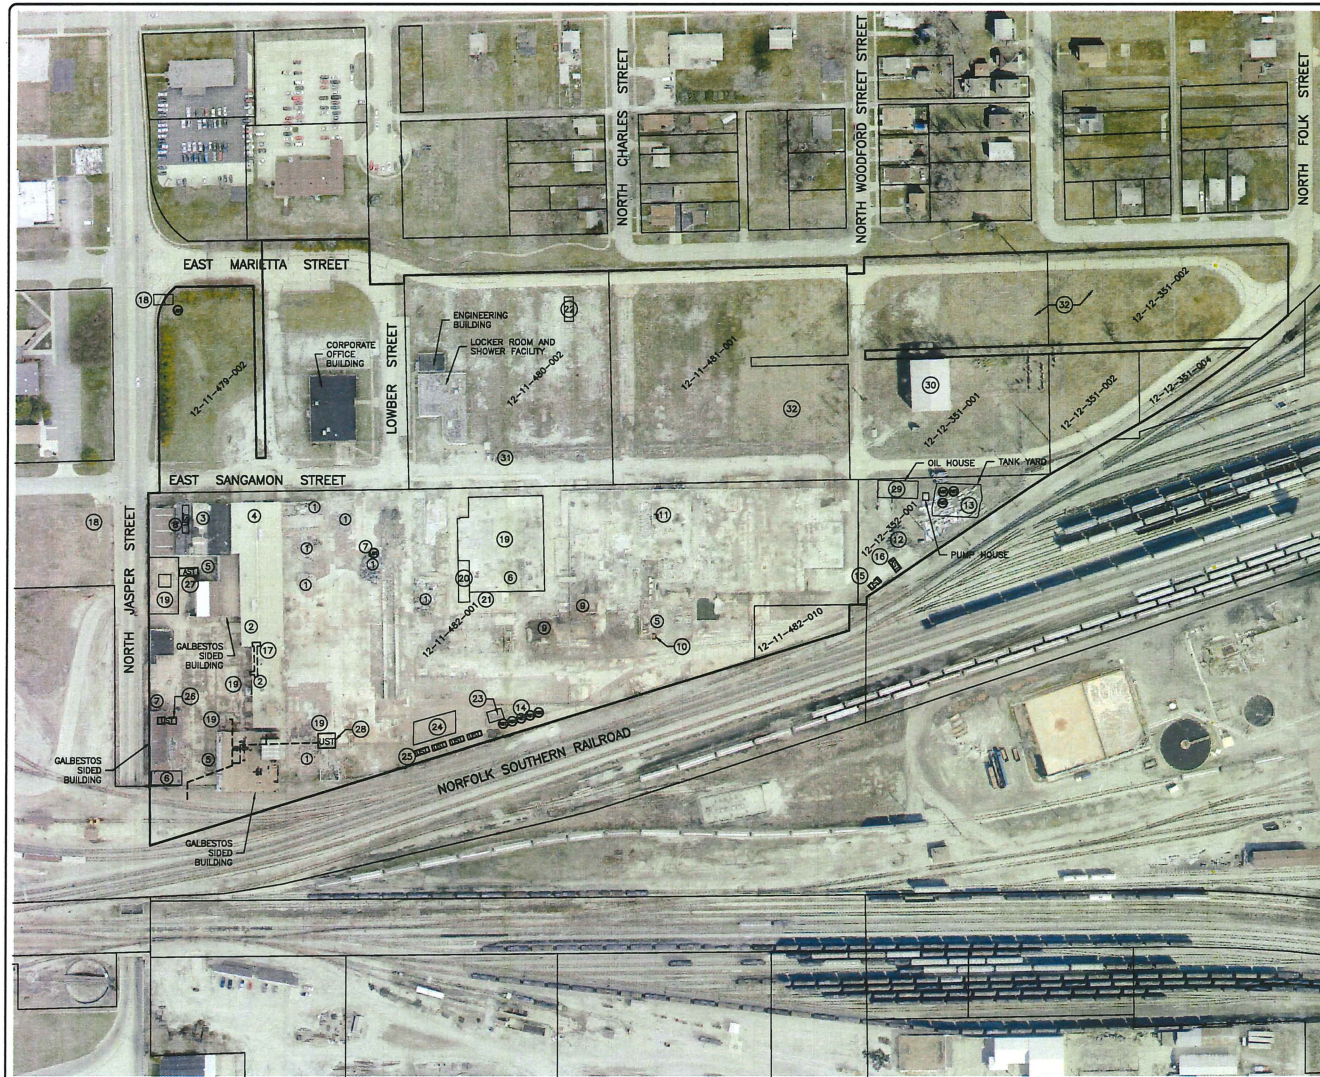
A large volume of stock-piled electrical transformers were present at the northern limits of the remaining industrial structure (Site Plan #4). Some of the transformers contained labels indicating they are of non-PCB content and some contained no identifying labels related to PCB content. Also present to the west of the transformers were multiple 55-gallon drums labeled "Hazardous Waste" and "Caution Contains PCBs". These drums appeared to be generally full and the lids were secure. However, staining was observed around the base of one drum as depicted in Attachment 3. Although a roof is present at the area, some sides of the structure have been removed as part of historical demolition activities, allowing direct access by unauthorized visitors and partial exposure to weather elements.

Just as concerning is what environmental impact may remain from the areas that the electrical transformers were removed from. During the site reconnaissance, three (3) former transformer yard areas were identified (Site Plan #5). The areas were in very poor condition. No records or evidence of the proper decommissioning of the former transformers have been identified to date. Signage indicates that the local electrical utility provider may have operated at least one of the former transformer yards. PCB impacts to underlying concrete, soil, and groundwater are of concern in addition to the surrounding demolition debris.

At the northeast corner of the site is an unsecured metal clad structure containing wastes that are suspected to have been former foundry-related manufacturing products (Site Plan #30). Multiple 55-gallon drums were observed and labeled as containing caustic liquids, surfactants, and solvents. Also present was what appeared to be foundry sand and chrome oxide (green) powder. Past experience with similar chrome oxide powders demonstrated that the material will typically fail a standard TCLP waste profile test for chromium, rendering it a hazardous waste as a result of toxicity. The sacks containing these powders were significantly weathered, allowing the materials to be actively released and exposed to precipitation runoff that had entered the structure through holes in the roof. Furthermore, the precipitation appeared to be carrying the materials to the exterior of the facility in some areas where they may be impacting soil.

A stockpile of transite (asbestos-cement) panels were observed at the southeastern region of the site (Site Plan #13). The panels are directly exposed to the elements and were exhibiting signs of weathering. It is presumed these panels were removed from the former structures at the time of demolition and stockpiled at their current location. Google Earth imagery depicts the panels showing up at this location sometime between 2009 and 2010.

Adjacent to the stockpiles of transite were a large pile of wire-framed cages of unknown use (Site Plan #12). The cages were wrapped in suspected asbestos-containing fabric insulation that exhibited significant signs of weathering and friability. It is presumed that these cages were used as part of the foundry operations, as they were also observed in some of the remaining structures with the same fabric coating. The wrapped wire cages were also observed in stockpiles of demolition debris that litter the site.

Piles of suspected asbestos-containing roofing materials and other demolition debris (plaster, floor tile, etc.) were observed throughout the southwestern region of the site (Site Plan #1). The previously-described wire cages wrapped with suspected asbestos fabric insulation was also observed in some of the piles of debris. It appears that when the former buildings were demolished, the salvageable materials were removed and the remaining debris was left onsite where it is currently present. In general, roofing components are typically non-friable. However, these materials were compromised by the demolition activities and subsequently left exposed to seasonal elements. Similar to the Galbestos, these materials have significantly deteriorated and exhibit evidence of friability. As a result, there is significant concern that asbestos fibers are potentially being released. The roofing materials and demolition debris are in a state where they will continue to be exposed to the open elements and further deteriorate.

A number of aboveground storage tanks and 55-gallon drums labeled as containing fuel and used oil remain onsite (Site Plan #s 10/11/31). The tanks and drums contain various amounts of liquids and appear to have been brought to the site to support demolition related equipment. The tanks and drums are directly exposed to the elements and evidence of small releases were observed in some of the areas. The tanks and drums are also located in close proximity to storm sewer inlets located throughout exterior areas of the site.

Several piles of foundry sand mixed with slag, other waste materials, and casted parts are located at the central region of the site (Site Plan #9). Based on our past experiences, similar foundry wastes are known to contain elevated levels of polynuclear aromatic hydrocarbons (PNAs) and heavy metals. The material is currently exposed to the elements. In addition, the material was observed as contacting precipitation, allowing for potential contaminants to be carried into surrounding storm sewer inlets via surface runoff and jeopardizing surface water bodies that the storm sewer systems discharge into. In addition, evidence that animals are coming in contact with the materials was also observed.
