Memorandum

October 6, 2017

0	
Re:	Post-Harvey TCRA Inspection and Maintenance Report – October 2017		ج د	Ö
		25	PM	\leq
	David Moreira, McGinnes Industrial Maintenance Corporation	ST.	\sim	
сс	Phil Slowiak, International Paper Company			$\overline{\mathbf{O}}$
From	John Laplante, John Verduin, Wendell Mears, and David Kelth		00	m
[rom	John Lanlanta, John Vardum, Wandell Maars, and David Kaith	AF C	7	$\boldsymbol{\Sigma}$
To:	Gary Miller and Anne Foster, U.S. Environmental Protection Agency		_

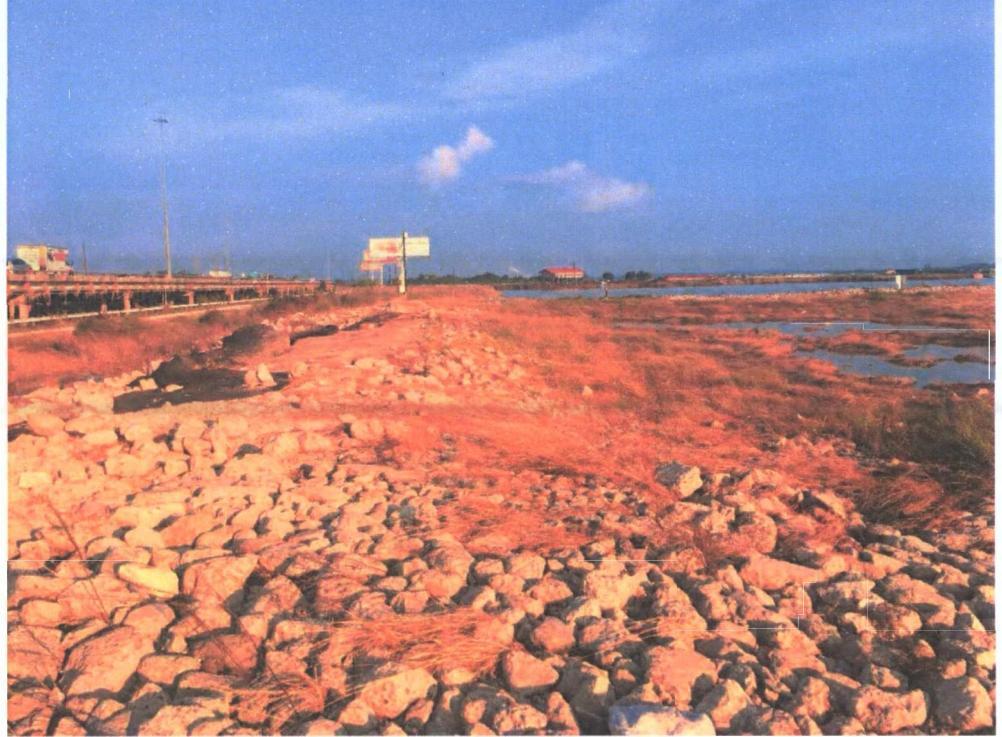
- Portions of the south berm crest in an area outside the footprint of the waste within the impoundments. There was displacement of the recycled concrete armor rock B/C in this location. On the west portion of the south berm crest, the underlying fabric was displaced, but the immediately adjacent three-layer geomembrane/geotextile cap in the Western Cell was intact and undisturbed, and there was no evidence that any waste had been exposed. This entire area is located outside of the footprint of the waste within the impoundments.

Photograph 1: Assessing south berm condition.

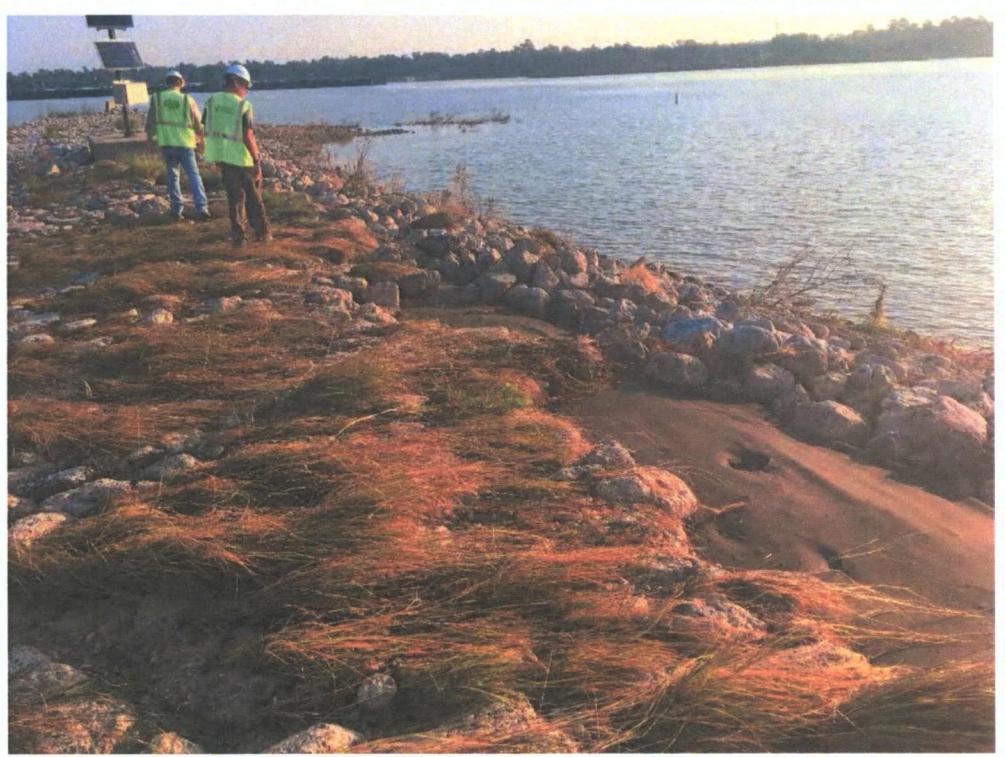
- Portions of the central berm crest, located outside the footprint of the waste within the impoundments There were discrete locations in which recycled concrete armor rock B/C had been displaced. The underlying fabric was present and intact along the central berm crest, and there was no evidence that any waste had been exposed. This entire area was outside of the footprint of the waste within the impoundments

Photograph 2: Assessing central berm condition.

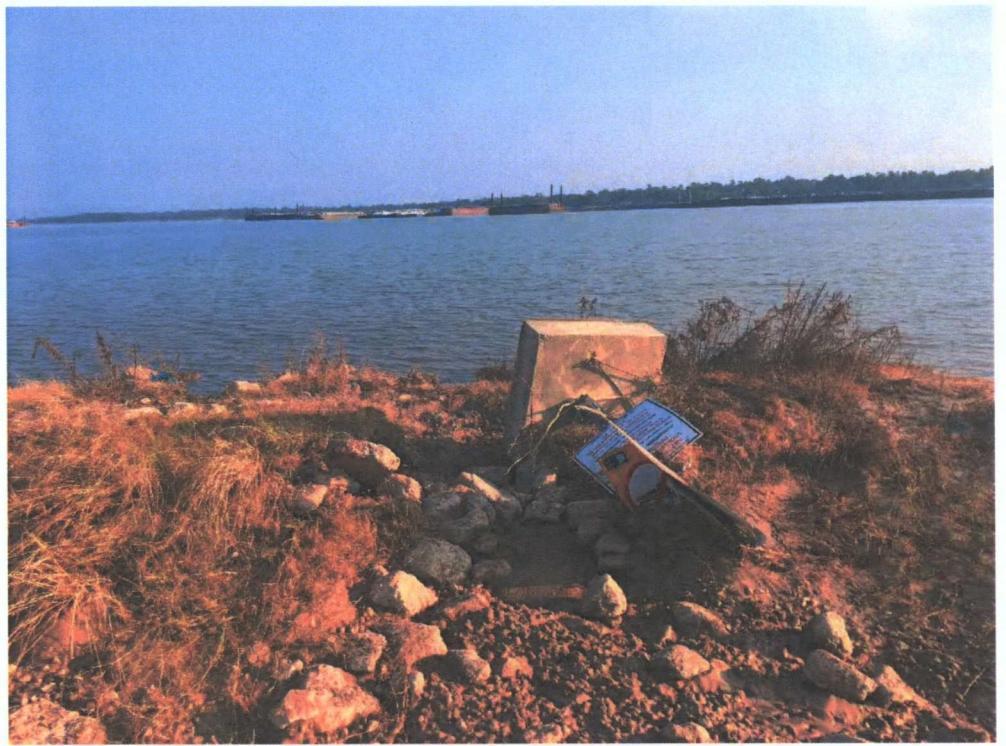
- Portions of the northern edge of the Western Cell In inspections conducted after the water had receded, there was visible geotextile at the water line in these locations

Photograph 3: Evaluating northwest shoreline condition

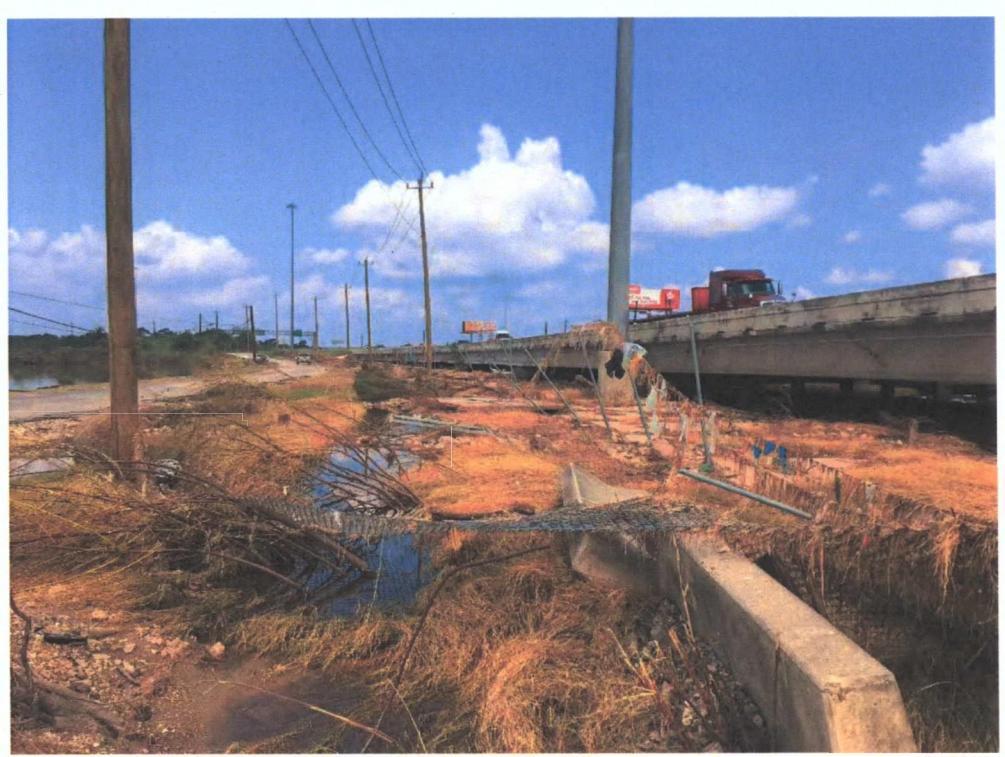
The perimeter fencing (Figure 2) on the west and east banks of the San Jacinto River was visually inspected for damage during the week of September 4, 2017 The entire fence line on the western side of the river was observed to have been damaged by high flows from Hurricane Harvey. There was no visible damage evident during a drive-by viewing of the fencing on the eastern side of the river

Photo 4: Evaluating south fence condition

Maintenance to repair the damaged perimeter fencing began during the week of September 4, 2017. Temporary fence panels were installed along the TXDOT right-of-way between the access road and the I-10 bridge on the north side of I-10. Temporary repairs were also made to the access gate. Permanent repairs to the access gate and to the fence line along the south side of the I-10 bridge are planned for October 2017 once crews are available.

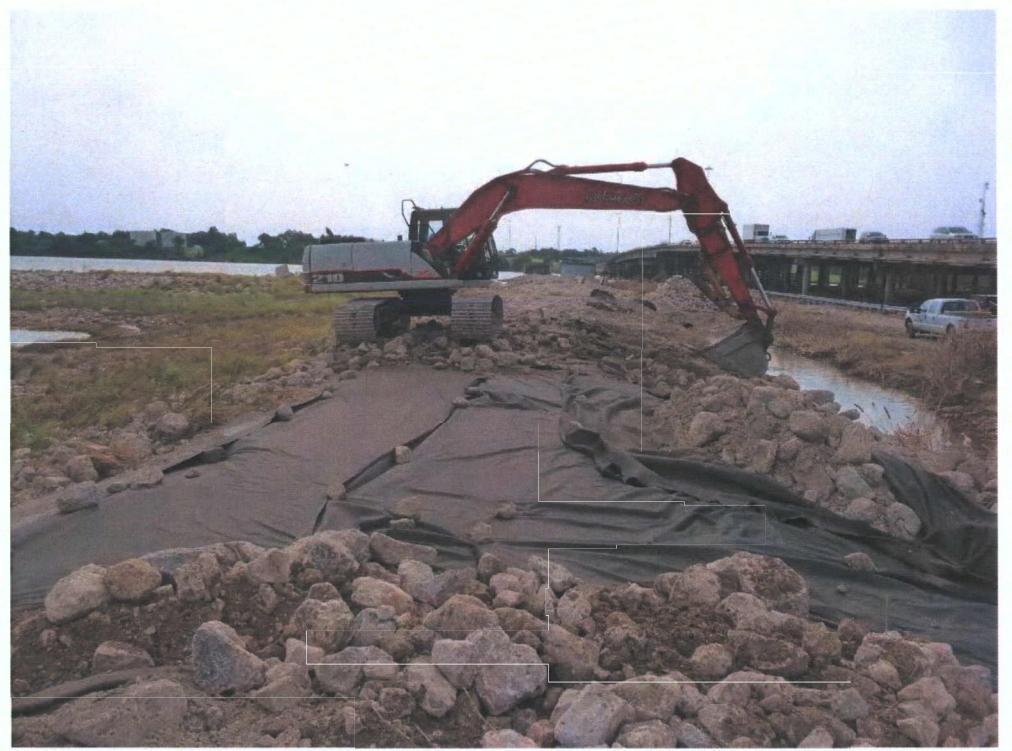
Photo 1 – south berm crest maintenance

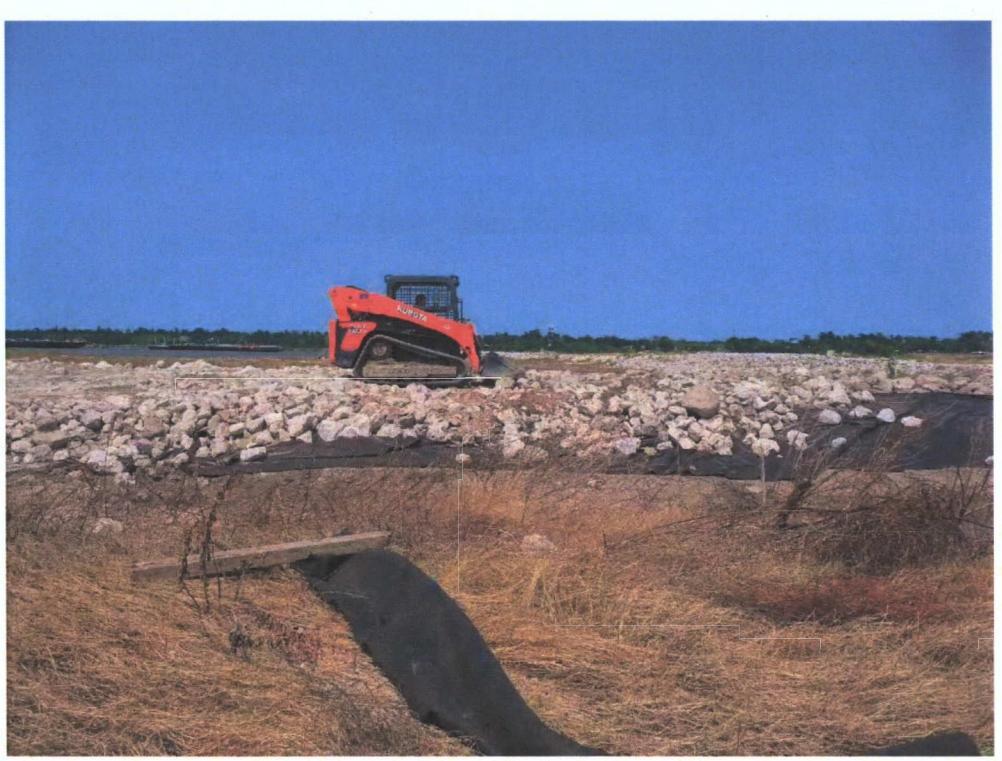
Photo 2 – dressing south slope of south berm

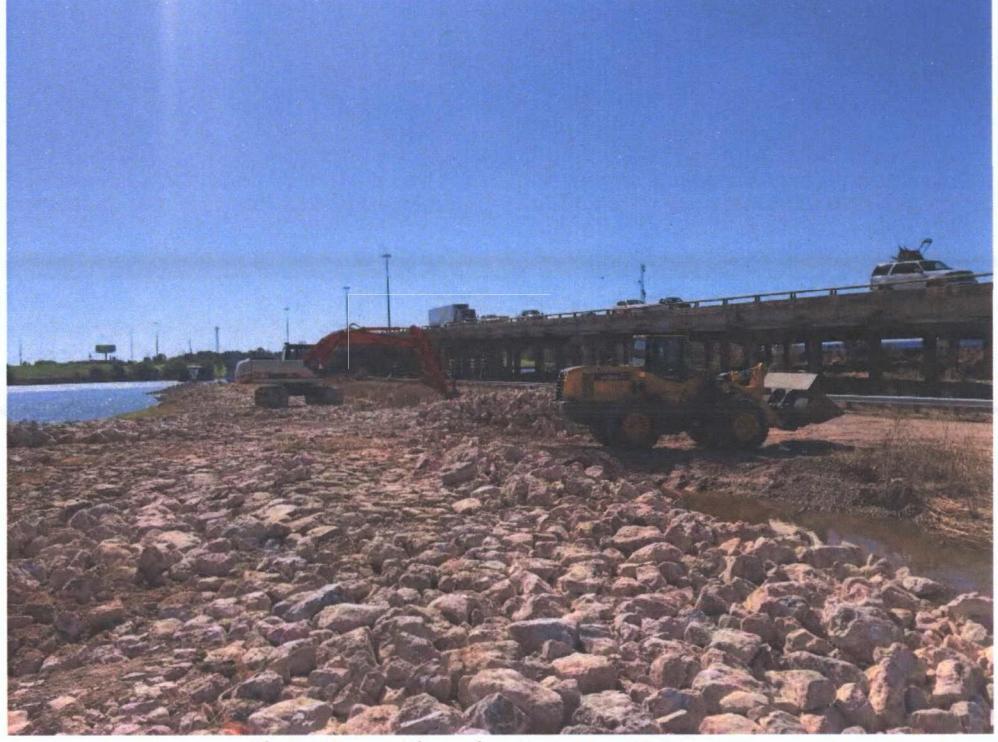
Photo 5 – southern berm crest maintenance

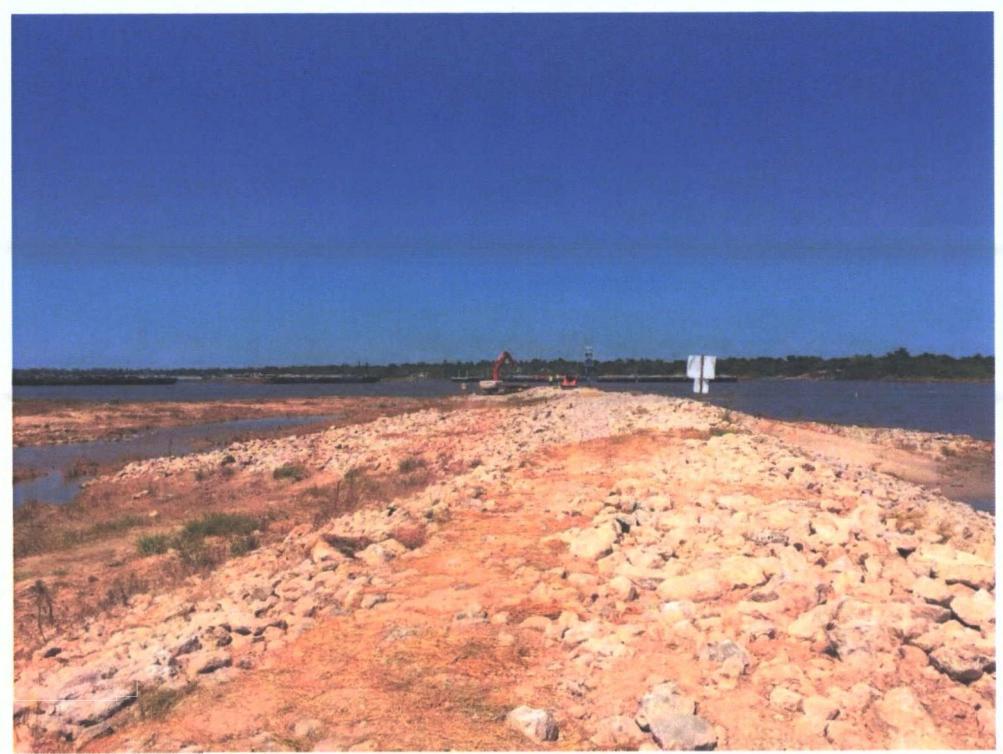
Photo 1 - maintenance of northern end of central berm

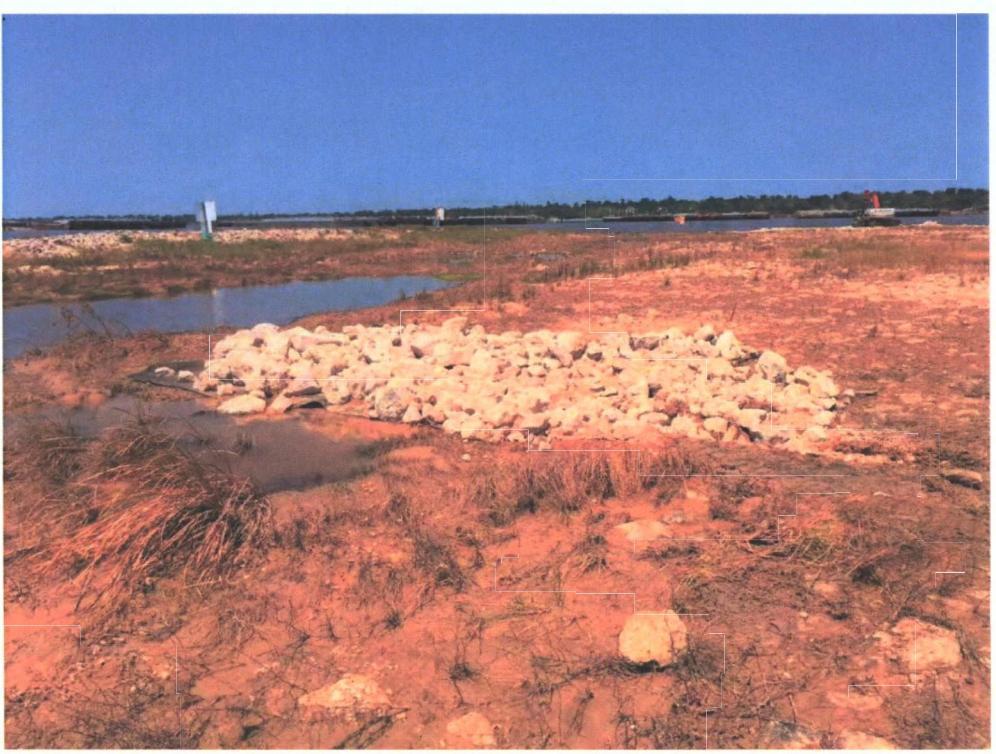
Photo 3 – maintenance of cap in western cell

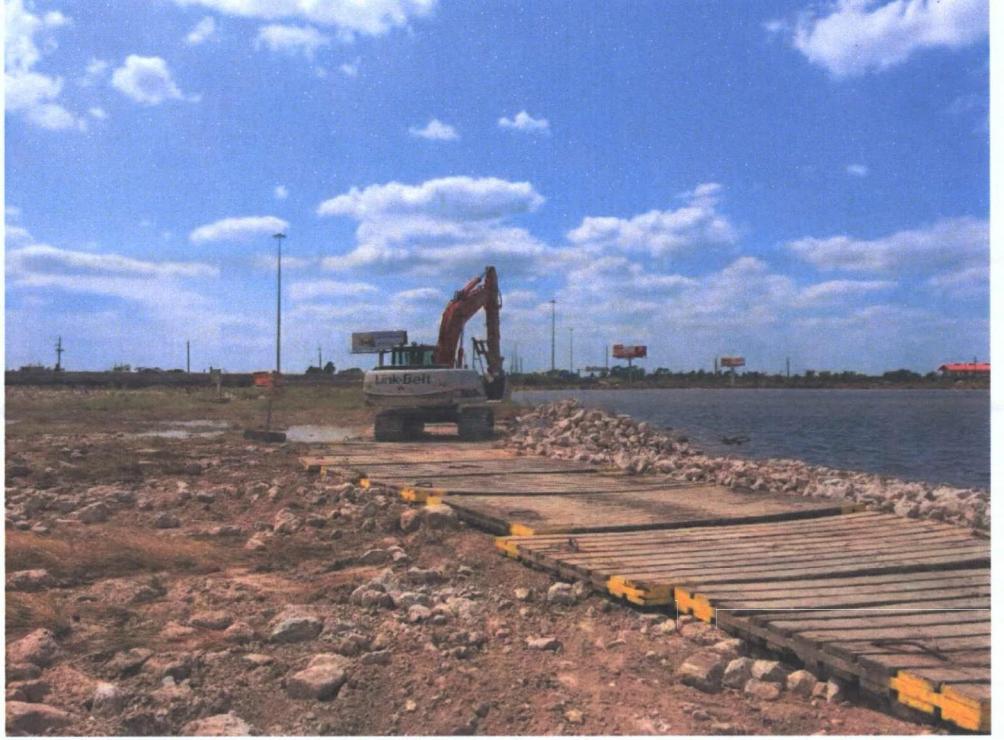
Photo 1 - maintenance of north shoreline between central and western berms

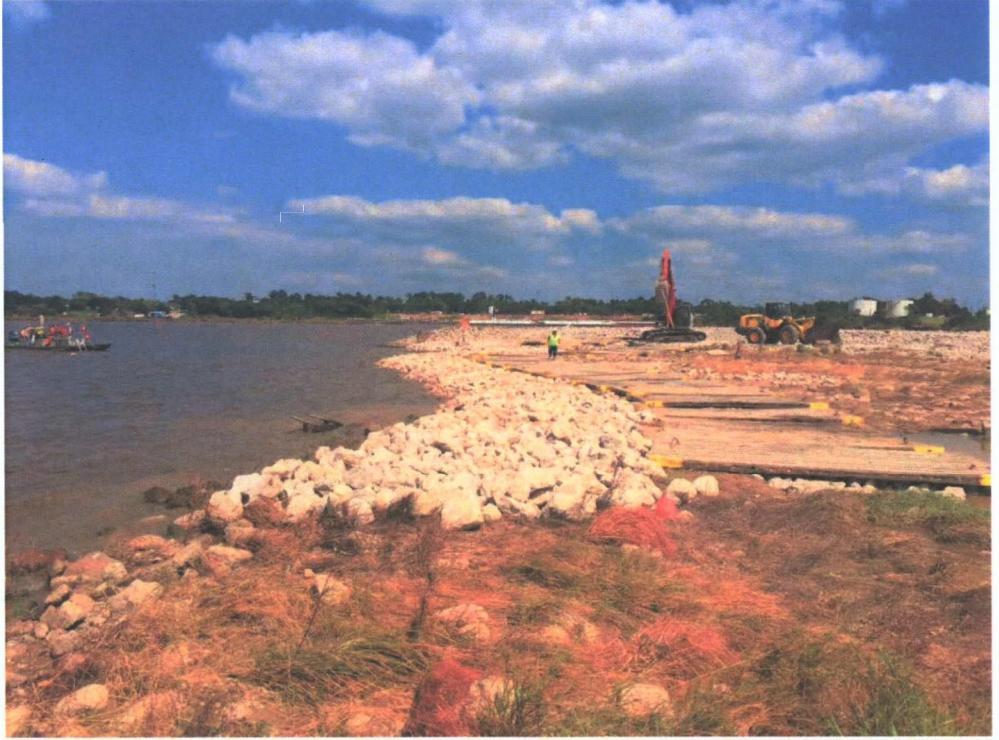
Photo 3 - maintenance of north shoreline between central and western berms

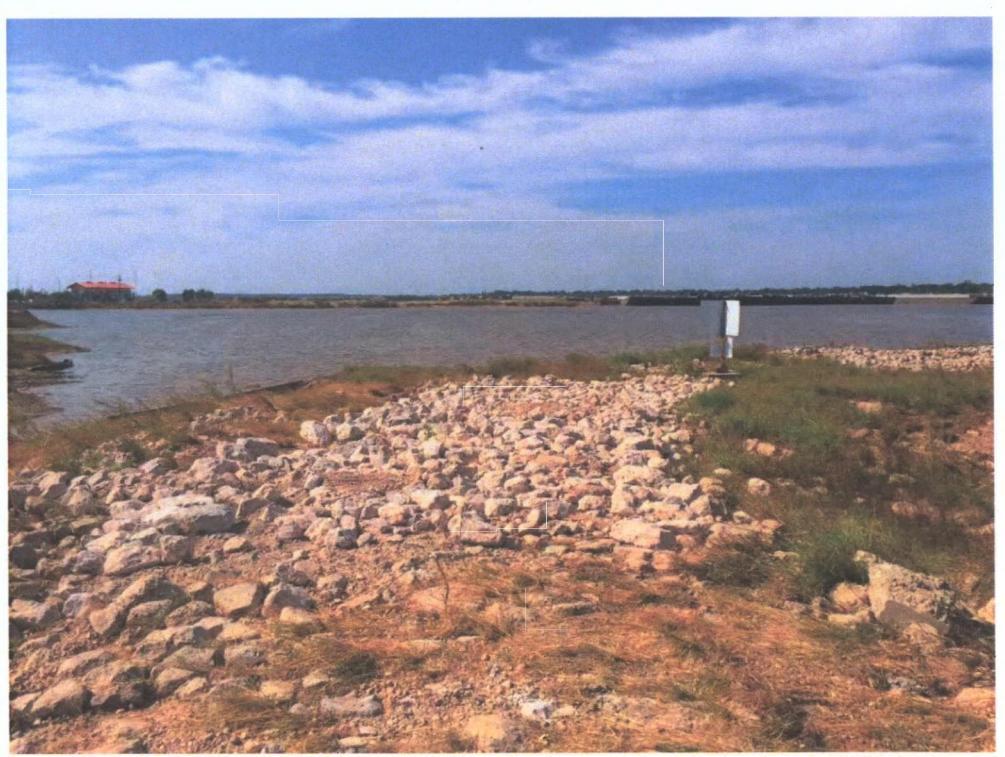
Photo 7 – southwest portion of southern berm following maintenance

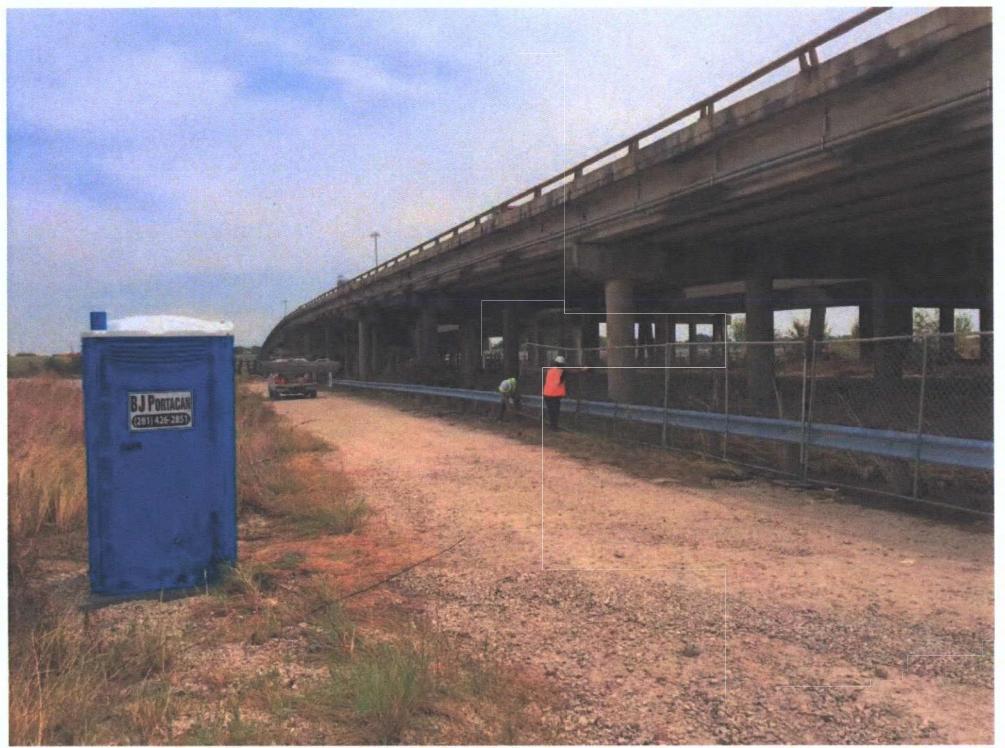
Photo 5 – erection of temporary fencing

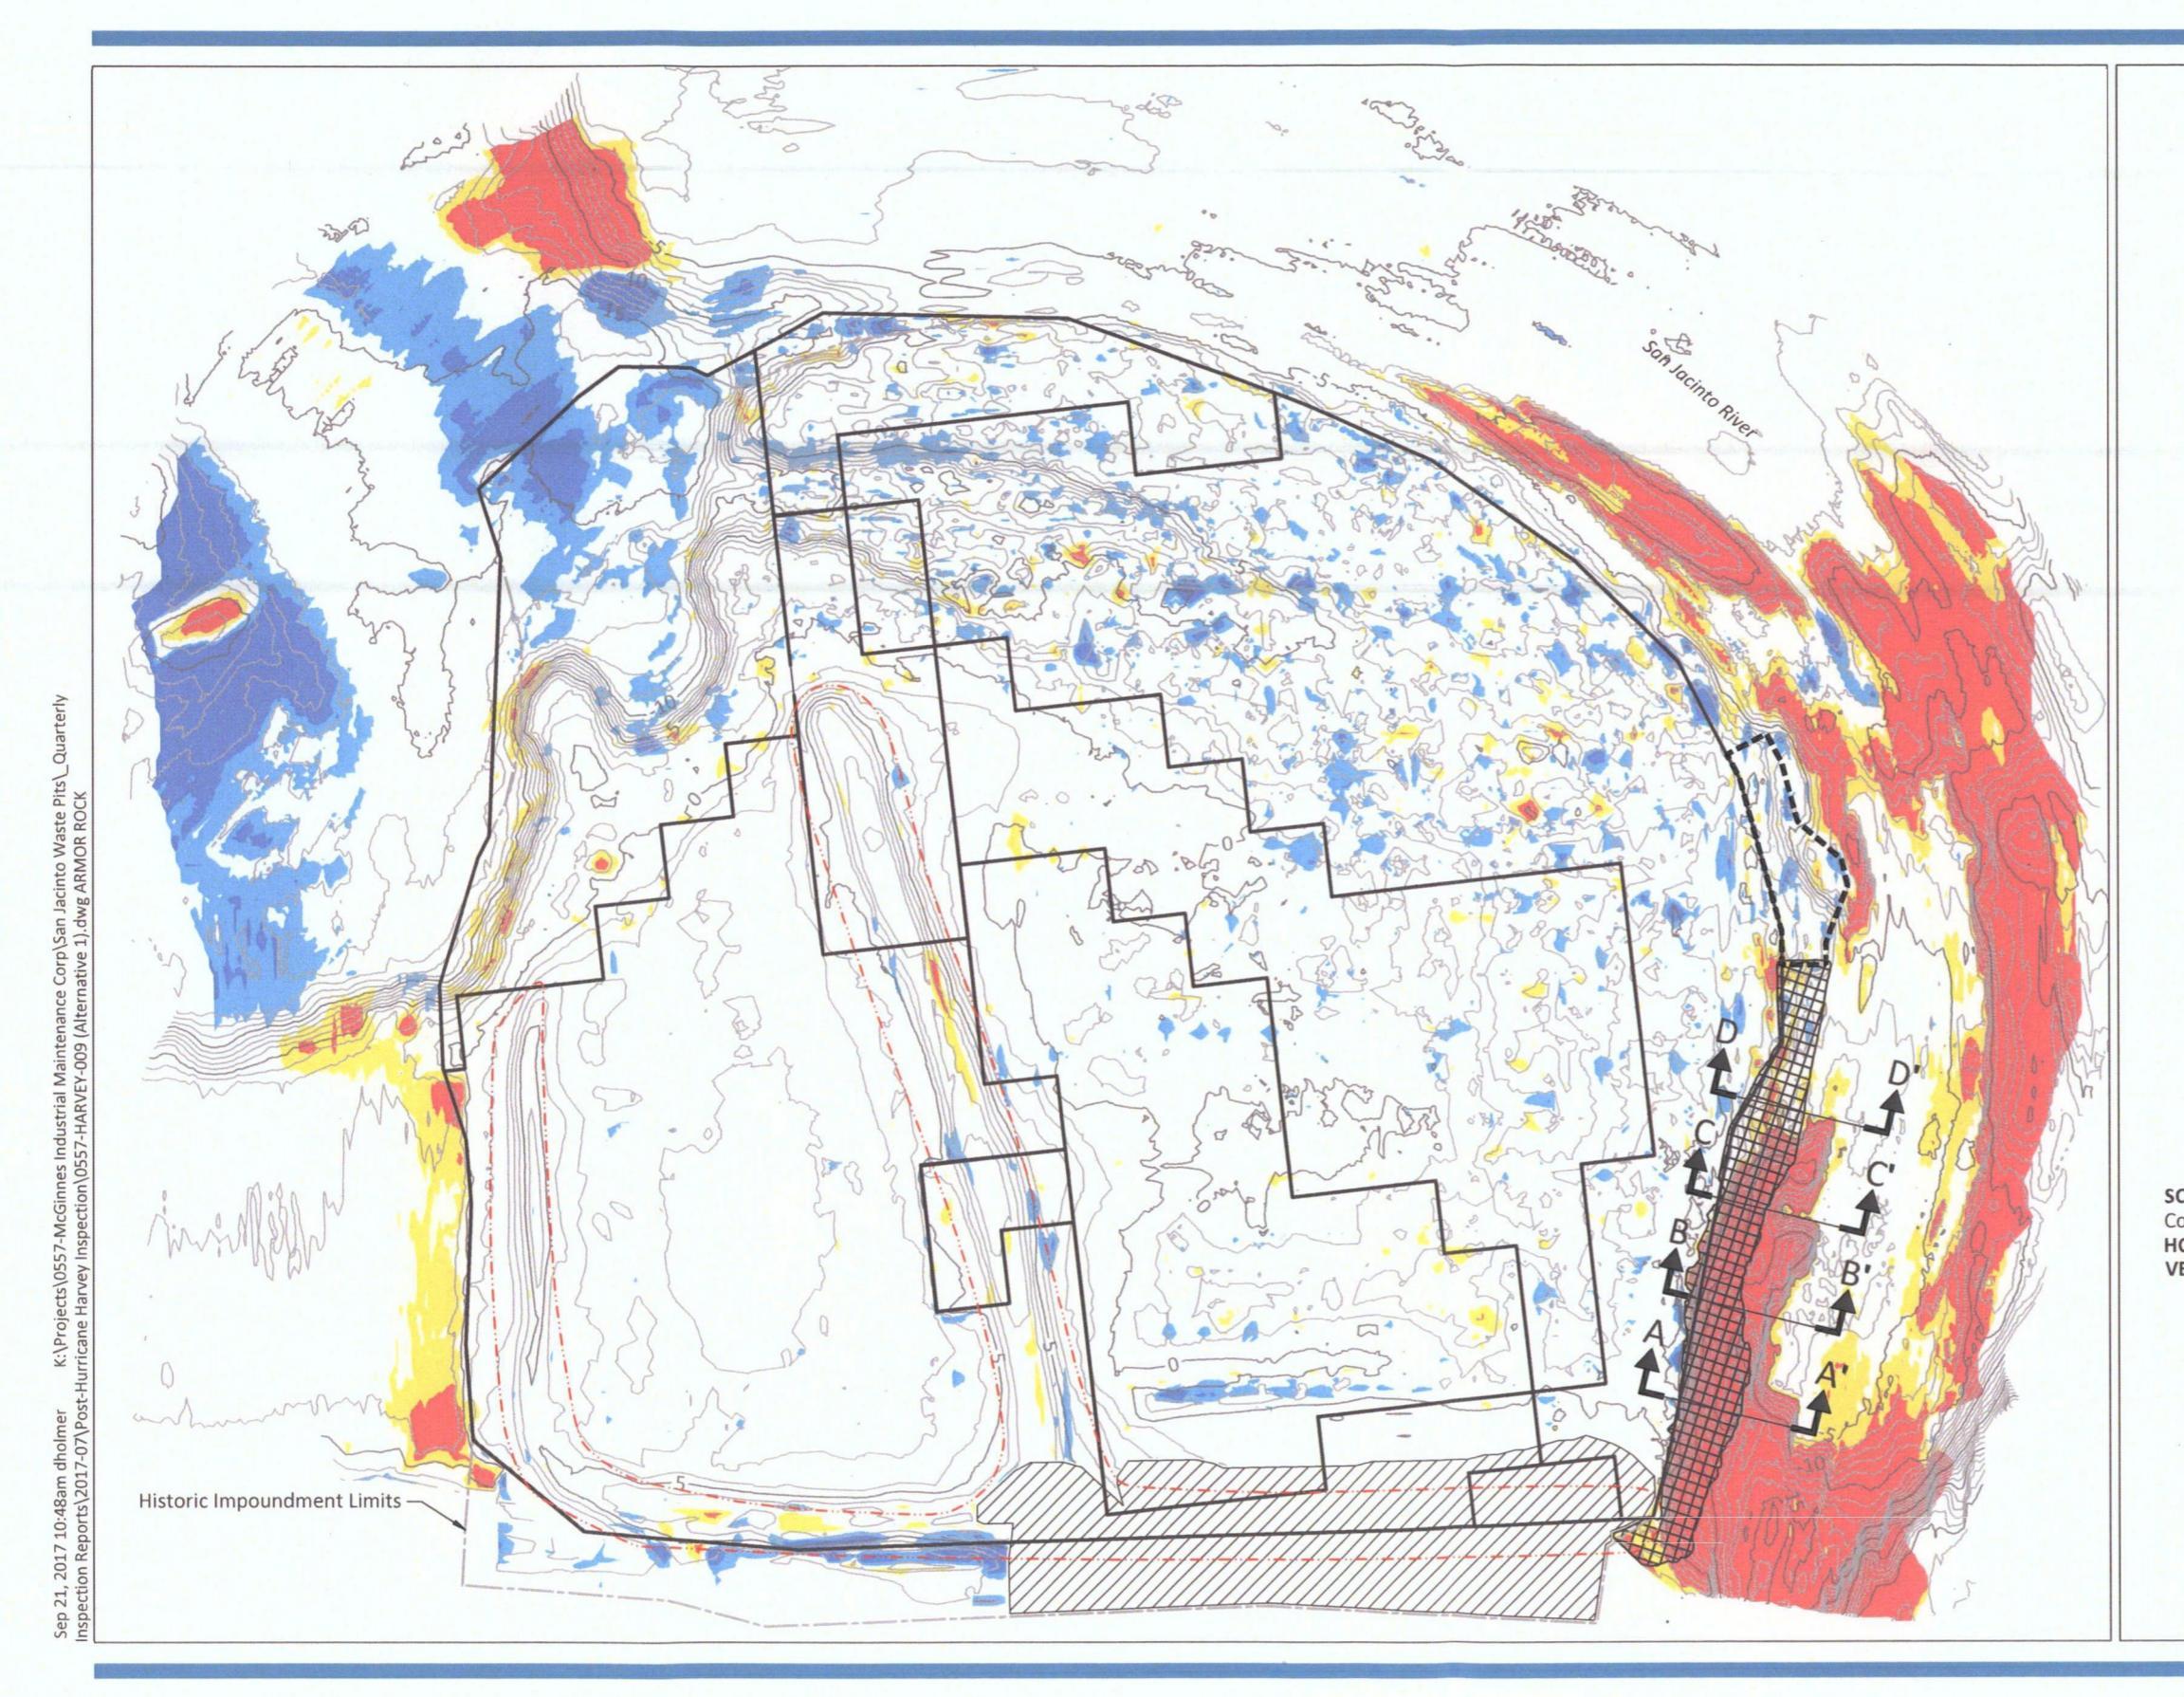
Figure 1

Plan View of Armor Rock Placement Area Post-Hurricane Harvey Work Plan (September 2017) San Jacinto River Waste Pits Superfund Site
