New Idria Mercury Mine Superfund Site Idria, San Benito County, California Removal Action Final Report

April 2012

Prepared for: U.S. Environmental Protection Agency Region 9

> Prepared by: Weston Solutions, Inc.

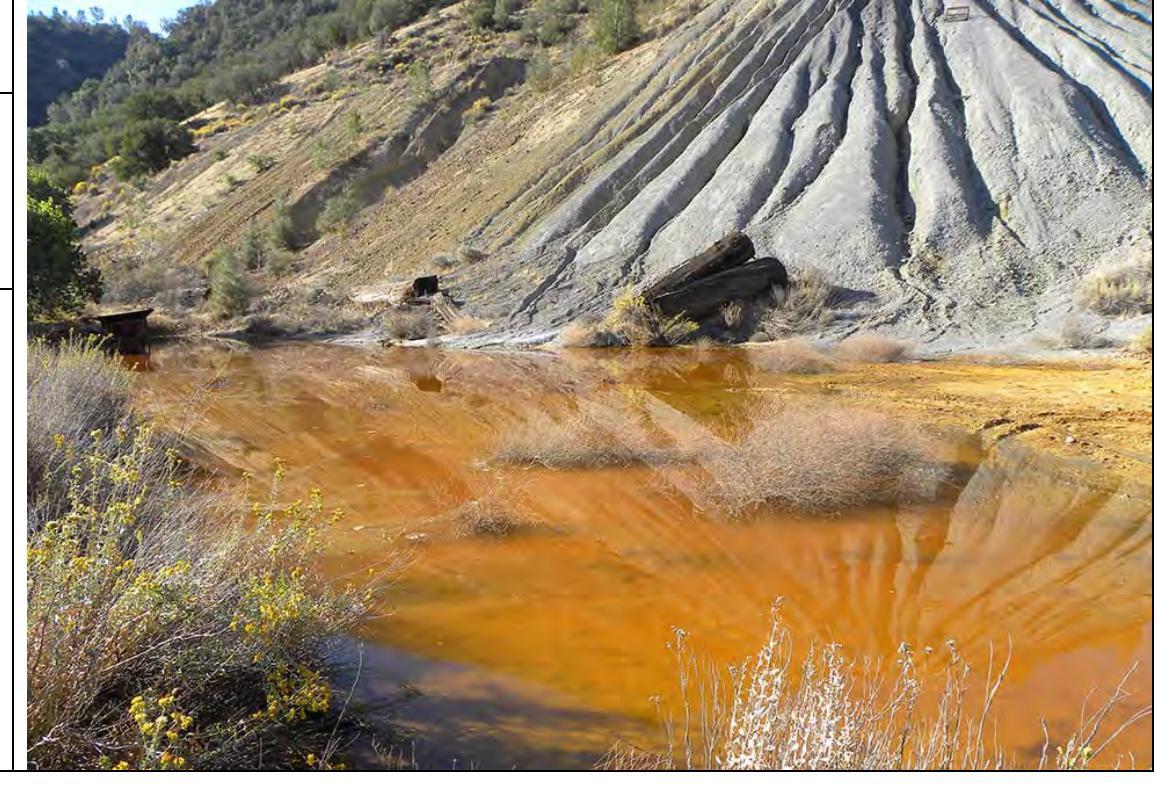
Before the removal action, the Lower Pond was filled with sediment and not functioning as an effective retention pond for the acid mine drainage.

Prior to completing the AMD Conveyance pipe, WESTON removed the existing AMD from the shallow Lower Pond with by pumping it out with a 6-inch trash pump. As mentioned above, the pond had become filled with sediment, and was no longer functioning as an effective retention pond for the AMD. After the Lower Pond was pumped dry, the sediments in the bottom of the pond were dredged with the CAT 330 excavator. The sediments were transferred via the loader to a repository that was constructed east of the Lower Pond. Sediments were removed to an approximate depth of 4 feet at the deepest point, and the new dimensions of the pond measure approximately 150 feet long by 60 feet wide. The pond was constructed to provide a minimum of 15 hours residence time for the maximum expected AMD flow of 120 gallons per minute (gpm).

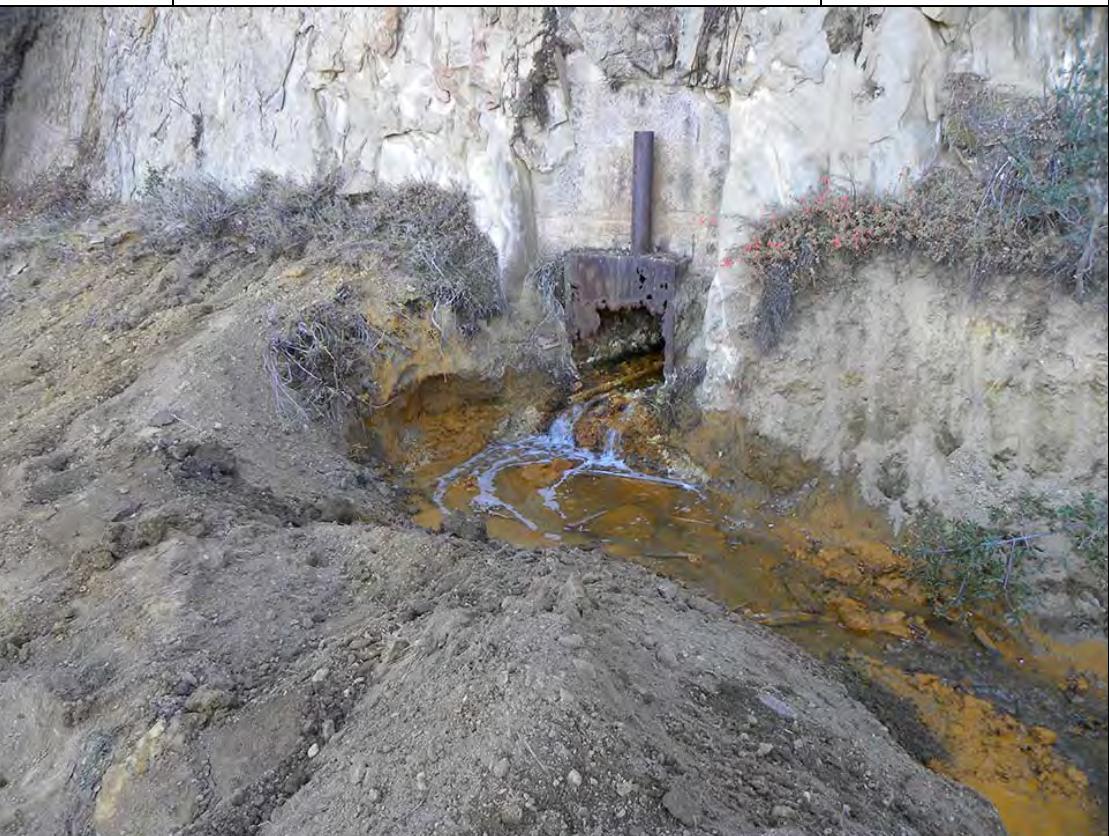
Photo No. 10	Date: Oct. 26 2011			
Direction Photo Taken:				
North

AMD was diverted into the alignment of the intermittent stream diversion channel prior to conveyance excavation.

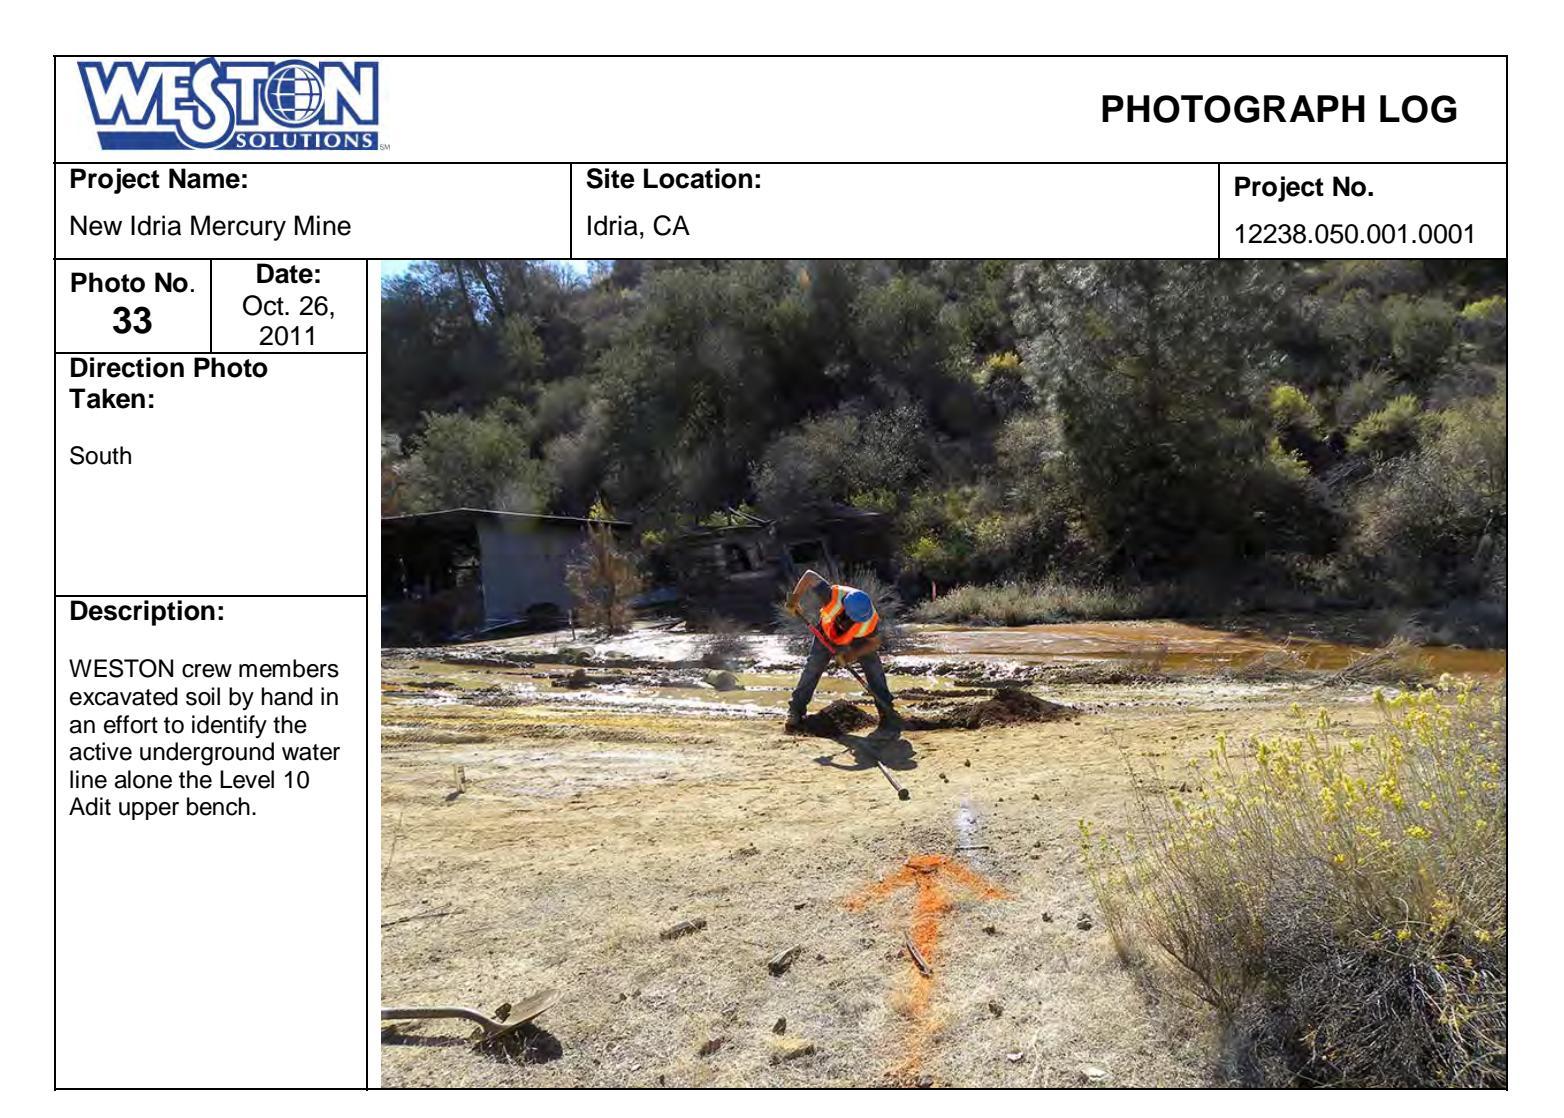
Photo No. 34	Date: Nov. 9, 2011	
Direction Photo Taken:		
West		
Description:		
View of the exposed active water line crossing the AMD Conveyance pipe alignment. Additional efforts were required to install the HDPE pipe beneath the water line.

Immediately prior to construction activities at the NIMM site, WESTON was notified that an active underground water line existed in an unknown location along the upper bench of the Level 10 Adit dump. It was suspected that the water line crossed the path of the planned AMD Conveyance alignment; therefore, it needed to be located prior to excavation of the alignment to ensure that it was not damaged. WESTON rented and underground utility locator and was able to identify the water line location by excavating test pits with a shovel along its path. The AMD Conveyance alignment was successfully excavated with no damage to the aging water line. The location of the water line required the HDPE pipe to be installed underneath line, and WESTON was required to purchase an electro-fusion coupler to join two sections of the HDPE pipe together.

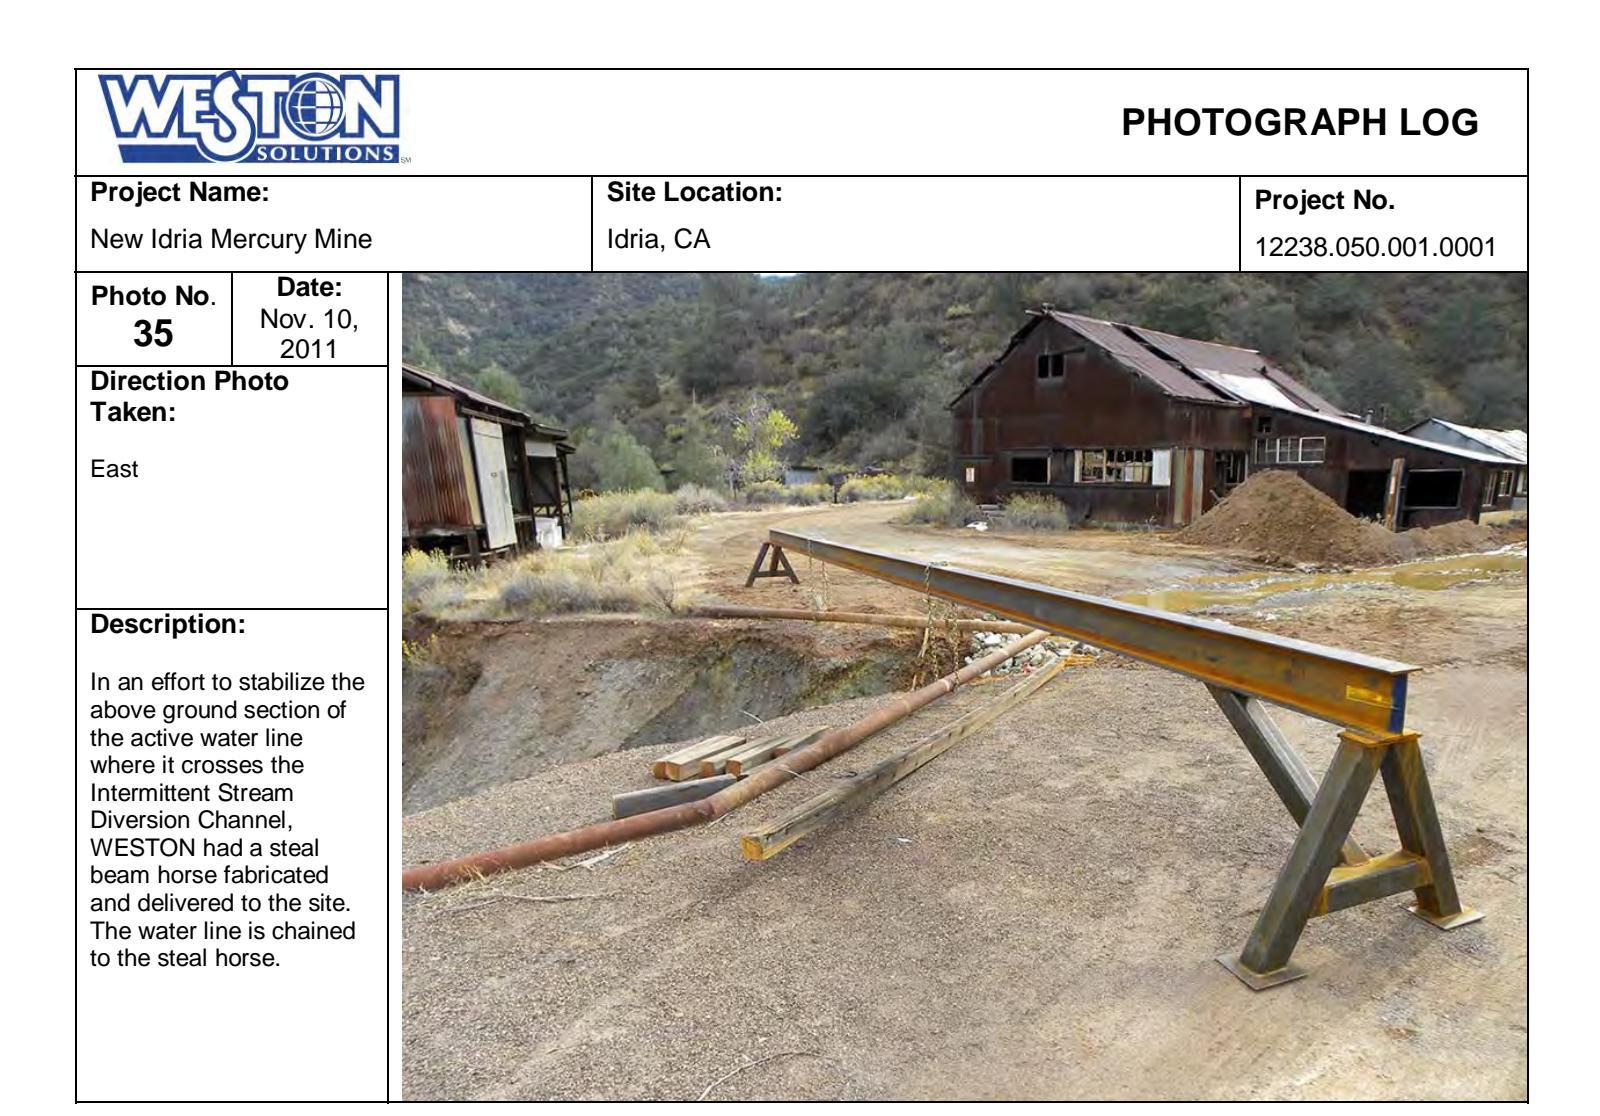
Photo No.
36Date:
Nov. 10,
2011Direction Photo
Taken:NorthDescription:

View of the water line stabilization above the rip rap portion of the Intermittent Stream Diversion Channel.

The active water line was also identified above ground at location that crossed the termination point of the Intermittent Stream Diversion Channel. Due to the excavation activities required for the channel installation, it was determined that the water line needed to be secured to prevent damage to the line. WESTON had a steal beam horse fabricated and delivered to the Site. The water line was secured to the steal horse with chains.

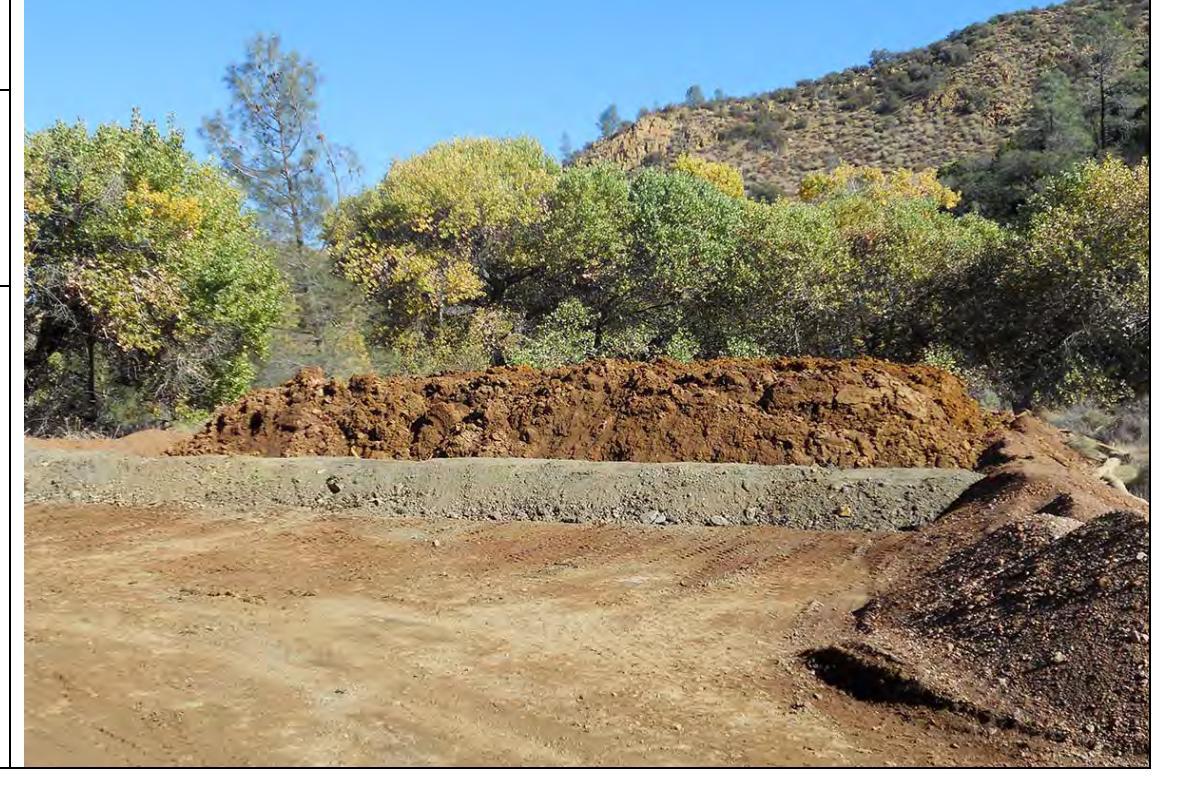
View of the filled Lower Pond several months after project completion.
