**Re: GE-Pittsfield/Housatonic River Site
Newell Street Area II (GECD450)
Summary of August 2010 Inspection of Natural Resource Restoration/Enhancement
Measures**

**NATURAL RESOURCE RESTORATION / ENHANCEMENT
INSPECTION CHECKLIST**

NEWELL STREET AREA II REMOVAL ACTION

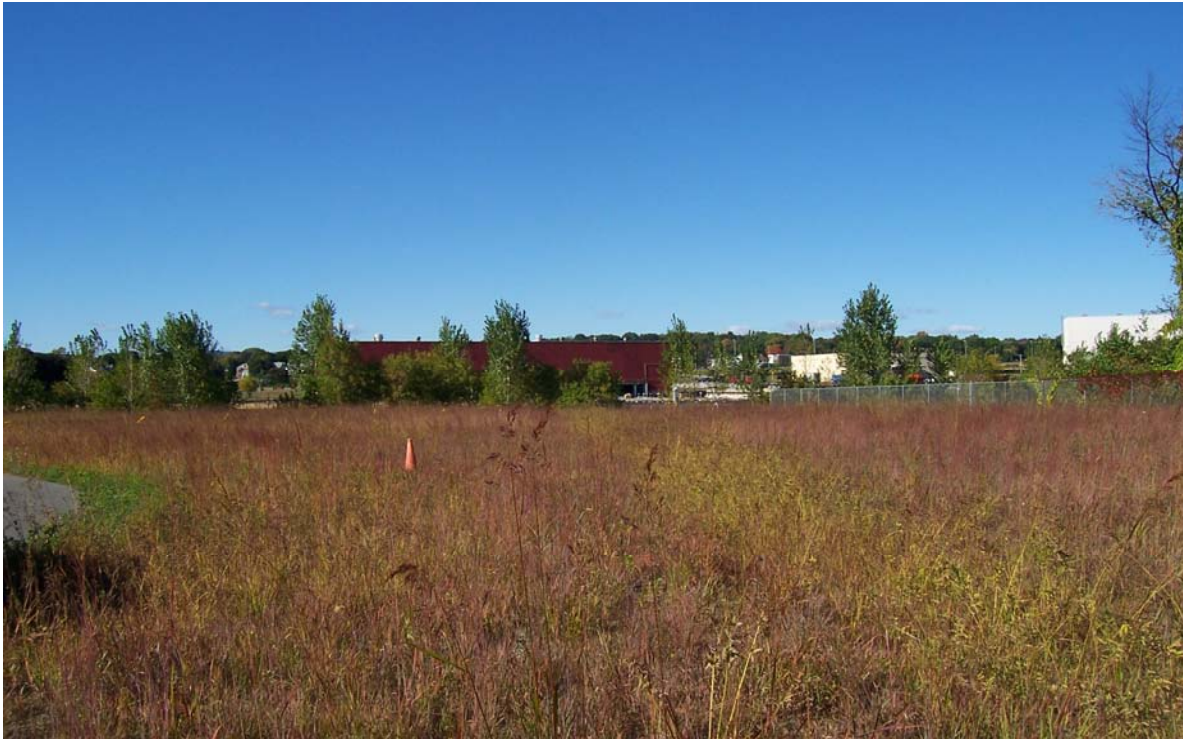
- Eastern and western portions of Newell Street parking lot area - approximately 100% groundcover.

Photo #1: Herbaceous cover within the NRR/E area at Newell Street Area II (looking north).

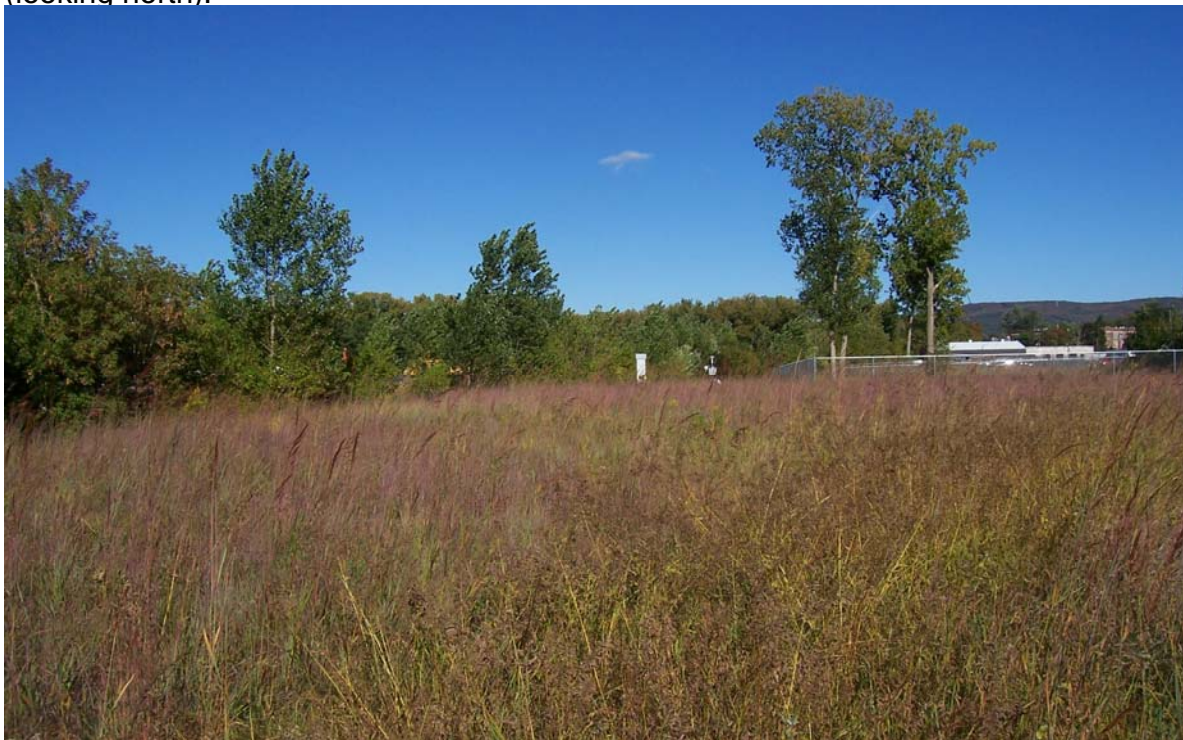
Photo #2: Herbaceous cover within the NRR/E area at Newell Street Area II (looking east).

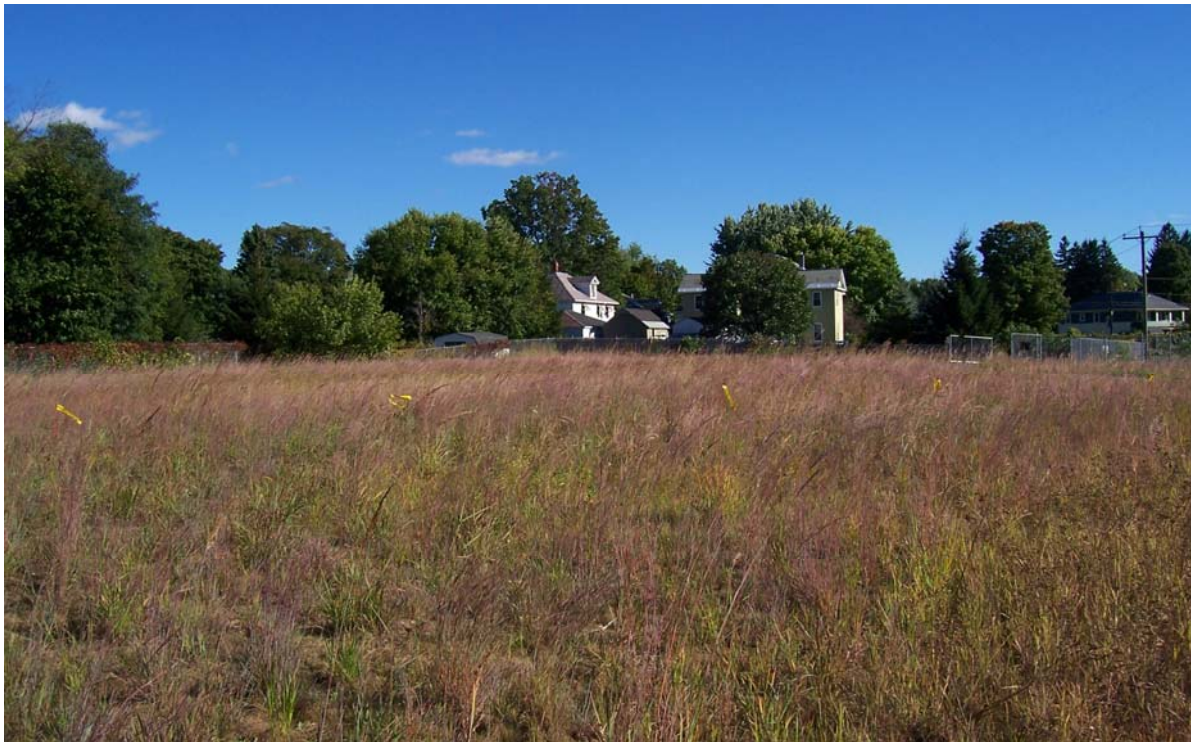
Photo #3: Herbaceous cover within the NRR/E area at Newell Street Area II (looking south).

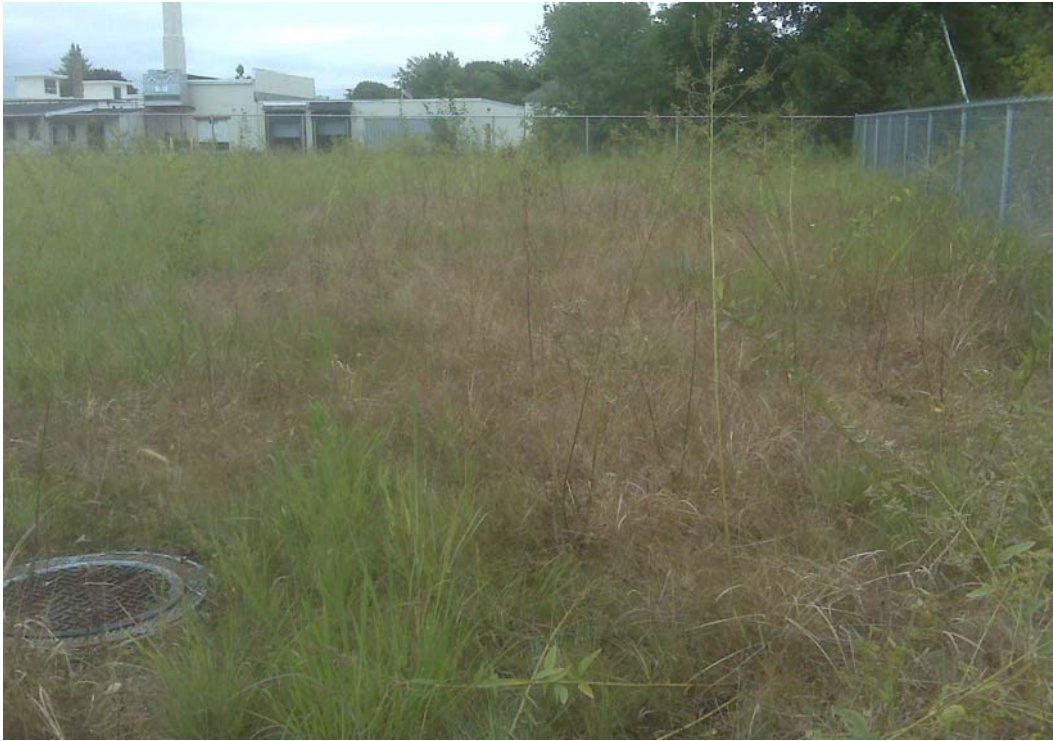
- Autumn and/or Russian olive seedling were observed in the eastern portion of the NRR/E planting area. Total percentage of area occupied by these species was observed to be less than 1%.

- Implemented a treatment program to control Autumn and/or Russian olive seedlings that had been observed in the eastern portion of the NRR/E planting area in June 2010. The treatment program appeared to be effective on the treated specimens however, as mentioned above, more Autumn and/or Russian olive seedlings were observed during the August inspection.

Photo #4: Area where Autumn and/or Russian olive seedlings were treated within the NRR/E area at Newell Street Area II.

Due to the presence of more Autumn and/or Russian olive seedlings, GE will continue the treatment program consisting of periodic applications in an effort to control these species.

- Continue treatment program to control Autumn and/or Russian olive seedlings.
- Mow NRR/E area in September/October 2010.

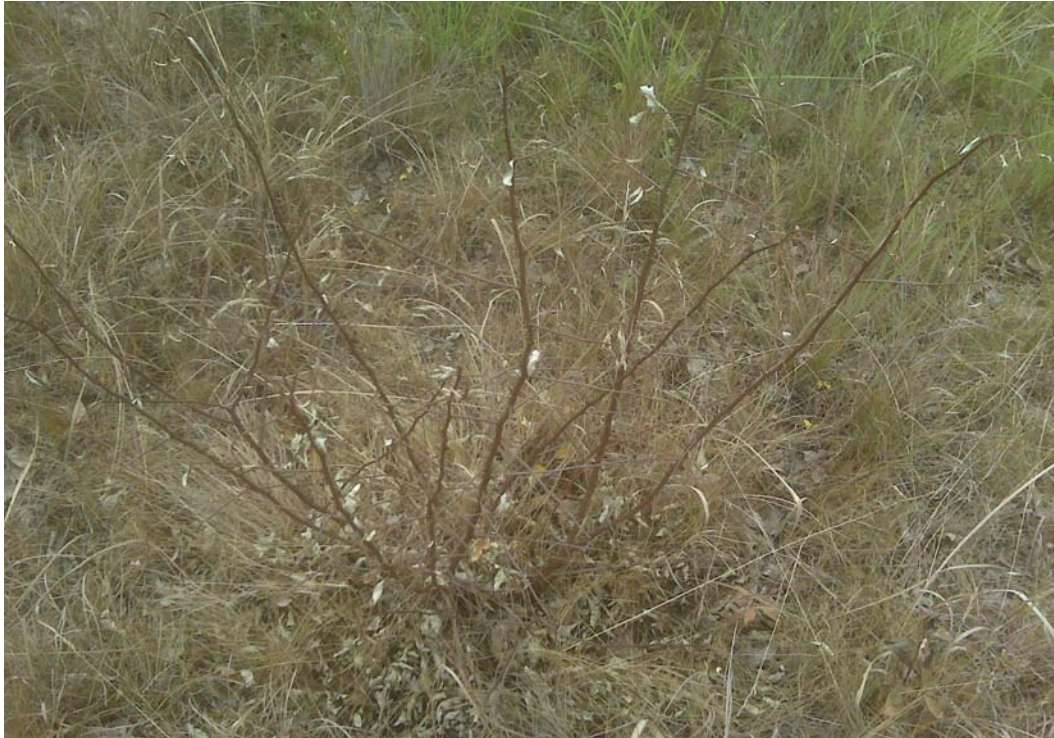
Photo #5: One of the treated Autumn or Russian olive seedlings within the NRR/E area at Newell Street Area II.

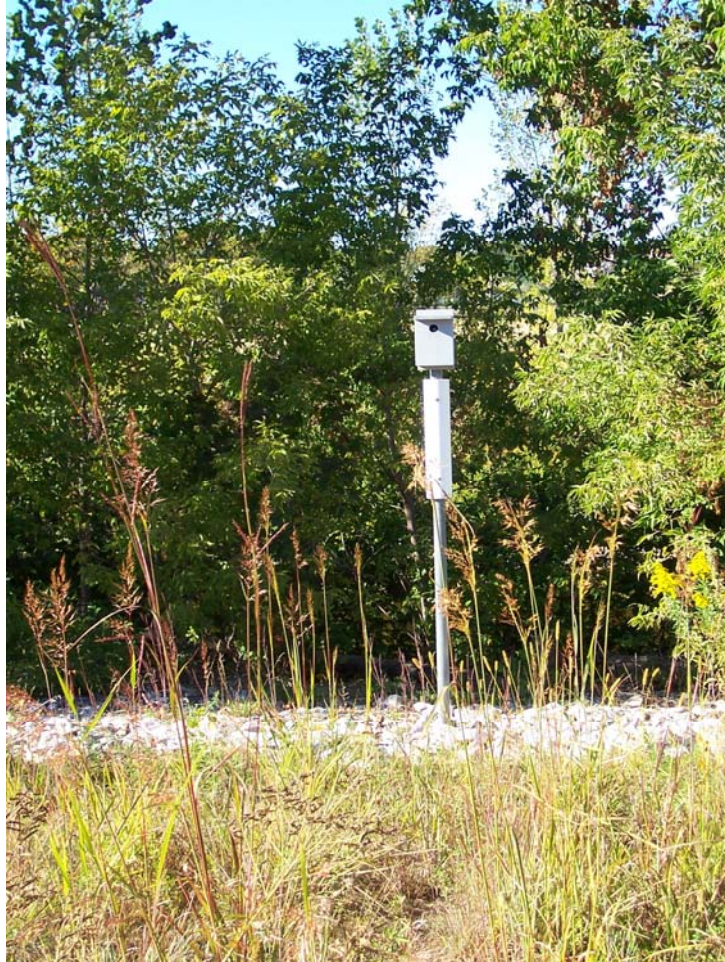
In addition, the NRR/E area is surrounded by a locked chain-link fence (except along the river) restricting trespasser access, and no signs of damage from trespassers were observed. Finally, the bluebird box was found to be present, intact, and in good condition.

- Bluebird box observed to be in good condition.

Photo #6: Bluebird box within the NRR/E area at Newell Street Area II.
