**FIVE-YEAR REVIEW REPORT FOR
HATHEWAY & PATTERSON SUPERFUND SITE
BRISTOL COUNTY, MASSACHUSETTS**

**U.S. Environmental Protection Agency
Region 1, New England
Boston, Massachusetts**

HATHEWAY AND PATTERSON SUPERFUND SITE
June 3, 2014 - SITE INSPECTION PHOTOGRAPHS

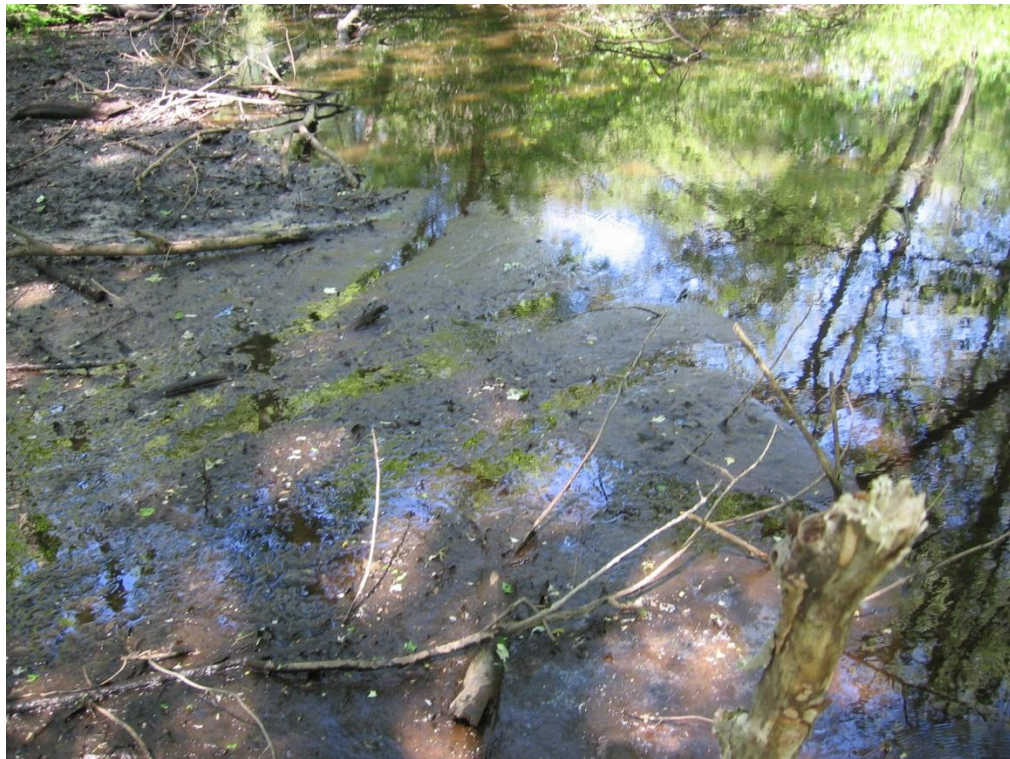
Photo #8. Backwash Channel Flowing (<<1 gpm, from left to right, in rivulet that crosses mud-filled channel) into Rumford River

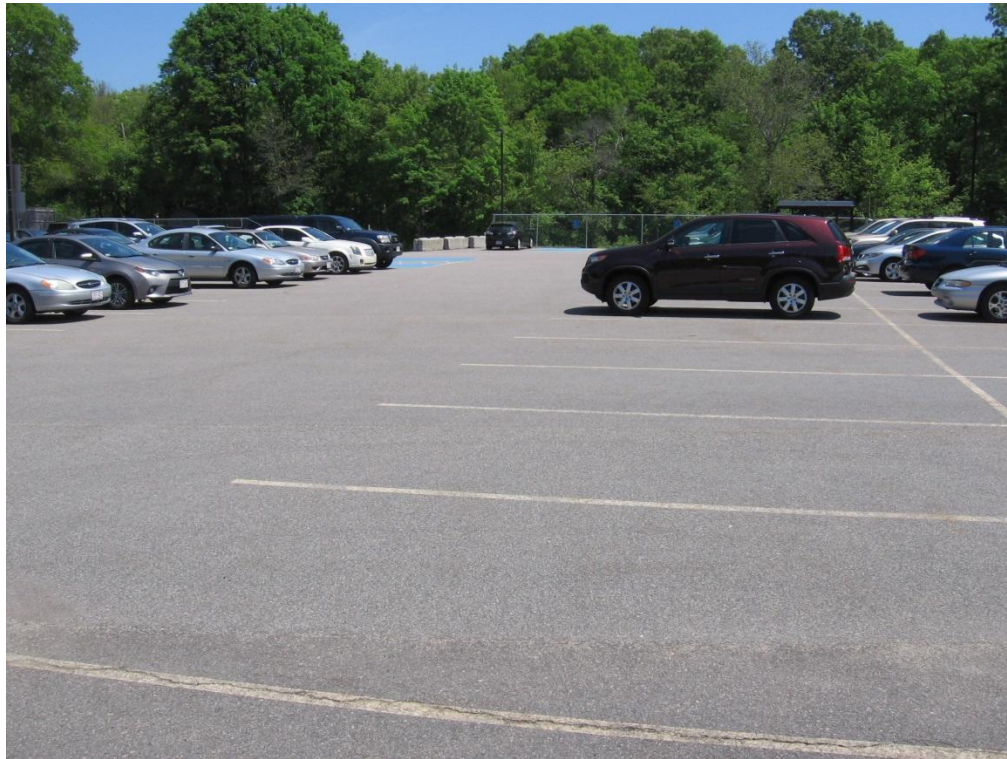
Photo #9. Commuter Parking Lot on Foxborough Portion of Site (Note minor crack in pavement in foreground along painted line)

The site was observed to be secure, and no evidence of trespassing or vandalism was noted. The NW Quadrant of the site is mostly covered with crushed rock except for a vegetated buffer along the Rumford River and a commuter parking lot for the Town of Foxborough in the extreme northwest corner. As described in the site inspection checklist, the parking lot is well maintained, and the fencing and gates that surround the entire NW and NE Quadrants of the site are in good condition (except for very minor damage to the stockade fence on the northwest side of the commuter lot).

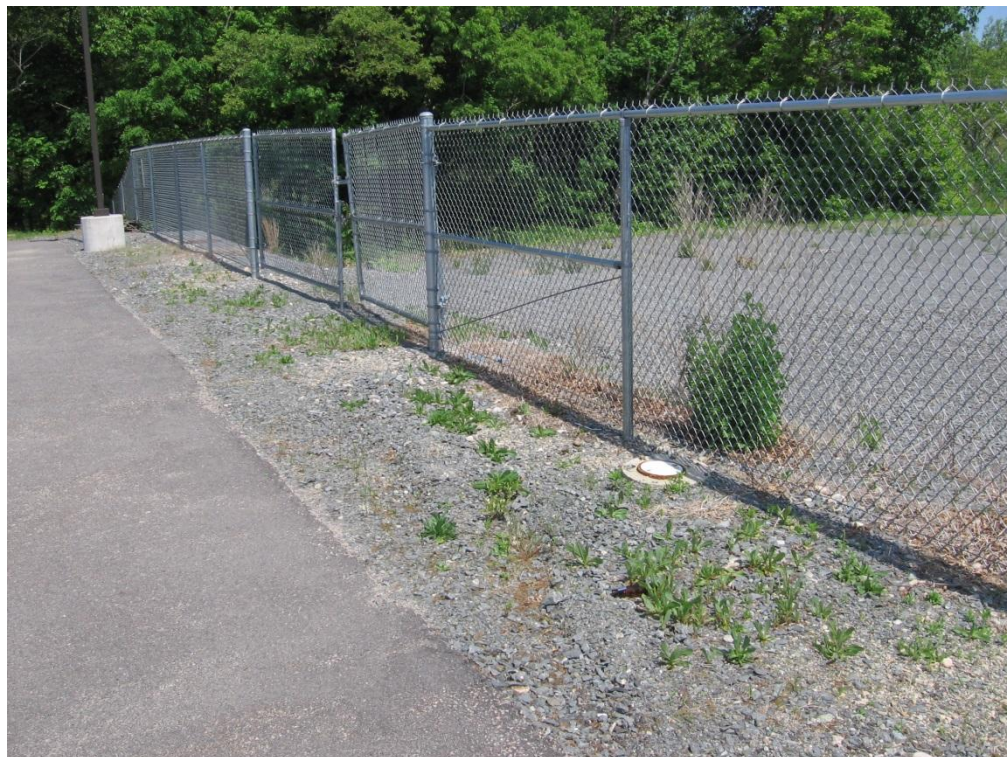
Photo #10. Gate Separating Commuter Lot from NW Quadrant of Site (note flush-mount monitoring well along fence, with road box painted white)

The monitoring wells that were observed were locked and appeared to be in good condition. The compliance boundary on the southwest side of the site is the backwash channel, which is a vegetated marshy area and is difficult to traverse. Where observed near its confluence with the Rumford River, the amount of water in the backwash channel was miniscule, and no flow was observable. However, at the actual confluence, it was confirmed that the trickle of flow in the channel was moving northwest and discharging to the river. The wells along the compliance boundary had been sampled several weeks before the site inspection and were found to be in good condition, and therefore were not inspected.

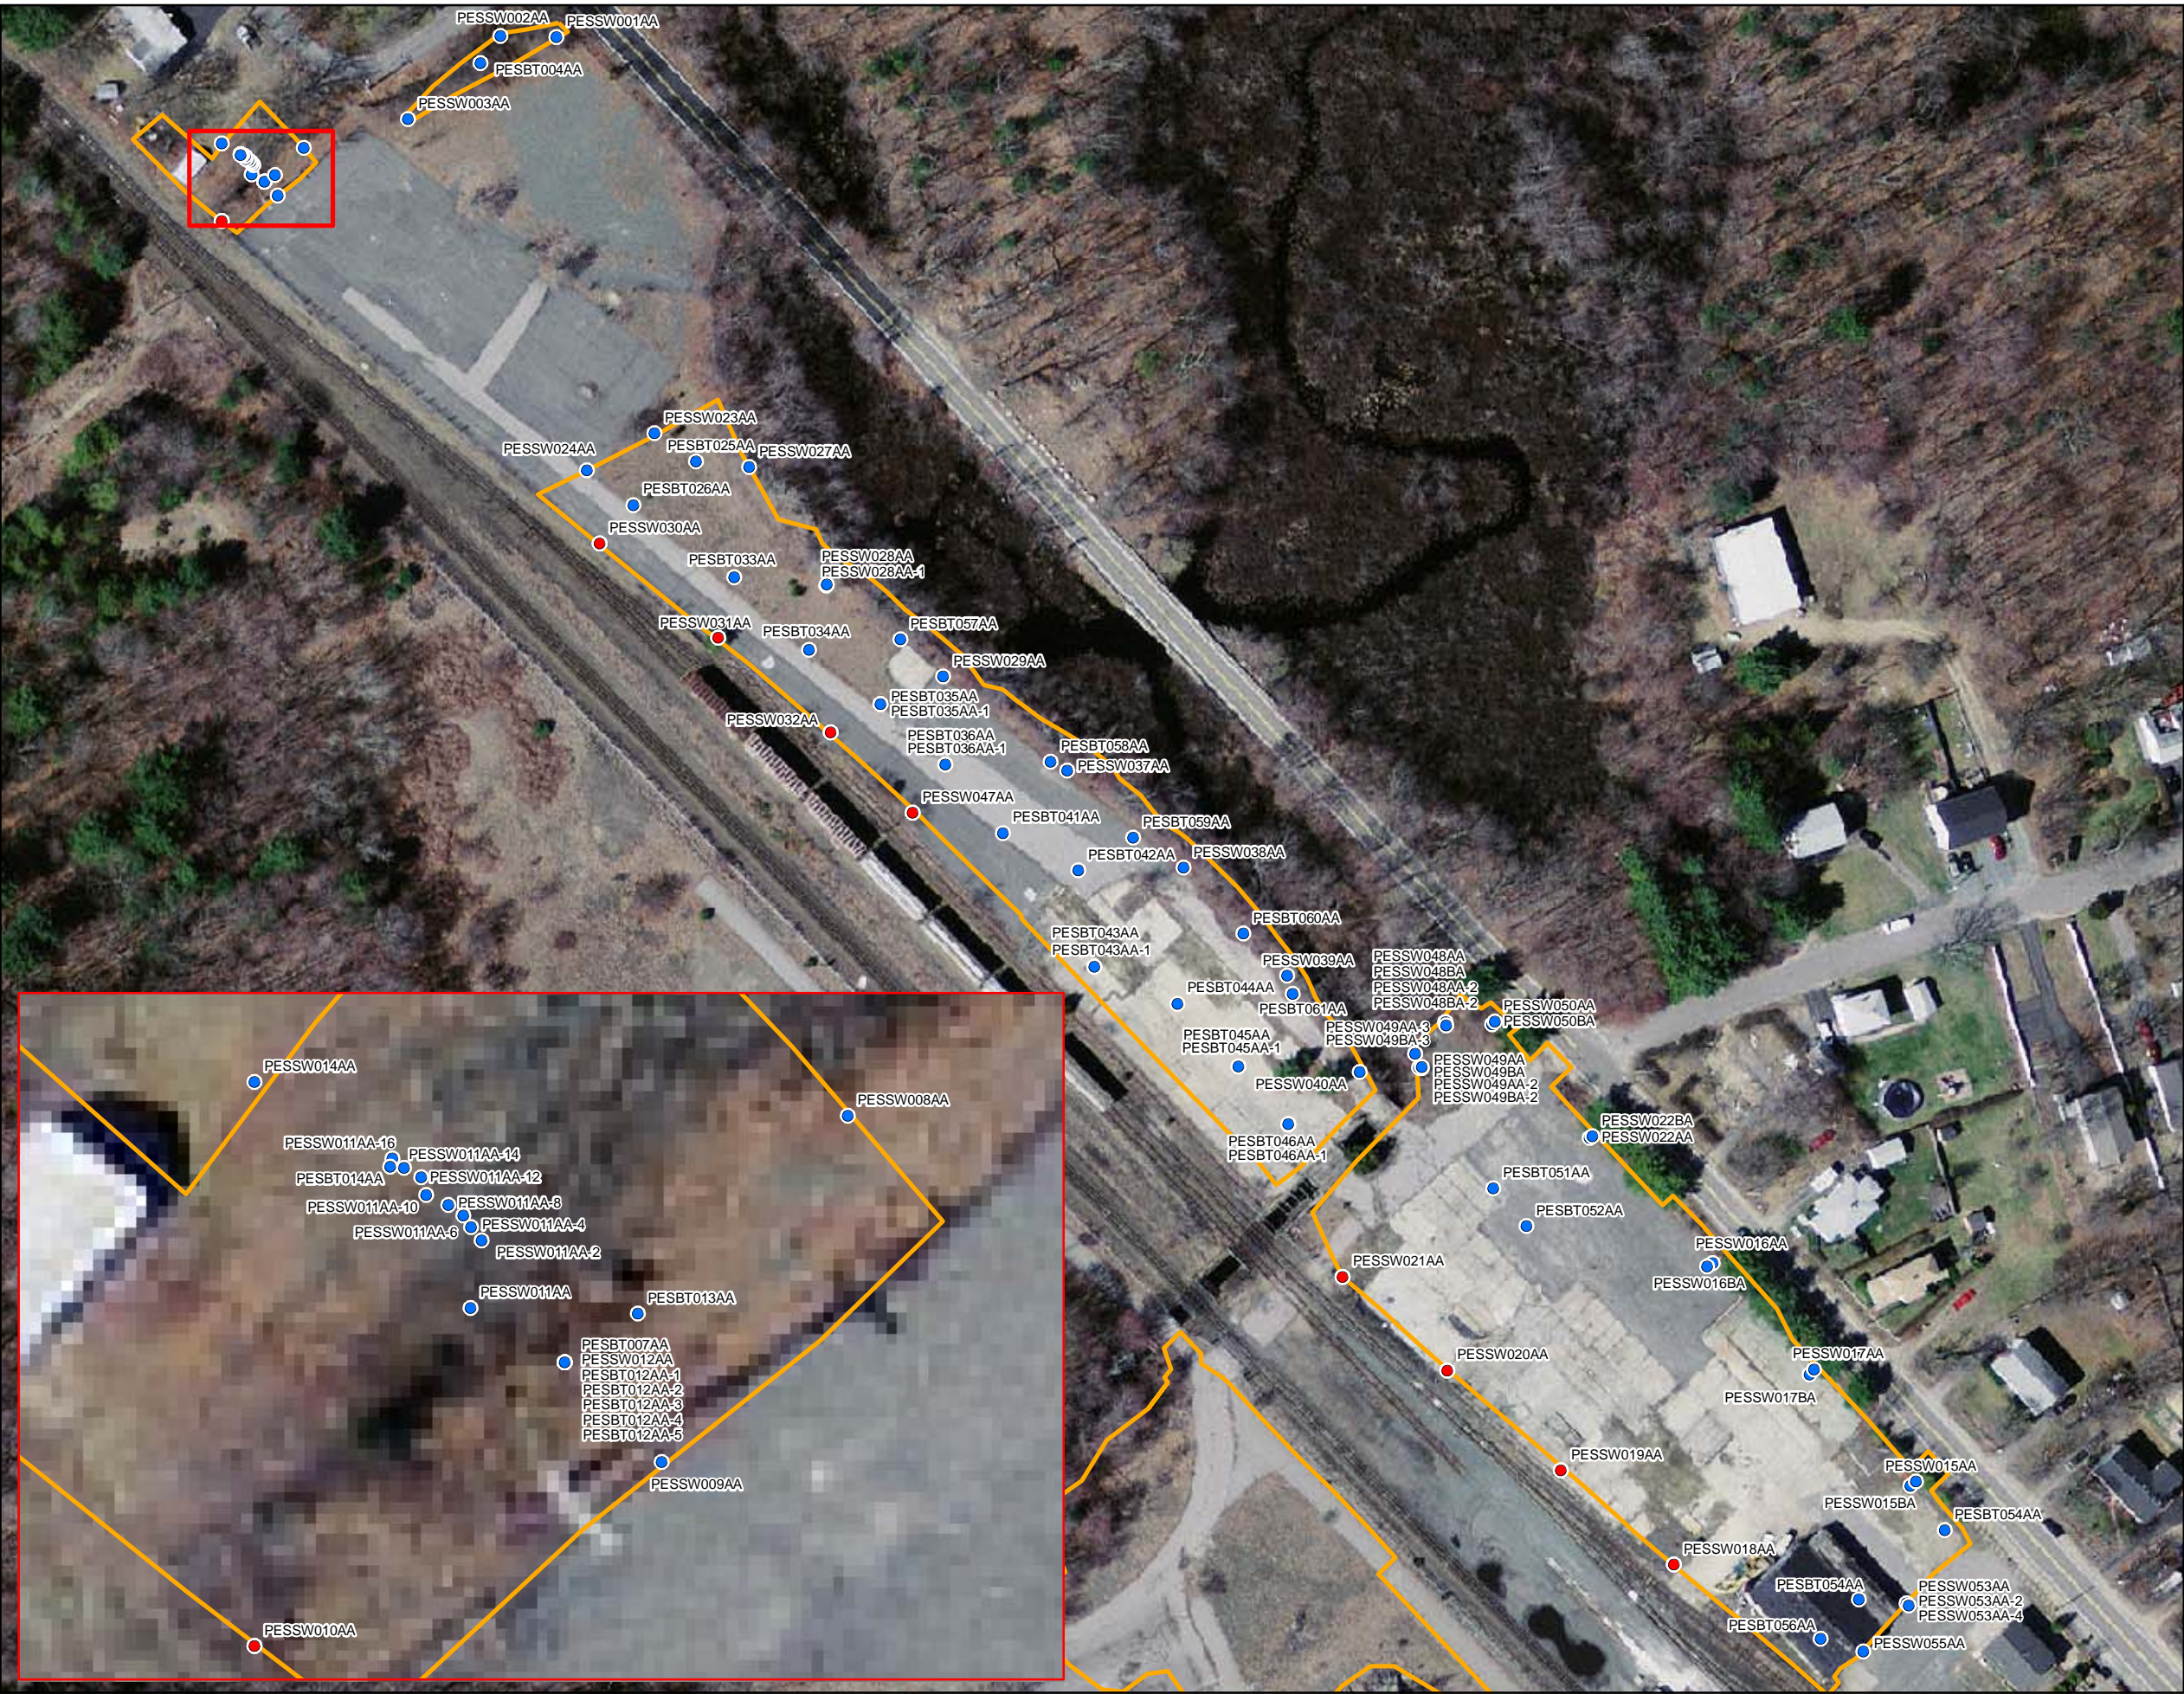
Post-Excavation
Soil Sample Locations

- Confirmatory Soil Sample Location (Hatheway-Patterson Site)
- Post Excavation Soil Sample Location (CSX Right of Way)
- Limit of Excavation
