**SECOND FIVE-YEAR REVIEW REPORT  
FOR  
ROSE HILL REGIONAL LANDFILL SUPERFUND SITE  
WASHINGTON COUNTY  
SOUTH KINGSTOWN, RHODE ISLAND**

U.S. Environmental Protection Agency  
Region 1  
BOSTON, MASSACHUSETTS

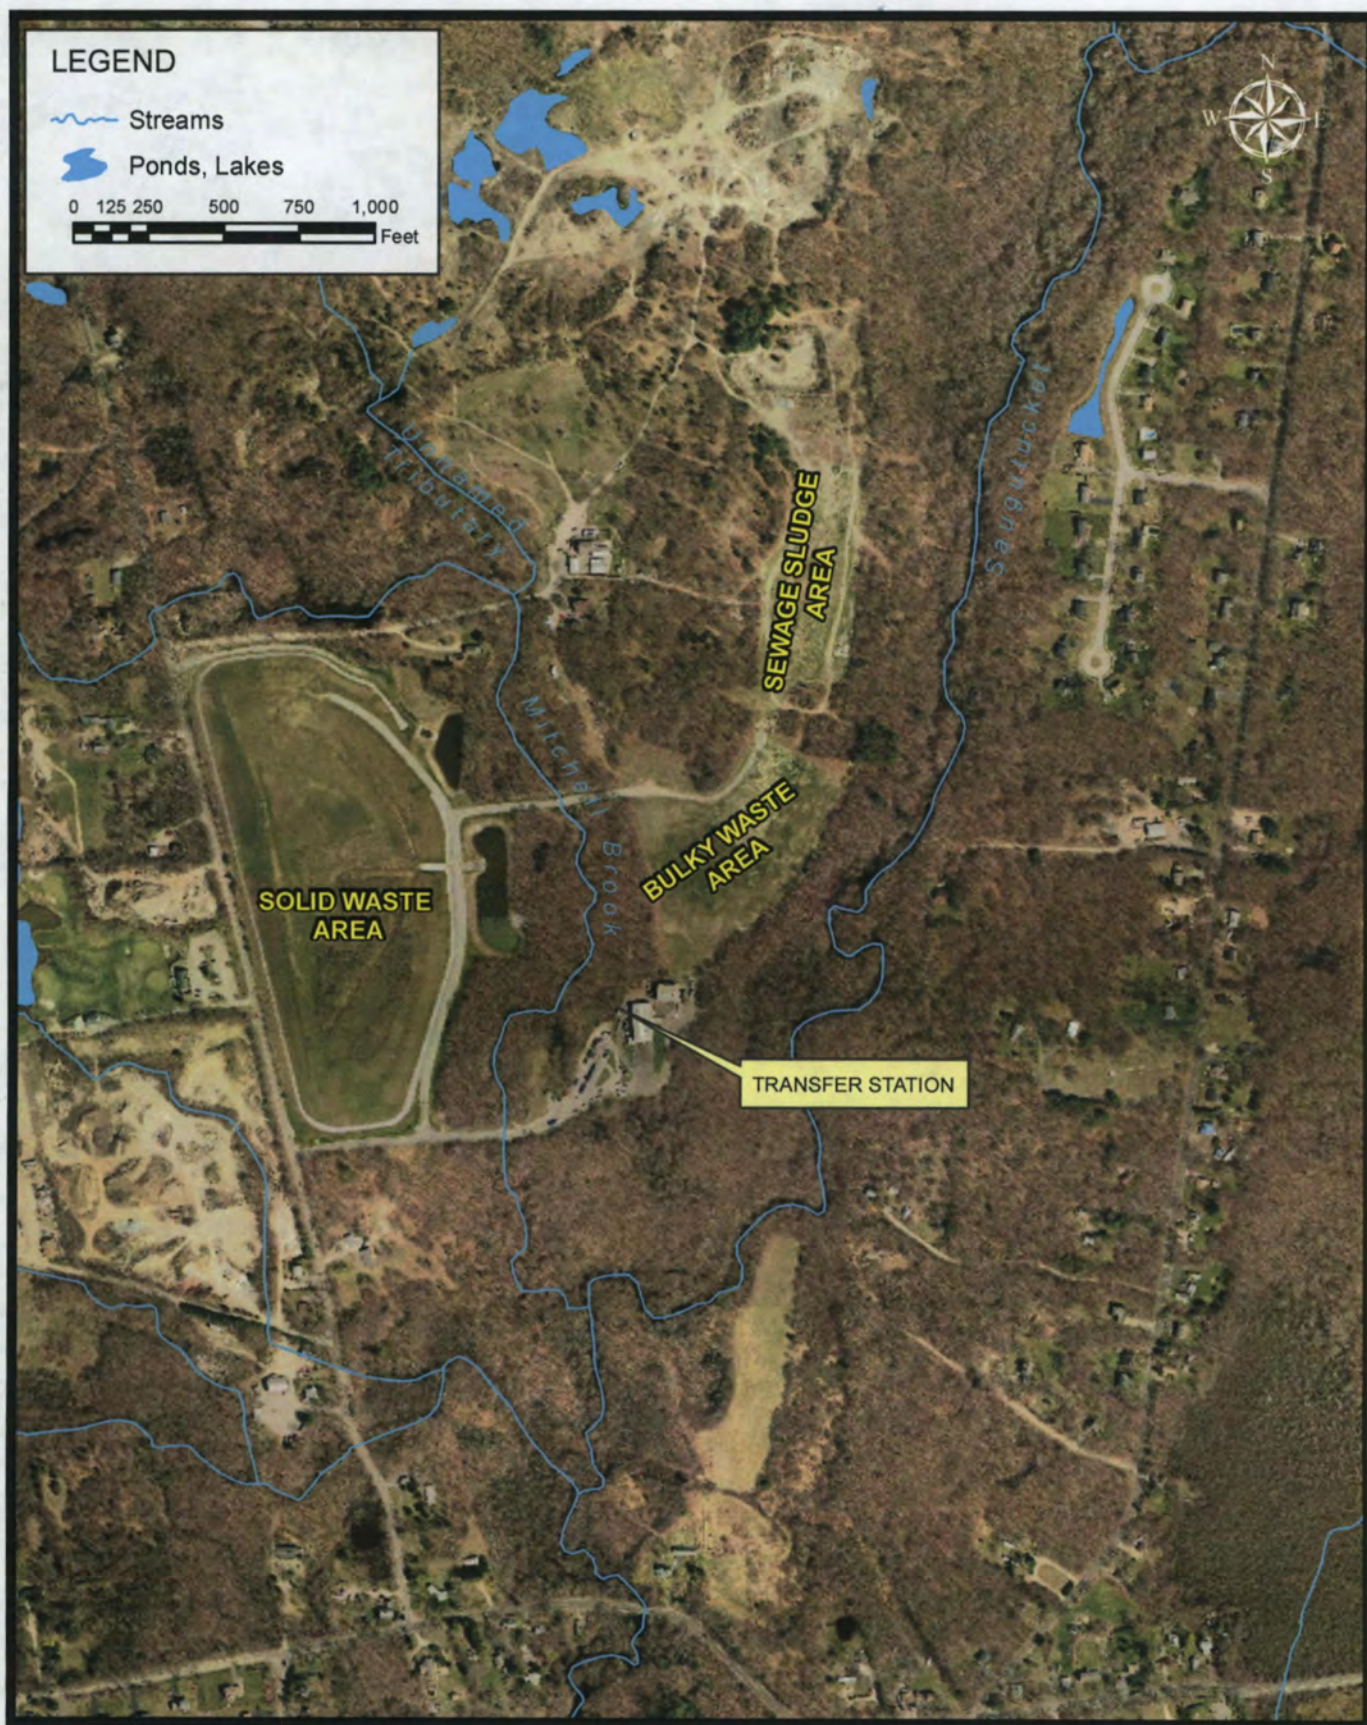
-   Destroyed Well
-   Monitoring well by M & E
-   Residential Well
-   Post-closure Monitoring Program Well
-   Existing Monitoring Wells
-   Streams
-   Ponds, Lakes

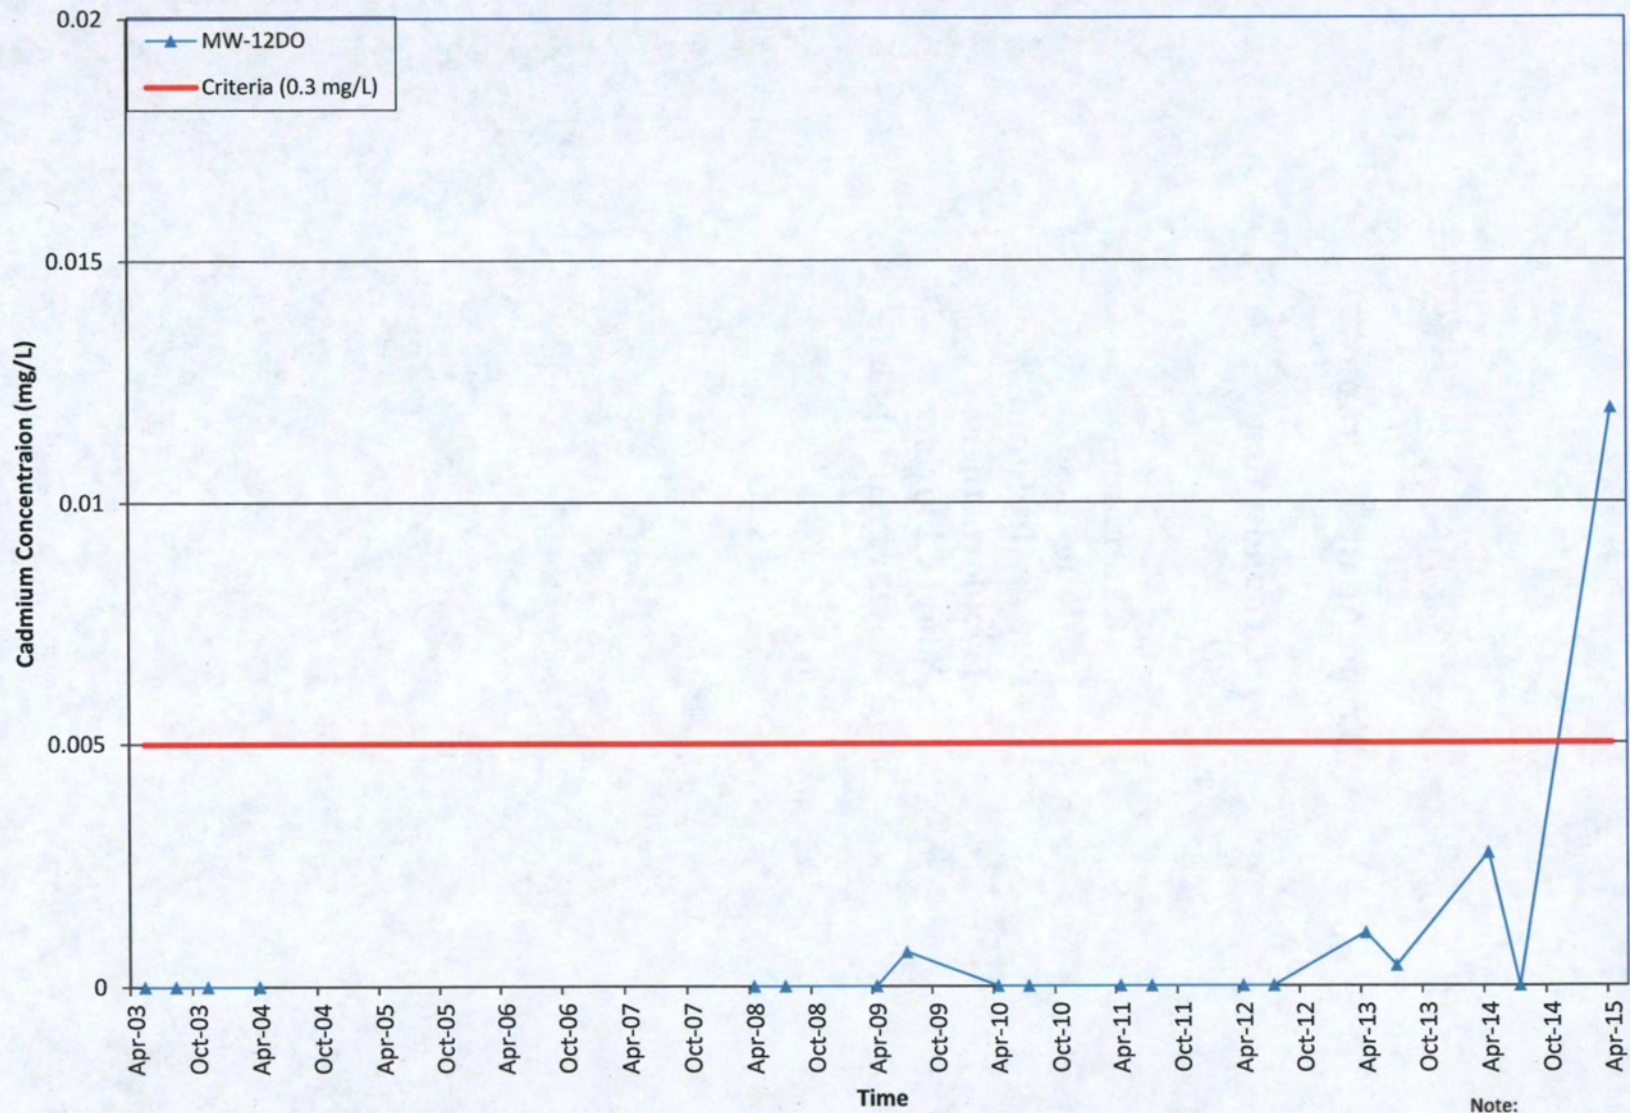
### Cadmium Concentration

Note:  
Non Detect sampling results  
are shown as zero value

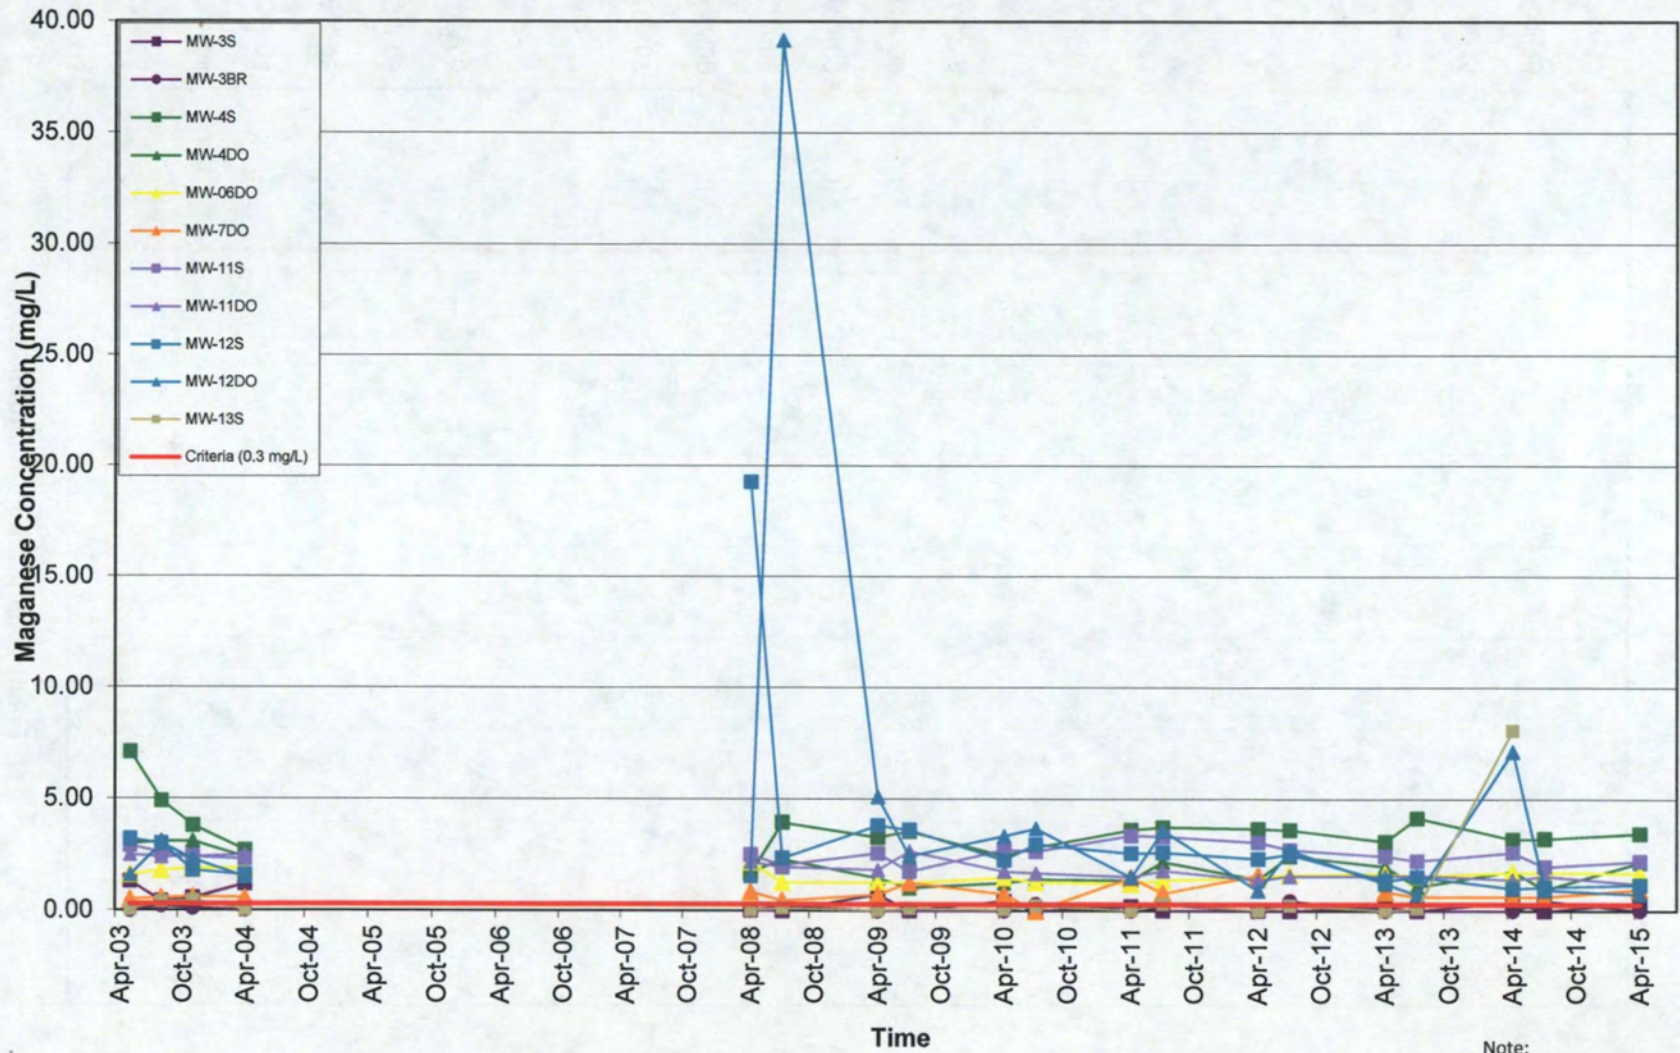
# Manganese Concentration

However, concentrations of vinyl chloride show an increasing trend from 2010-2015. Concentrations of manganese have been generally stable across the site from 2003-2015, with a spike in manganese concentrations observed around the commencement of post-closure monitoring in 2008.

Note:  
Non Detect sampling results  
are shown as zero value

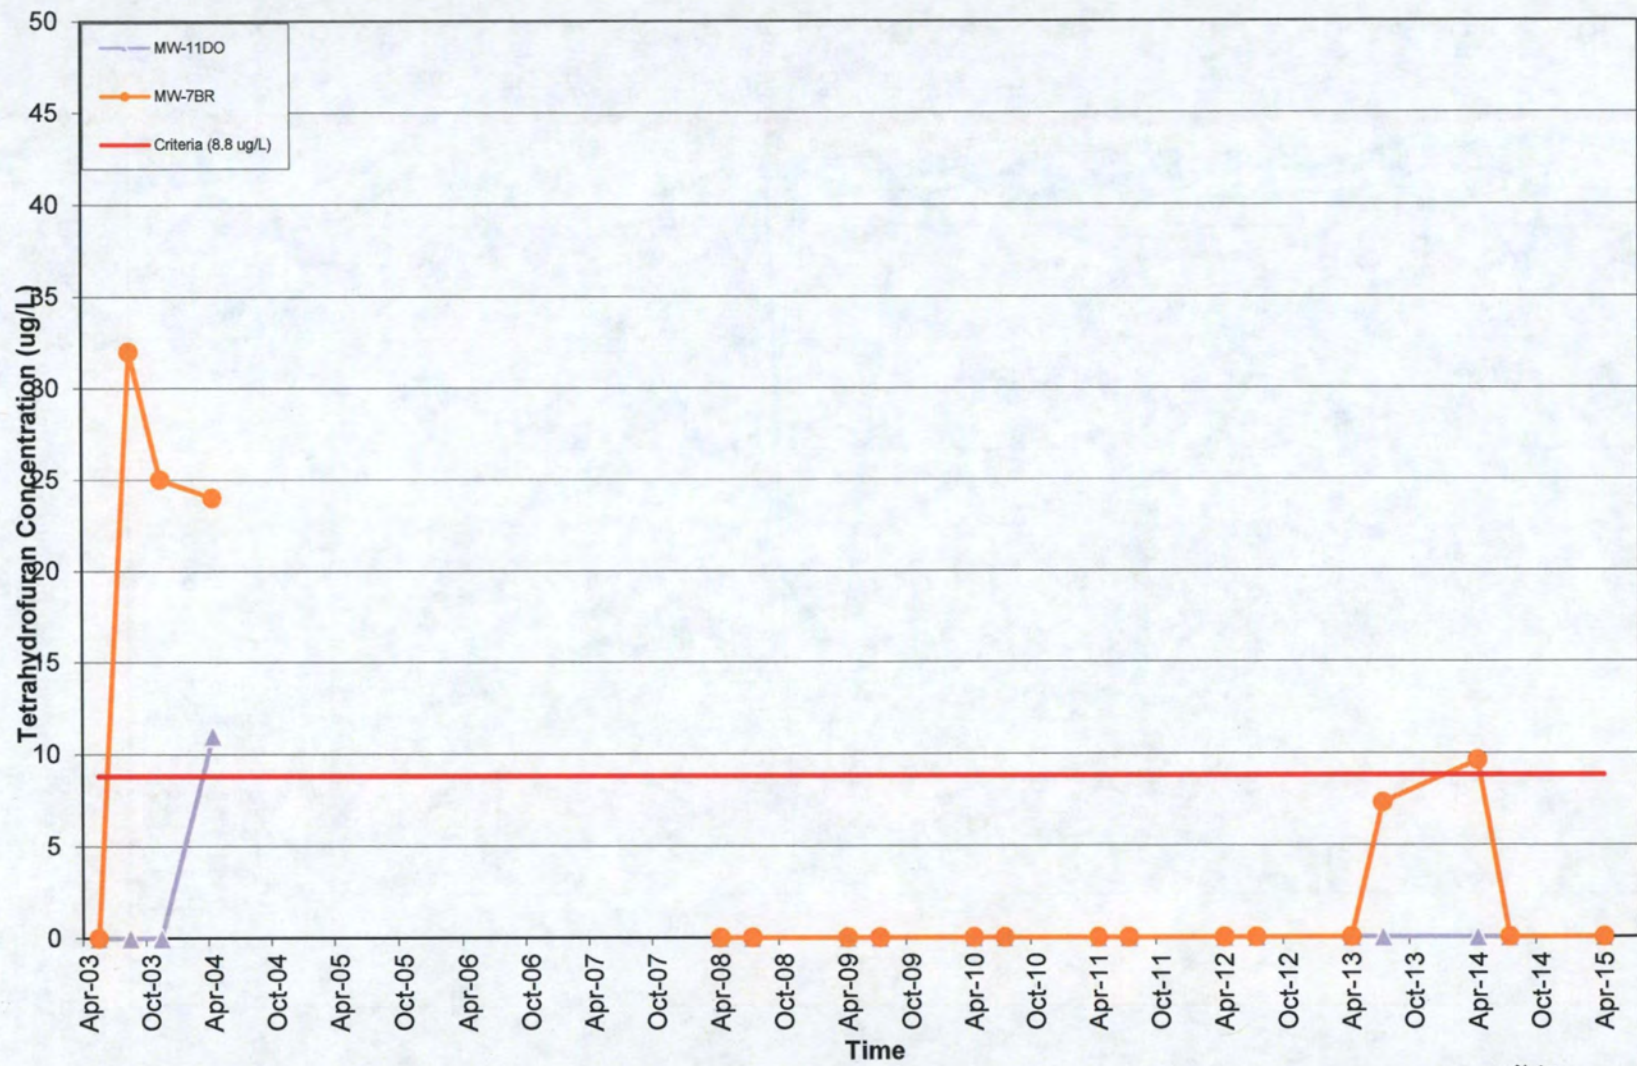
### Tetrahydrofuran Concentration

Note:  
Non Detect sampling  
results

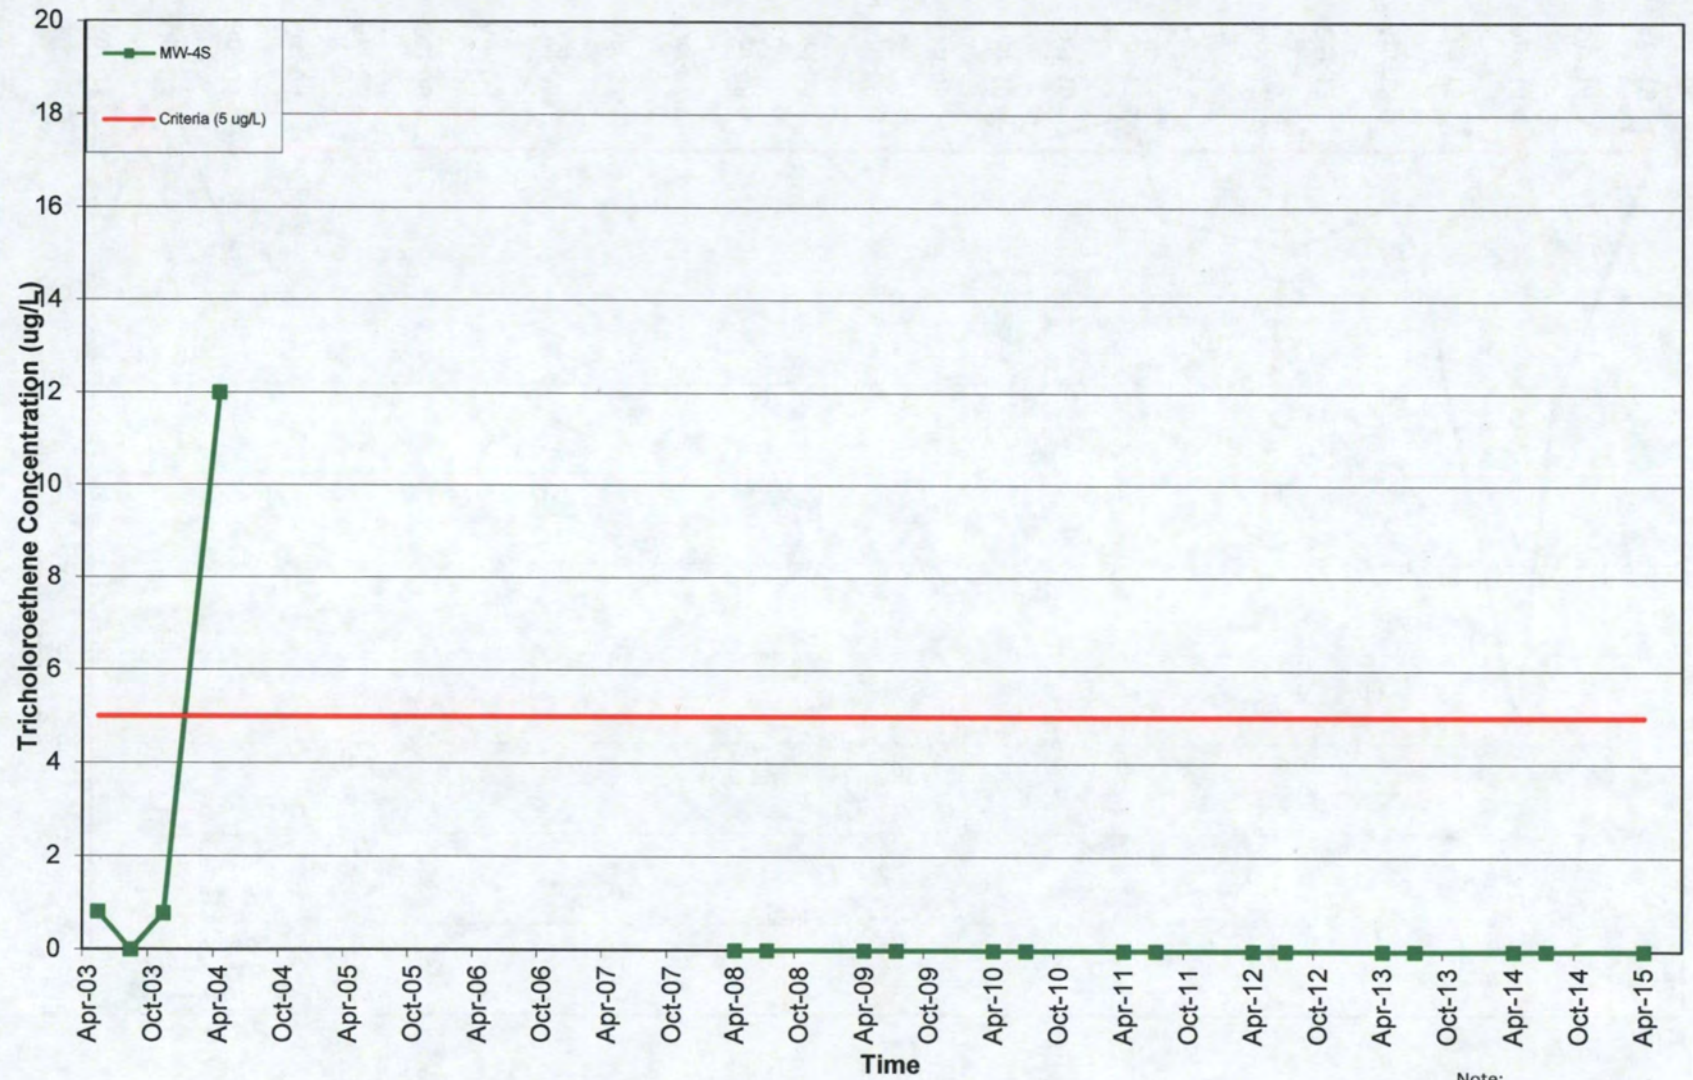
### Trichloroethene Concentration

Note:  
Non Detect sampling results  
are shown as zero value

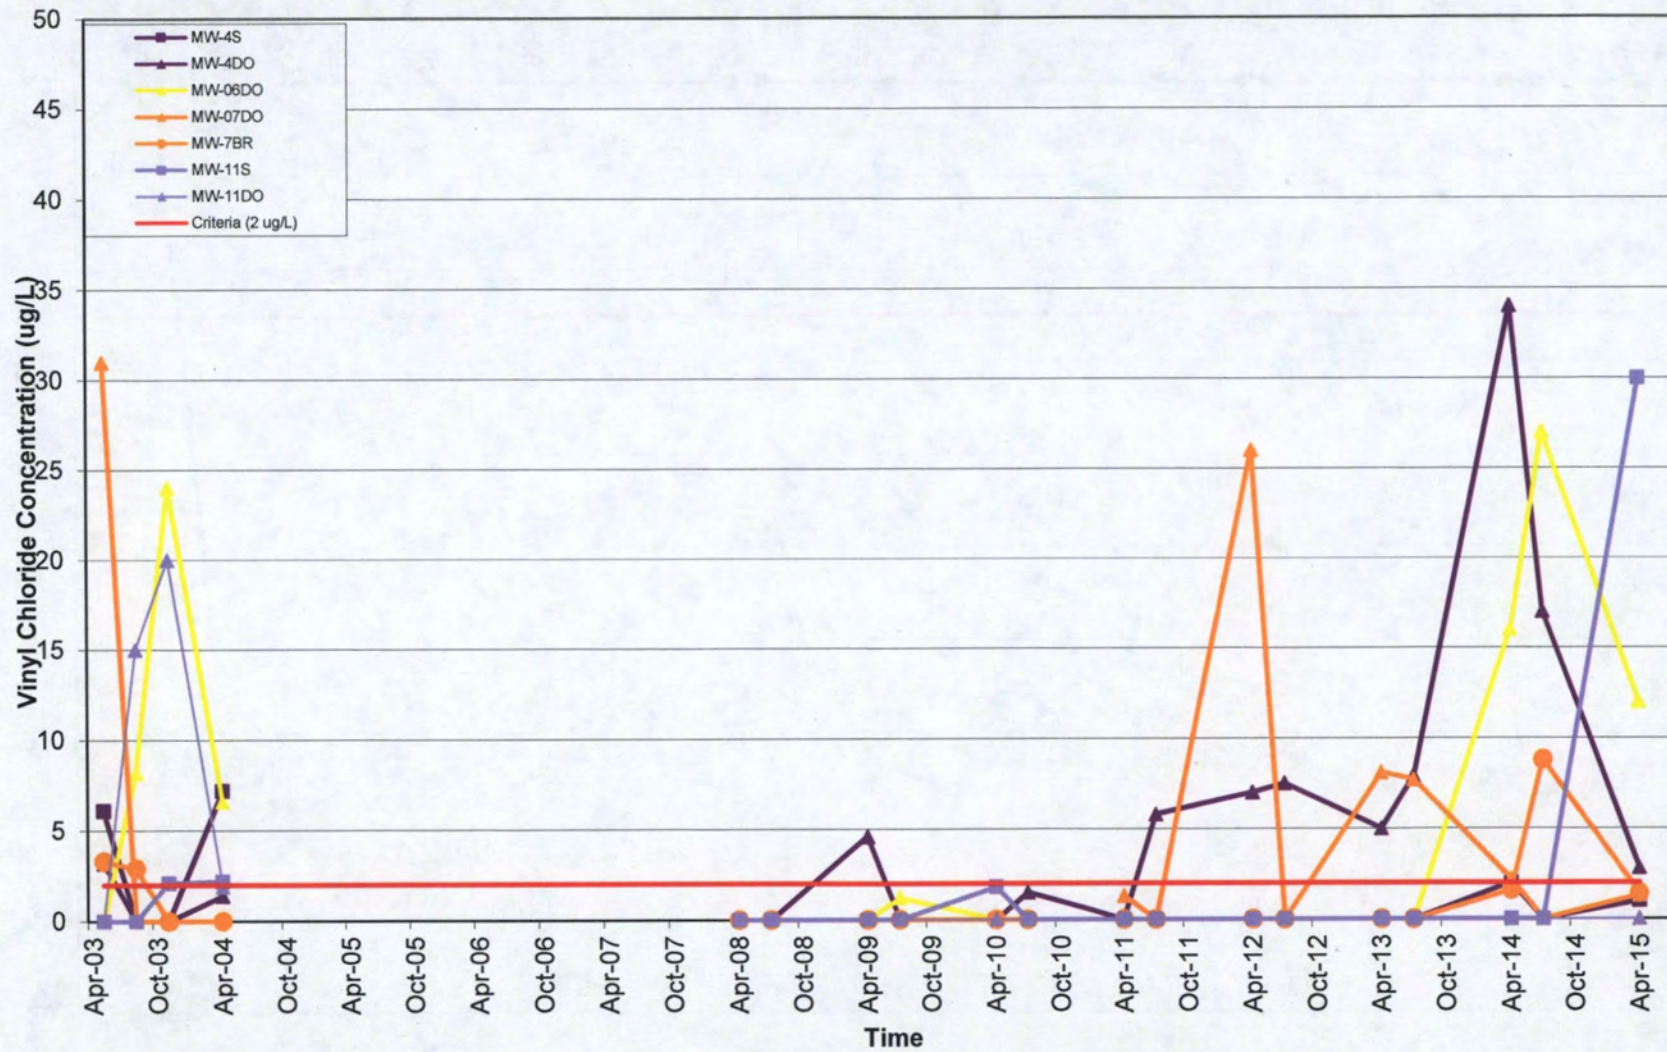
## Vinyl Chloride Concentration

Note:  
Non Detect sampling results  
are shown as zero value

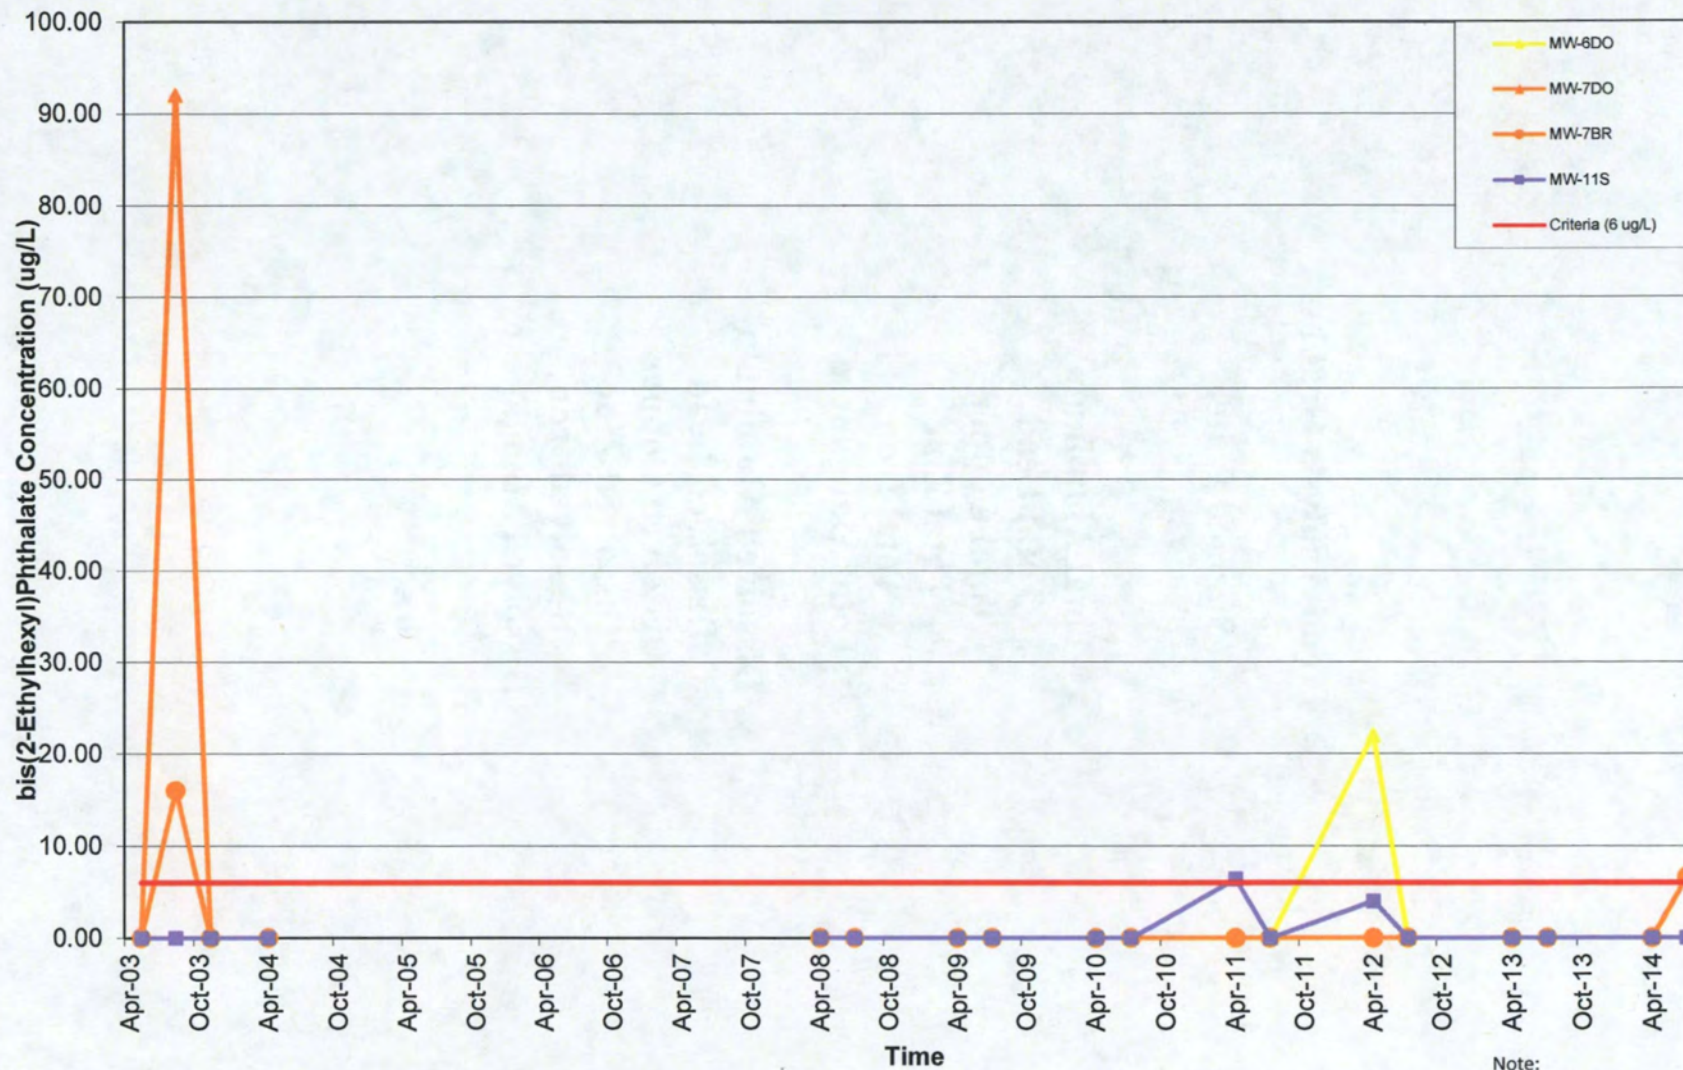
### bis(2-Ethylhexyl)Phthalate Concentration

Note:  
Non Detect sampling  
results
