**SECOND FIVE-YEAR REVIEW REPORT  
FOR  
ROSE HILL REGIONAL LANDFILL SUPERFUND SITE  
WASHINGTON COUNTY  
SOUTH KINGSTOWN, RHODE ISLAND**

U.S. Environmental Protection Agency  
Region 1  
BOSTON, MASSACHUSETTS

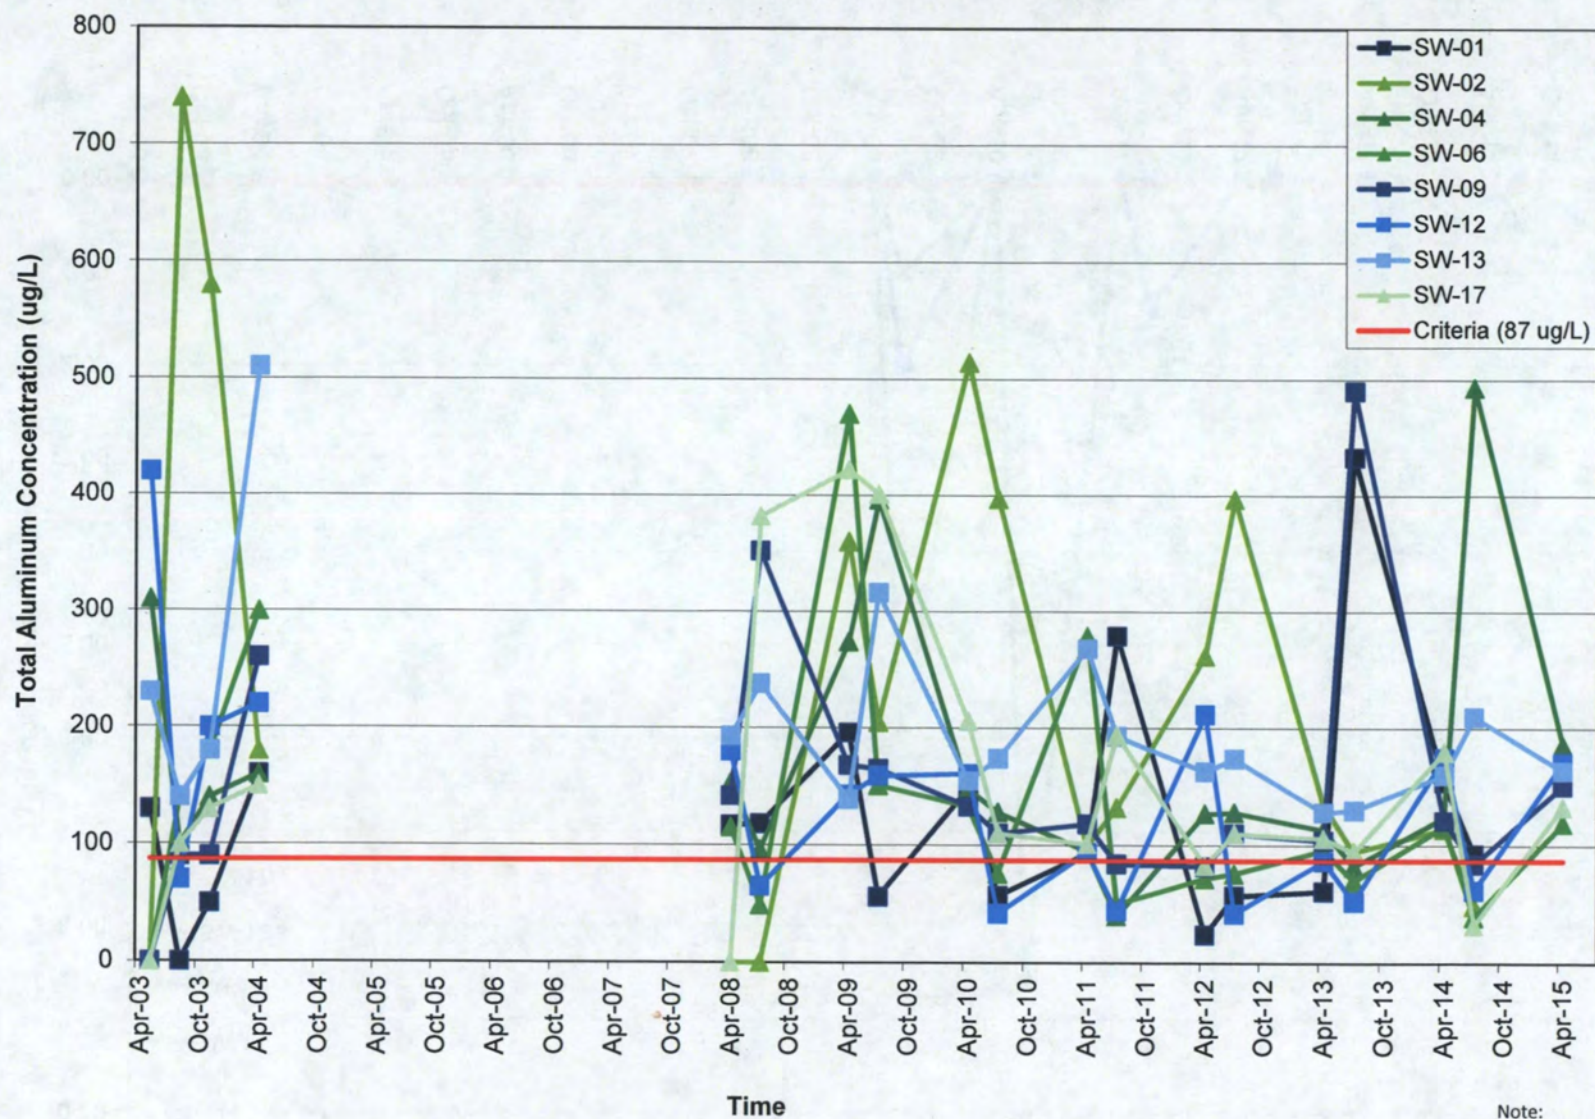
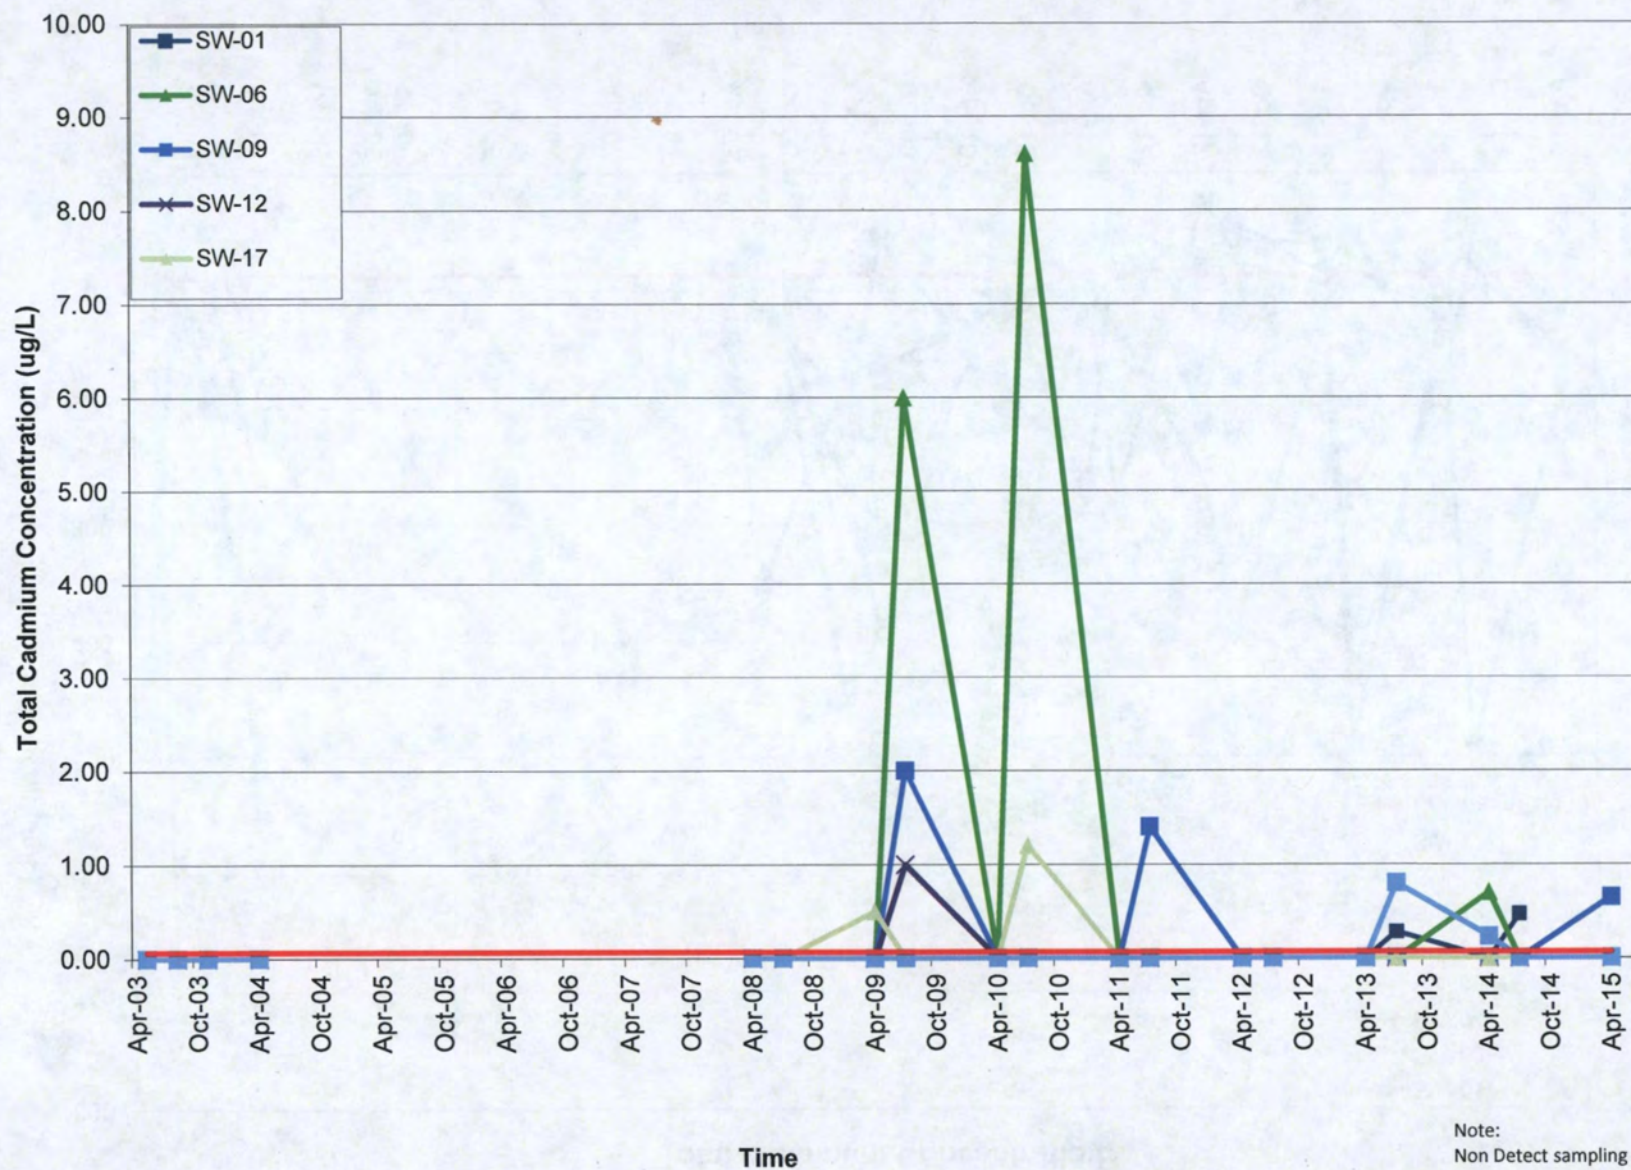
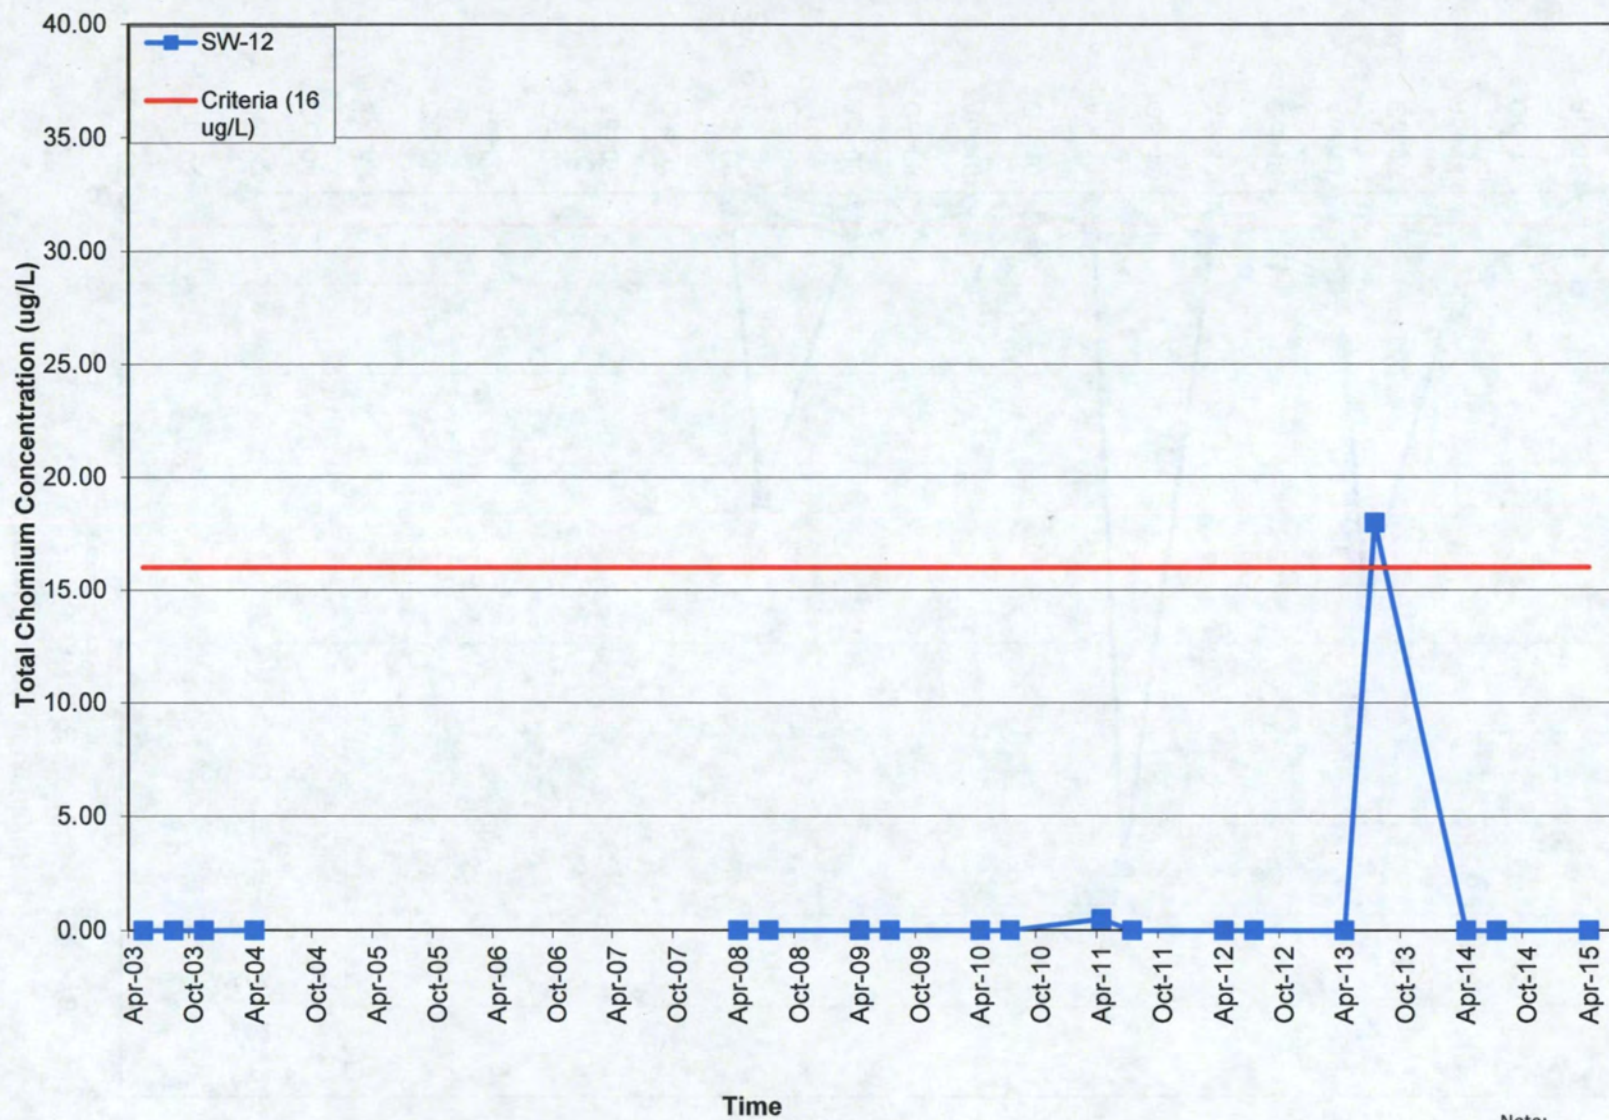
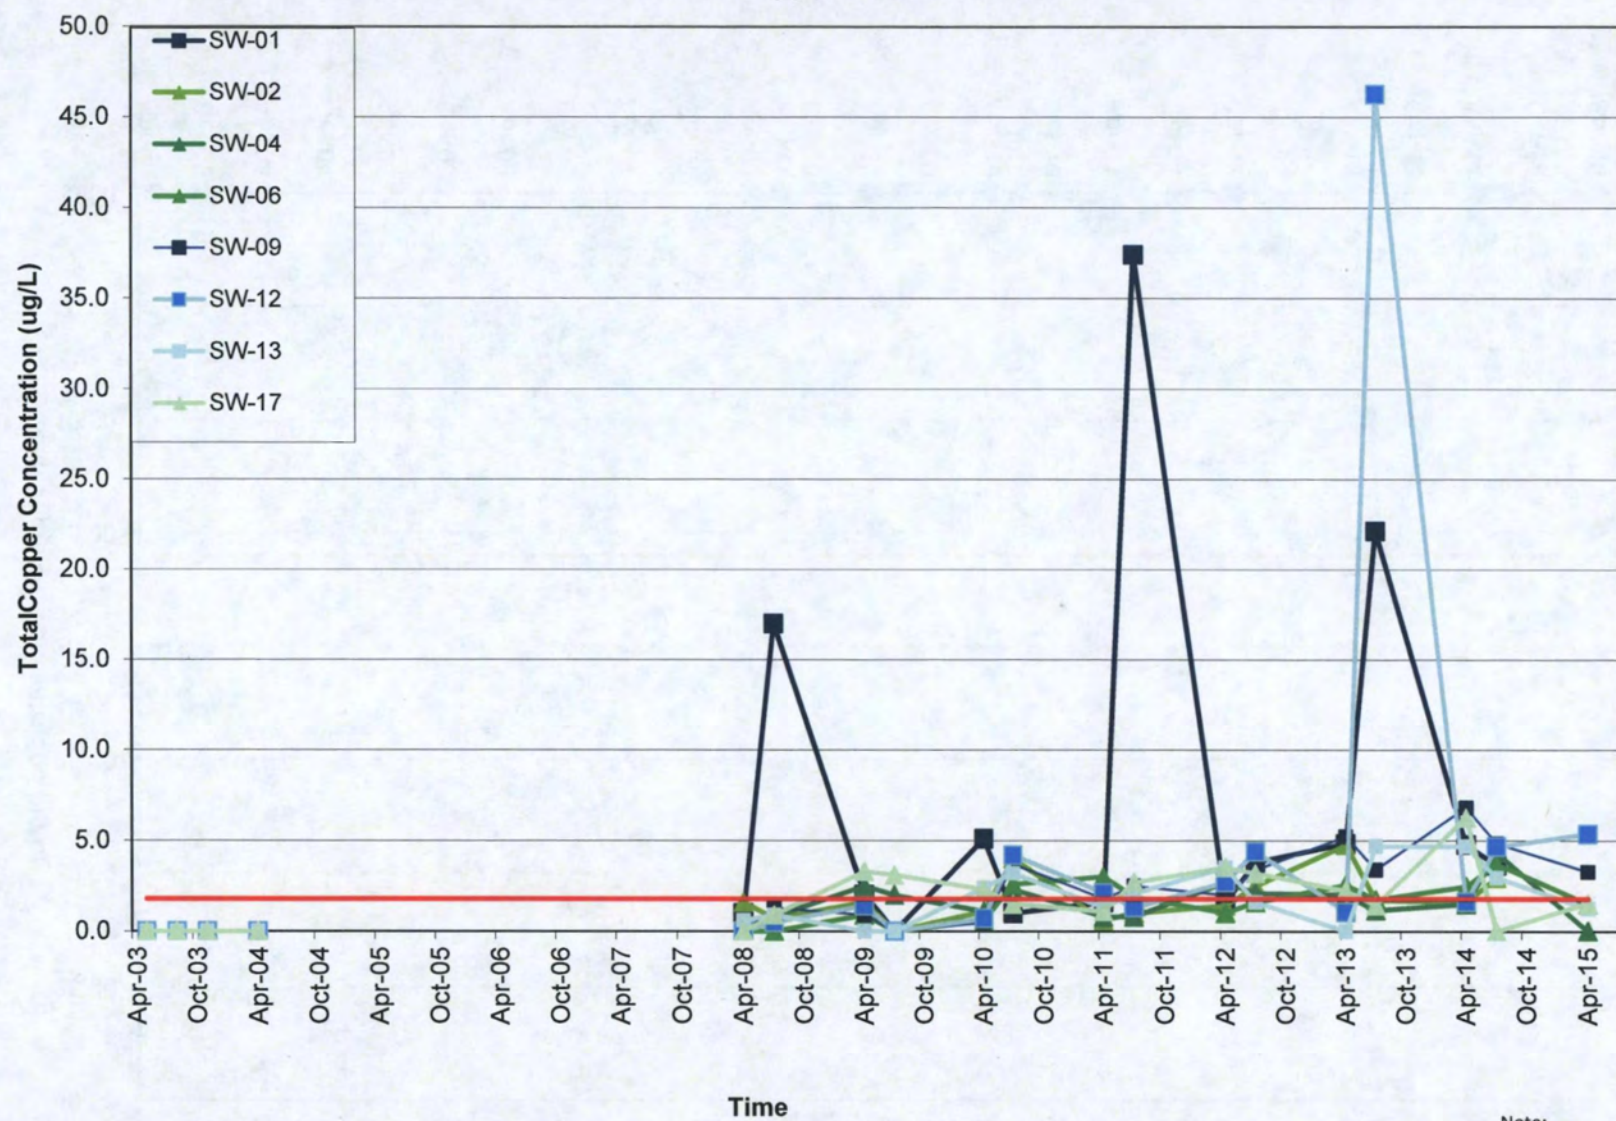
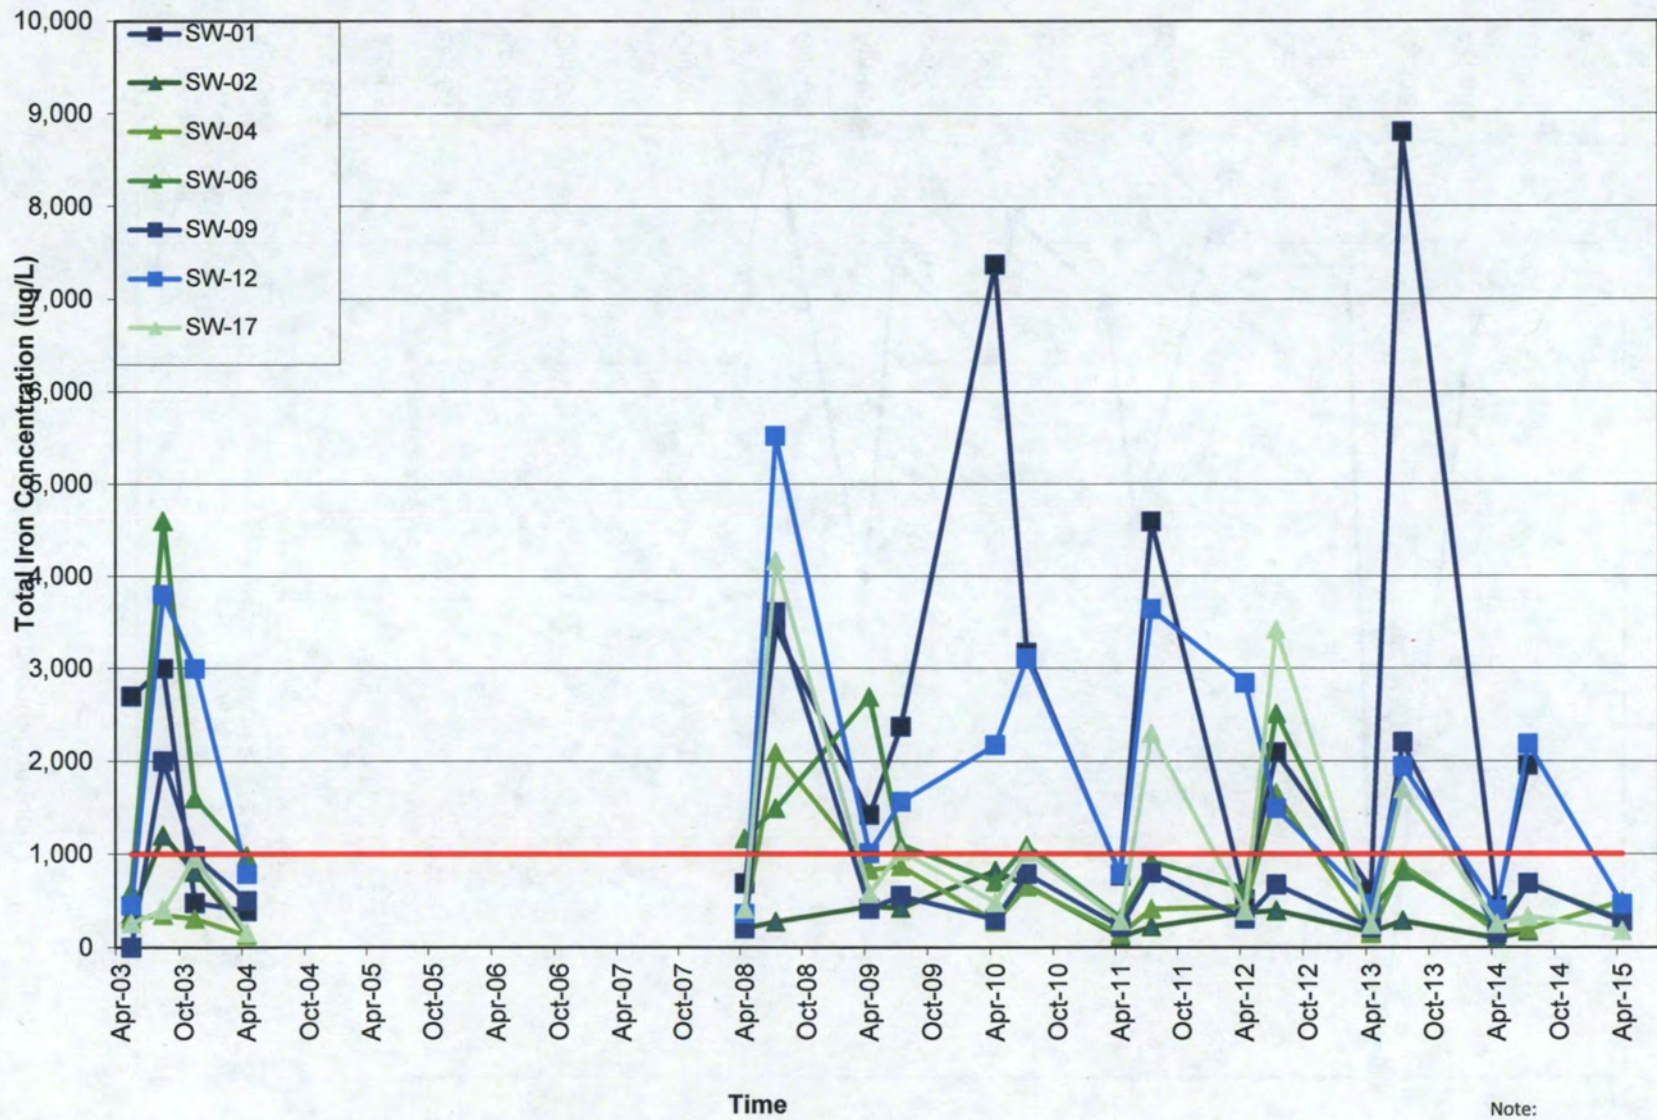
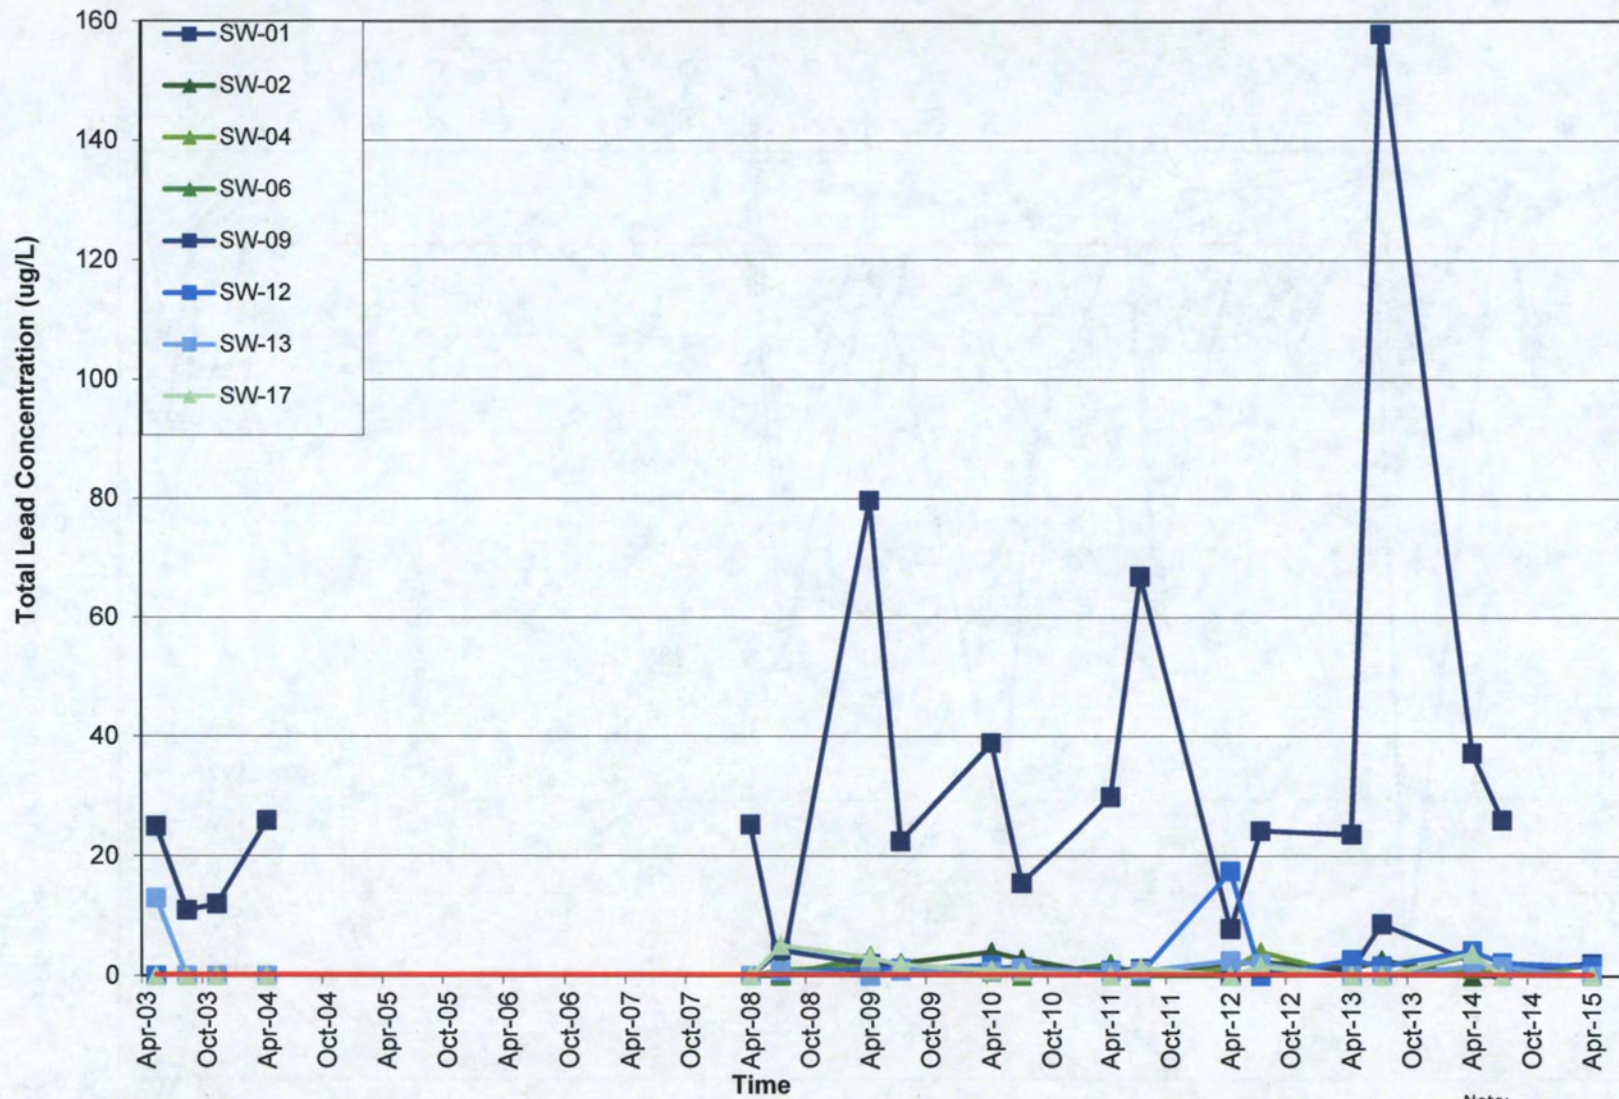
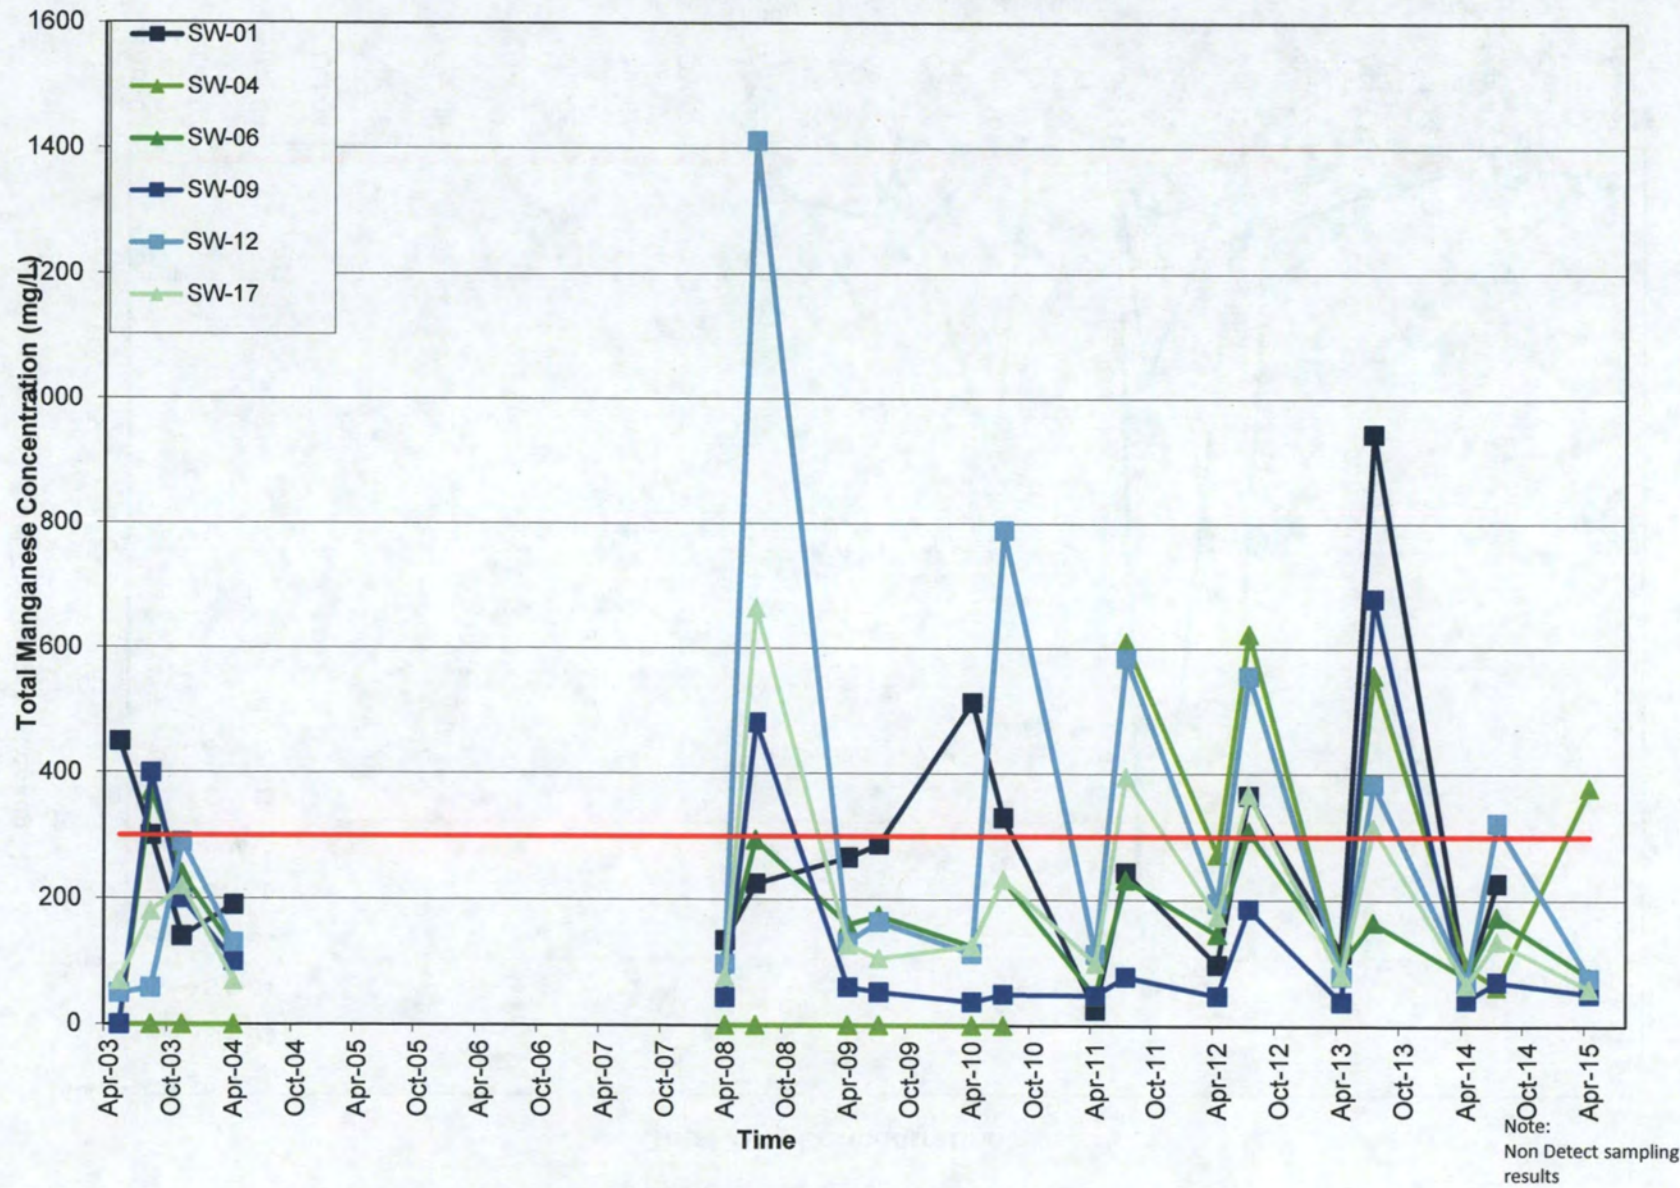
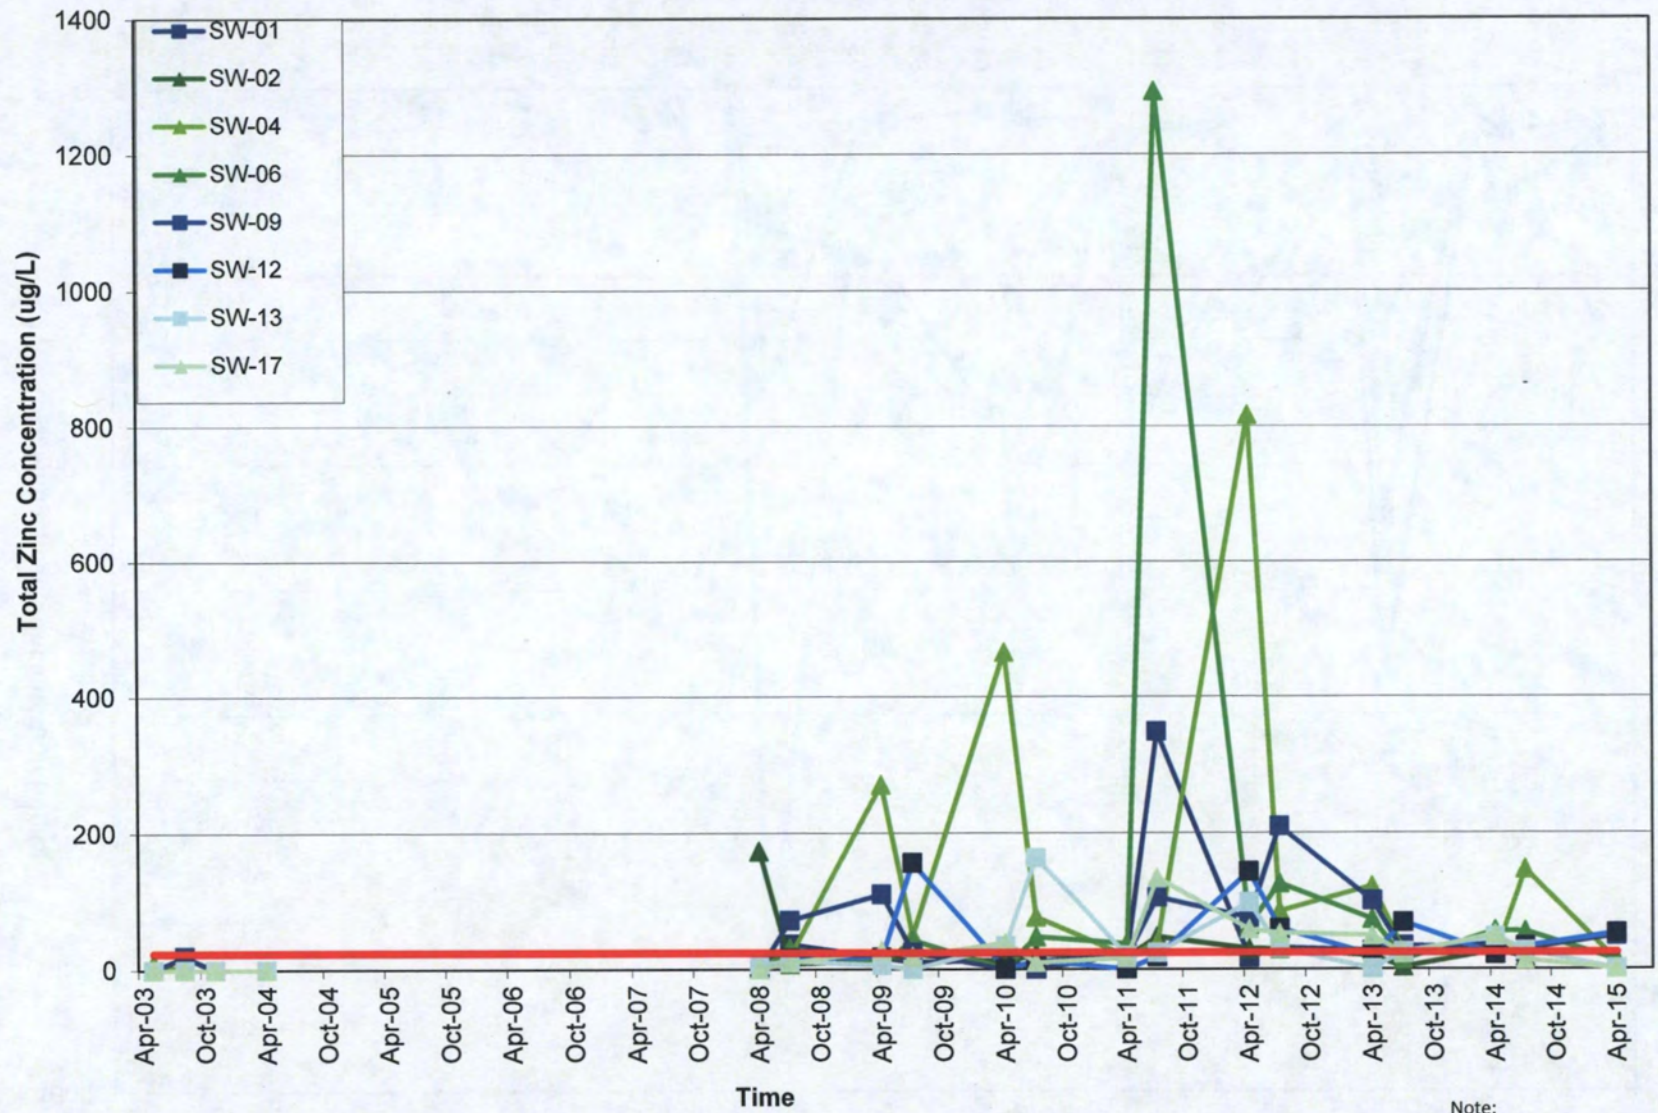
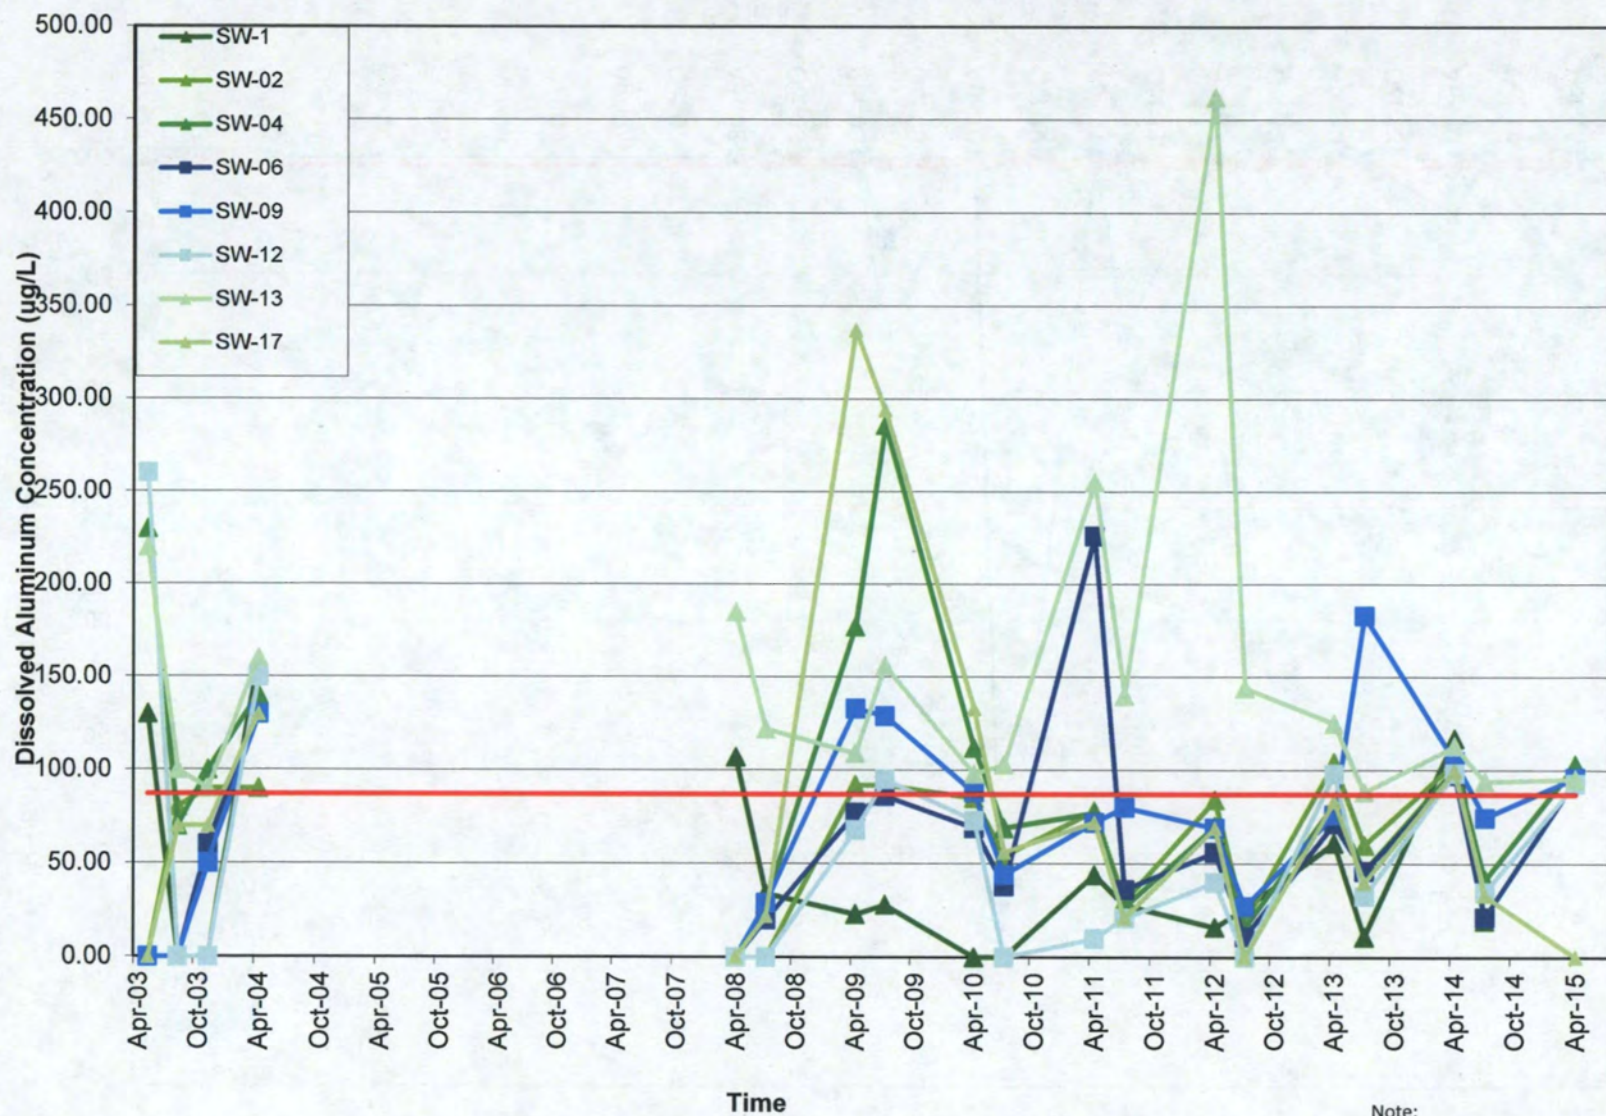
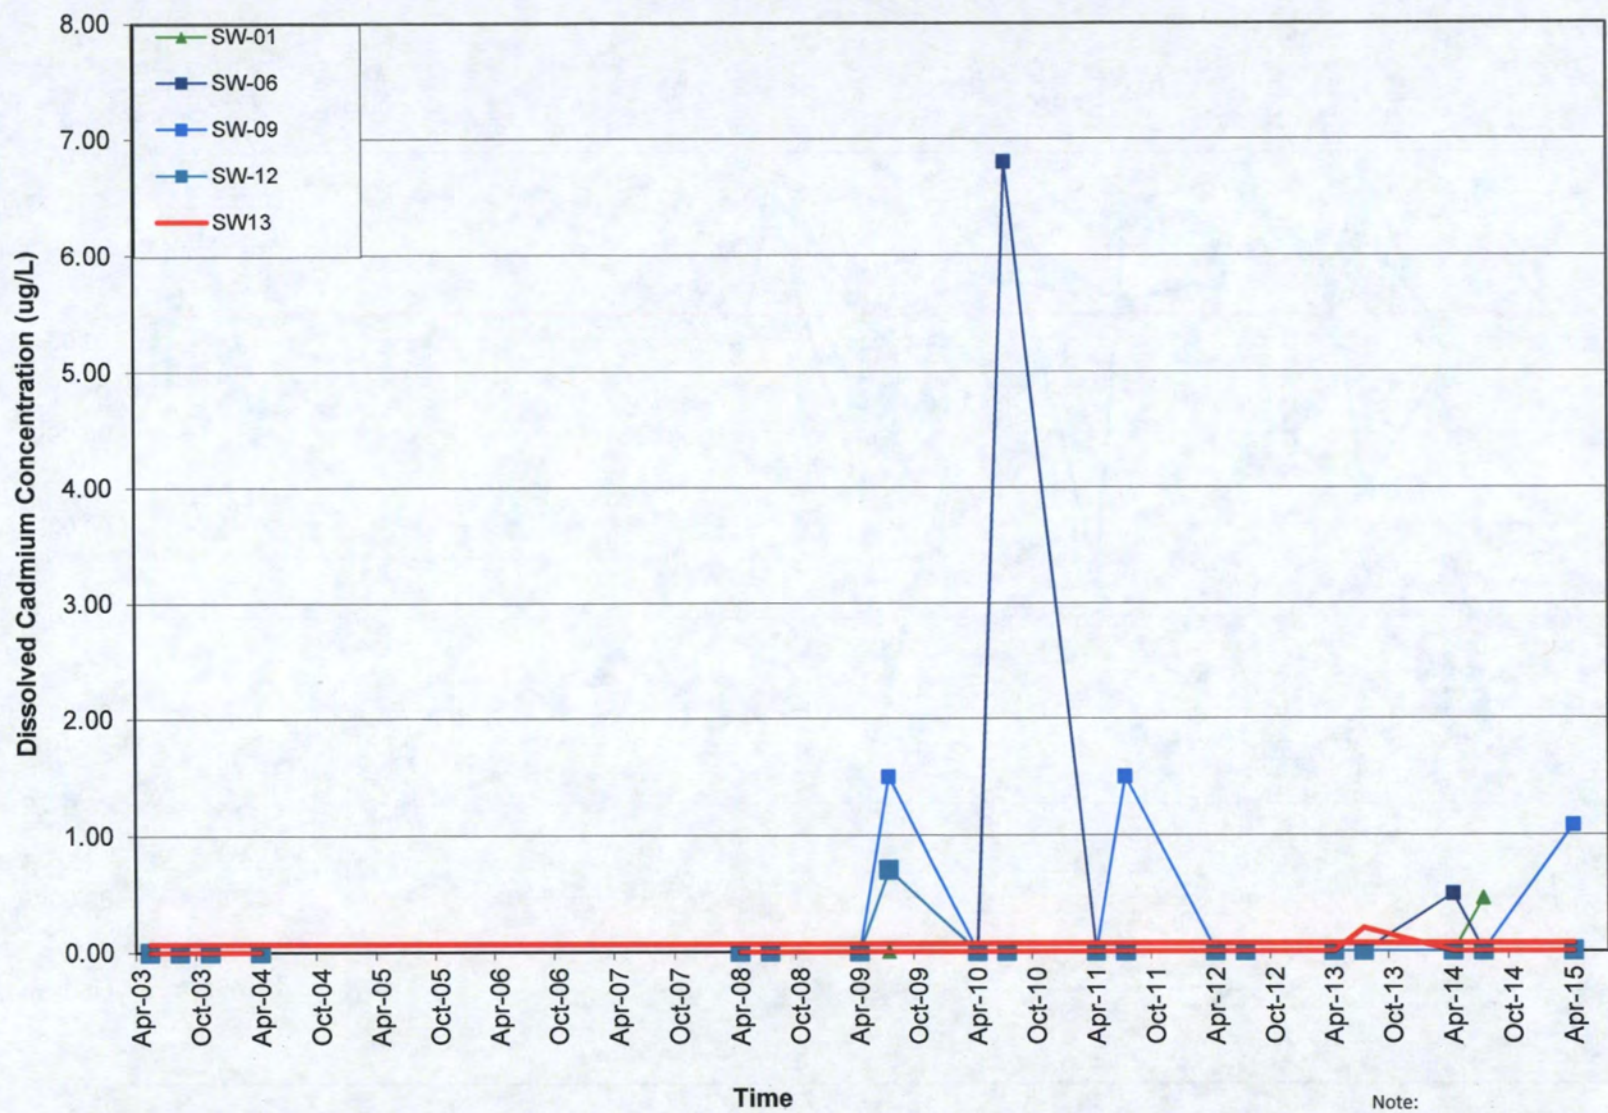
Graphs showing these trends are provided in Appendix E. The trend analysis graphs are presented for both dissolved metals and total metals. All of these metals show fairly similar results during post-closure monitoring except for concentration spikes detected in the July 2013 monitoring round. It is noted that concentrations typically trend higher in July than in April. The reason for this even greater spike in metals concentration across the site in July 2013 is unclear; however, metals concentrations in surface water have remained fairly constant on

Based on the results of post-closure monitoring, continued biannual surface water monitoring is recommended.
