**SECOND FIVE-YEAR REVIEW REPORT  
FOR  
ROSE HILL REGIONAL LANDFILL SUPERFUND SITE  
WASHINGTON COUNTY  
SOUTH KINGSTOWN, RHODE ISLAND**

U.S. Environmental Protection Agency  
Region 1  
BOSTON, MASSACHUSETTS

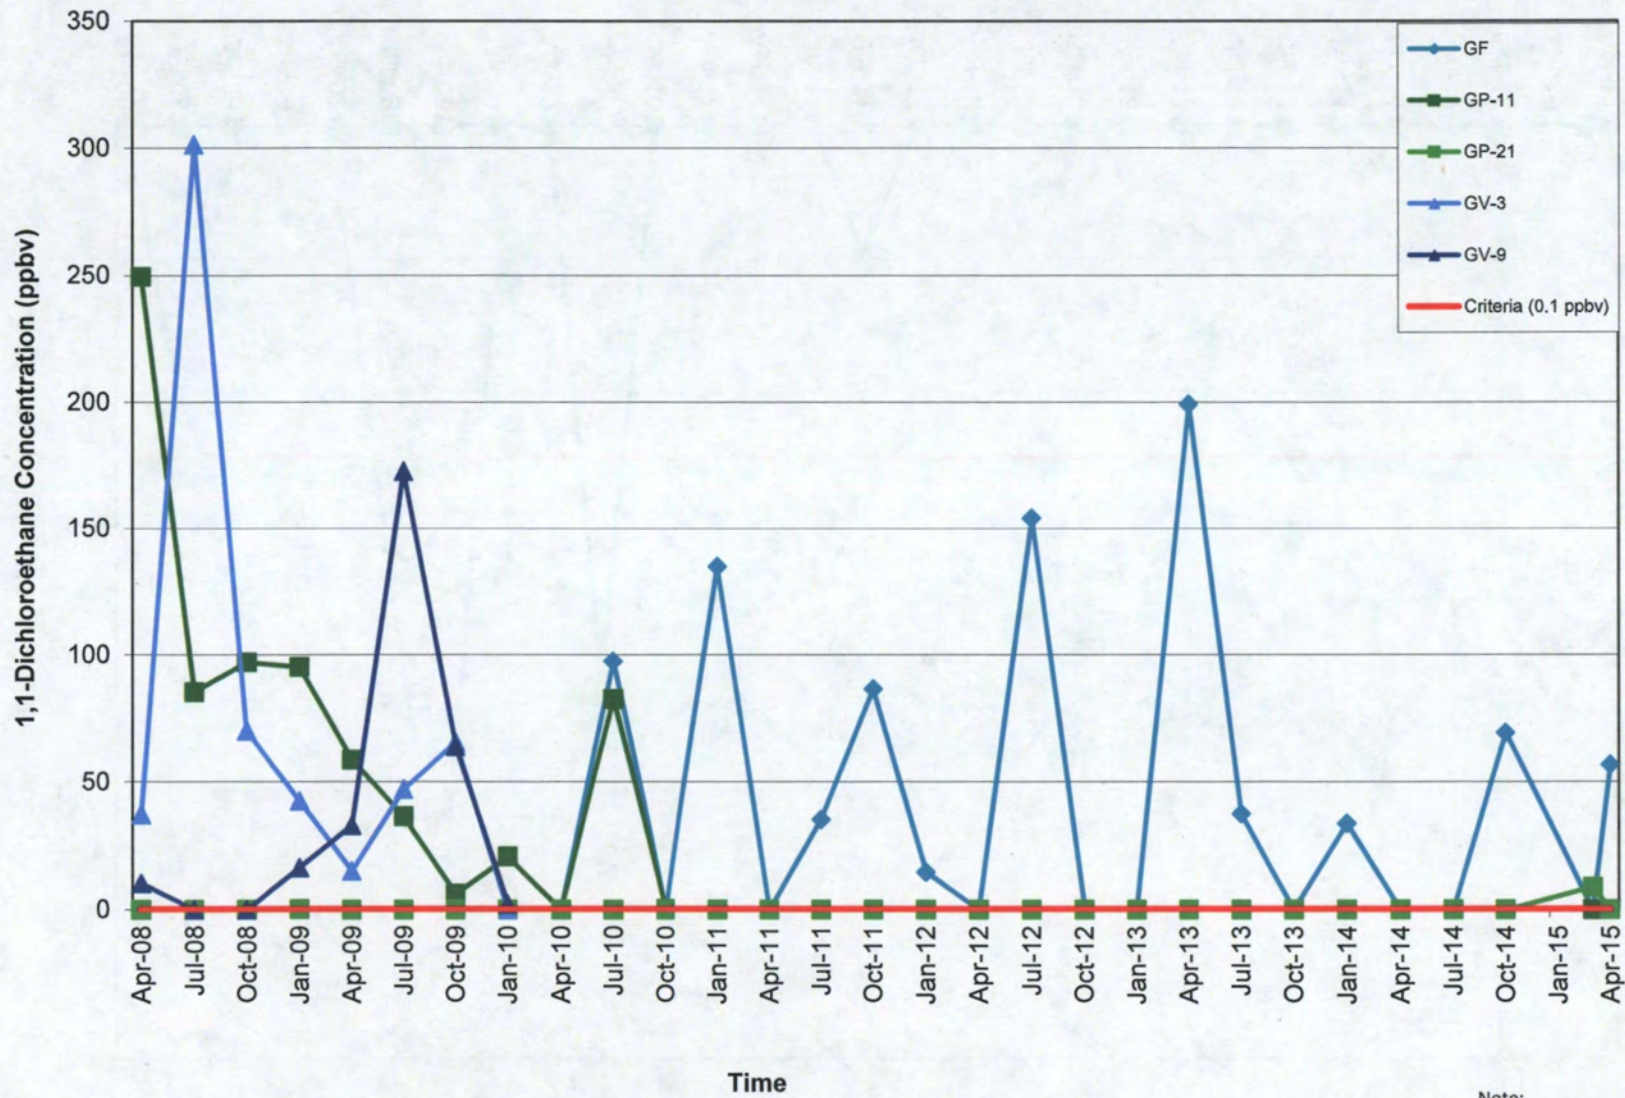
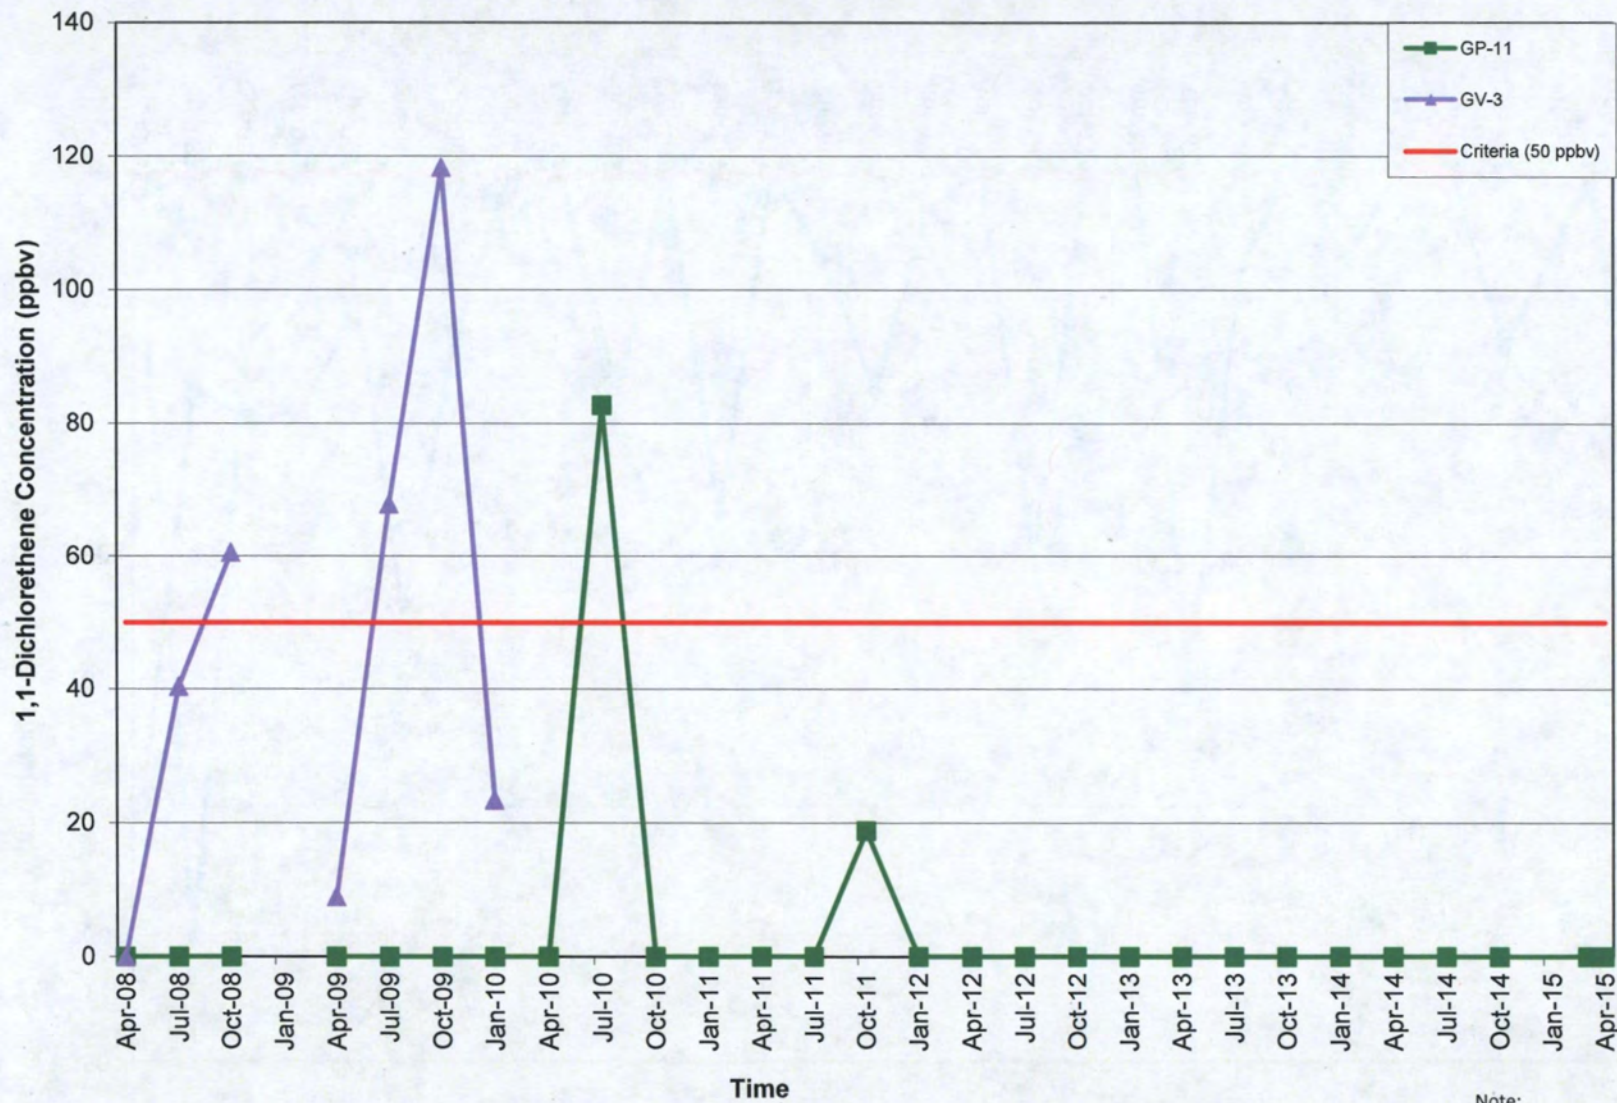
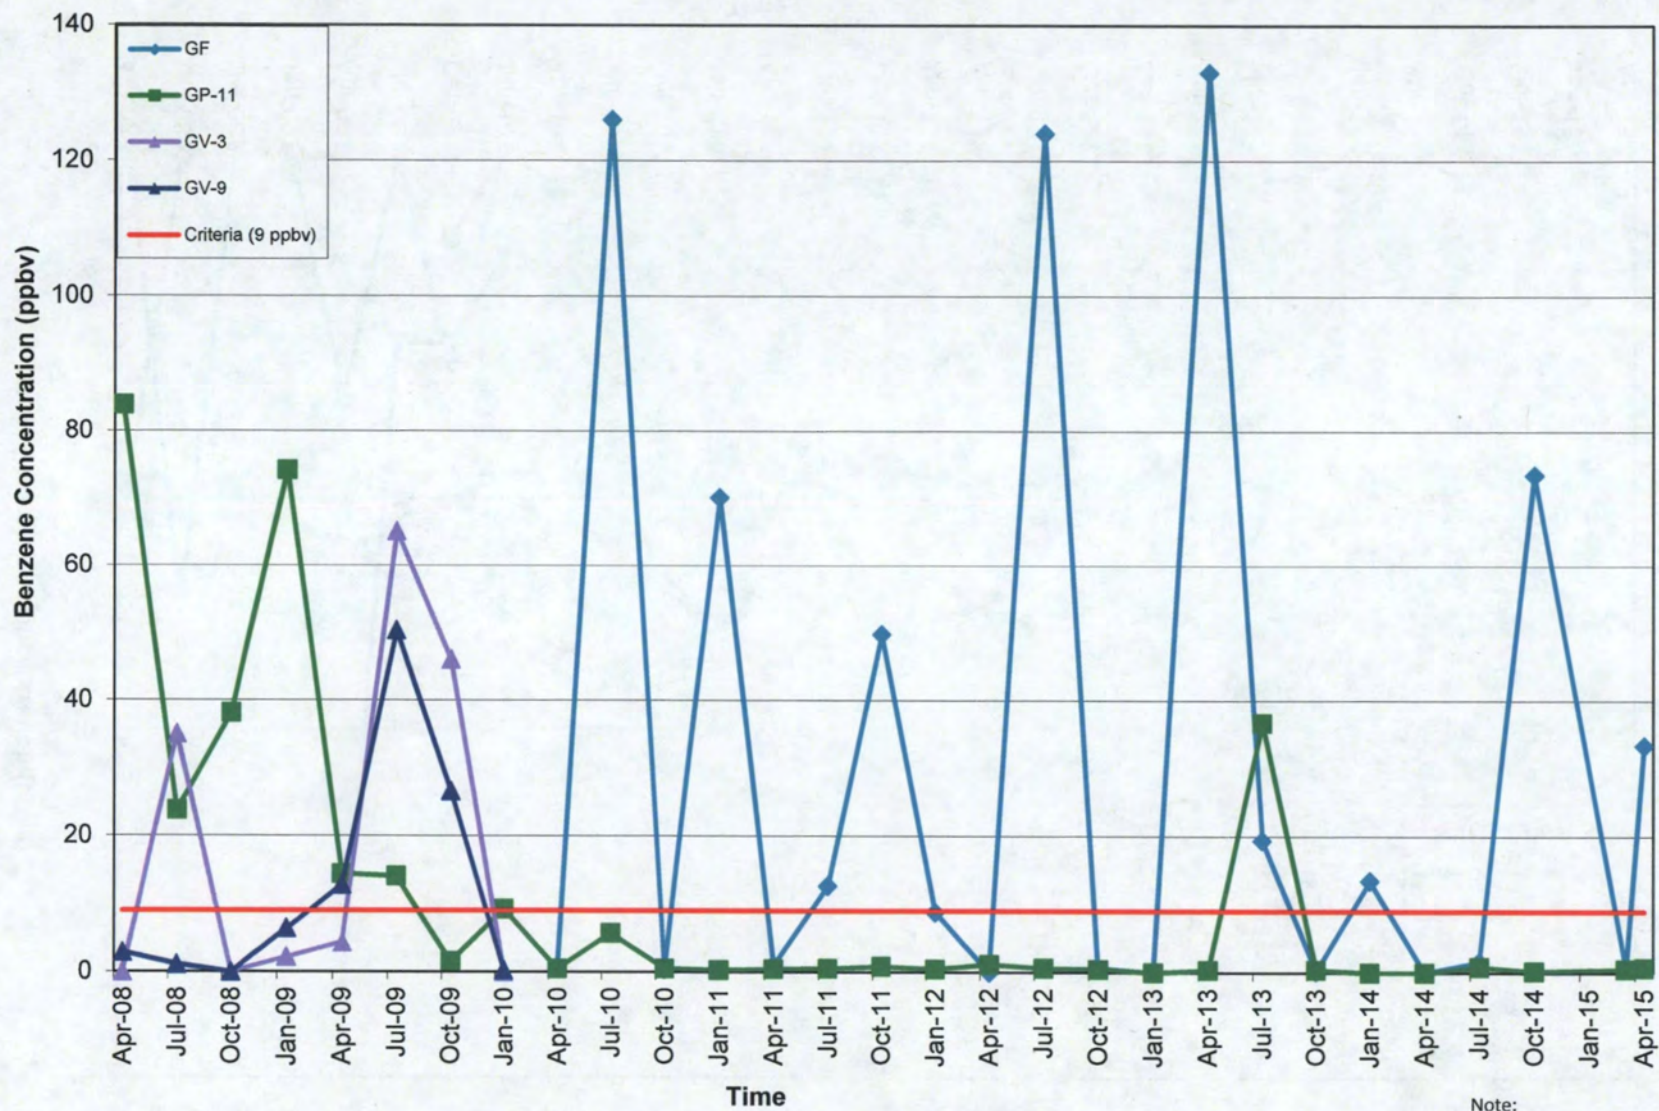
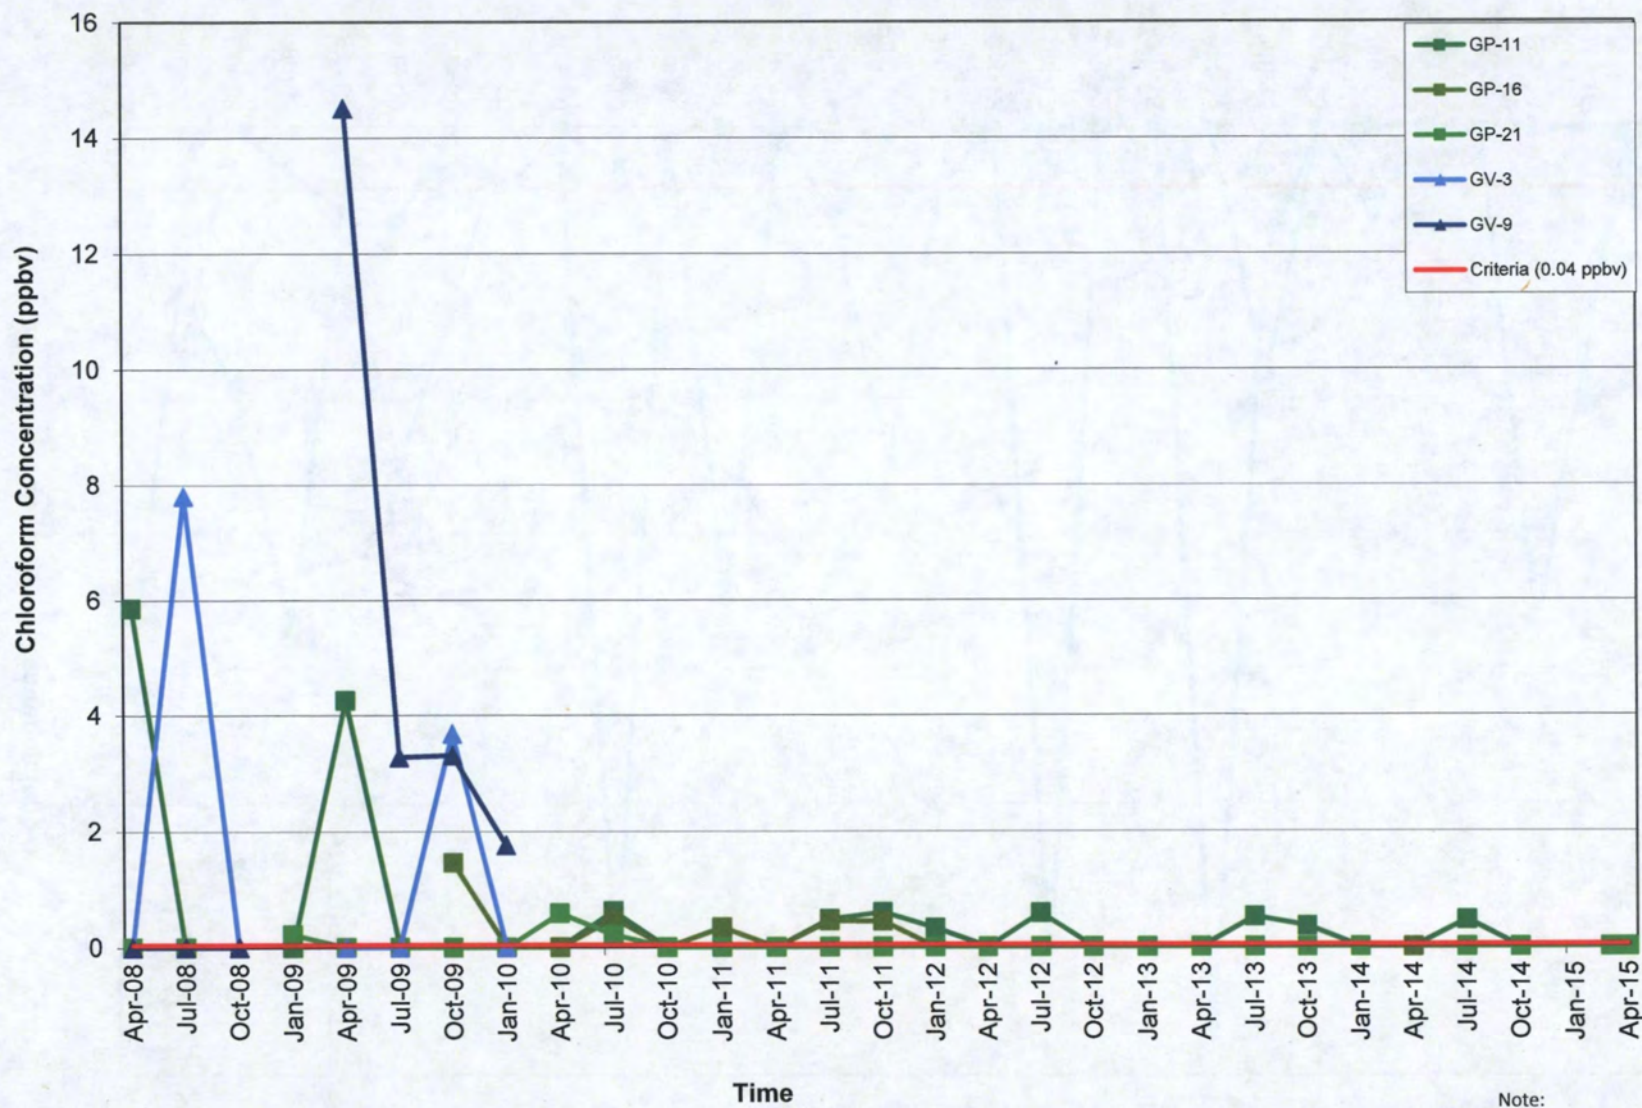
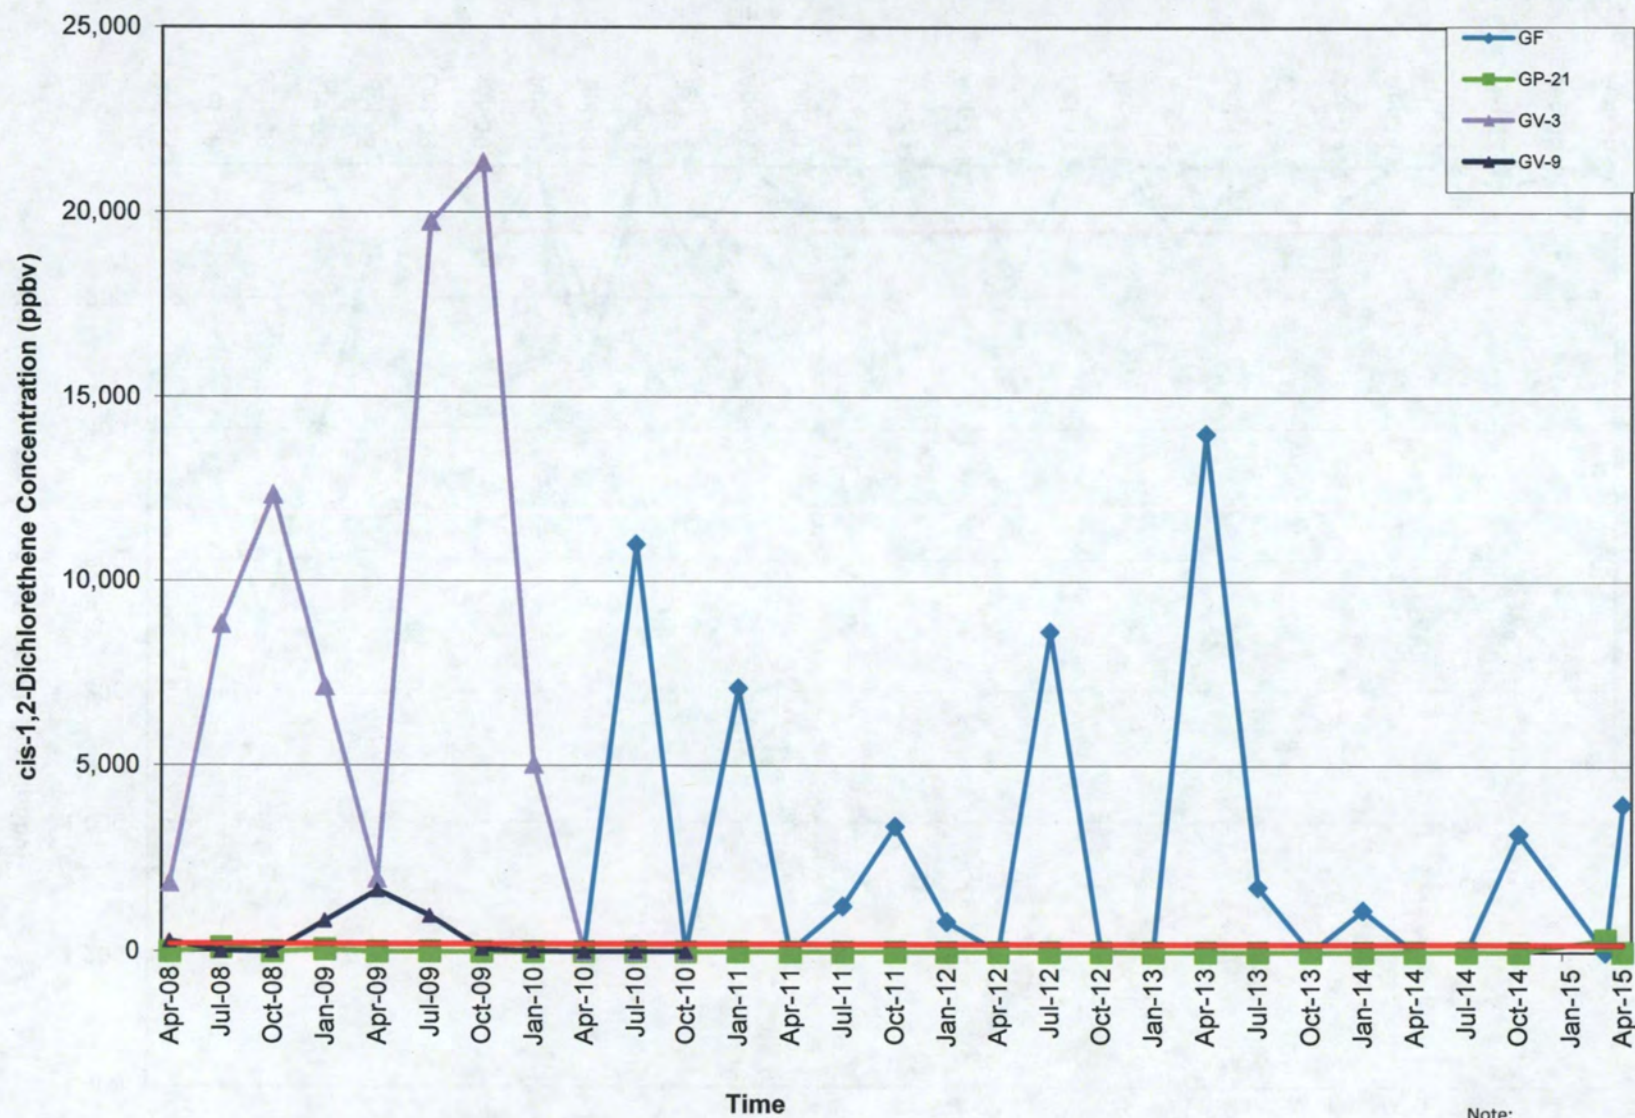
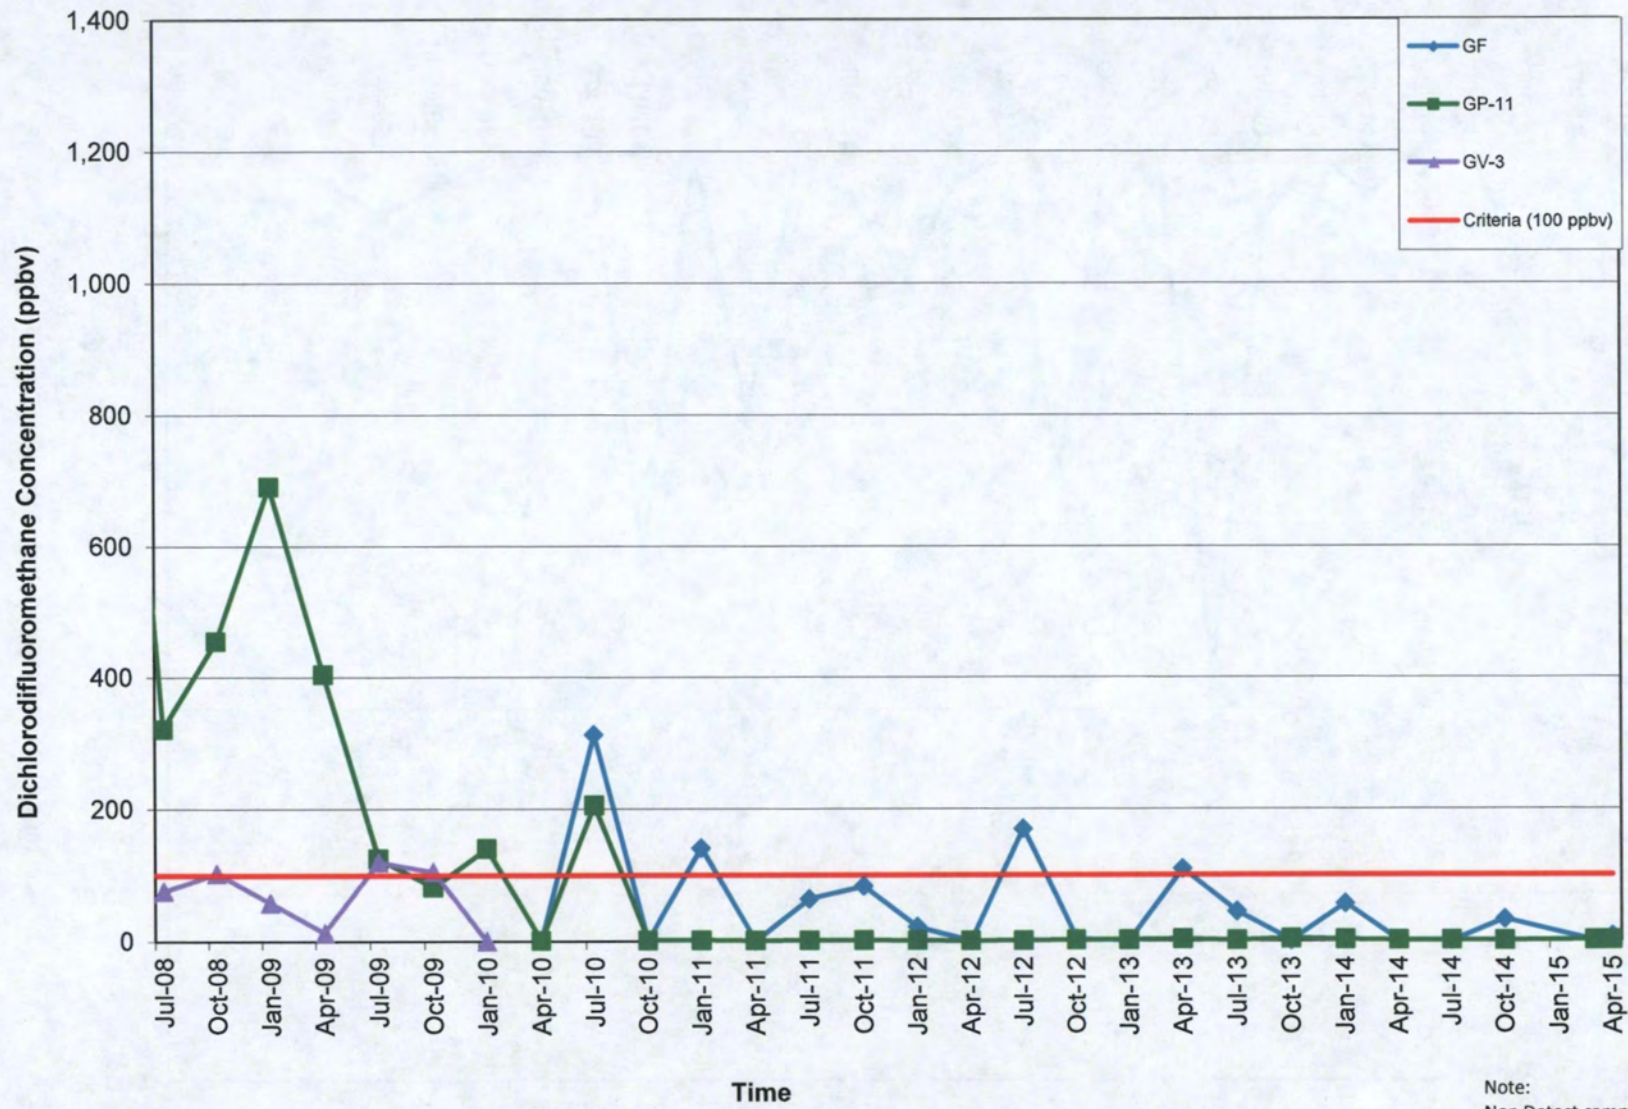
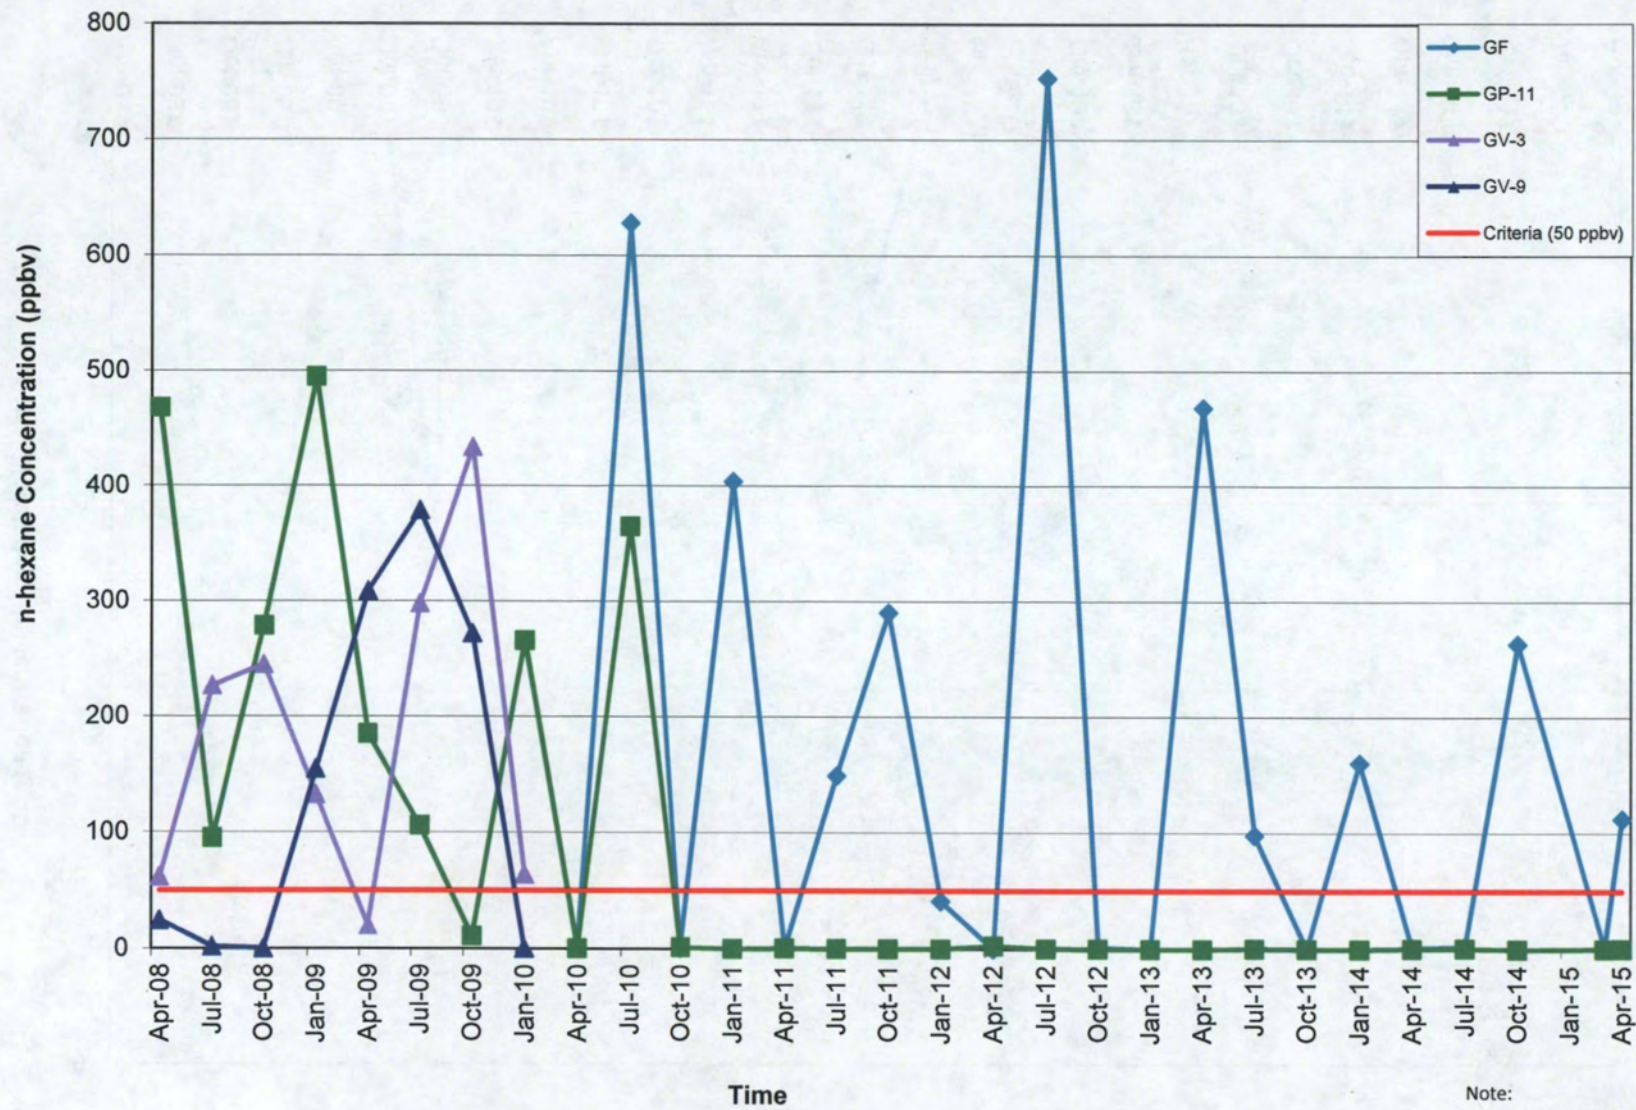
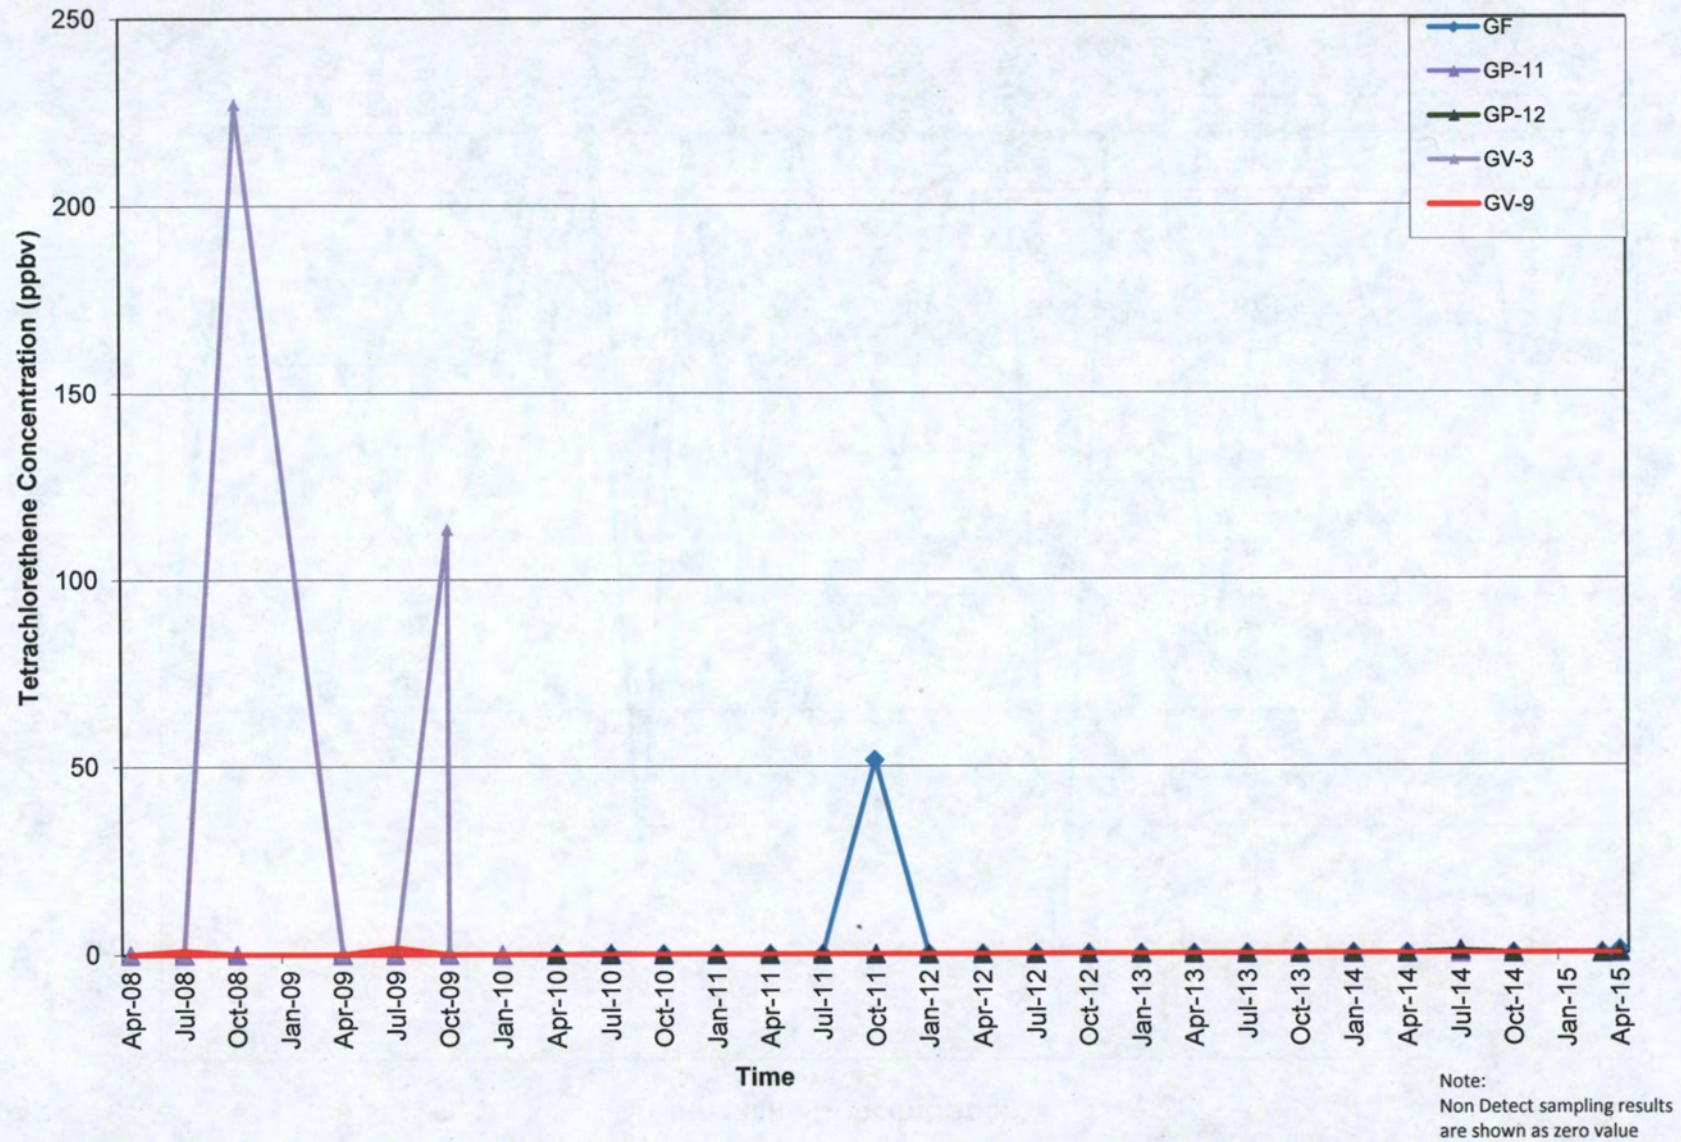
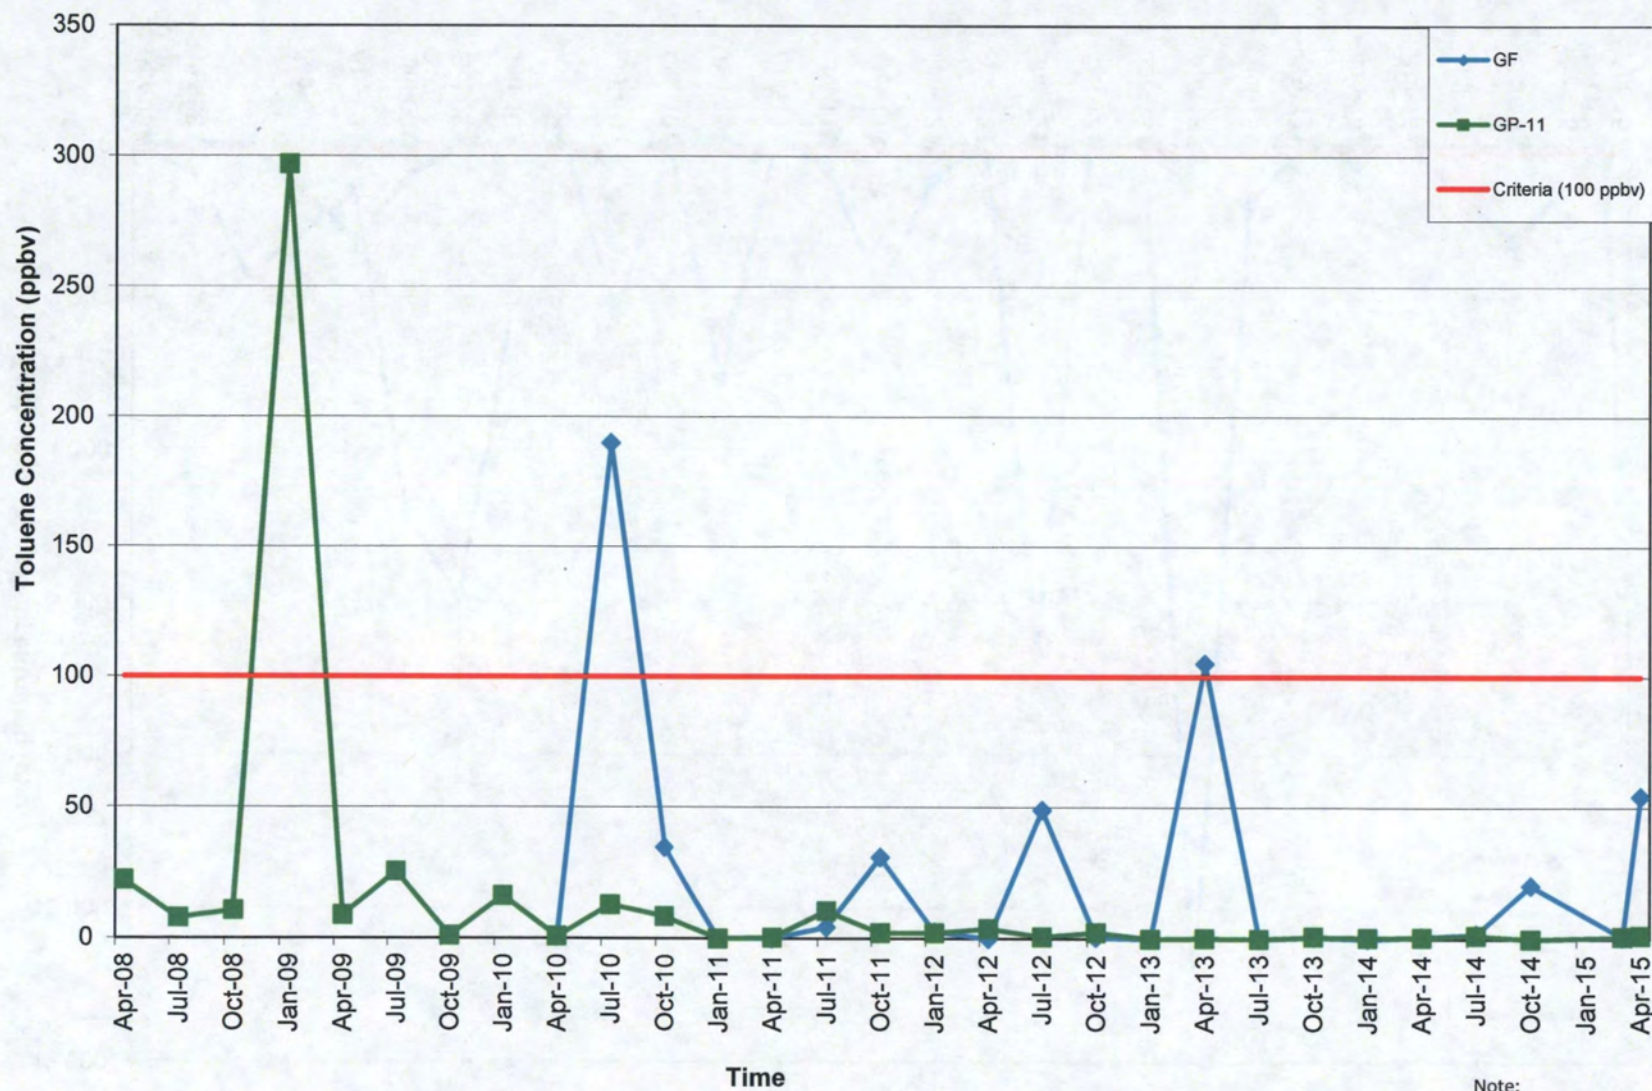
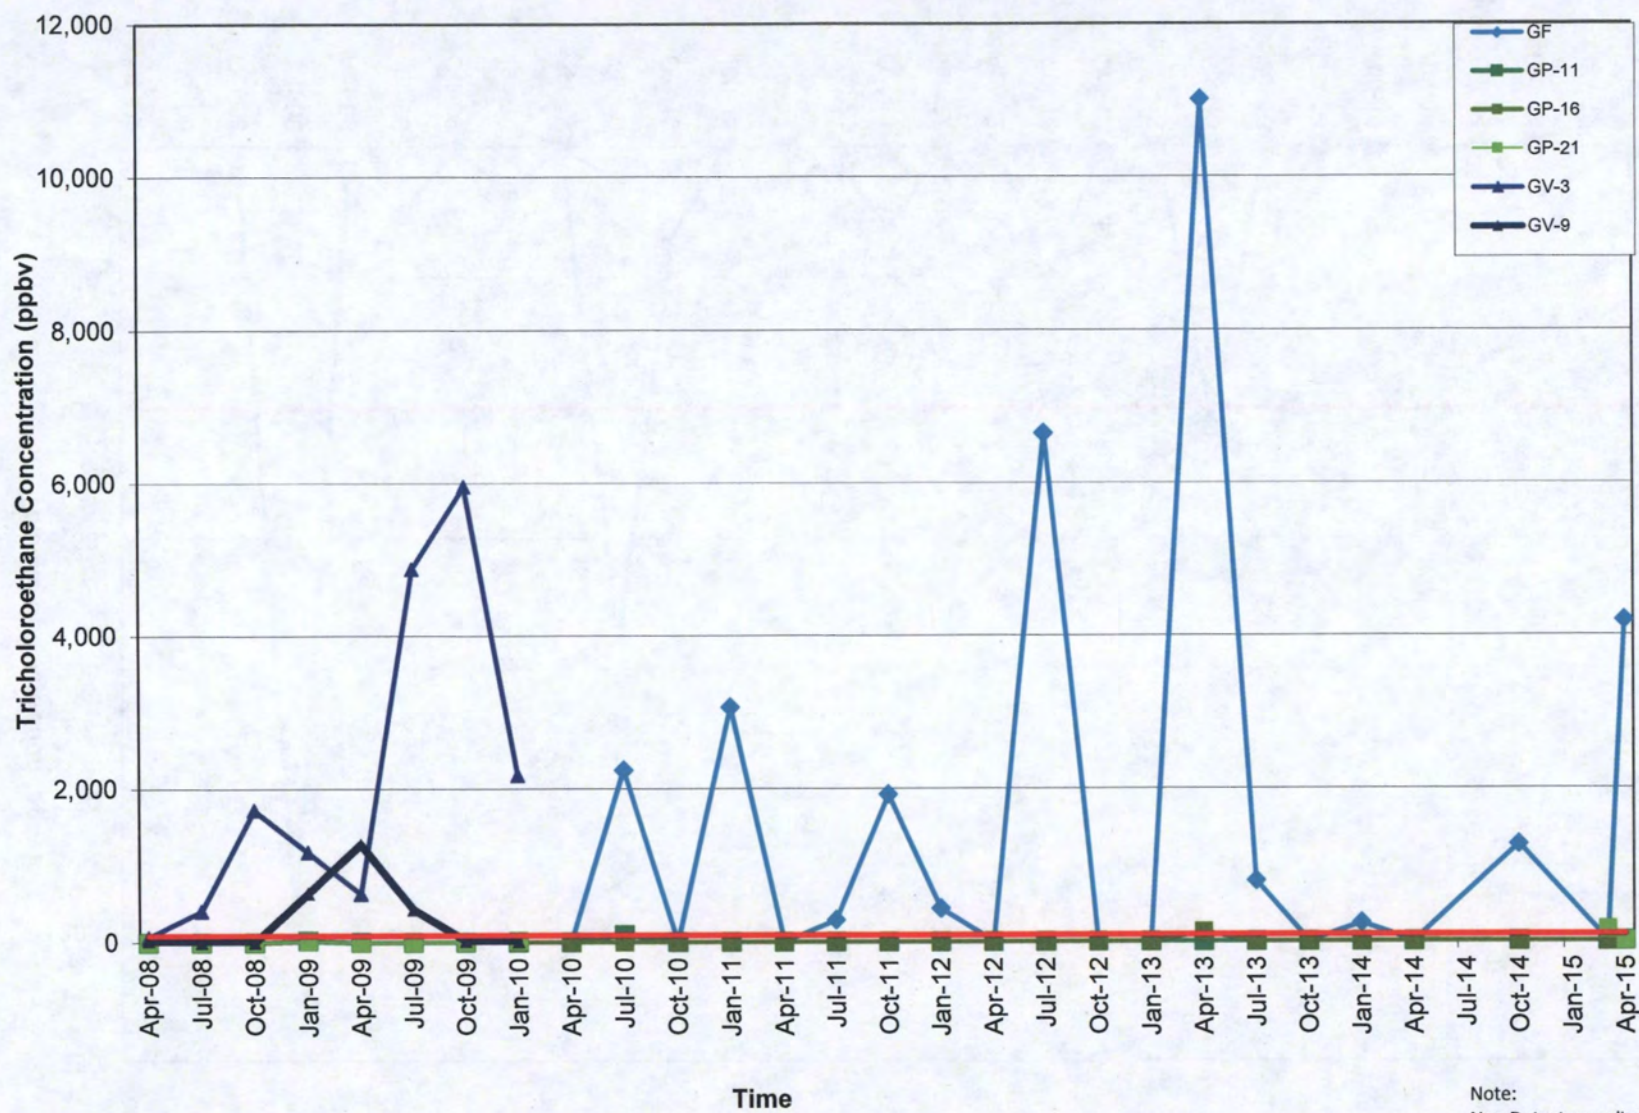
Graphs showing these trends are provided in Appendix E. All of these VOCs showed an overall general decreasing trend between 2010 and 2015. A similar result for reduction in methane concentrations is also observed, with all off-Site measurements of methane concentrations at or below 1% since the start-up of the gas flare.
