**THIRD FIVE-YEAR REVIEW REPORT FOR
SACO MUNICIPAL LANDFILL SUPERFUND SITE
SACO, MAINE**

**U.S. Environmental Protection Agency
Region 1
Boston, Massachusetts**

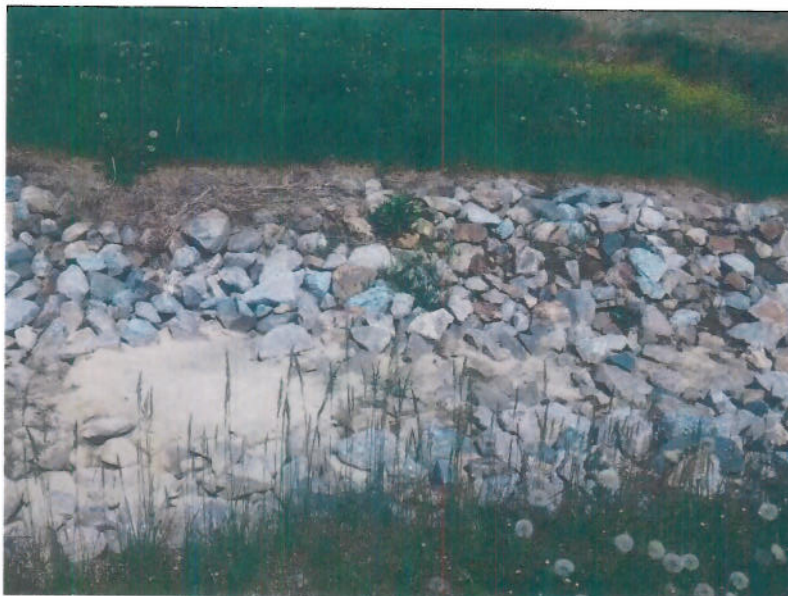
Description: Sediment buildup in channel E.

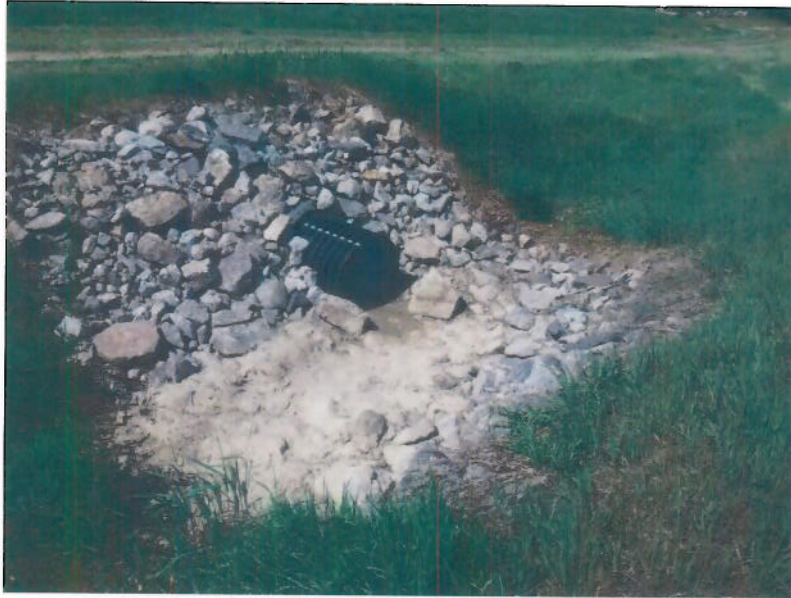
Description: Sediment buildup at the outfall of Culvert 2.

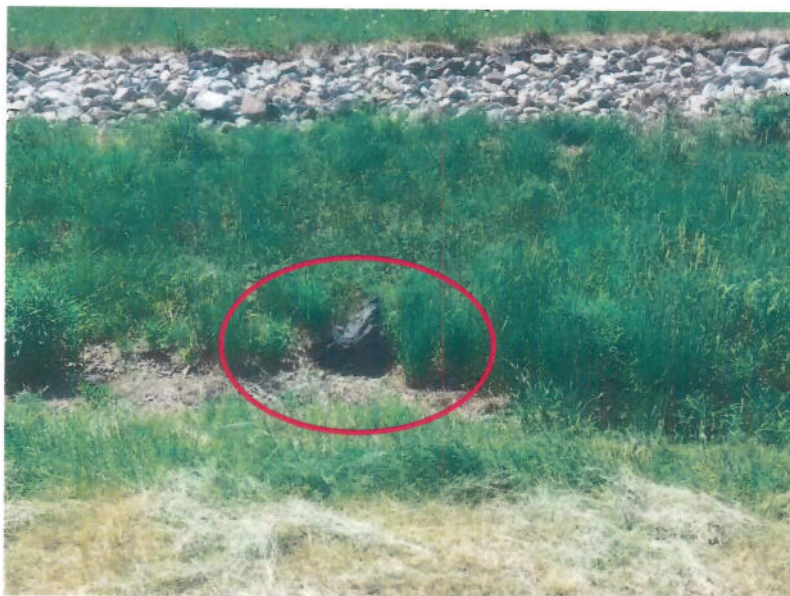
A small piece of filter fabric material was observed protruding from the ground in an area located north of the perimeter drain on the north slope of the landfill. It is unclear at this time what caused the fabric to become exposed.

Description: Piece of filter fabric exposed on the northern side of the perimeter drainage channel along the north slope of the landfill.

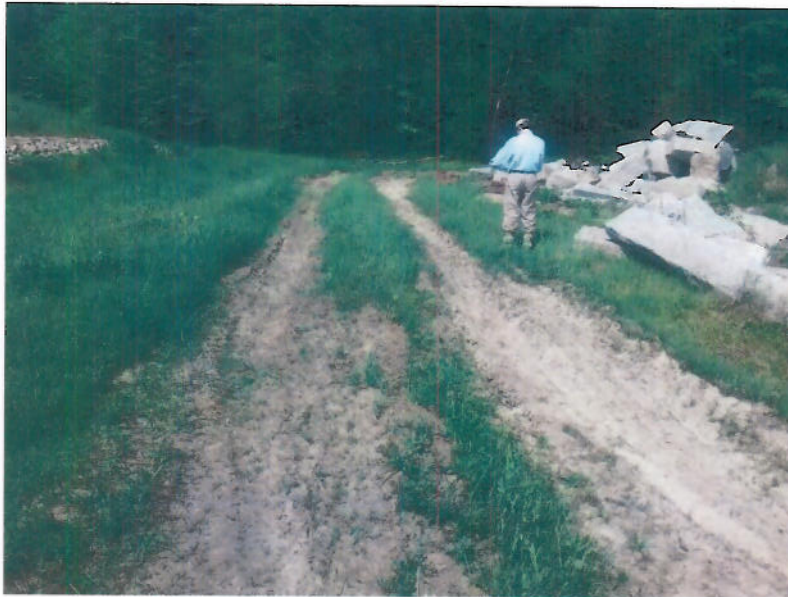
EPA observed light rutting at the terminus of the perimeter road to the south of the Area 4 landfill; this rutting was unchanged from previous inspections. EPA observed light rutting at the end of the northern perimeter road near the granite stockpiles. Should this condition worsen, repairs may be necessary. Otherwise, the perimeter roads were in good condition with no signs of erosion, ruts, or potholes.

Description: Minor ruts observed at the end of the northern access road near the granite stockpiles.

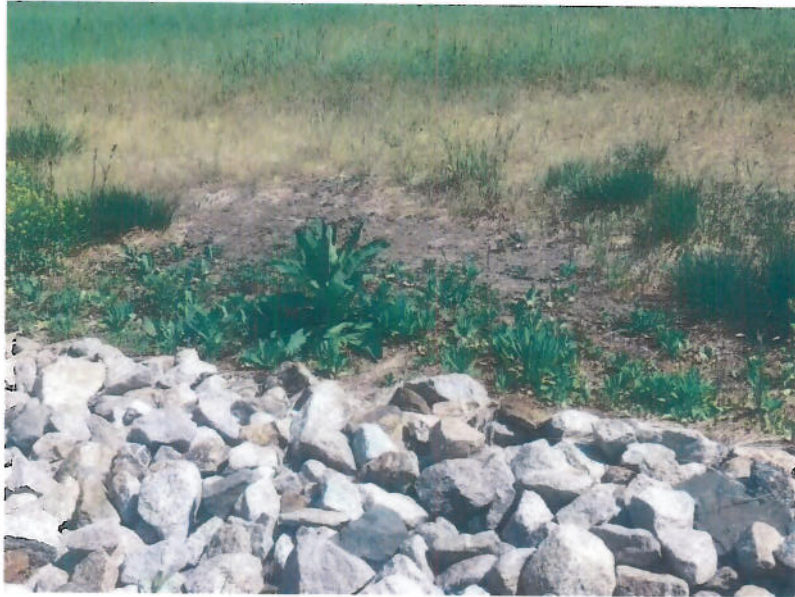
The vegetative cover over the landfill surface was generally in good condition. EPA observed two areas of thin cover. One area was located in the southwest area of the cap near Bench I. The other area was a small bare spot located along the north side of the riprap channel located along the southwestern toe of the landfill slope.

Description: Bare spot observed along the southwest toe of the landfill.

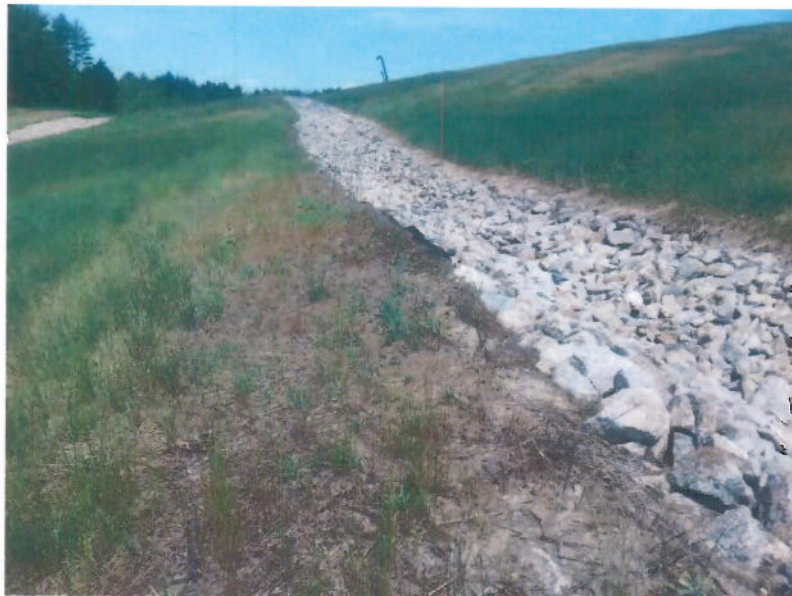
Description: Thin vegetation along Bench I.

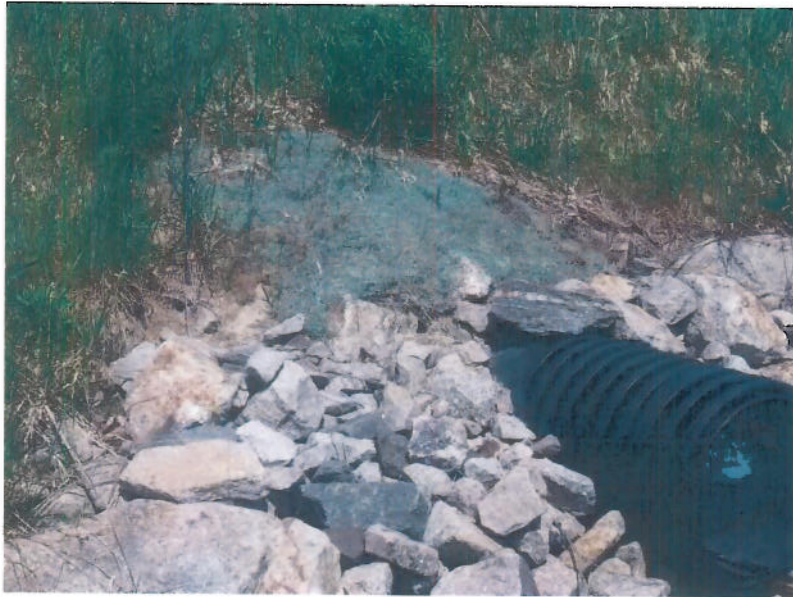
During historical inspections, animal burrows were in two locations on the cap—at the base of GV-15 and above the culvert outlet at the southern end of the sedimentation basin. Currently, the burrow at the base of GV-15 appears to be filled in/abandoned and the burrow above the culvert has been repaired. There were no new burrows identified during the FYR Site inspection.

Description: Repaired animal burrow above the culvert in the sedimentation basin.

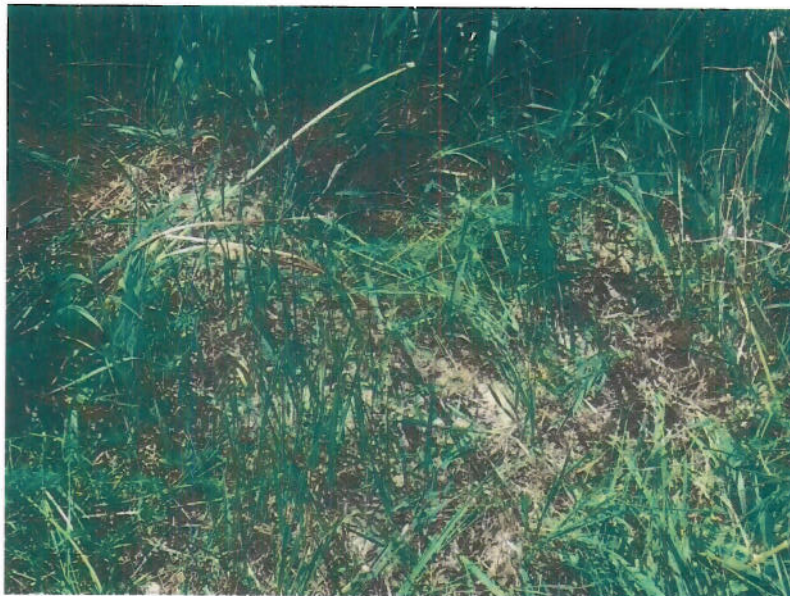
Description: Former animal burrow at the base of GV-15.

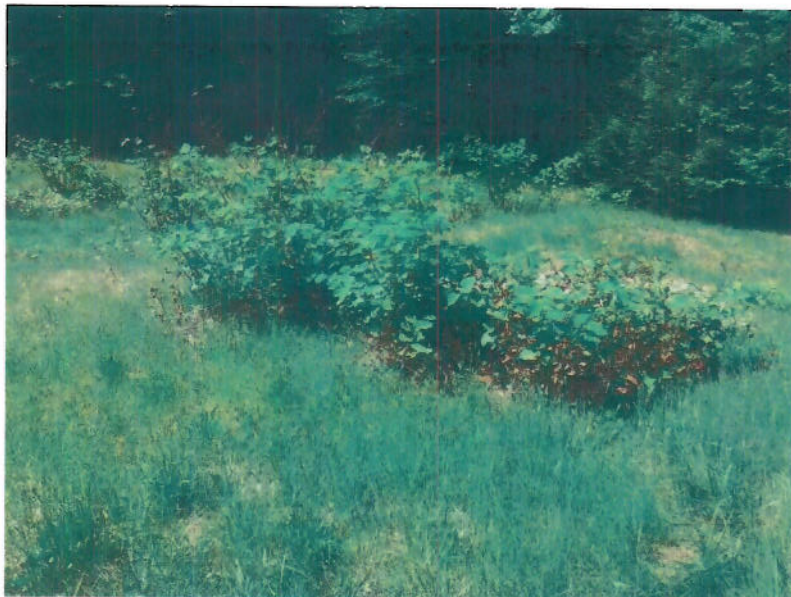
During the FYR inspection, EPA observed a new stand of Japanese Knotweed growing near a small riprap lined drainage area located approximately 75 feet from the southwestern corner of the landfill. This stand of Knotweed is not located on the cap; it should be controlled to prevent spread to other areas of the Site and the landfill cap.

Description: New stand of Japanese Knotweed located 75 feet from SW corner of LF.

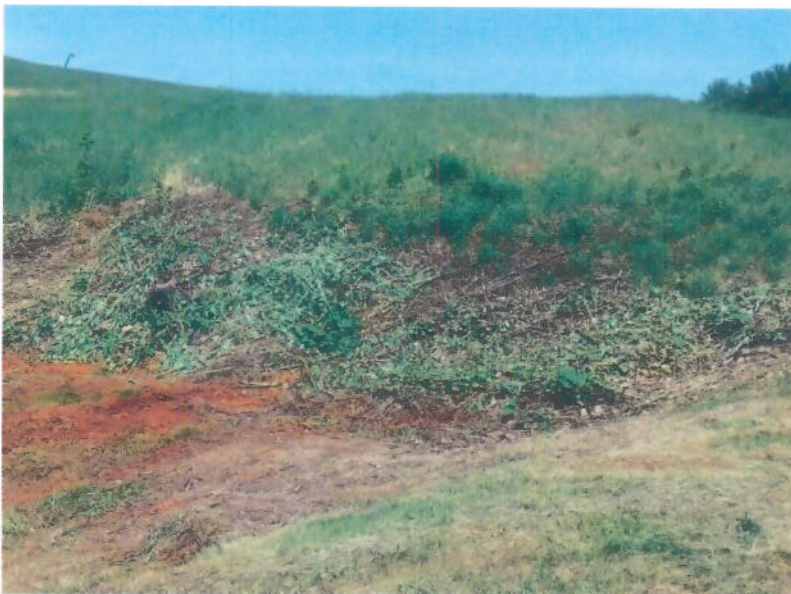
Description: Japanese Knotweed cut down at the sedimentation basin.

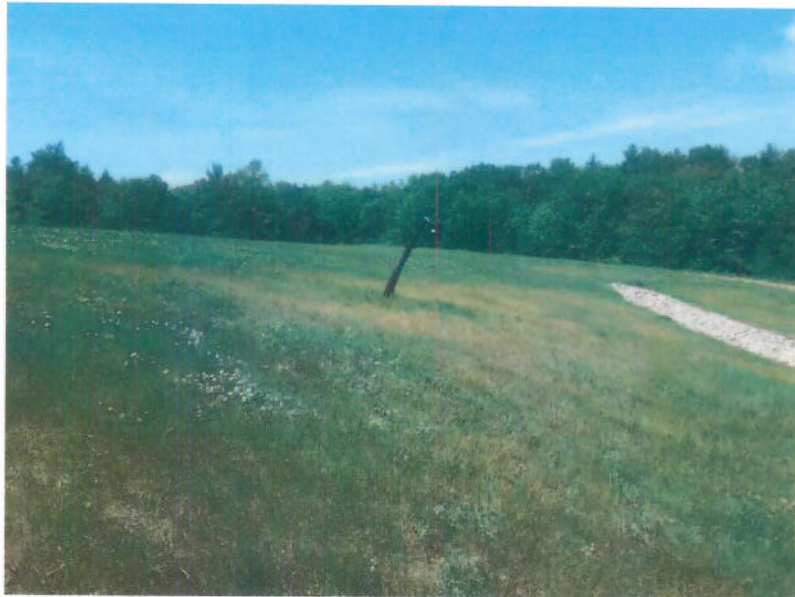
GV-11 and GV-15 exhibited the furthest extent of tilt. The tilt did not appear to be impacting the effectiveness of the vents, and no crimping or other structural deformity was observed. A review of photos from previous inspections identified no apparent change to the tilt of the gas vents.

Description: Angle of pipe at GV-11.

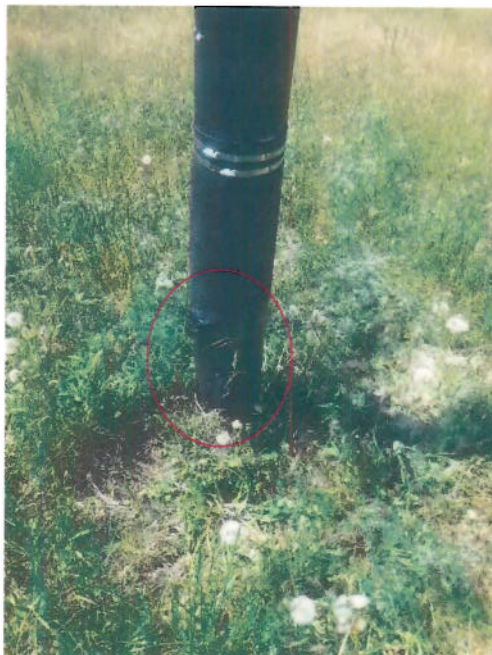
Description: Damage to geomembrane boot at GV-2.

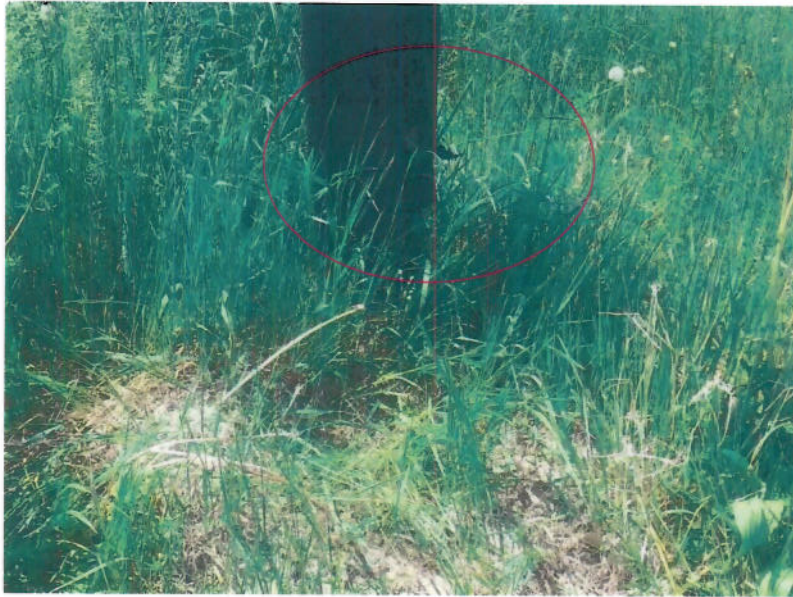
EPA observed gashes in the outer geomembrane boot at the base of GV-11, GV-15, GV-8, GV-9, and GV-5 that may have been caused by mowing equipment. The damaged portions of the geomembrane boots are not physically connected to the landfill cap geomembrane. The vents will continue to be monitored for damage to the inner vent section that connects to the cap geomembrane.

Description: Damage to geomembrane boot at GV-15.

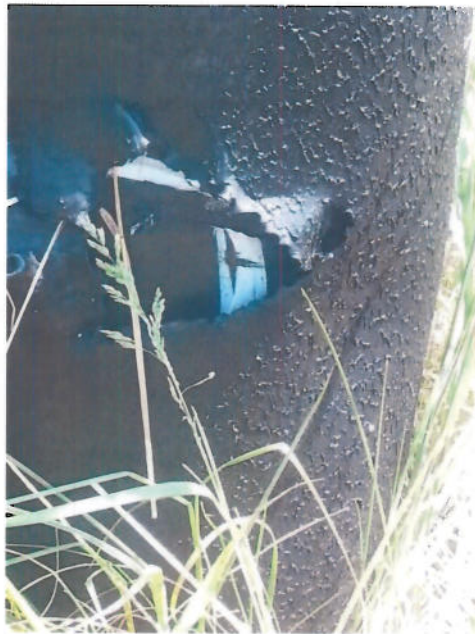
Description: Damage to geomembrane boot at GV-5.

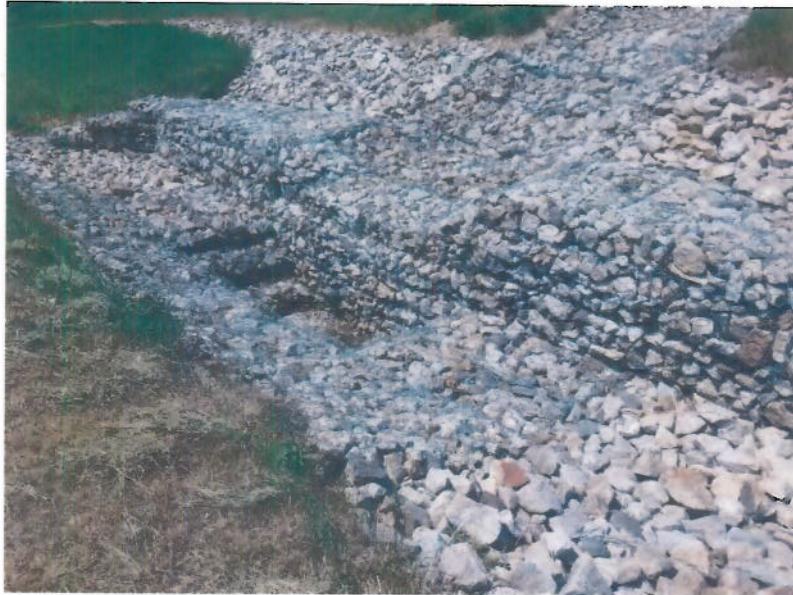
No significant bulging or tilting was observed in the gabion baskets forming the retaining structure at the bottom of the down-drain on the east end of the landfill.

Description: View of the gabion wall facing southwest.

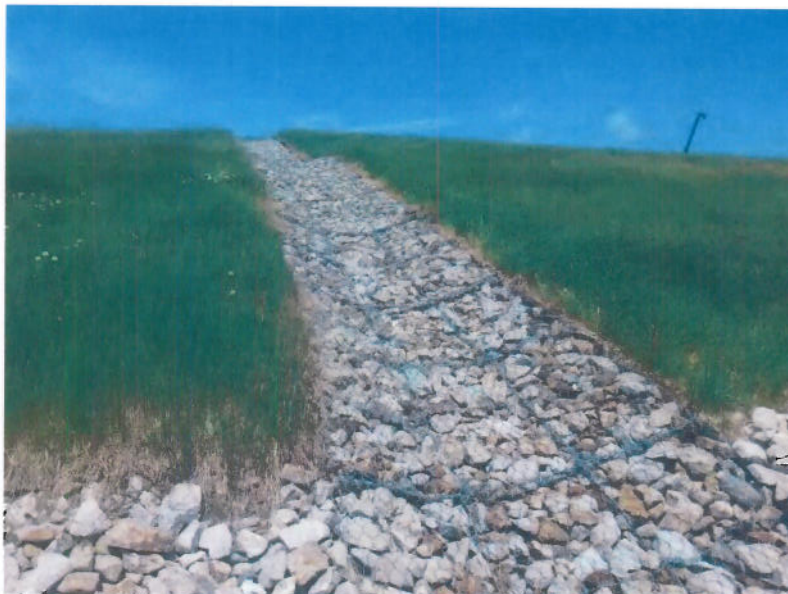
The gabion-lined letdown channels on the east end and northwest slope of the landfill were in good condition with no signs of settlement, material degradation, erosion, undercutting, or obstructions. The sump between the eastern down-drain and the sedimentation basin appeared to be in good condition with no obstructions.

Description: View of the letdown channel facing northwest.
