Fourth Five-Year Review Report for C & R Battery Superfund Site Chesterfield County, Virginia

September 2013 Prepared by: United States Environmental Protection Agency Region 3 Philadelphia, PA

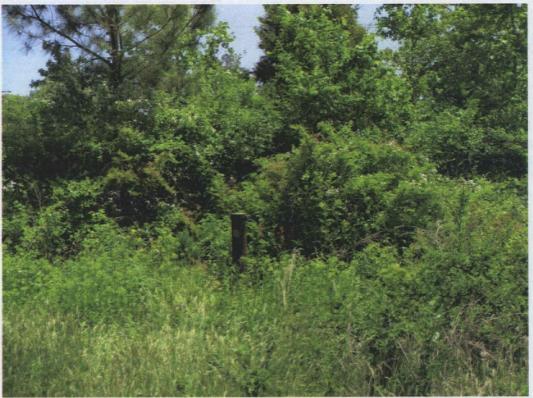
Photograph 3: Monitor Well MW-6 (Looking east toward Capitol Oil)

the attendees and no significant issues identified during the site visit. During the site visit, several of the monitoring wells were observed. The wells observed were capped, secured and in good condition with no visible damage

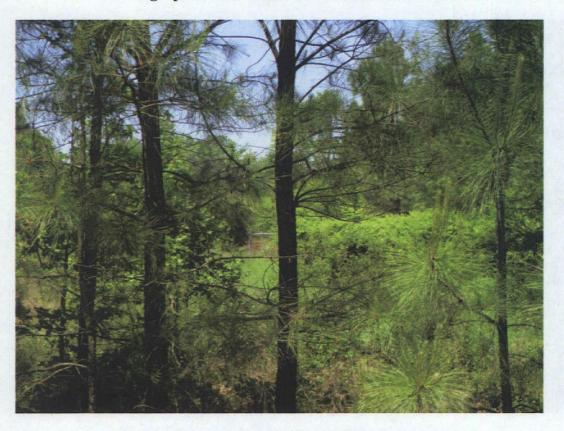
Photograph 6: North view towards fence at back of Site

V. ACCESS AND INSTITUTIONAL CONTROLS ✓ Applicable □N/A
	Fencing
1.	Fencing damaged \Box Location shown on site map \checkmark Gates secured \Box N/A
	Remarks: Fencing is present at the site (installed during the removal action), but was not identified as
•••	part of the remedy. Fencing is in good condition.
В.	Other Access Restrictions
