FINAL REMEDIAL INVESTIGATION ADDENDUM

for BoRit Asbestos Superfund Site Operable Unit 1 Ambler, Pennsylvania

Work Assignment No.: 029-RICO-A3EN Document Control No.: 3330-029-RT-RIRT-02825

May 22, 2015

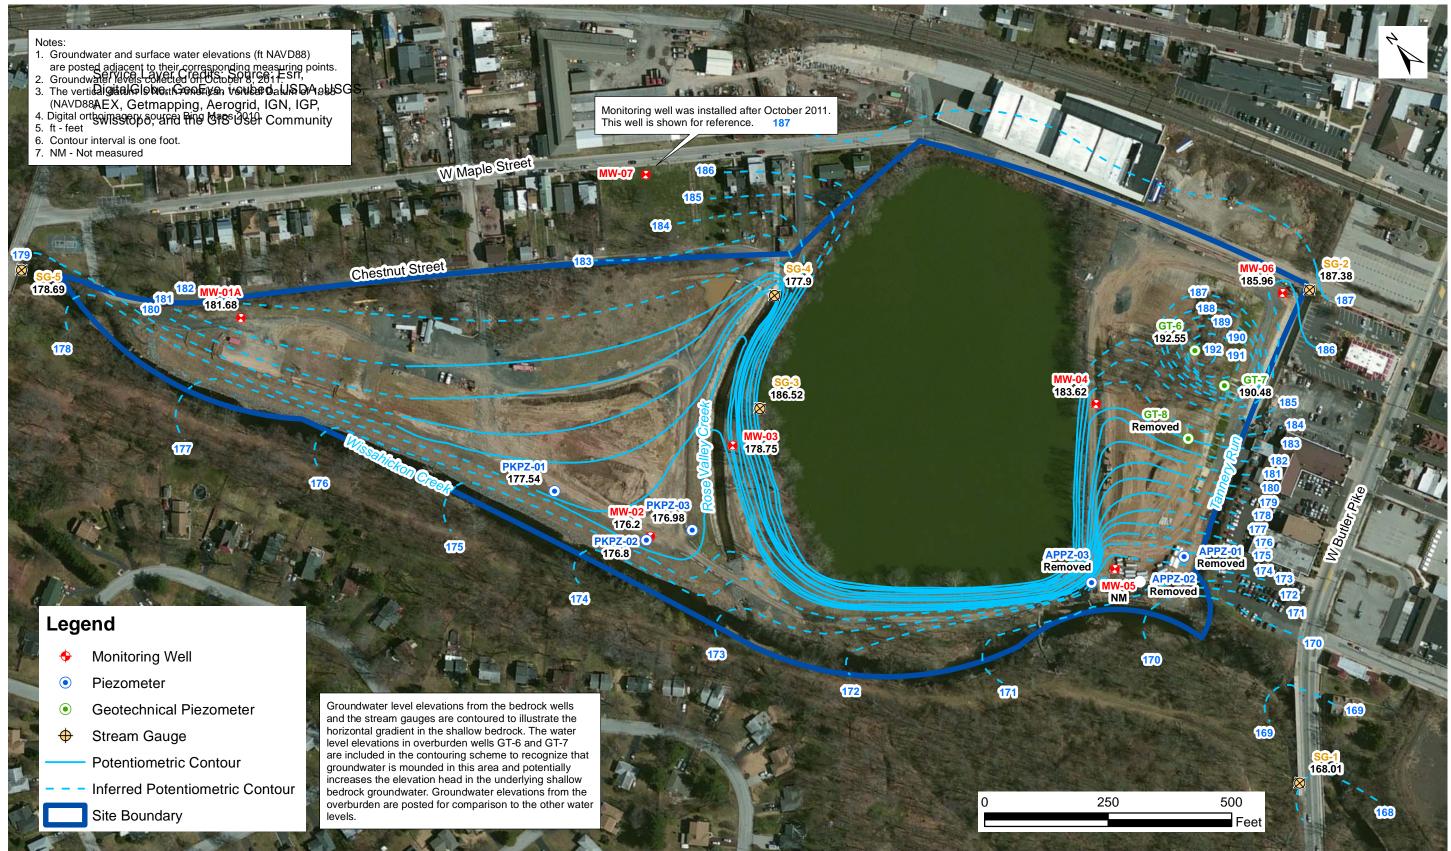
BoRit Asbestos Superfund Site, OU-1 Ambler, Pennsylvania Figure ES-4 Potentiometric Surface Map October 2011 Document Path: F:\Borit\GIS\ArcGIS\Projects\Revised FS\Revised Figures\Figure 1-5 Potentiometric Surface-July2014_1002.mxd

The shallow groundwater is found in the fractured upper bedrock, with discontinuous occurrences in the overburden material in the Park parcel near Wissahickon Creek and in the Asbestos Pile parcel. The horizontal groundwater gradient in the shallow bedrock is from northeast to southwest across the Park parcel, which suggests discharge to Wissahickon Creek. A local gradient also suggests that a component of Site groundwater discharges to Rose Valley Creek. This gradient pattern is typical in the near-creek settings of the region. The shallow groundwater is expected to flow upward toward these discharge points. Multiple groundwater synoptic rounds were conducted as part of the RI field activities; a typical potentiometric map from October 2011 (the latest during the RI) is included as **Figure ES-4**. The Site background monitoring well (MW) (labeled MW-07) was not installed until May 2013; therefore, the water level for MW-07 is not shown on Figure ES-4.

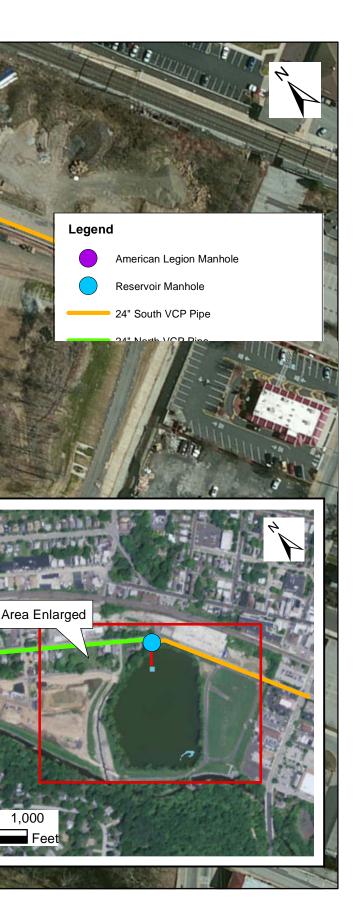
Figure ES-8 Site Features Related to Potential Sources of Inflow to the Reservoir

Figure ES-8 also shows an area of standing water in a pit in the northeastern corner of the Reservoir. This area of standing water is located above the polyvinyl chloride (PVC) pipe that extends from the new Reservoir manhole. One theory on the origin of this standing water is that groundwater flows into the old VCP (the "North VCP Pipe") under West Maple Street via cracks in the North Pipe VCP and flows via the North VCP Pipe to the manhole. However the PVC pipe extending from the Reservoir manhole was capped in July 2014 to prevent water from flowing into the Reservoir during draining. The elevation of the standing water in the northeast corner of the Reservoir, coupled with groundwater elevations in the area, suggests that this water could be groundwater coming into the Reservoir through the Reservoir bottom. However, data suggest that a clay layer is present under this portion of the Reservoir, which would limit communication.

In August 2014, the EPA Removal Program completed draining the Reservoir in order to conduct the remaining Removal Program work. On August 12, 2014, after a period of dry weather with no rainfall accumulating in the Reservoir, CDM Smith observed isolated pockets of water in the southern corner of the Reservoir where the Removal Program had drained water from the Reservoir. Water pathways were also visible within the sediment in the southern portion of the Reservoir. EPA observed the accumulation of standing water in the southern corner of the Reservoir after both dry and wet weather (August 20, 2014). The accumulation of water in this area of the Reservoir, which aligns with the area where CDM Smith conducted the temperature study in late July 2014, may be due to groundwater inflow to the Reservoir. Groundwater influence is typically not measurable when the Reservoir is full. When the Reservoir is dry, the surcharge of water placed on the saturated zone at this surface water body and the additional pressure head, inferred to create a downward vertical gradient beneath the Reservoir, are removed, which would then allow for an upward or horizontal inflow of groundwater in areas where geology allows communication. The accumulation of standing water in this area of the Reservoir could also be due to the release of water from sediment pore spaces or the presence of a zone of perched groundwater. Subsequent observations made of the drained Reservoir after July 2014 noted that water continues to collect in the southern portion of the Reservoir, but not at a rapid rate. On January 15, 2015, personnel from EPA's START contractor observed water flowing and accumulating on top of clean cover material and fabric that has been placed on the west side of the Reservoir by the EPA Removal Program. Several possible explanations for this source of inflowing water include the spring located on the west side of the Reservoir adjacent to Wissahickon Creek, the 24-inch North Pipe under West Maple Street, or snow and ice melt (Weston 2015). However the EPA's START contractor did not indicate the direction of the flowing water.

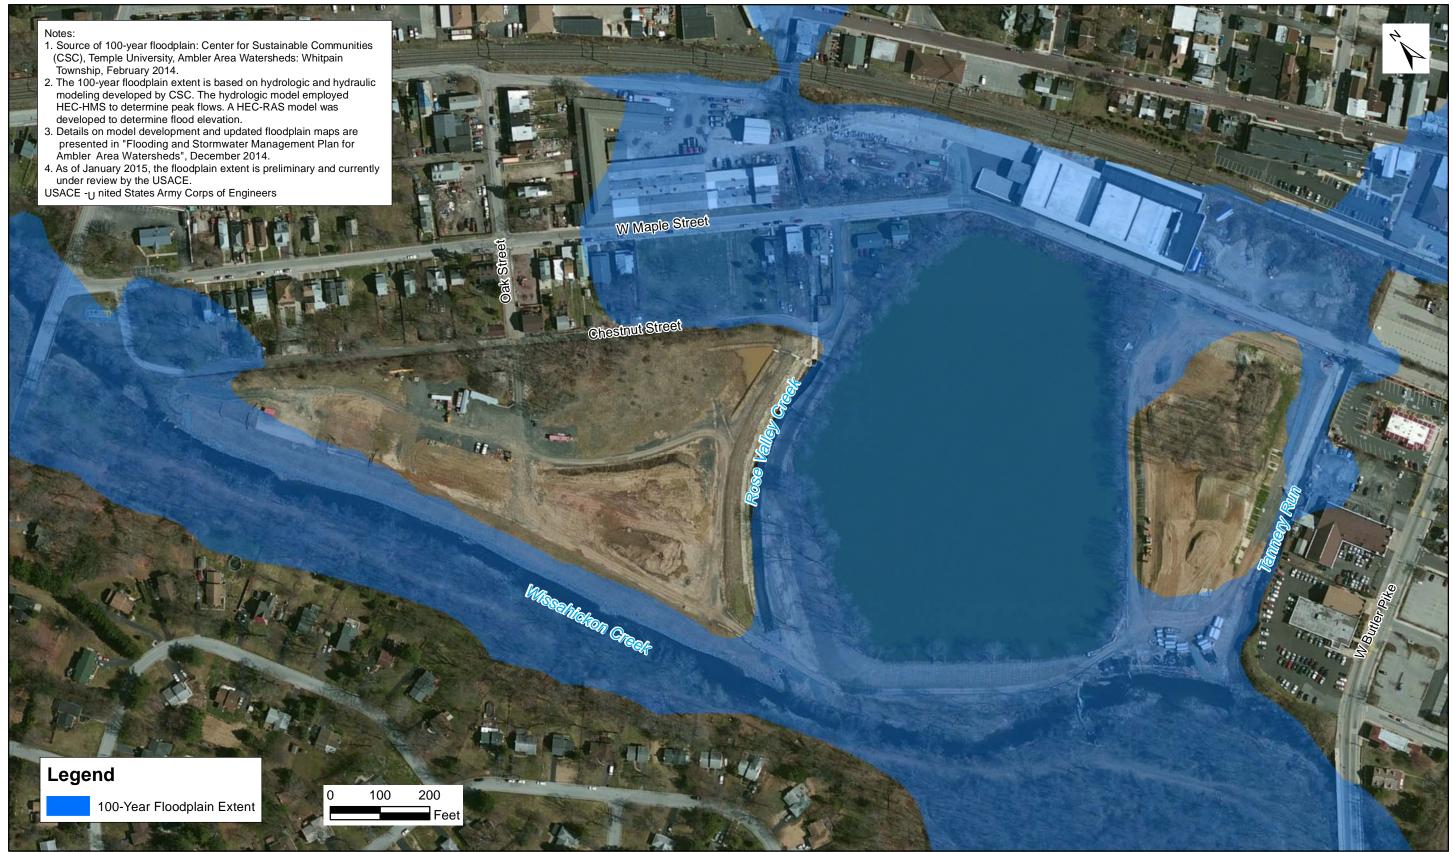
Figure ES-9 Preliminary 100-Year Floodplain Extent

prepared a stormwater management plan for urban watersheds in southeastern Pennsylvania (CSC 2014). The plan presents the results of watershed studies conducted to update 1996 FEMA flood hazard zones at the BoRit Site, specifically the 100-year and 500-year floodplains (CSC 2014). The preliminary extent of the 100-year floodplain updated by CSC is shown in **Figure ES-9**. As of January 2014, updated floodplain maps are currently under review by the USACE. CSC's preliminary floodplain maps were generated based on hydrologic and hydraulic models employed to determine peak flows and flood elevations (CSC 2014). The 100-year flood zone was identified to be an area surrounding the three creeks that intersect the BoRit Site: Wissahickon Creek, Rose Valley Creek, and Tannery Run. The northern area of the Asbestos Pile extends into the 100-year floodplain. Relative to the 1996 FEMA maps, recent updates to the 100-year flood zone show the 100-year flood extent increasing in area to surround the entire perimeter of the Reservoir and extending northwest up West Maple Street. The CSC's stormwater management plan for Ambler area watersheds also provides Site-specific recommendations which include channelization for Rose Valley Creek in West Ambler to significantly reduce the 100-year floodplain immediately northwest of the Reservoir parcel. The CSC's stormwater management plan also recommends consideration of flooding and stormwater management issues while EPA remediation efforts continue on the Site (CSC 2014).

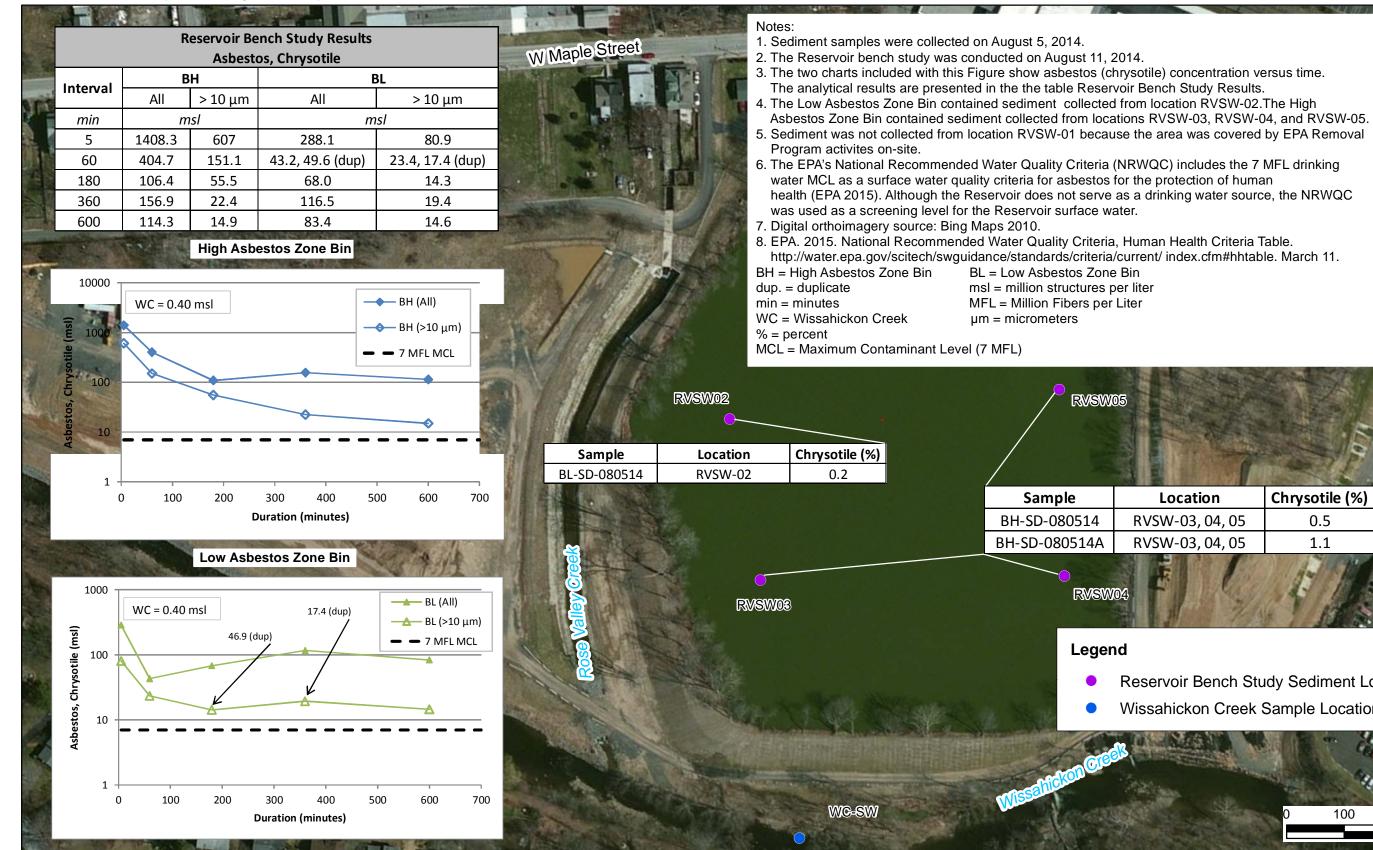
Figure ES-11 **Reservoir Bench Study** Sediment Locations and Reservoir Bench Study Results Path: F:\Borit\GIS\ArcGIS\Projects\FS\Figure_1-1_Site_Map.mxd

and the second
Location	Chrysotile (%)
RVSW-03, 04, 05	0.5
RVSW-03, 04, 05	1.1
	and the

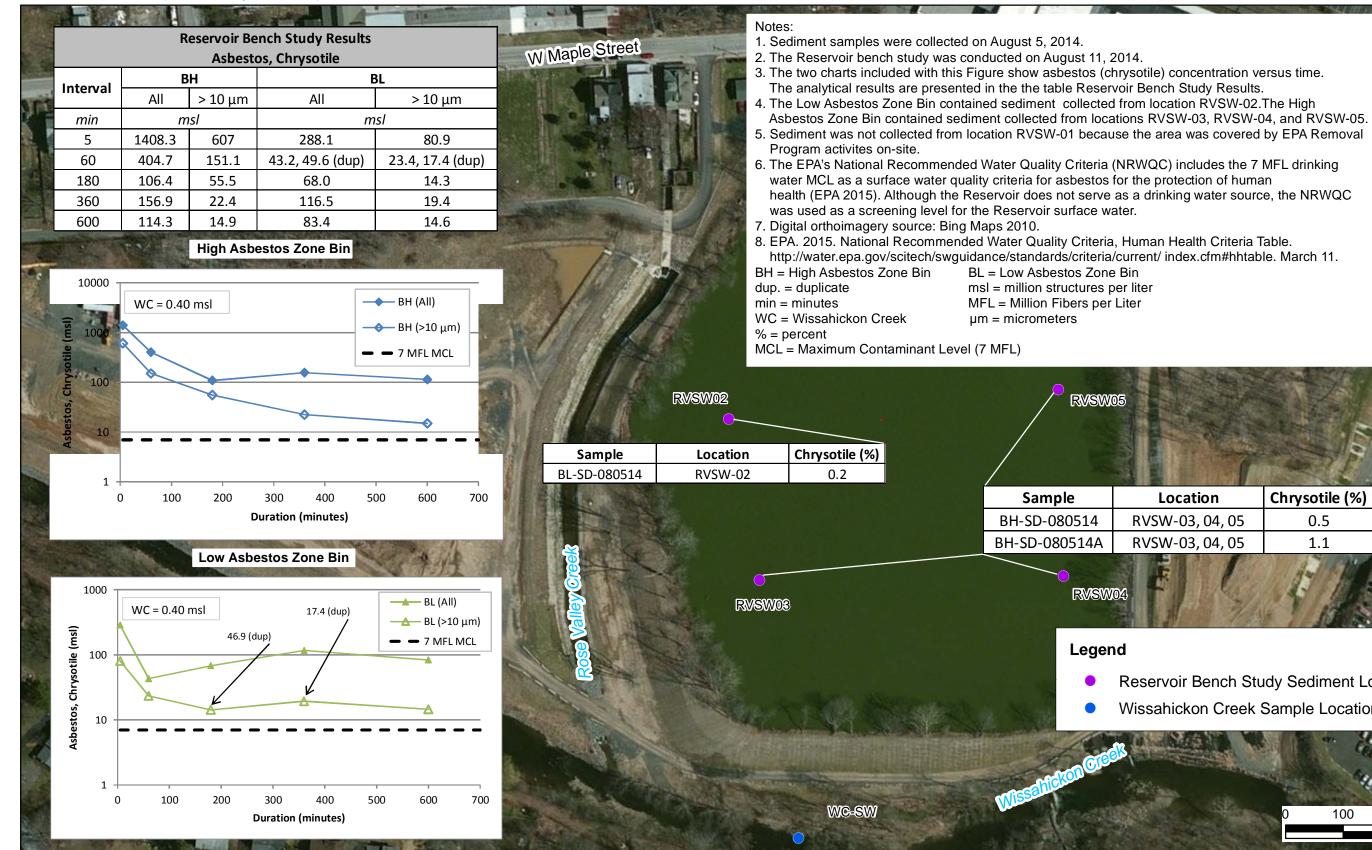
Figure 4-1 **Reservoir Bench Study** Sediment Locations and Reservoir Bench Study Results Path: F:\Borit\GIS\ArcGIS\Projects\RI Addendum\Figure_5-1_Weston_Reservoir_Sediment_Locations.mxd

AND THE REAL
Location	Chrysotile (%)
RVSW-03, 04, 05	0.5
RVSW-03, 04, 05	1.1
	11 1 1 1 1 1 1

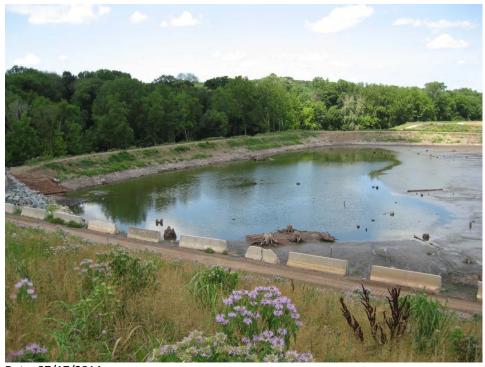
Date: 07/17/2014 Time: 1149

Description: Southern corner of the Reservoir during pumping. Photograph was taken facing southwest from the top of the Asbestos Pile.

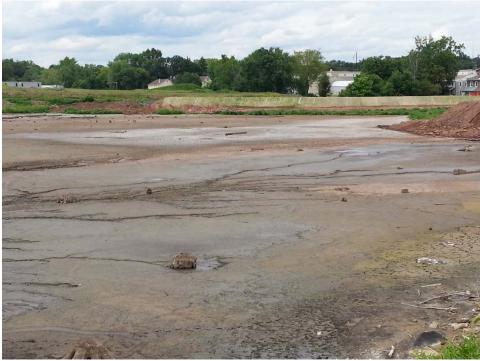
Date: 07/29/2014 Time: 1428 Description: Center

Description: Center portion of Reservoir during pumping. Photograph was taken facing northwest from the construction access road between the Asbestos Pile and the Reservoir.Photographer: A. Donaghue (CDM Smith)

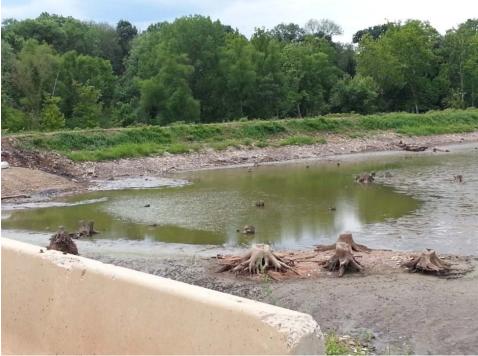
Date: 07/29/2014 Time: 1429

Description: Southern corner of the Reservoir during pumping. Photograph was taken facing southwest from the construction access road been the Asbestos Pile and the Reservoir.

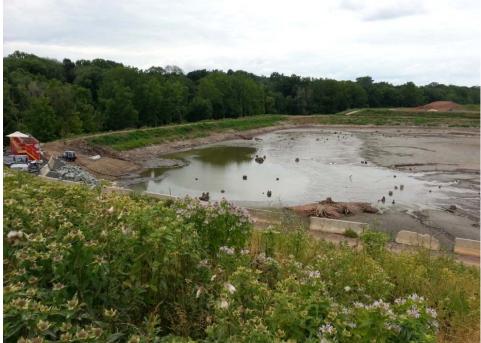
Date: 07/29/2014 Time: 1449 Description: Western, southwest end of the Reservoir taken from the top of the Asbestos Pile. Photograph was taken facing southwest. Photographer: A. Donaghue (CDM Smith)

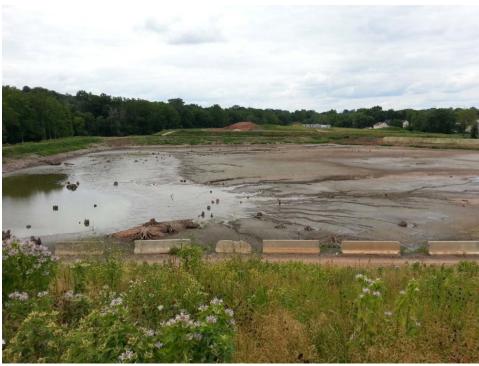
Date: 07/29/2014 Time: 1449

Description: Center portion of the Reservoir taken from the top of the Asbestos Pile. Photograph was taken facing west.

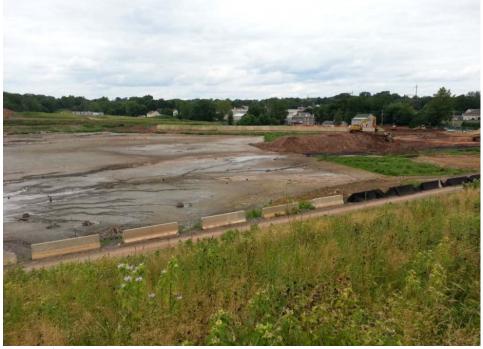
Date: 07/29/2014 Time: 1449

Description: Northern end of the Reservoir taken from the top of the Asbestos Pile. Photograph was taken facing north.

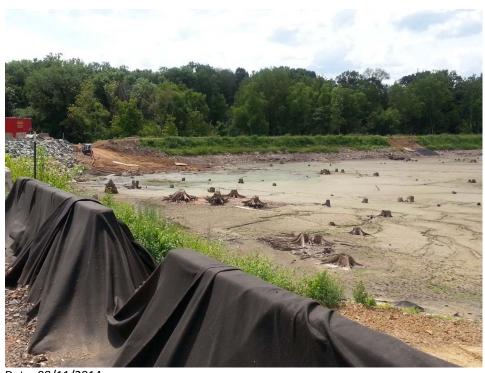
Date: 08/11/2014 Time: 1429

Description: Western, southwest end of the Reservoir after continuous pumping terminated on July 31, 2014. Photograph was taken facing southwest.

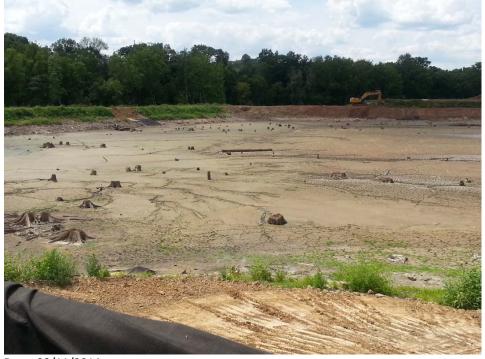
Date: 08/11/2014 Time: 1429 Description: Center portion of Reservoir after continuous pumping terminated on July 31, 2014. Photograph was taken facing west.

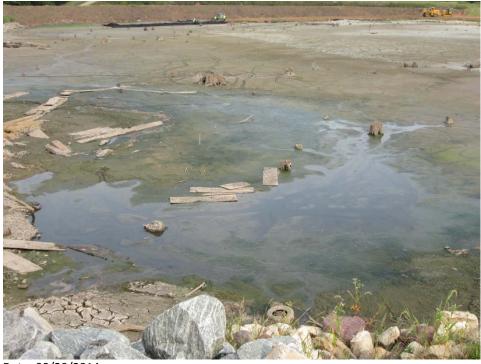
Date: 08/20/2014 Time: 0917

Description: Southwestern end of the Reservoir after continuous pumping terminated on July 31, 2014. Photograph was taken facing northwest. Photographer: J. Lowe (EPA)

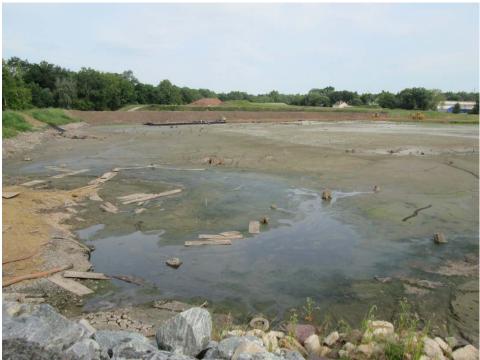
Date: 08/20/2014 Time: 0918 Description: Southwestern end of the Reservoir after continuous pumping terminated in July 31, 2014. Photograph was taken facing northwest. Photographer: J. Lowe (EPA)

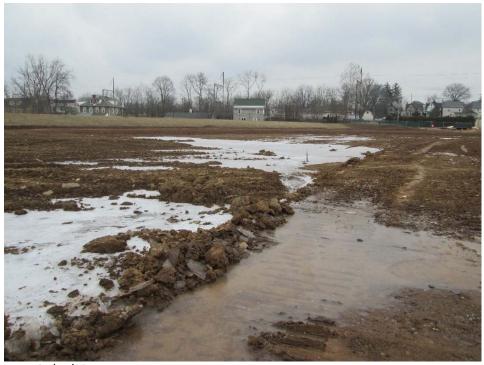
Date: 01/15/2015 Time: 1049

Description: Photograph of the Reservoir taken facing north towards West Maple Street. Water is shown accumulating over clean fill material and geotextile fabric placed on the Reservoir bottom by the EPA Removal
