Potential Bank Stabilization Methods

**Wissahickon Creek, Tannery Run and Rose Valley Creek
near the Bo-Rit Site
Ambler, Pennsylvania**

Prepared for
**United States Environmental Protection Agency
Region III**

September 2006

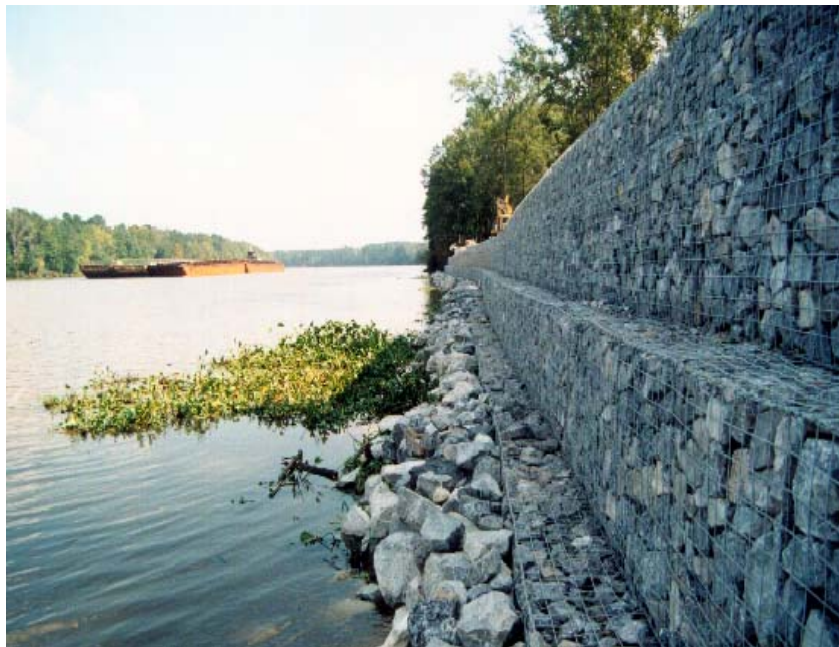
Gabion Wall

Gabion Wall

Wissahickon – Possible. Not recommended due to potential basket failure and high O&M.

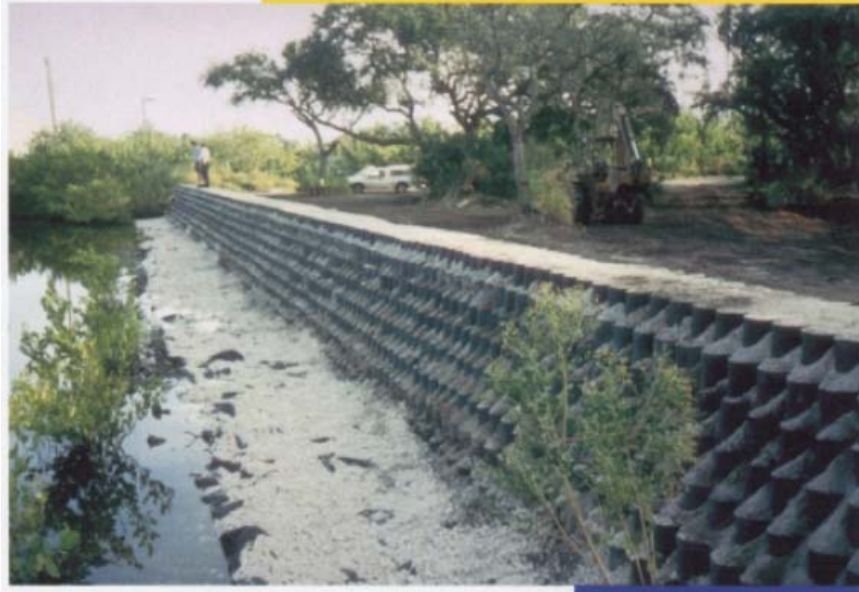
Stacked Geoweb Wall

Confined Cellular System Wall (CCS)

Wissahickon – Possible. Not recommended due to relative cost.

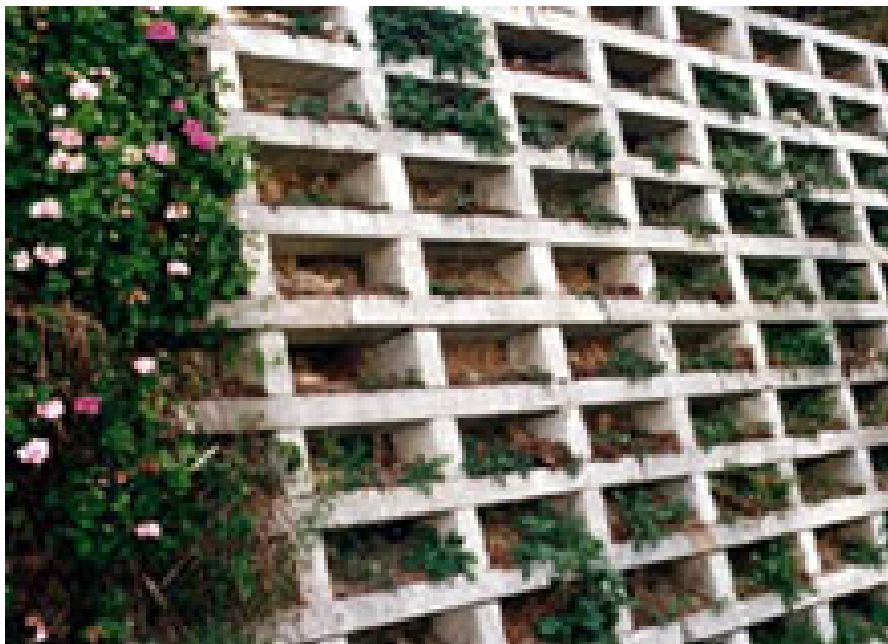
Bin Wall

Bin Wall

Wissahickon – Inappropriate due to relative cost

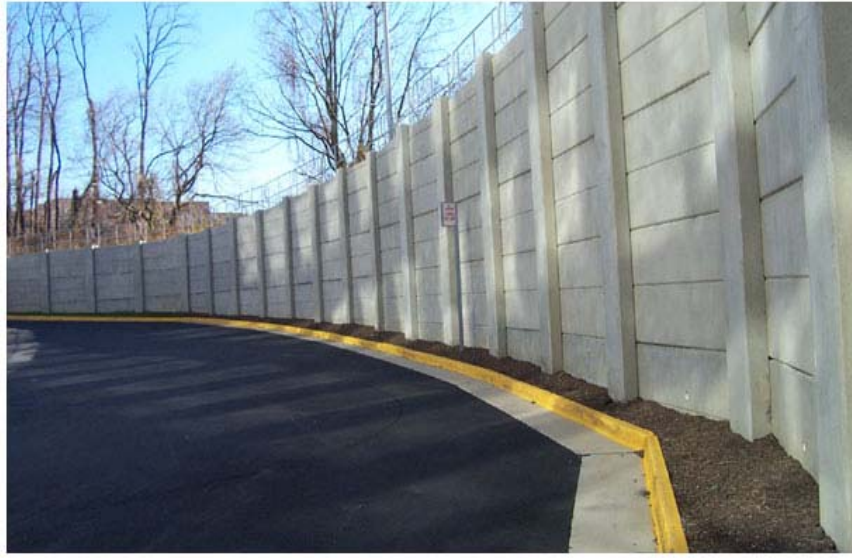
Post and Panel Wall

Post & Panel

Wissahickon – Possible. Not recommended due to relative cost

Tannery Run – Possible. Cost estimate will be computed.

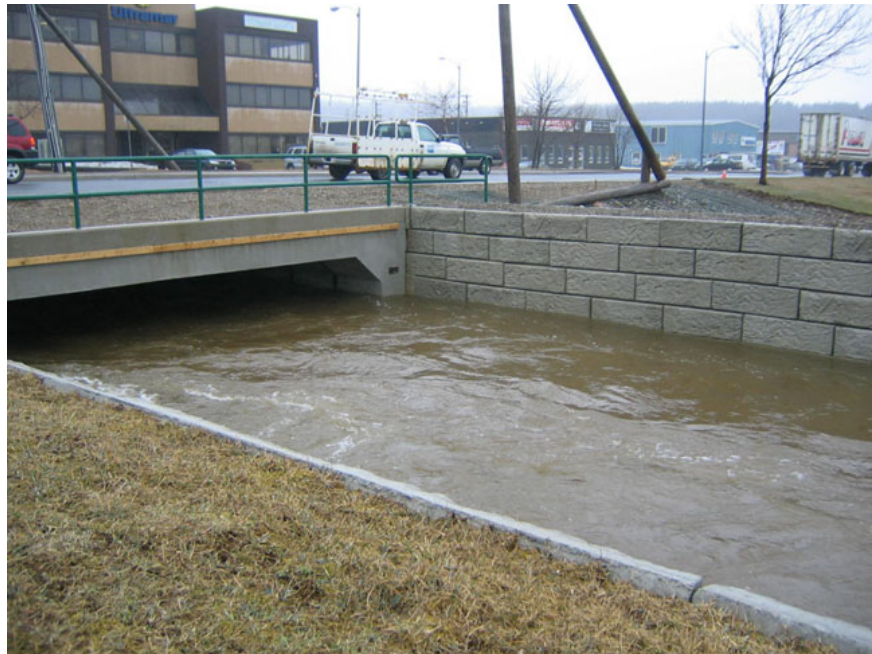
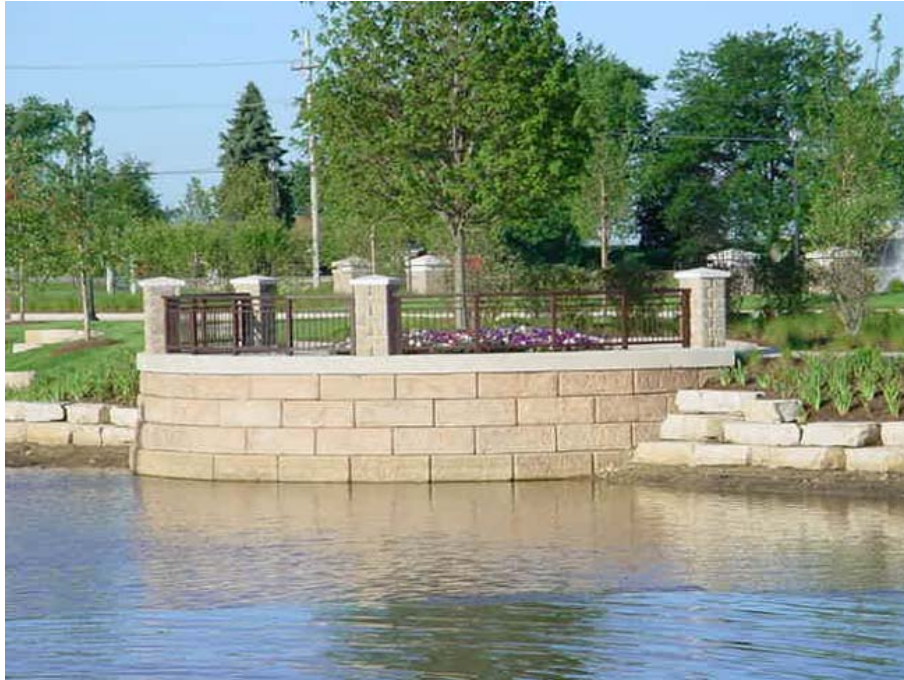
Precast Concrete Block Wall

Pre-cast Concrete Blocks

Wissahickon – Possible. Cost estimate will be computed.

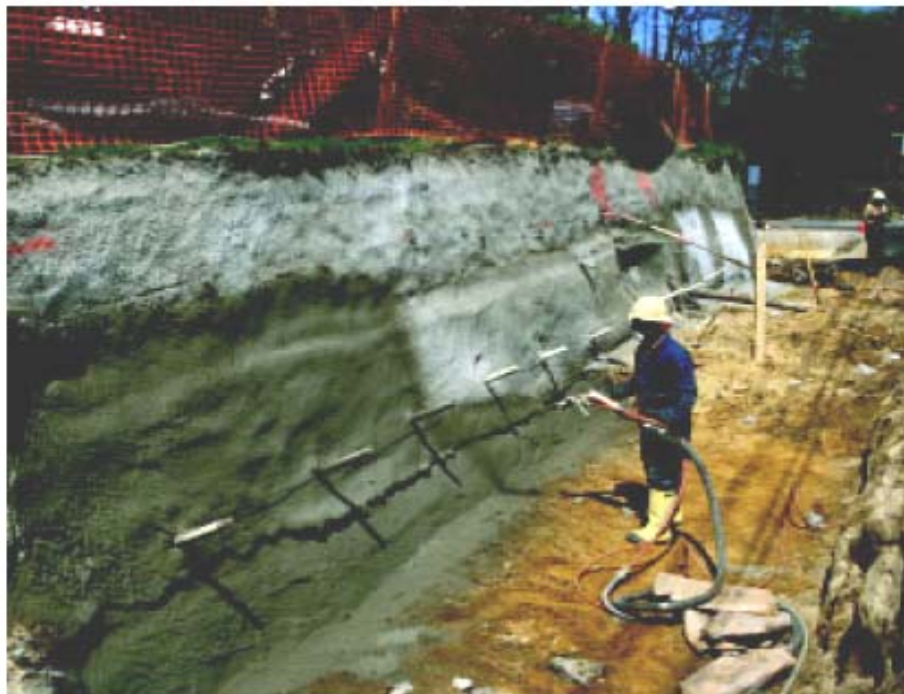
Soil Nailed Wall with Shotcrete Cover

Soil Nailed Wall with Shotcrete Cover

Tannery Run – Possible. Recommended due to limited possibilities for steep slopes. Cost estimate will be computed.

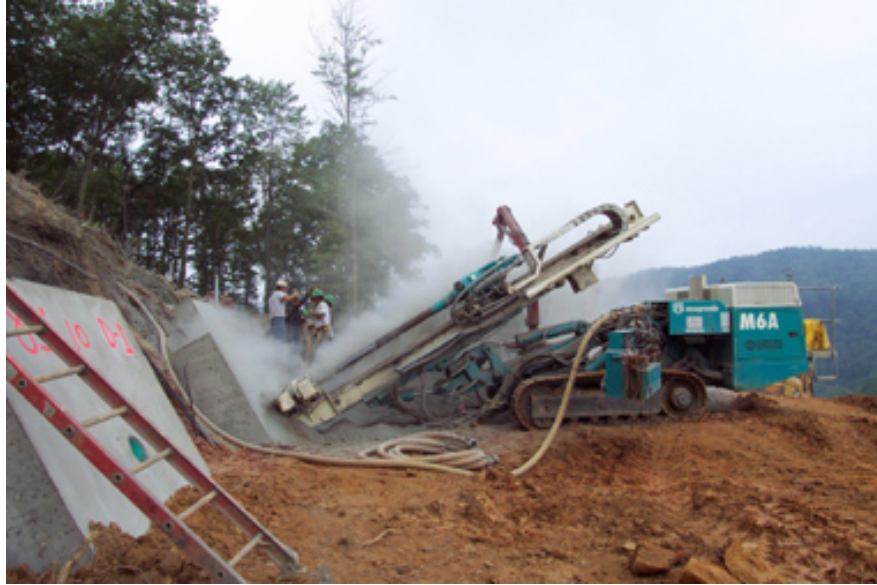
Soil Nailed Wall with Shotcrete Cover- Drilling for Nails

Due to the narrow channel width along Tannery and Rose Valley, construction may have to be performed from the tops of the existing banks. However, some options, such as soil nail with shotcrete and possibly the post and panel wall will require access from the bottom of the banks.

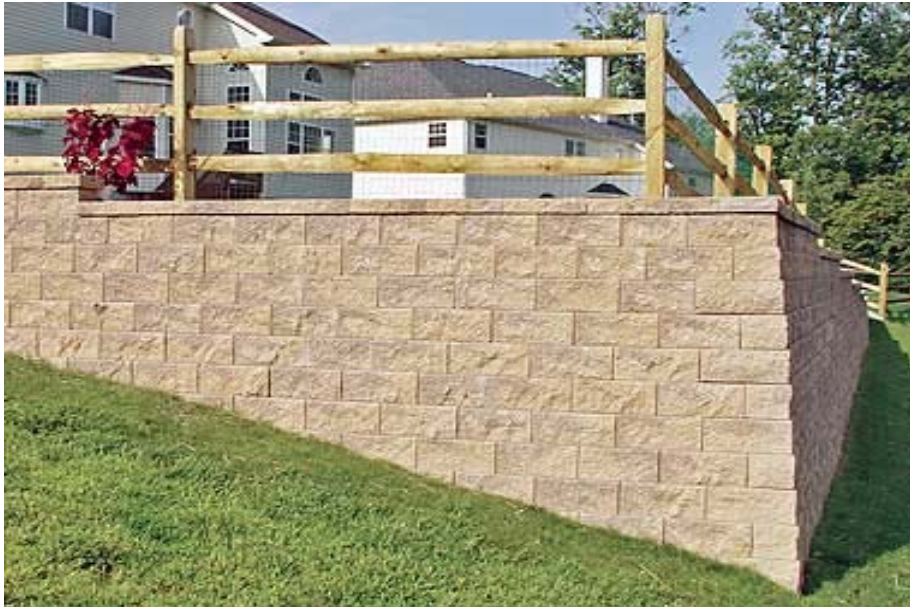
Architectural Block Wall (Smaller Size)

Architectural Block Wall

Rose Valley – Possible. Cost estimate will be computed.

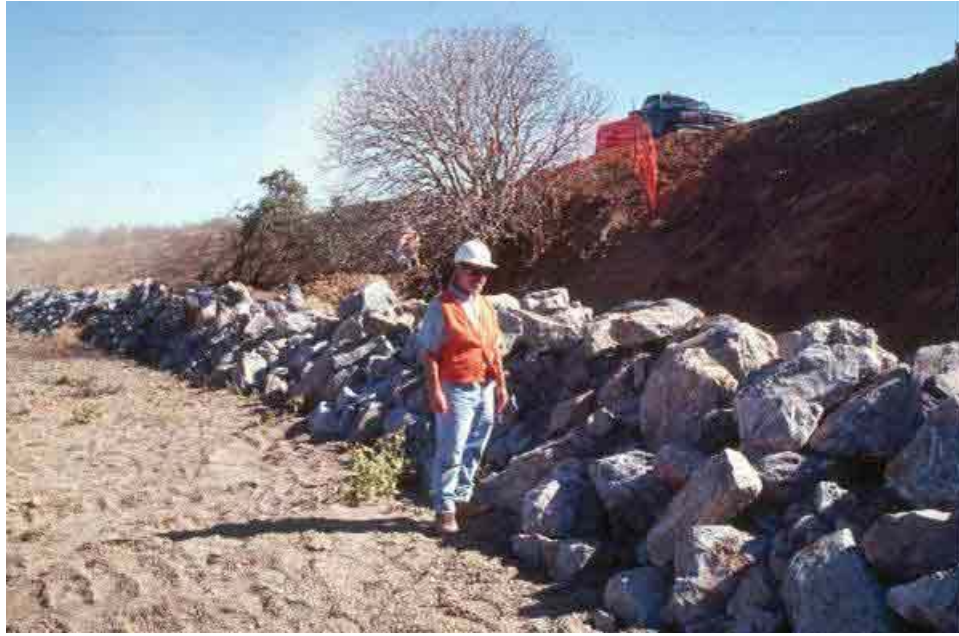
Natural Stone Toe (Large Stone)\

Natural Toe Stone (Large Stone)

Wissahickon – Possible. Cost estimate will be computed.

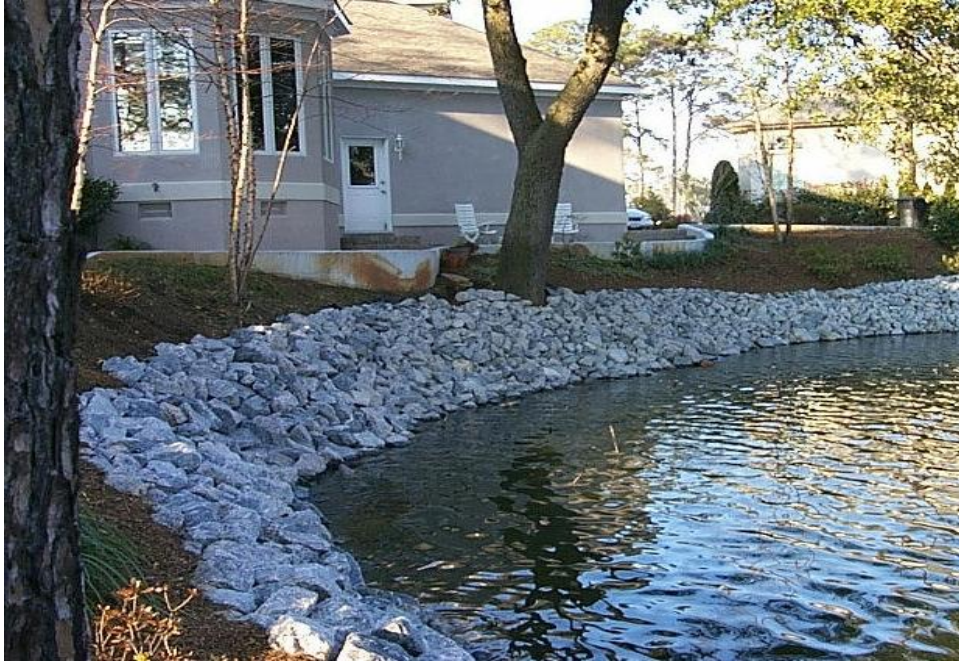
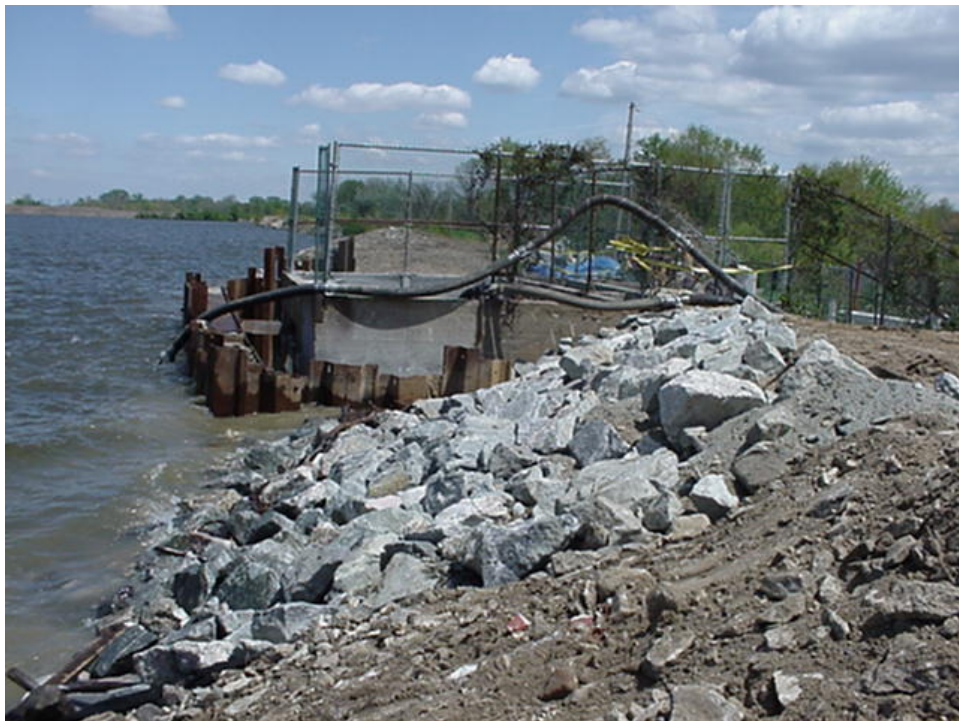
Riprap

Riprap

Wissahickon – Possible, but not recommended. Relative cost too high due to notching of riprap into the bedrock stream bottom.

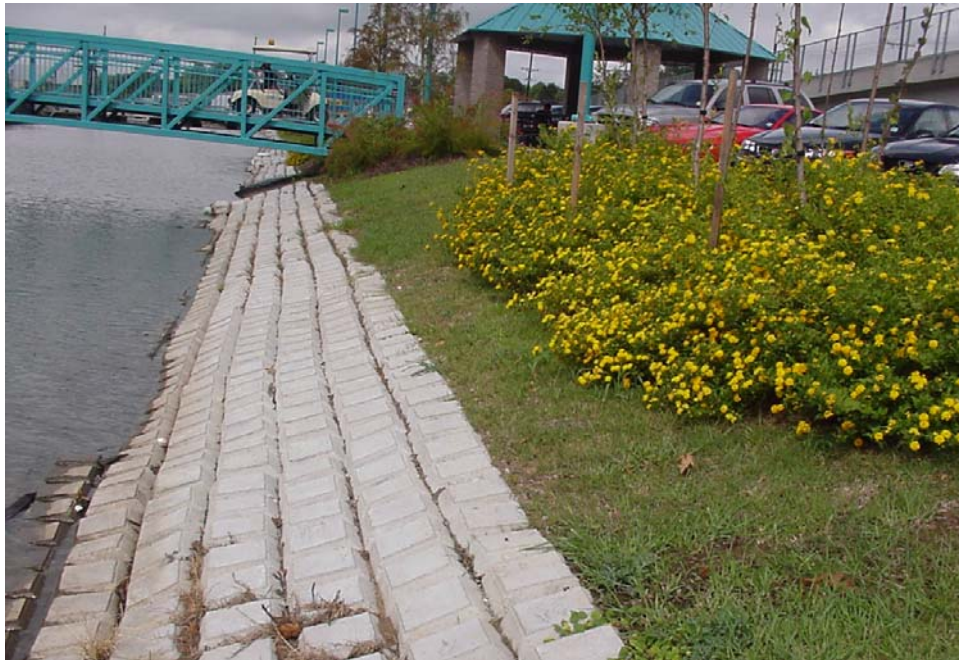
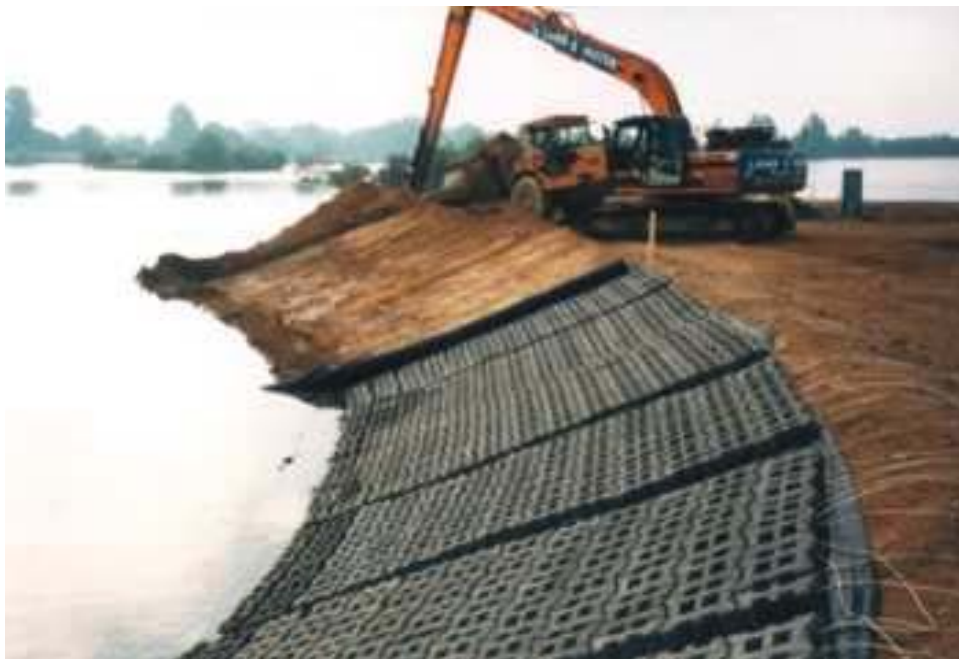
Articulated Concrete Mat

Articulated Concrete Mat

Wissahickon – Possible. Cost estimate will be computed.

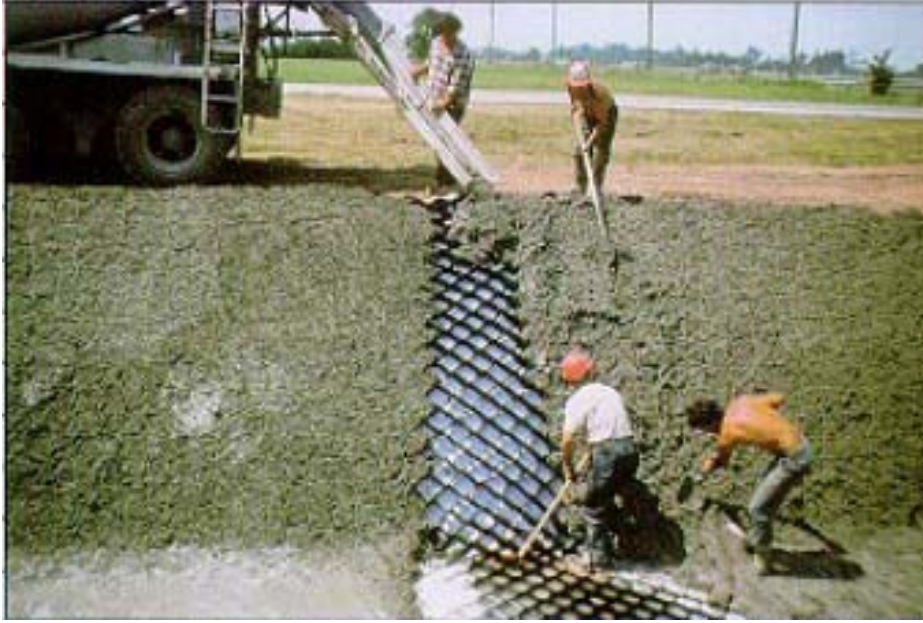
Concrete Filled Geoweb

Geoweb (Concrete Filled)

Tannery Run – Possible on right bank only. Left bank is too steep in places. Cost will be computed for right bank.

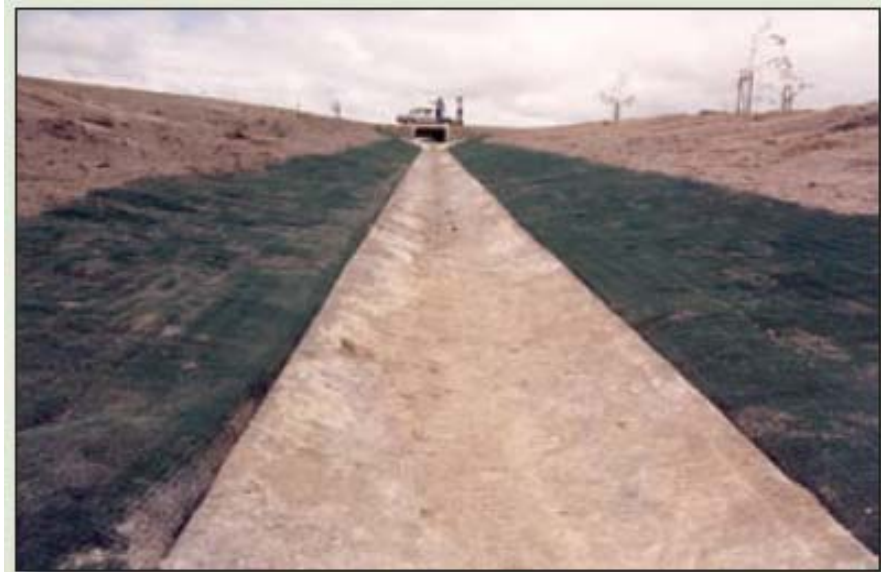
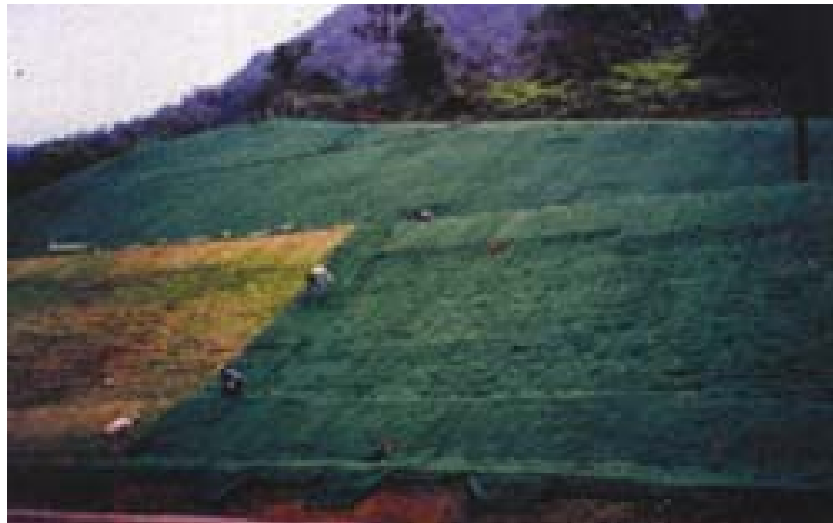
Erosion Control Mat

Erosion Control Mat

Wissahickon – Possible. Cost estimate will be computed.

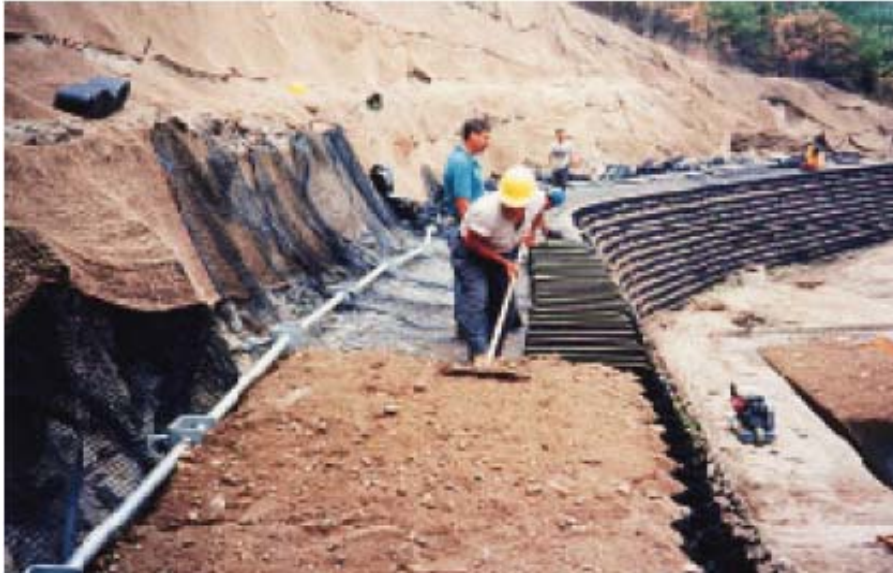
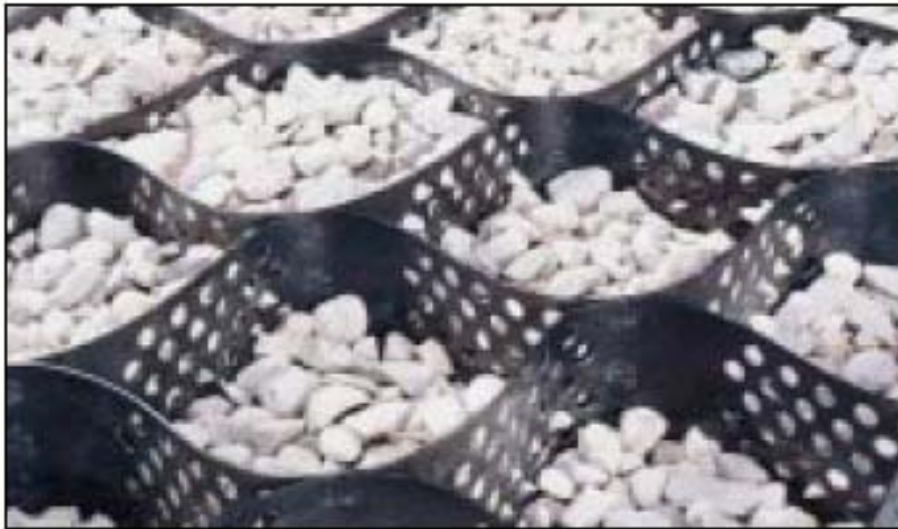
Geoweb (Gravel Filled)

Geoweb (Gravel Filled)

Wissahickon – Possible. Cost estimate will be computed.

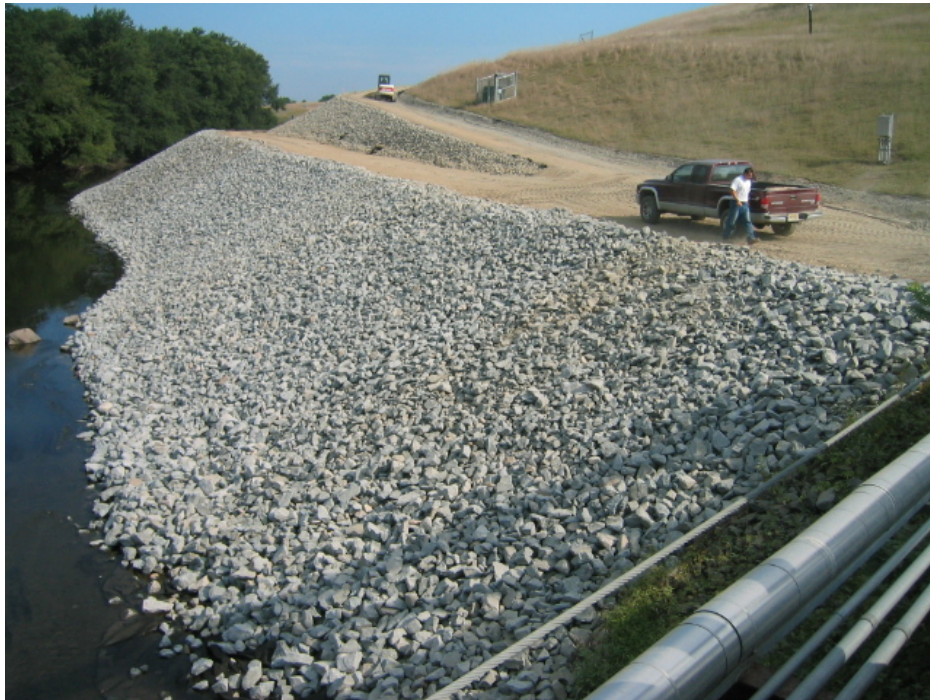
Small Riprap

Small Riprap

Wissahickon – Possible. Cost estimate will be computed.

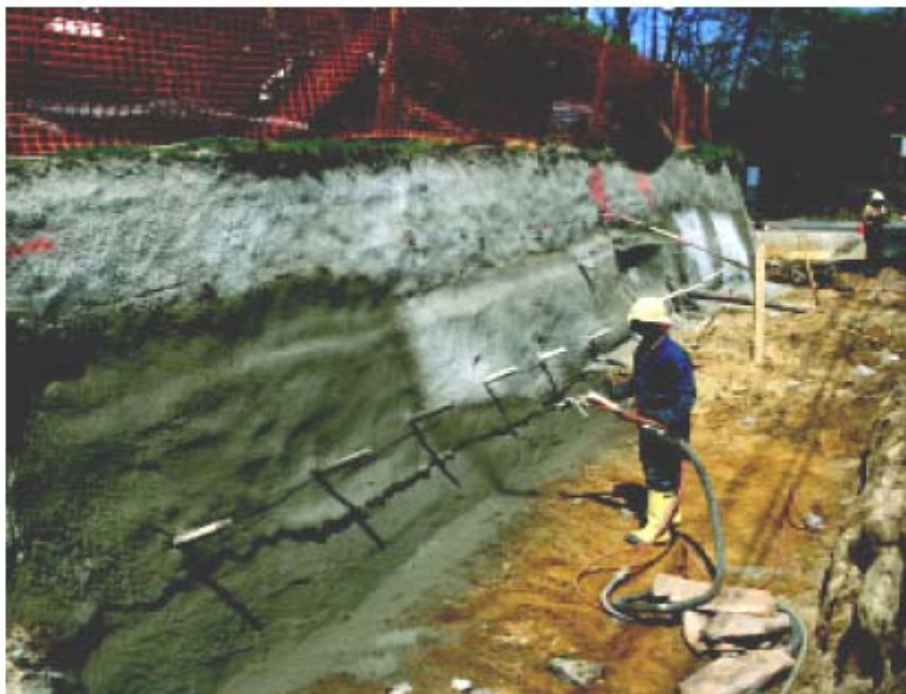
Soil Nailed Wall with Shotcrete Cover

Soil Nail & Shotcrete

Tannery Run – Possible. Not recommended on right bank due to high relative cost. Recommended for left bank due to limited possibilities for steep slopes.

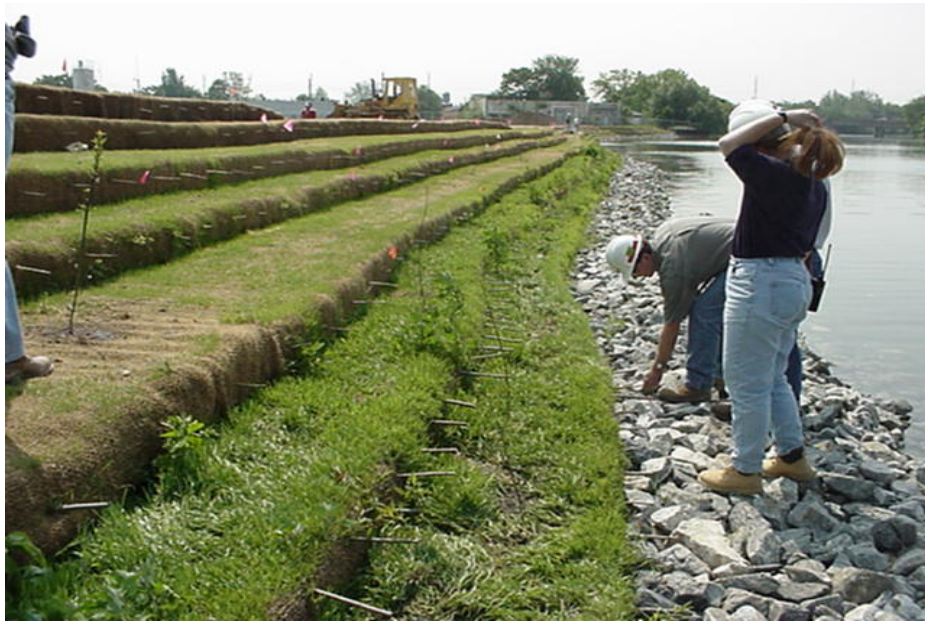
Willow Plantings (Coir Mat)

Willow Plantings (Coir Mat)

Wissahickon – Inappropriate since Willows will be planted above toe protection where soil will not be wet enough.

Tannery Run – Inappropriate due to steep banks with insufficient space for planting benches required for Willows.
