**FIVE-YEAR REVIEW REPORT FOR  
RYELAND ROAD ARSENIC SUPERFUND SITE  
BERKS COUNTY, PENNSYLVANIA**

**September 2016**

**Prepared By:  
United States Environmental Protection Agency  
Region 3  
Philadelphia, Pennsylvania**

# **Second Five-Year Review Report for Ryeland Road Arsenic Superfund Site**

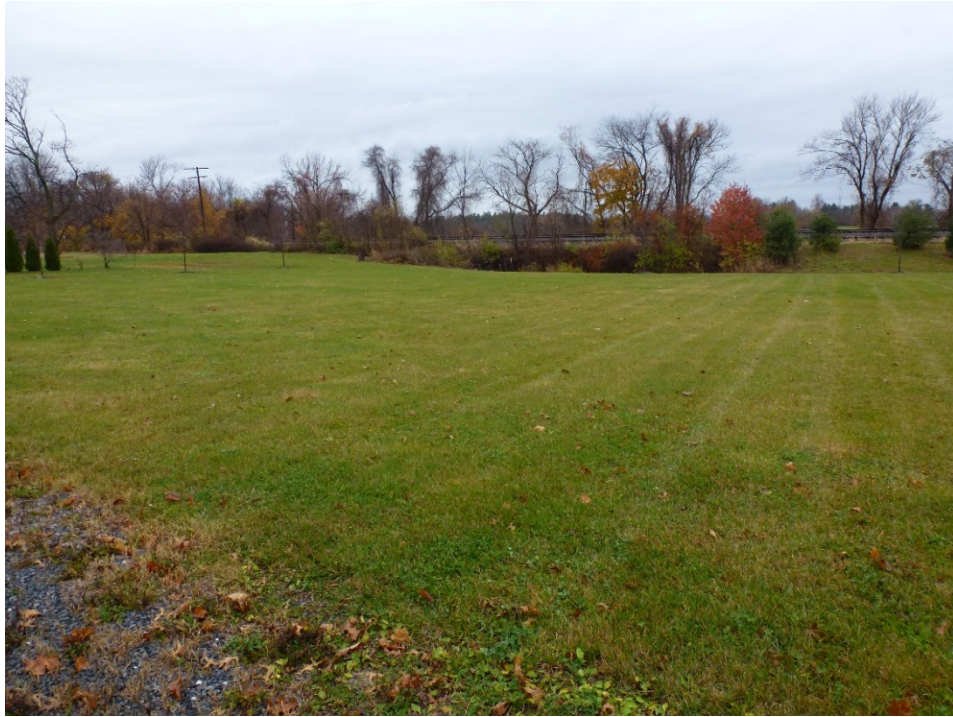
Vegetated and landscaped NSA field

The inspection of the NSA area, on the northern side of West Ryeland Road, determined that the grass cover established at the site during the RA, continues to be well established and vegetated, including the rail line embankment. The former spring-fed pond which is now the EPA-constructed wetland, the existing spring-fed creek, tributaries of the Tulpehocken creek, and VFW post area were inspected. The former spring-fed pond area where the wetland was constructed is in good condition though some invasive species (phragmites and knotweed) were observed. The (former) phytoremediation area was also in good shape. The VFW Park area showed no sign of site-related issues. There was heavy rainfall on the day of the inspection but the land surface was drier than usual due to low rainfall in the preceding months.

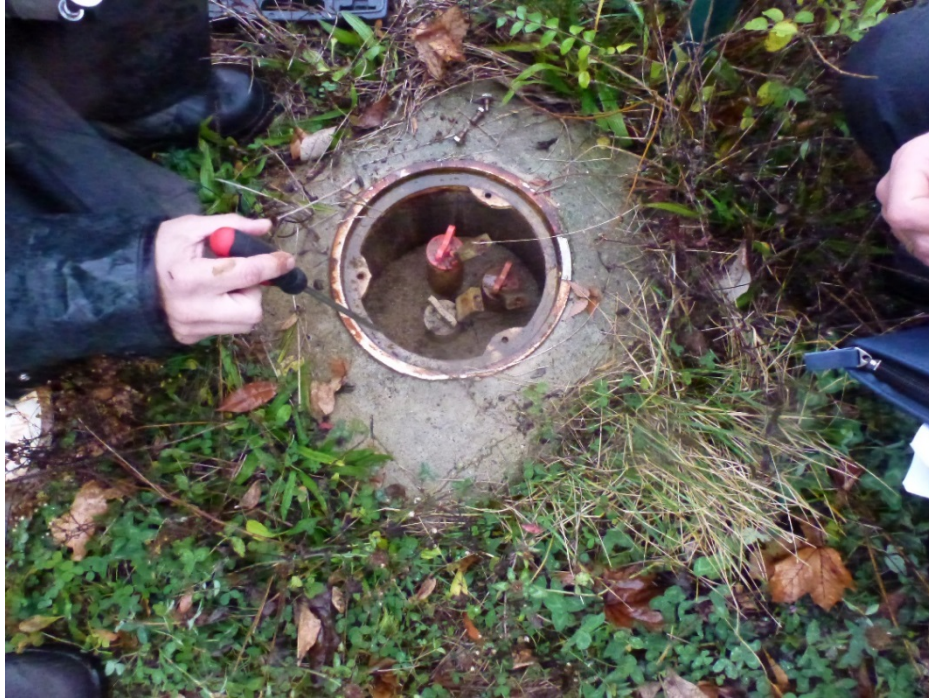
Open wells MW 12 S, M and D. All wells observed were flush mounted, locked and appeared to be in good working order, labels are on inside

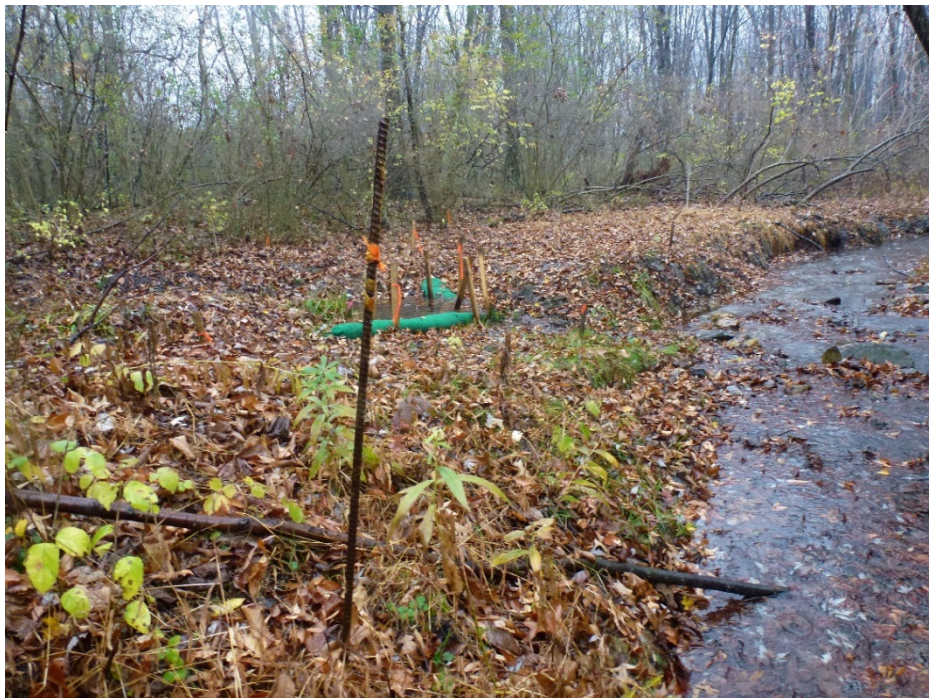
Plot A fern bioremediation area - the seep feeding the stream at Plot A is undergoing pilot studies to determine if a permeable reactive barrier can treat arsenic coming out of the seep

Groundwater monitoring wells and permeable reactive barrier (PRB) logs, placed in the spring-fed creek as part of a pilot study to treat groundwater seeps, were also inspected and found to be in good condition.

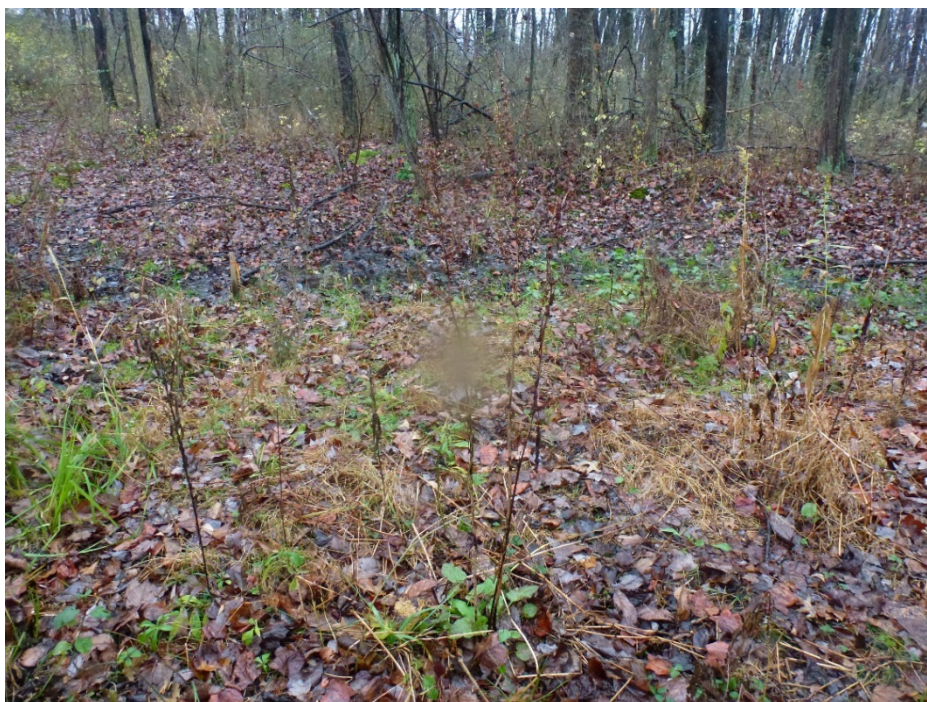
Plot B fern bioremediation area - this area was washed out during the previous FYR. Rocks deposited during the flood event are sinking back into the ground

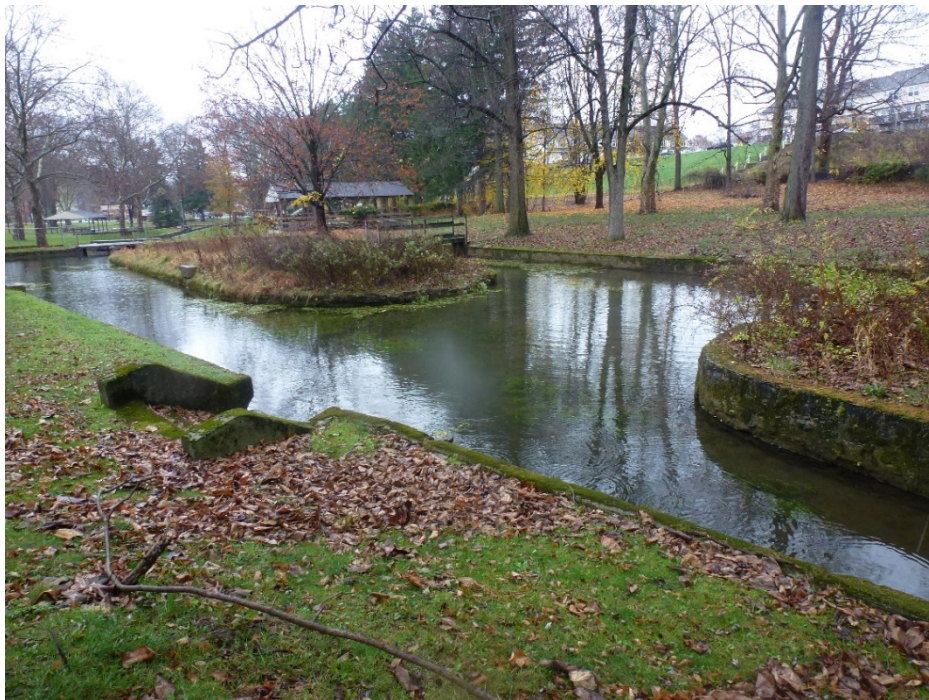
Ponds at the VFW Park. EPA dredged ponds during removal actions
