**Tennessee Valley Authority
Regulatory Submittal for Kingston Fossil Plant**

**On-Scene Coordinator Report for the Non-Time Critical Removal Action for the
Embayment/Dredge Cell**

EPA -AO-063

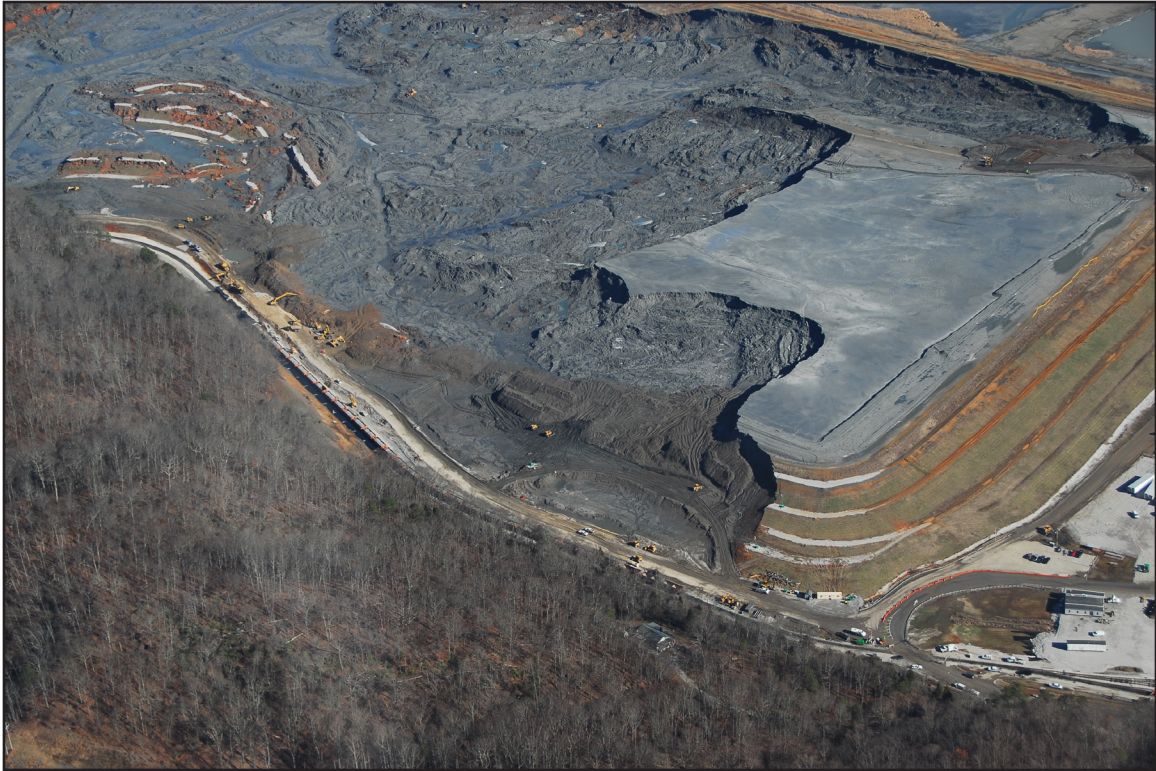
2A – Oblique of the failed Dredge Cell after release (viewing from the southwest). January 8, 2009.

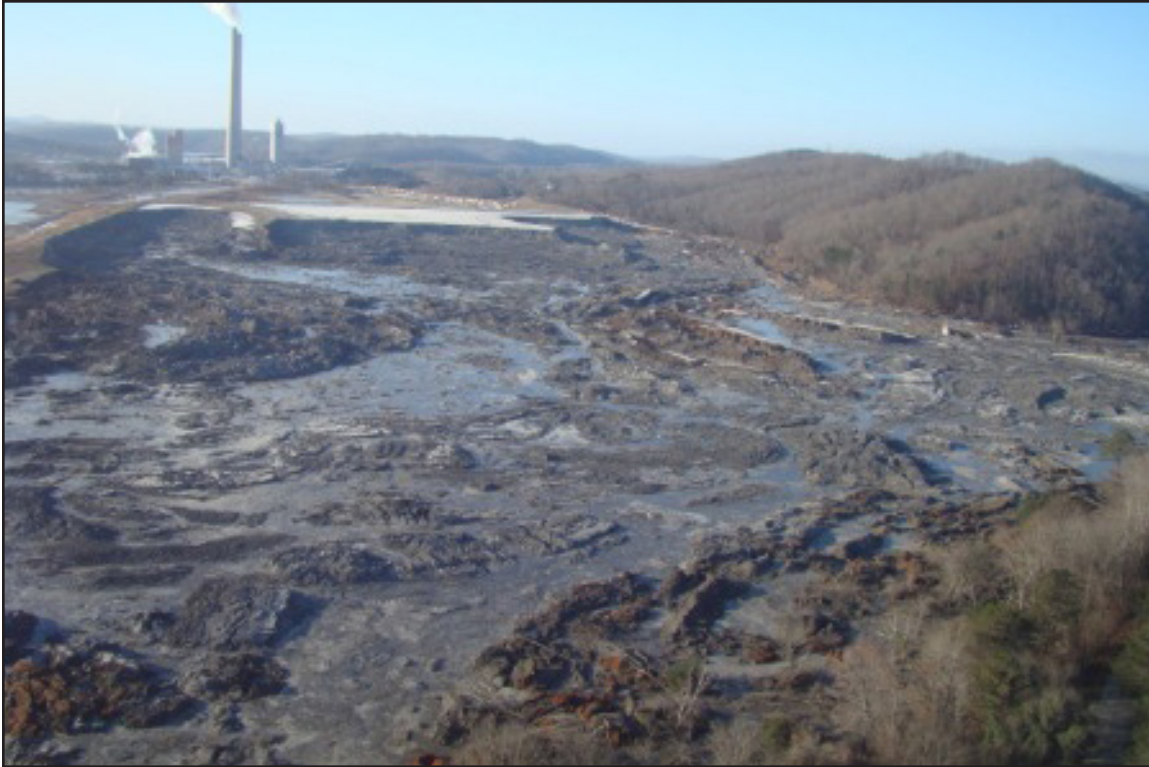
3A – Oblique of the failed Dredge Cell after release (viewing from the north). January 8, 2009.

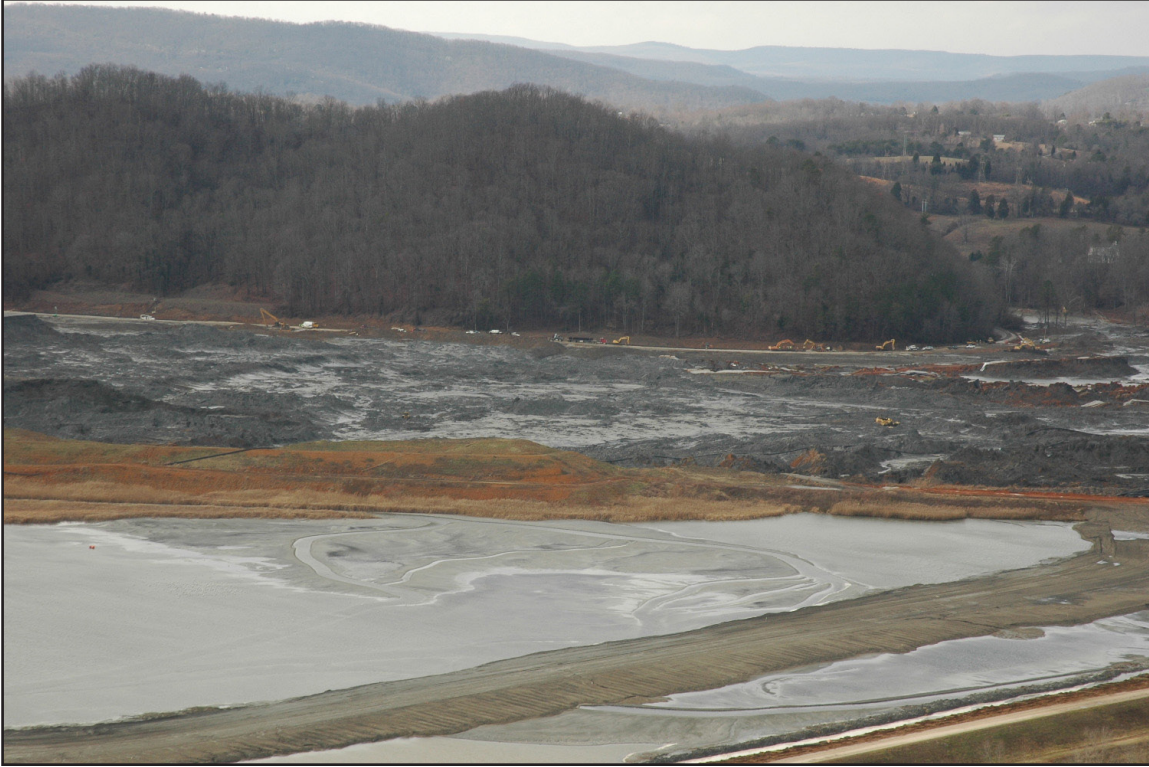
4A – Oblique of the failed Dredge Cell after release (viewing from the east). January 7, 2009.

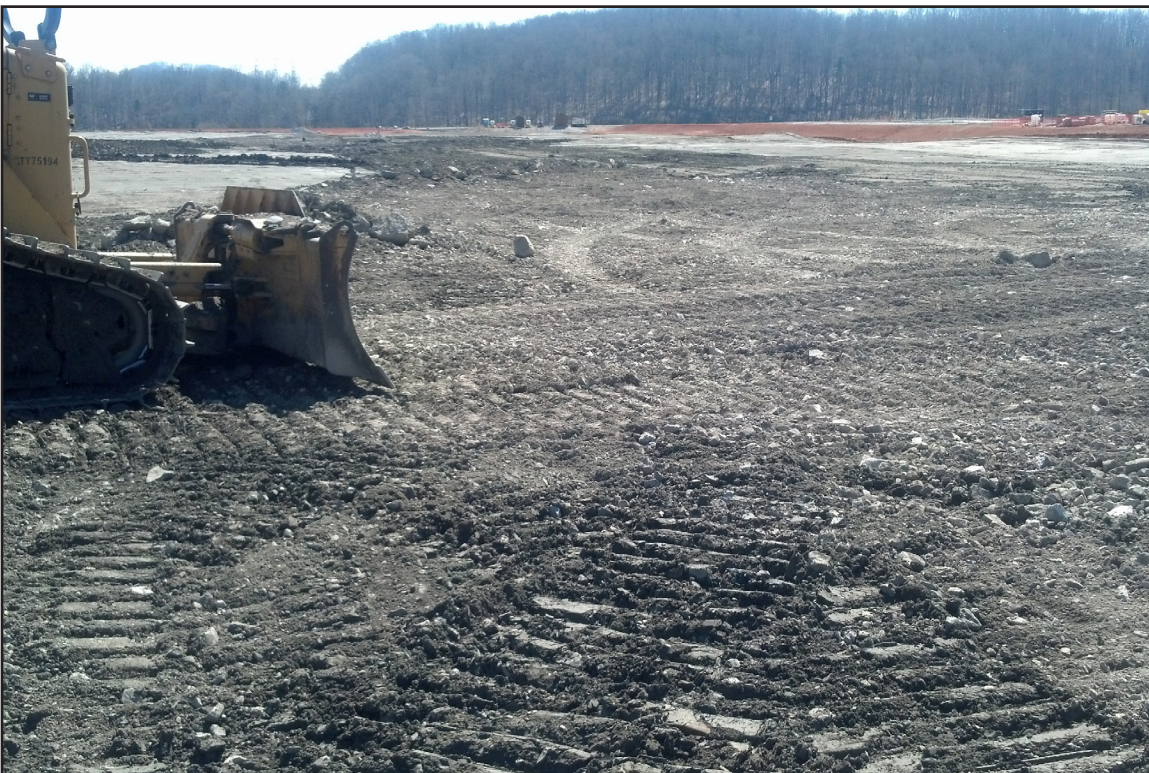
20B – Ash stacking: Stabilization of the subgrade in the Ash Pond using a gravel base. March 20, 2014.

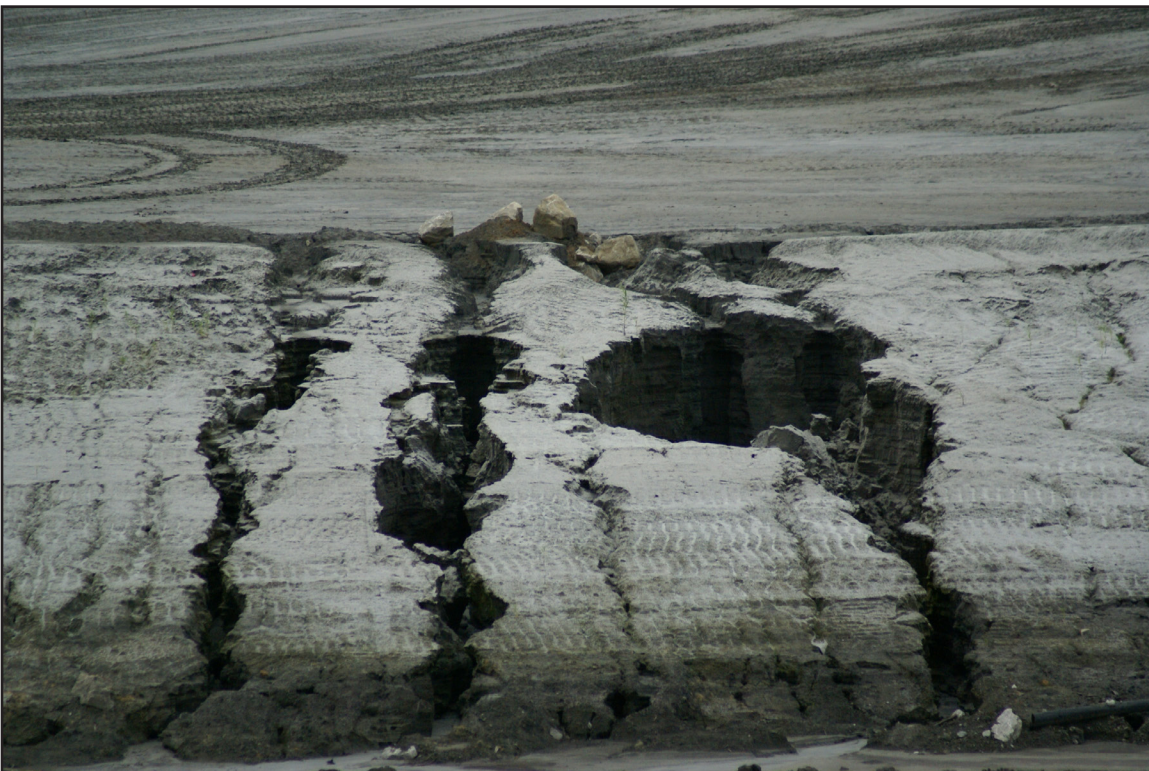
21B – Ash Stacking: Erosion damage to edge of ash stack following storm event. August 12, 2013.

- Ash stacking lessons learned. Geotechnical monitoring, including piezometers and inclinometers, proved critical to safely controlling ash stacking rates. Prolonged wet weather degraded the stacking subgrade and impaired productivity. Mitigation measures such as waiting for the conditions to dry out, “clipping” the subgrade surface and replacing that material, and disking or blading the material in place to enhance drying were effective at improving subgrade conditions, but were nominally successful during winter months.

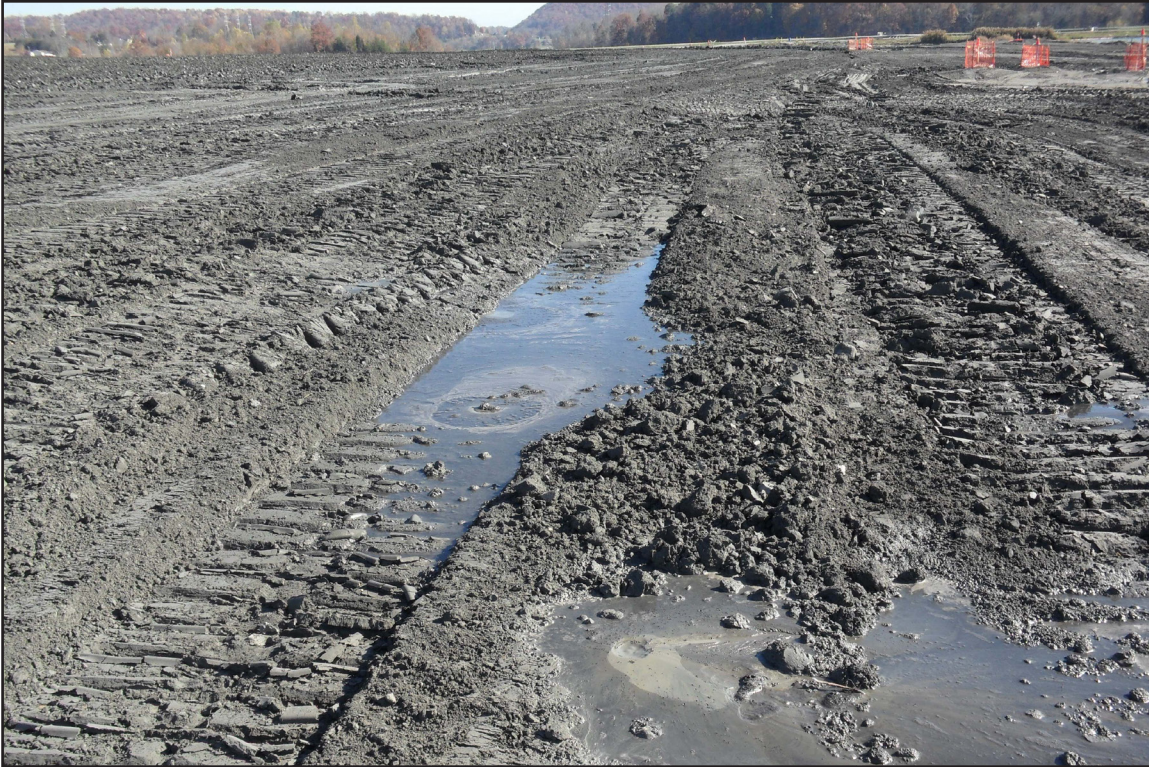
22A – Ash Stacking: Mud boils inducing wet subgrade conditions during ash stacking in the Lateral Expansion. November 8, 2011.

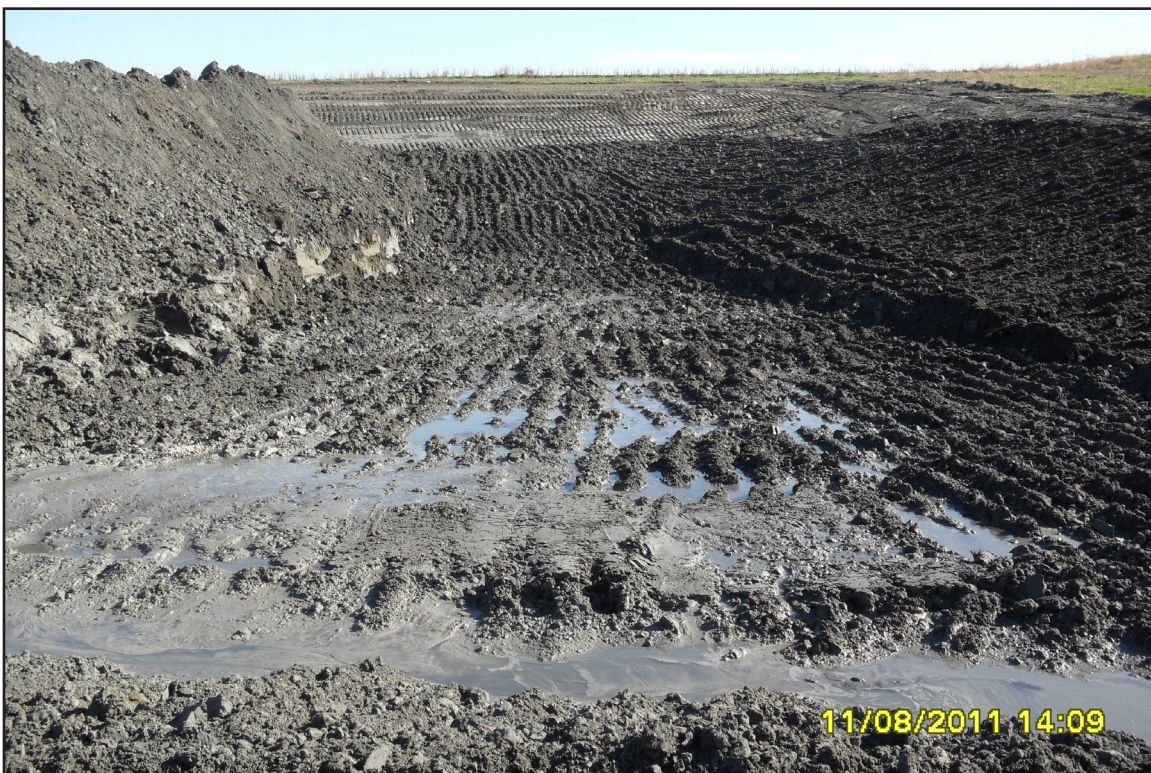
22B – Ash Stacking: Repair of mud boils by excavation of wet subgrade for construction of French drains. November 8, 2011.

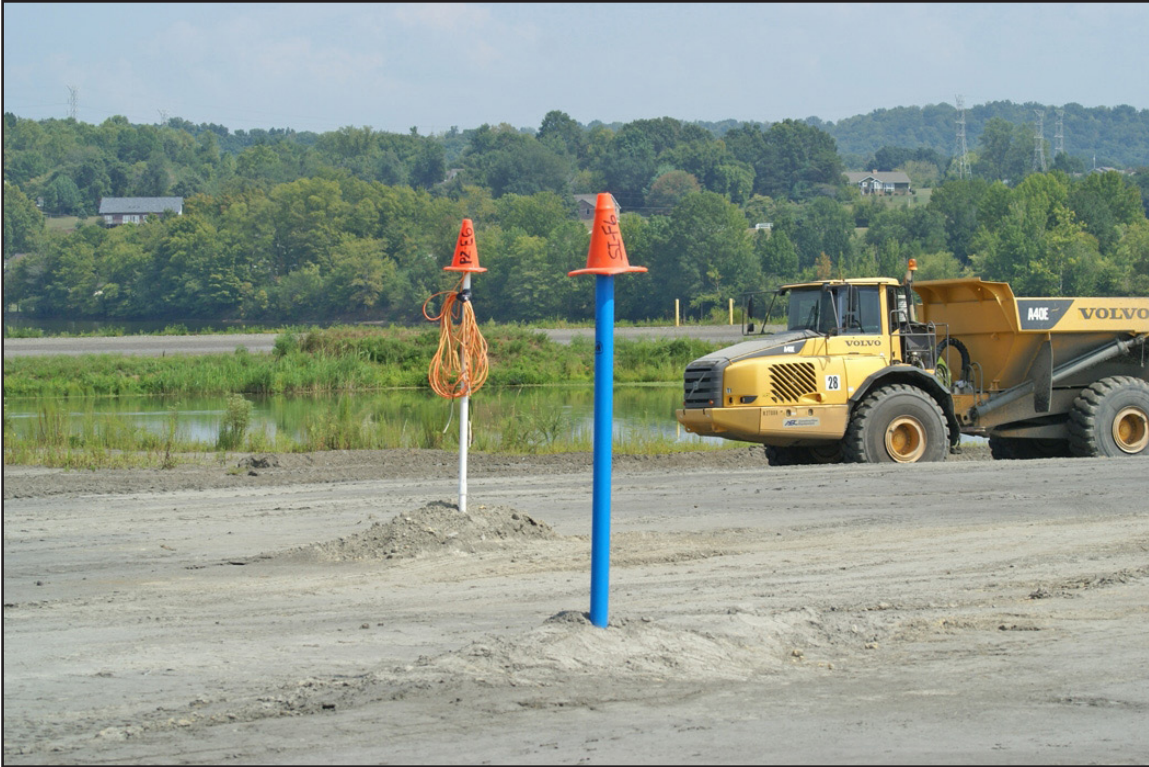
23A – Ash Stacking: Geotechnical instrumentation used for monitoring ash stacking; piezometers (white) and slope inclinometers (blue). August 30, 2011.

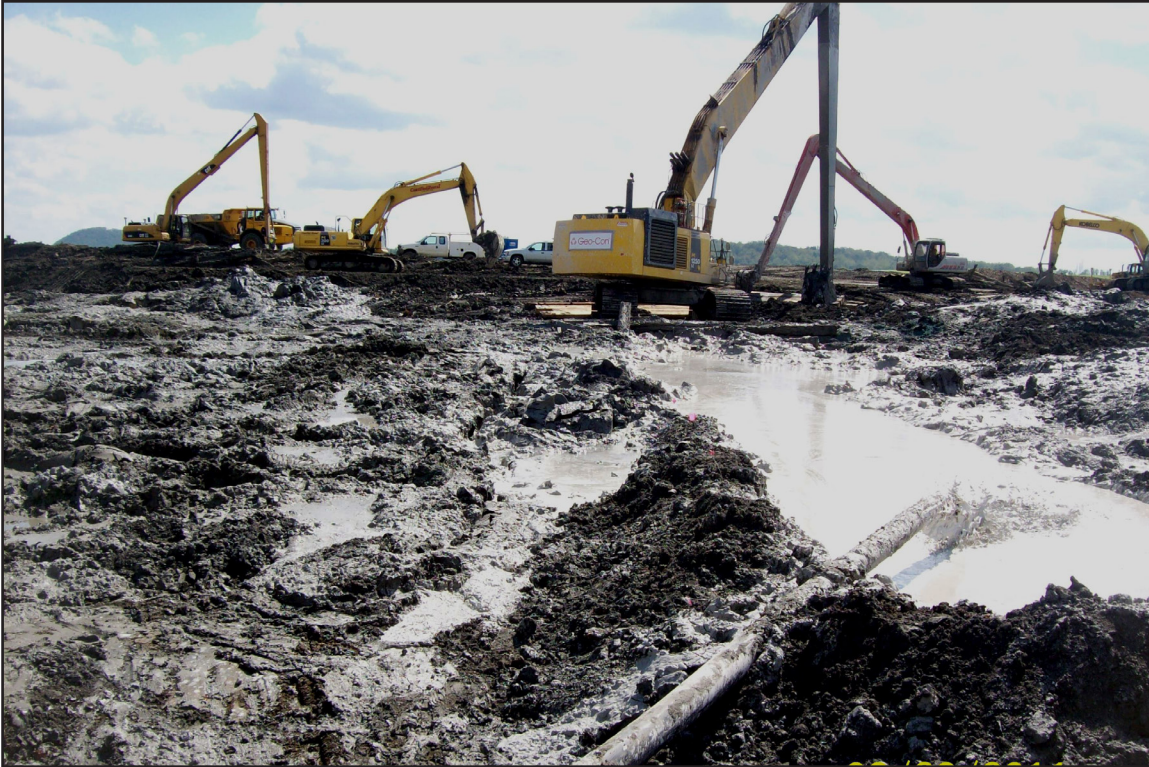
- Problems were encountered early in the trenching operations as work platform conditions deteriorated during trenching. Groundwater levels rose to near the ground surface, causing trench collapse and platform deterioration. Equipment support (layered crane mats) was impacted, requiring at times more than six layers of mats. Several options were tested for stabilization of the work platform so as to improve equipment support: stone/rock, stone/rock with geogrid reinforcing fabric, bottom ash, lime-treated fly ash, and cement-stabilized fly ash. Stone/rock surfacing was the most successful and cost-effective method for improving platform stability. Additional techniques proved helpful in abating near-surface groundwater levels that had led to deterioration of the platform: dewatering finger drains, raised platform elevation, and reducing spillage of slurry trench spoils onto the platform.

29A – PWS: Platform deterioration occurred due to rainfall and high water table, resulting in very wet conditions under excavator. September 29, 2011.

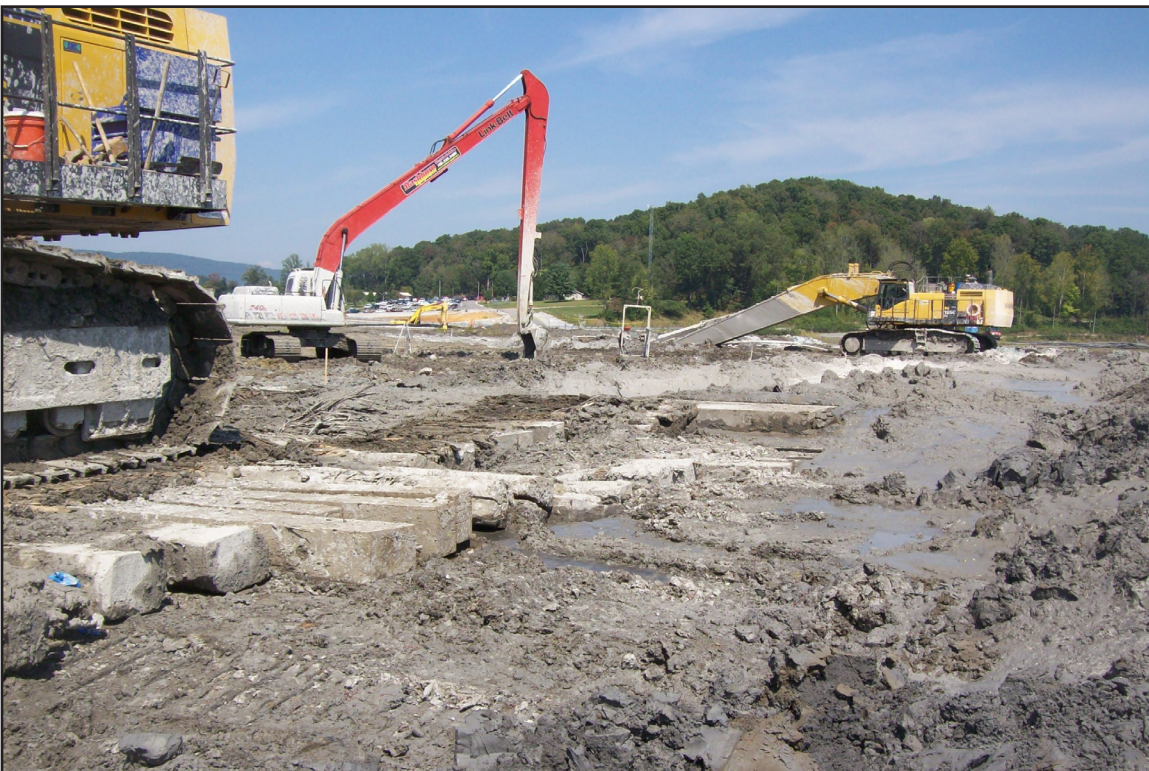
29B – PWS: Platform deterioration resulted in use of crane mats oftentimes stacked several layers thick. September 14, 2011.

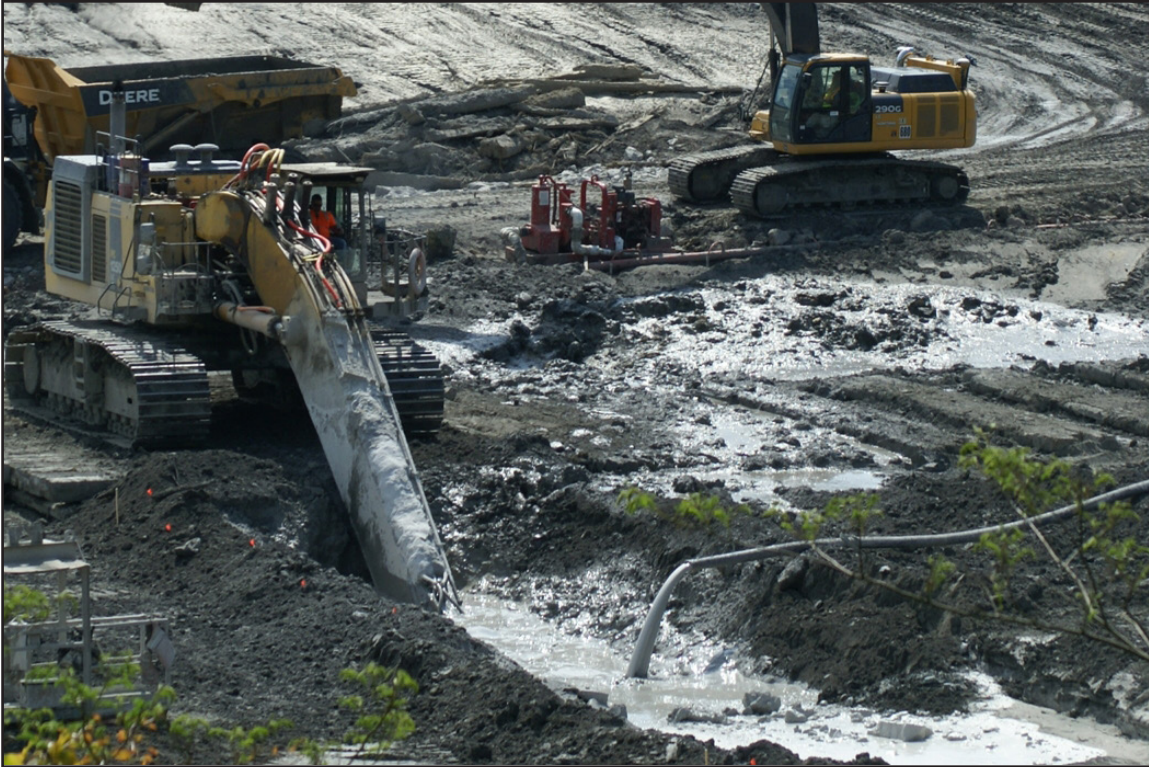
30A – PWS: Platform deterioration due to spoils spillage onto ground surface next to the trench. May 13, 2013.

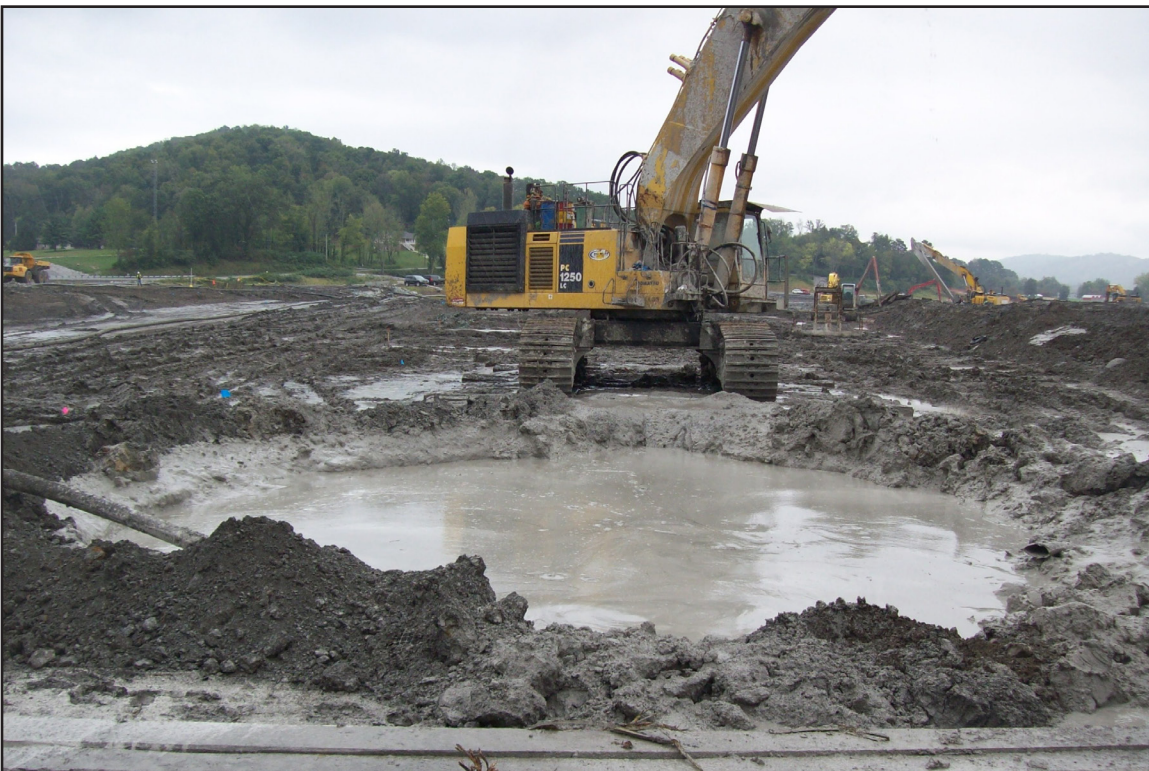
- Problems were encountered during trenching operations that led to excessive sloughing and/or sidewall collapse. Several conditions contributed to trench sidewall instability: shallow depth to groundwater in some areas, artesian groundwater pressures near the base of Pine Ridge, liquefiable sands and fly ash, closely spaced shear walls that exacerbated liquefaction, and hard rock that further exacerbated liquefaction. Improvements that were successful in reducing collapse included raising the working platform elevation, sequencing the wall installations by skipping more than one shear wall in a pattern, and dewatering using both shallow well points in the ash and wells in the deeper sands. These efforts reduced frequency of trench collapse, but did not eliminate trench instability issues.

30B – PWS: Slurry trench collapse, resulting in wide trench at top. September 23, 2011.

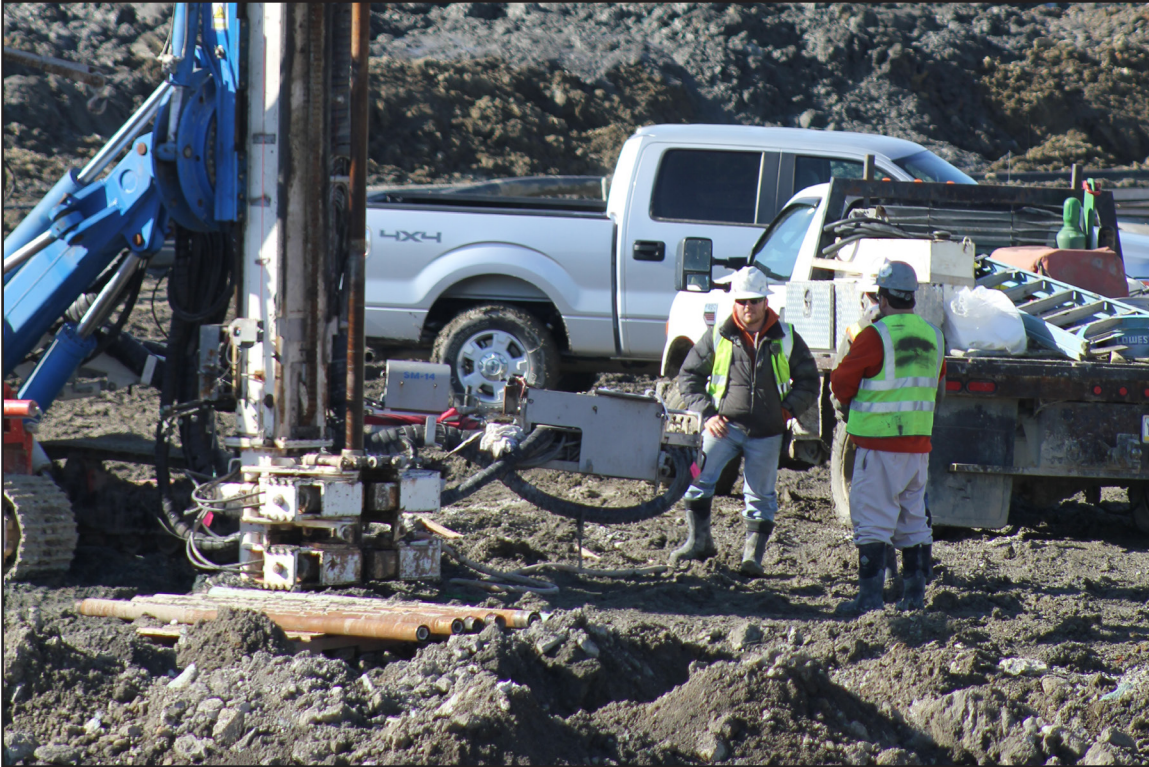
33A – PWS: GeoCon (Armstrong Drilling) predrilling holes for jet grout mitigation of wall defects. January 20, 2014.

- Coring for uniformity detected numerous inclusions of unsolidified materials in sections of the wall. Most of these defects were a result of platform instability and wall collapse, as discussed above, as well some areas of low strength. Mitigation of defects in the wall was accomplished by either excavating adjacent wall panels or by jet grouting of defects. Jet grouting consisted of pre-drilling 3- to 4-inch-diameter holes then pressure injecting cement grout to form columns nominally 4 ft in diameter within the unsolidified material. A total of 5,490 linear ft of adjacent wall panels and 3,275 jet grout columns were constructed to repair defects. Approximately 18% of the wall required defect mitigation.

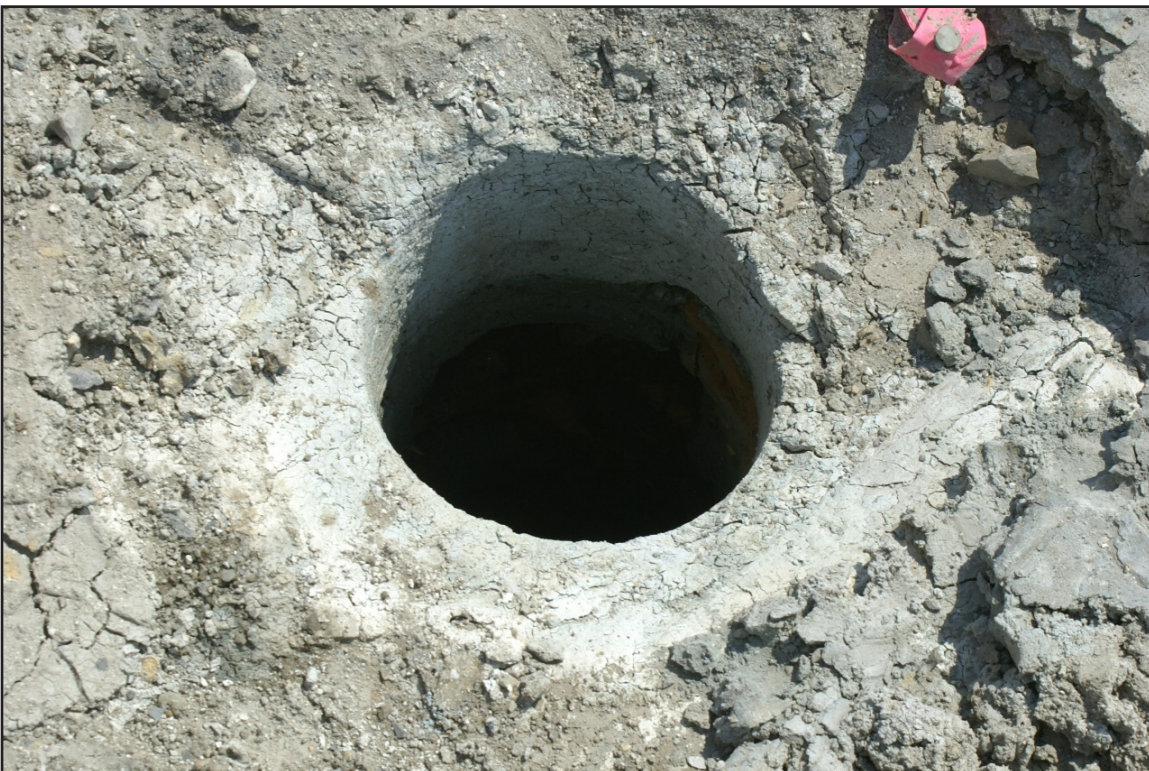
33B – PWS: Predrilled hole in wall for mitigation of wall defects. August 30, 2011.

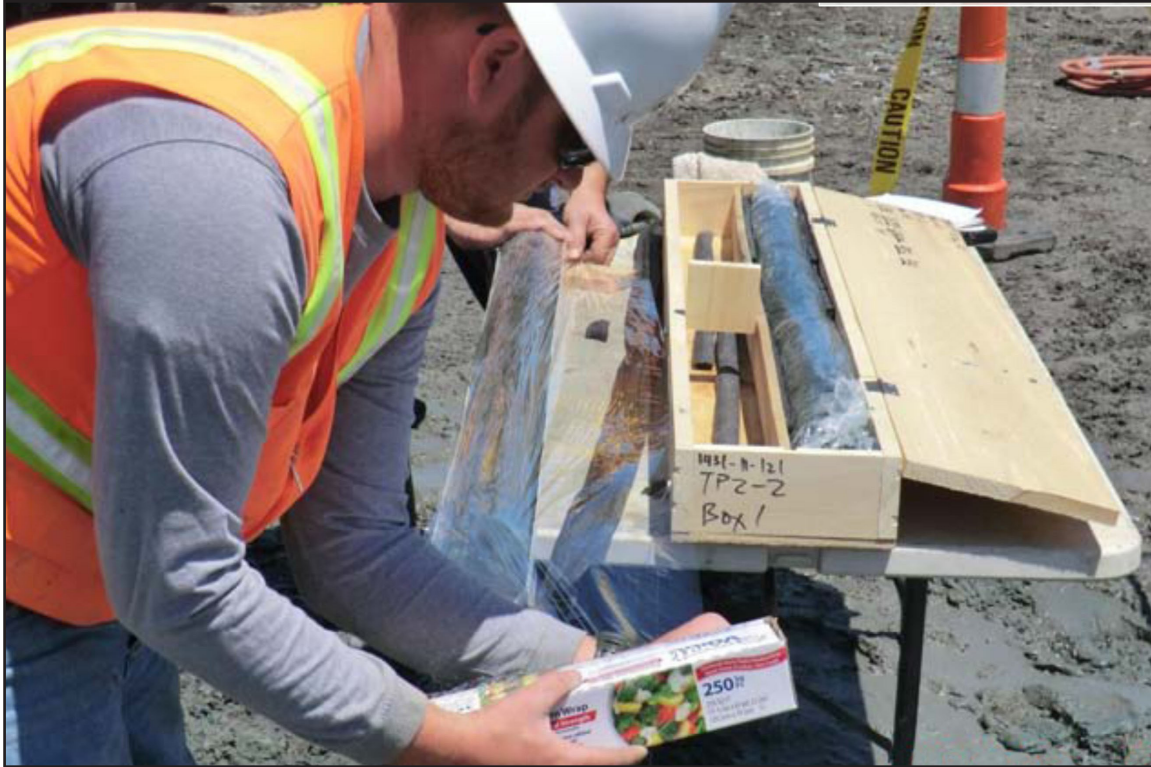
34A – PWS: S&ME logging cores of cured grout for quality control of wall uniformity. May 5, 2011.

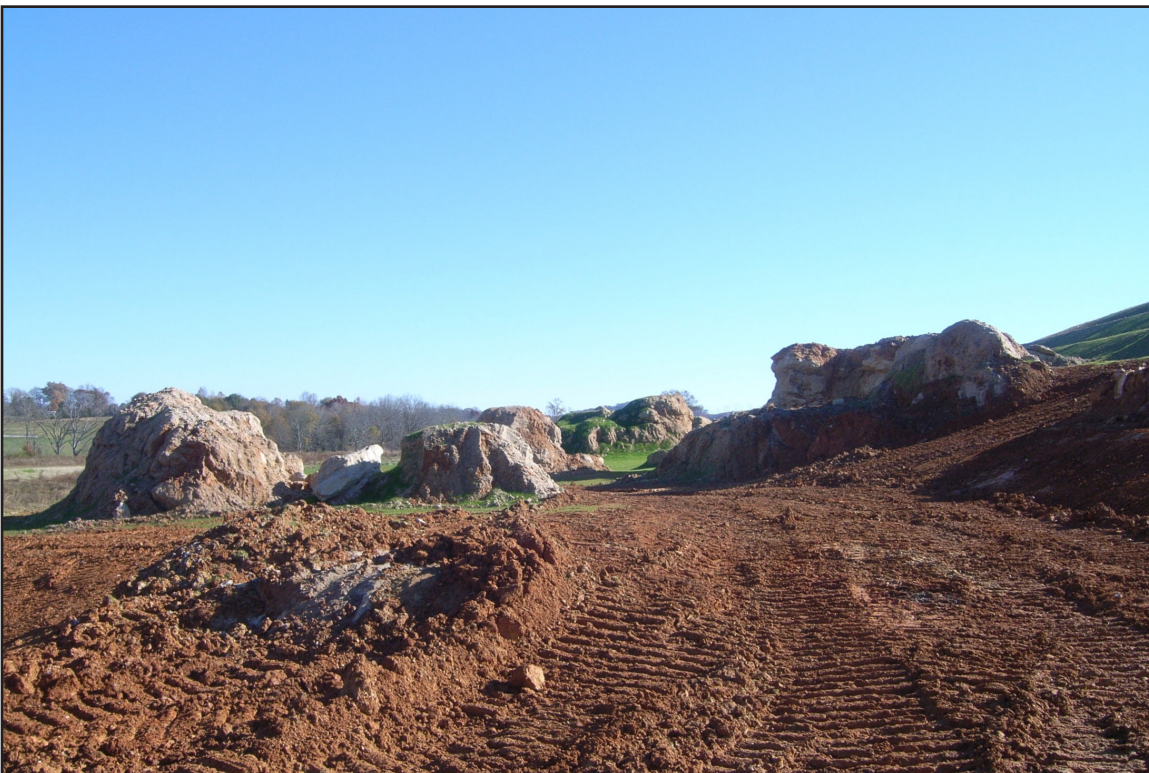
46B – Borrow Area: Rock outcrops encountered in borrow pits. November 8, 2013.
