Document No. EPA-AO-063A

Kingston Ash Recovery Project

**On-Scene Coordinator Report Addendum for the
Non-Time-Critical Removal Action
for the Embayment/Dredge Cell**

**TVA Kingston Fossil Fuel Plant Release Site,
Roane County, Tennessee**

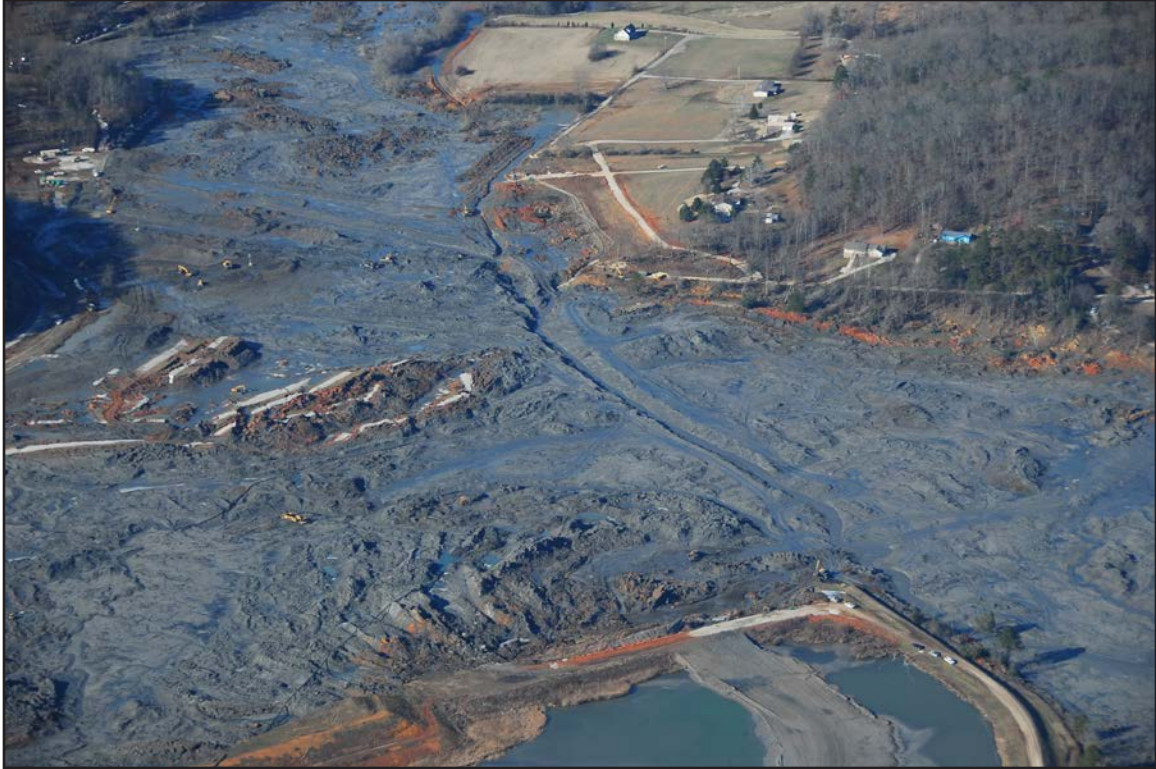
1A – Oblique of the Middle Embayment after release (viewing from the east). January 8, 2009.

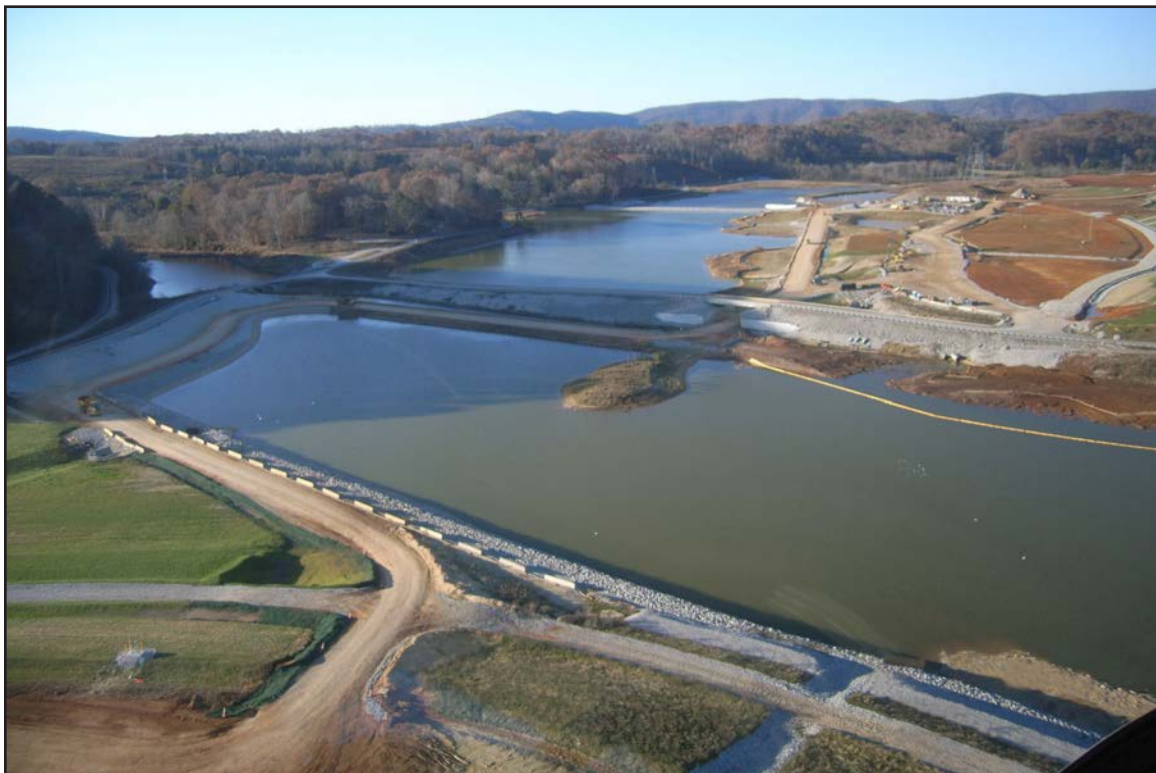
1B – Oblique of the Middle Embayment following SPEER Non-Time-Critical Removal Action. November 18, 2014.

Effectiveness of Embayment Grading. The western section of the Middle Embayment was graded to create a hummocky topography at the bottom of the reservoir, including depressions and piles of stones, to enhance the natural fish and macroinvertebrate habitat. The eastern section of the Middle Embayment was graded to re-create the islands and peninsulas that existed prior to the ash release and that provide an aquatic habitat feature important to fish and other aquatic species. Grading targeted an elevation of 743.0 ft mean sea level (msl) for tree planting in reforestation areas to avoid extensive submersion during high lake levels and improved survivability of the newly planted trees. In the northwestern corner of the North Embayment, the surface grades were lowered to create a transitional wetland area that will remain attractive to water birds for nesting and foraging. The transitional wetland area was graded with a steeper riparian shoreline bank and several low-lying closed depressions. Grading of the Clean Water Ditch consisted of filling in the ditches to restore pre-spill streamflow through the embayments and restore the riparian and/or terrestrial habitat at the embayment shoreline.

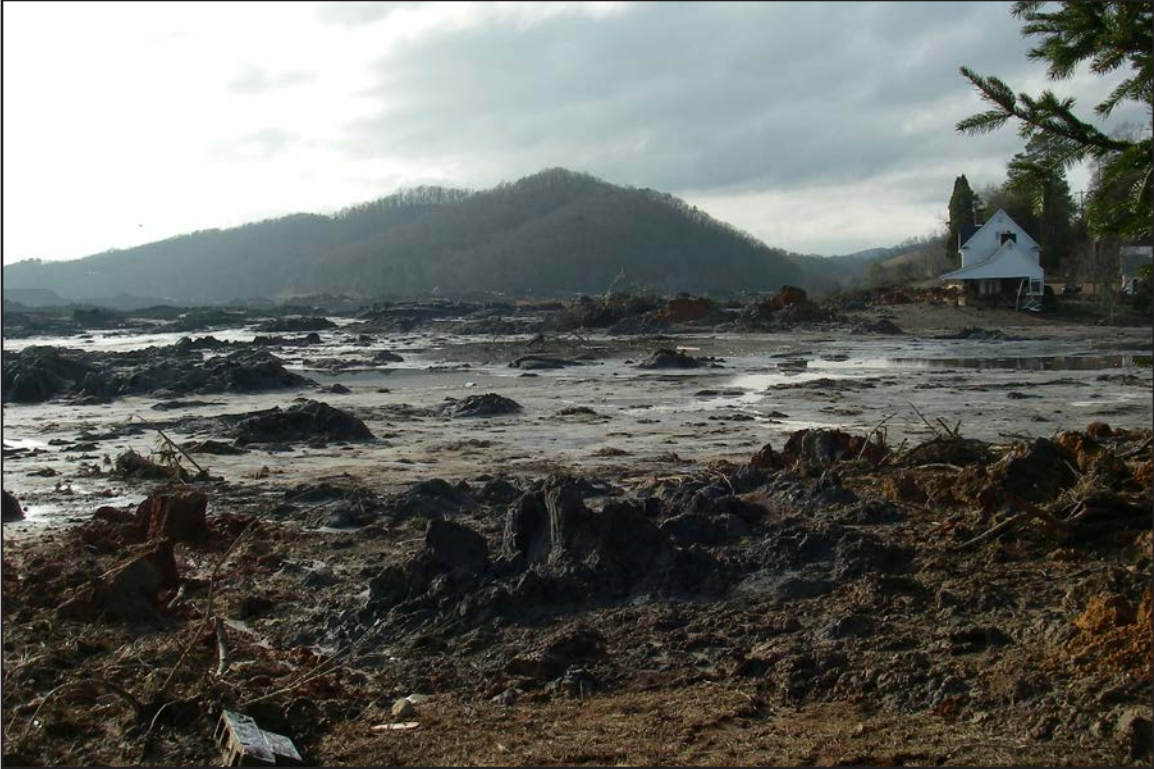
1C – Middle Embayment after release. December 27, 2008.

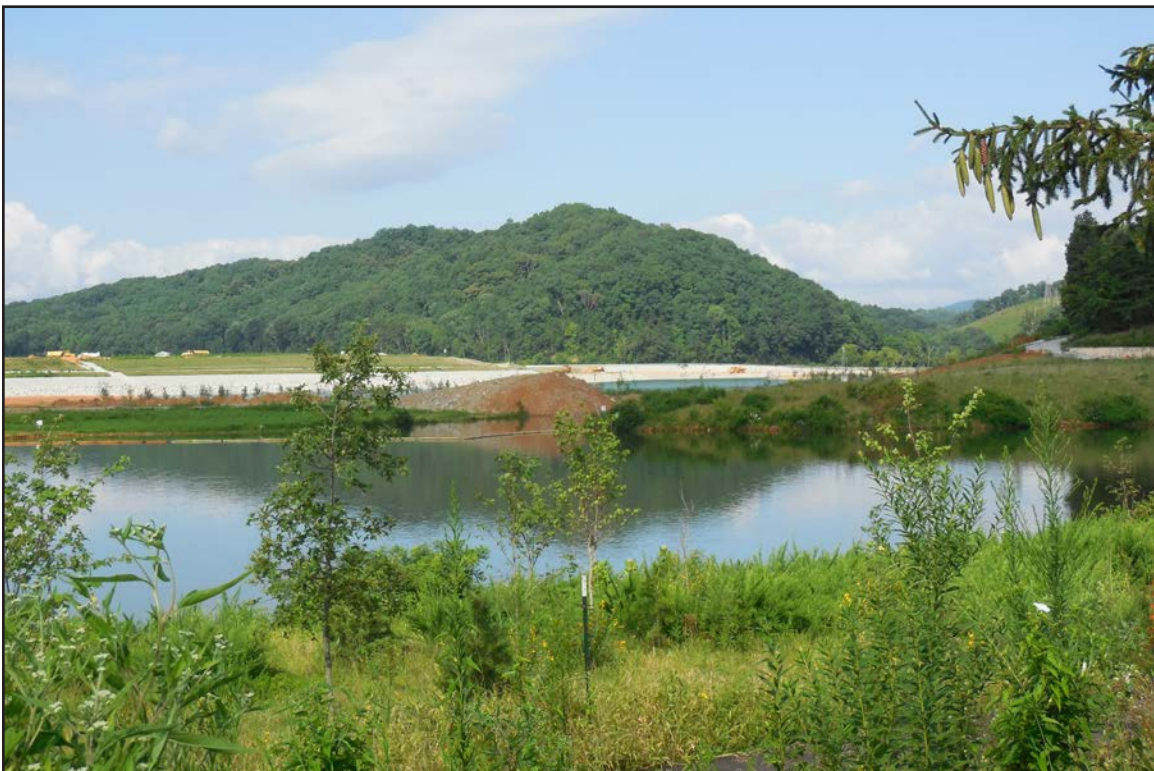
1D – Middle Embayment following SPEER Non-Time-Critical Removal Action. July 29, 2014.

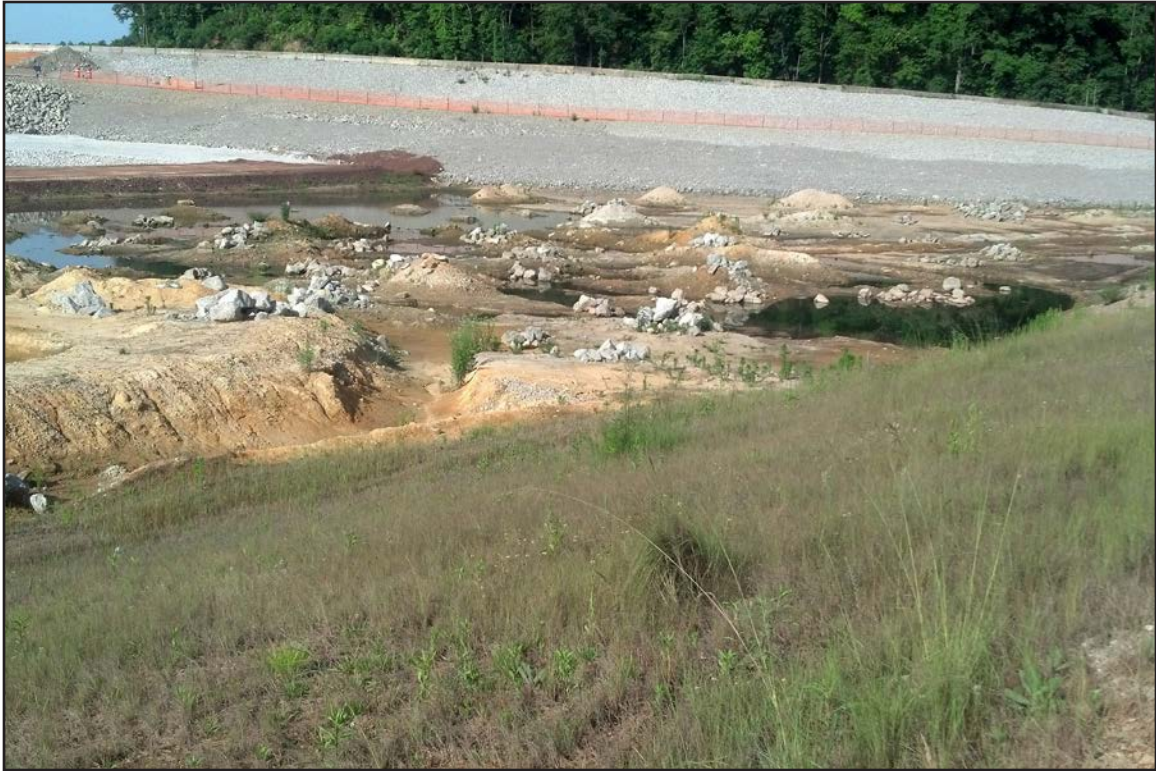
2A – Middle Embayment before inundation with rock piles as fish habitat. May 24, 2014.

Effectiveness of Habitat Structures. Fish habitat structures, consisting of submerged brush and woody debris and/or small piles of boulders, were placed within the embayment bottom prior to inundation to provide fish cover and habitat to enhance angling opportunities and fish populations. Simulated fallen trees, consisting of felled trees anchored in the embayment bottom, were installed to serve as fish

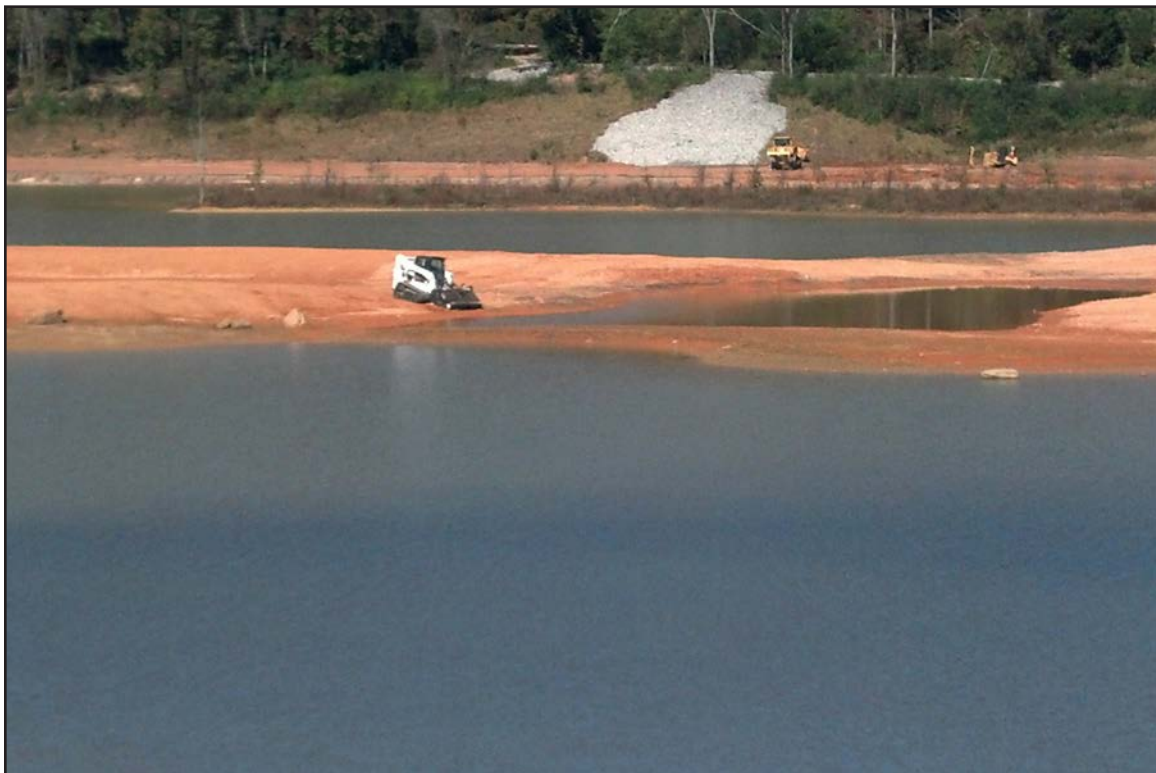
2B – Middle Embayment final grading by Merit to remove rocks. October 22, 2014.

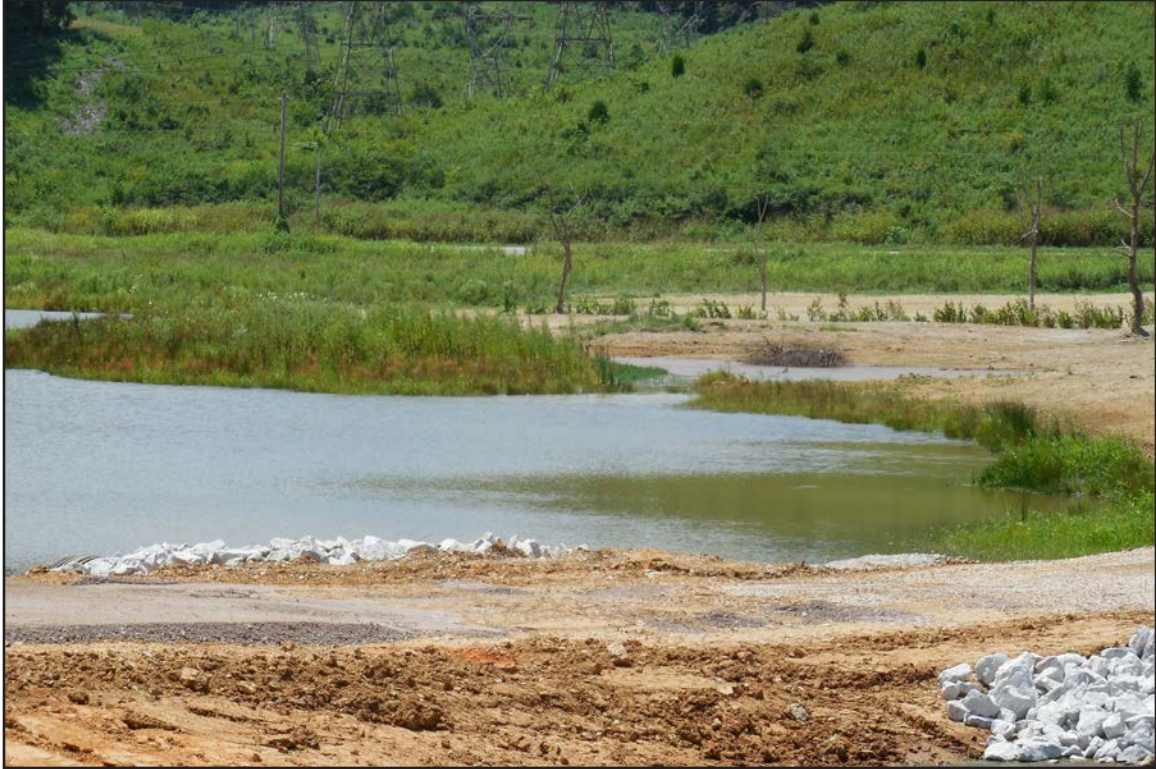
3A – North Embayment grading of transitional wetlands area. July 29, 2014.

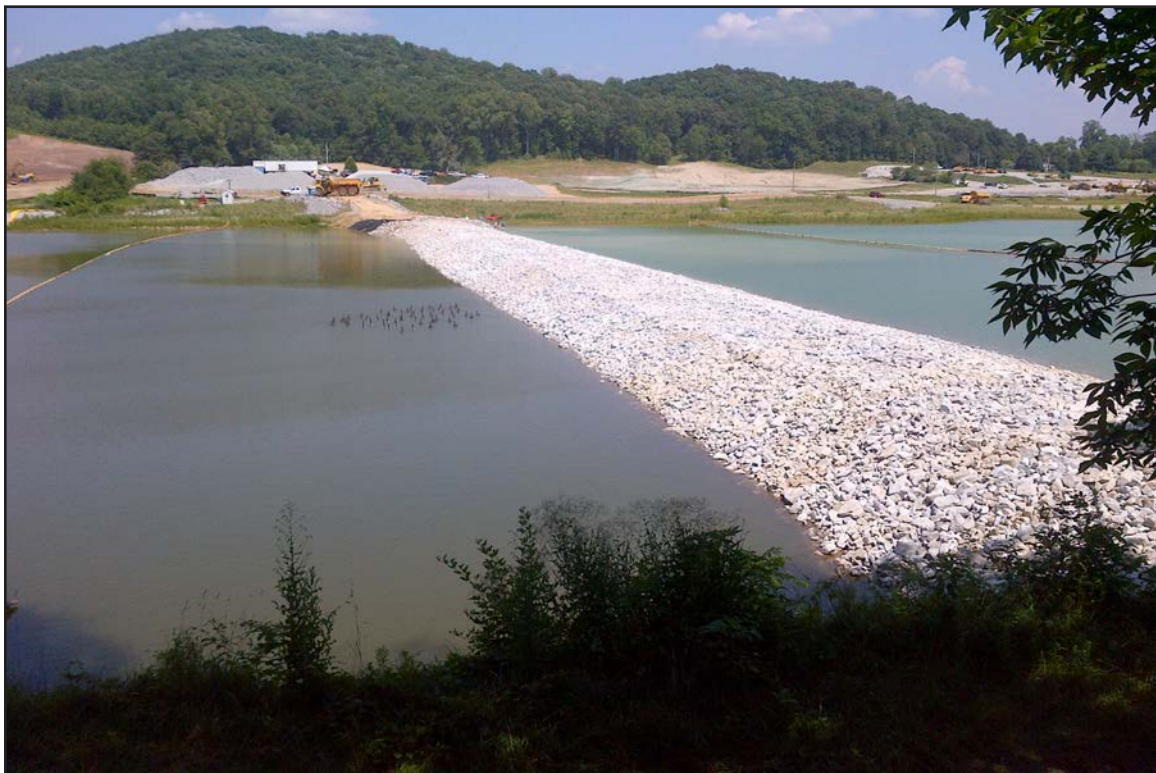
3B – North Embayment riprap armoring of the North Berm dike. July 7, 2014.

The berm traversing the North Embayment had been installed in 2010 as a temporary storm water control berm during ash removal from the North Embayment. In cooperation with the Natural Resource Damage Assessment (NRDA) trustees, it was agreed that the berm would remain permanently so as to establish optimum riparian habitat under a stable (fixed) shoreline in the upper half of the North Embayment. The TVA Dam Safety Governance organization classified the berm as a low risk dam that could be overtopped during significant storm events. As a result, riprap armoring was placed on the berm for erosion protection. The riprap extended partially down the upstream face of the berm, across the top of the berm, and full depth of the downstream face of the berm. The riprap armoring extended from abutment to abutment, approximately 670 ft. The riprap armoring was constructed by SCS in July and August 2014.

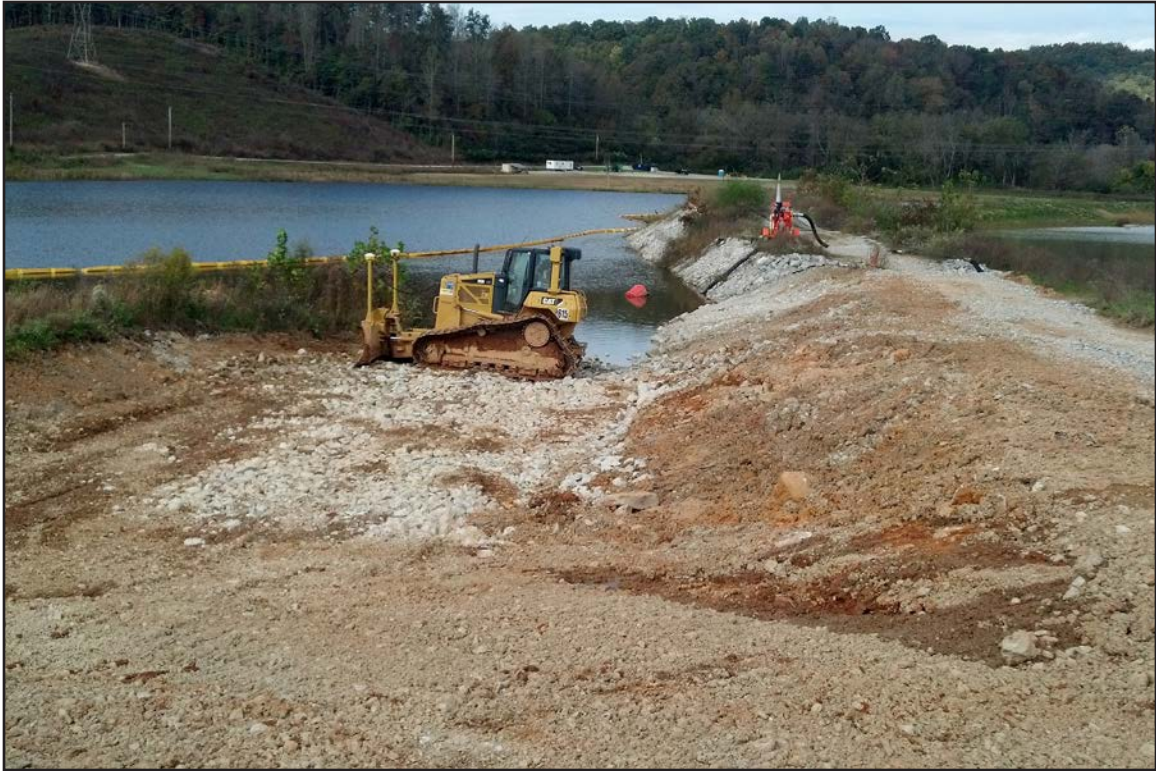
4A – Grading of clean water ditch - Filling in North Embayment. October 20, 2014.

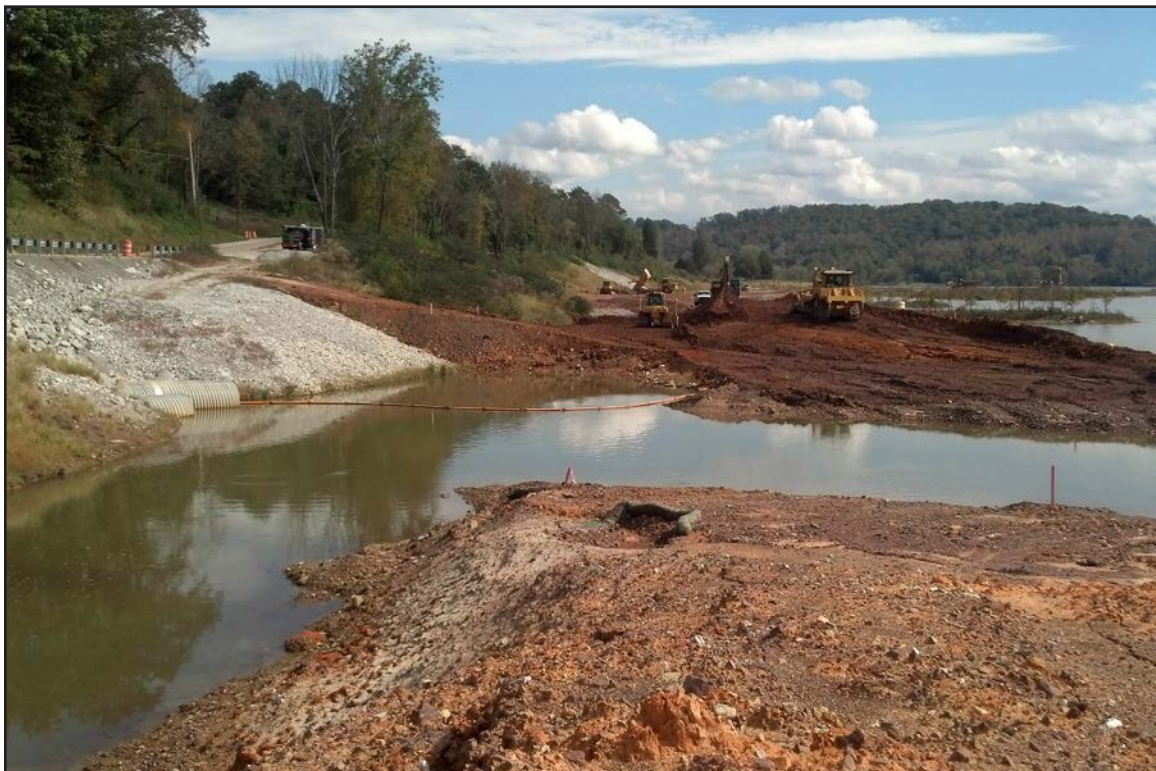
4B – Grading of clean water ditch - Filling in Middle Embayment. October 20, 2014.

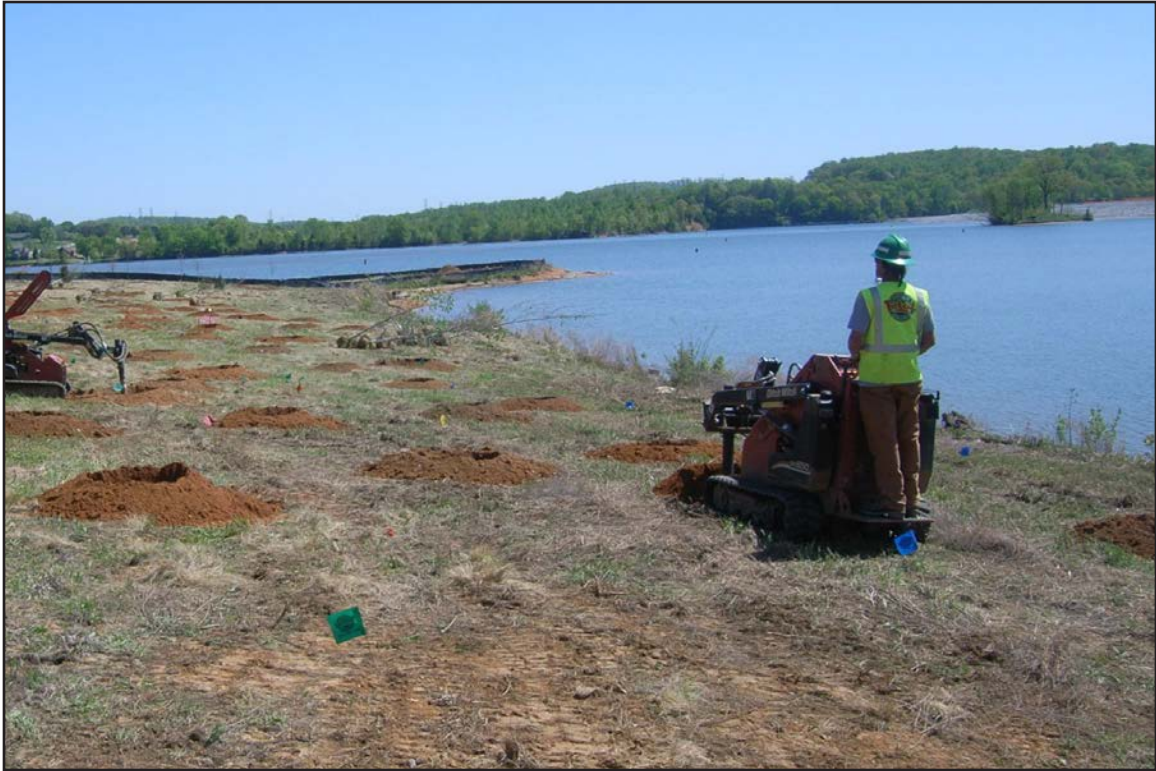
5A – Plantings - Augering holes for trees. April 23, 2014.

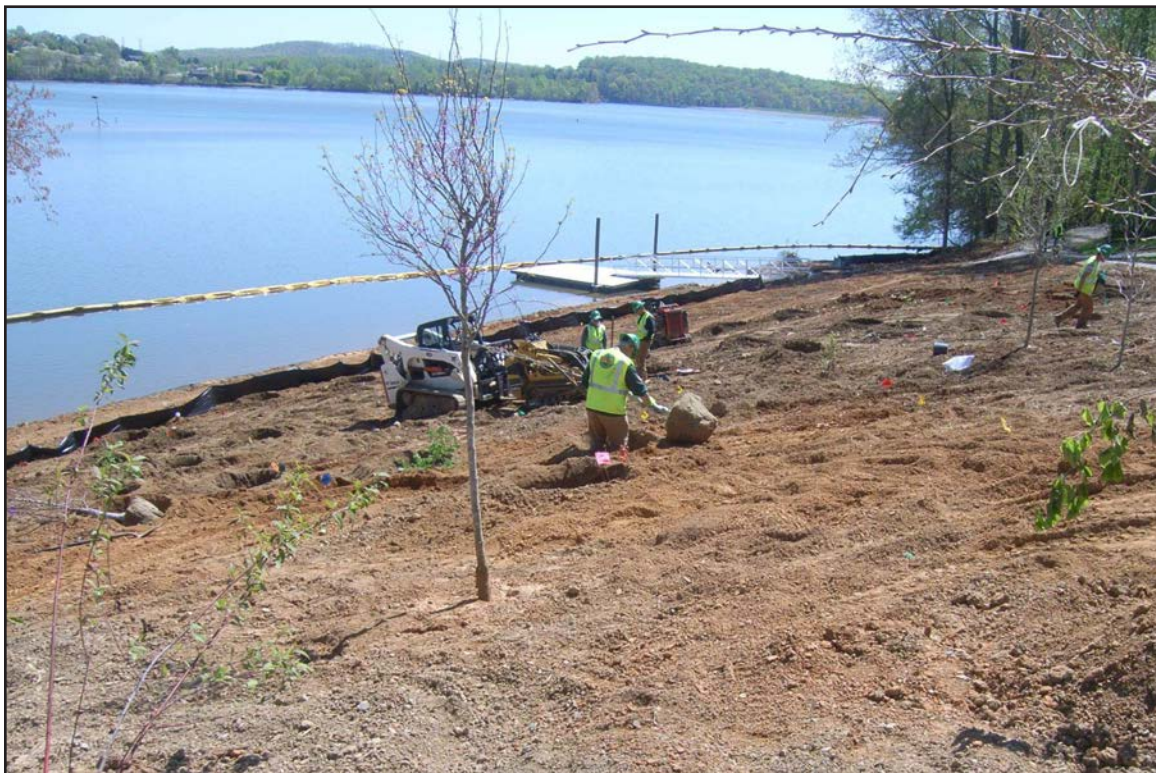
5B – Plantings - Placing balled and burlapped trees in reforestation areas. April 16, 2014.

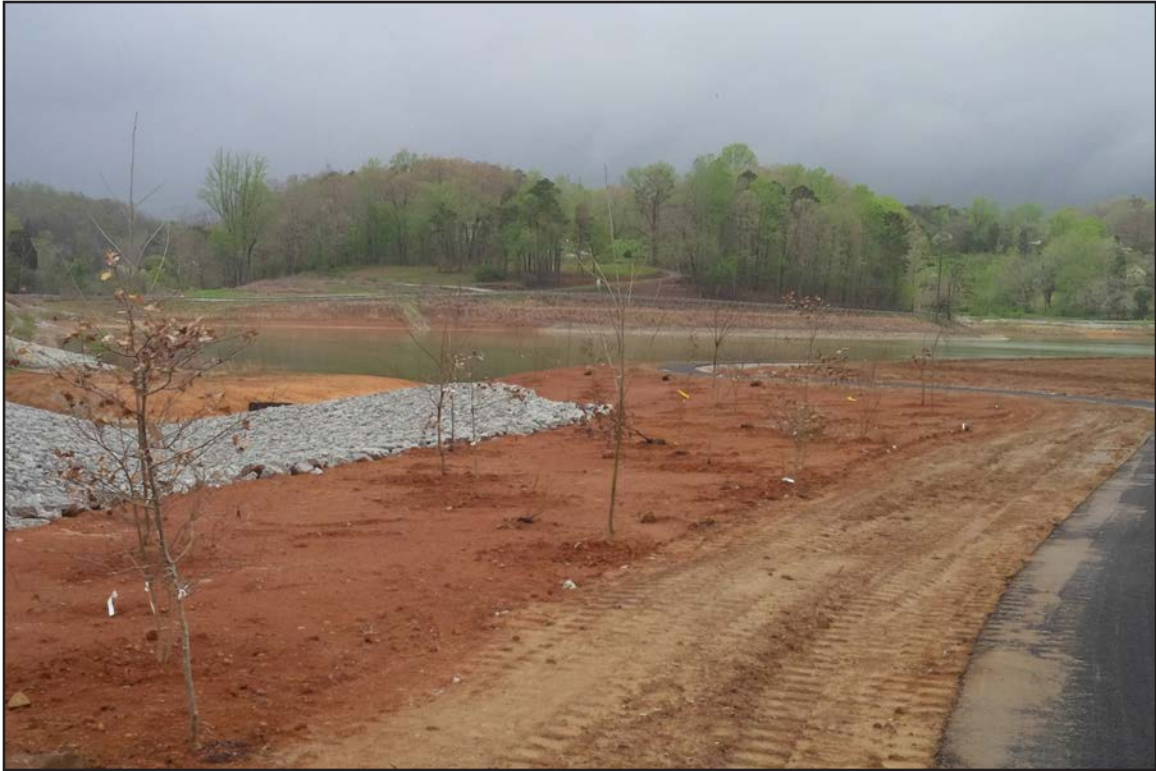
6A – Plantings - Reforestation area in the North Embayment. April 10, 2015.

- Tree survivability in reforestation areas was problematic due to topographic and weather-related impacts. Trees were planted on relatively flat terrain, planted just prior to prolonged hot, dry weather in the summer of 2014, and trees planted following severe cold weather in the winter of 2015 may have contributed to tree loss. Tree survivability was improved by raising the elevation of the islands and replanting of trees in damaged areas. Other plantings and ecological enhancements were successful in achieving objectives of the non-time-critical removal action.

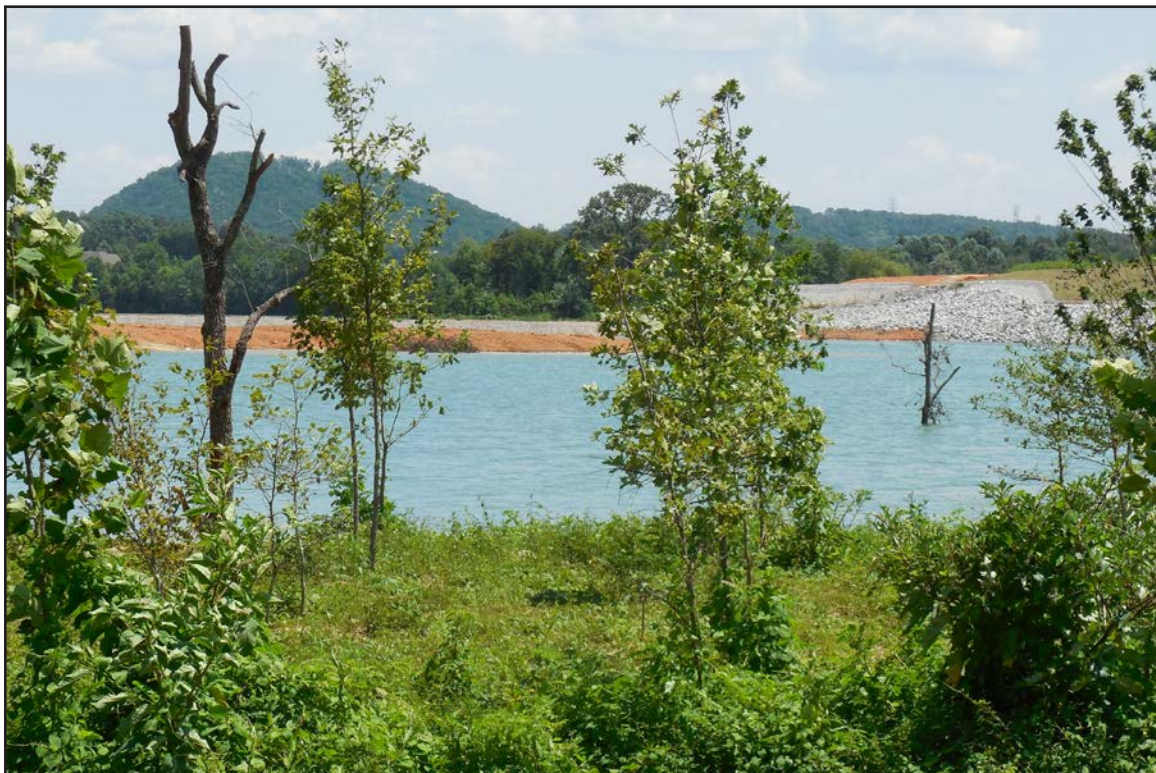
6B – Plantings - Reforestation area in the Middle Embayment. July 29, 2014.

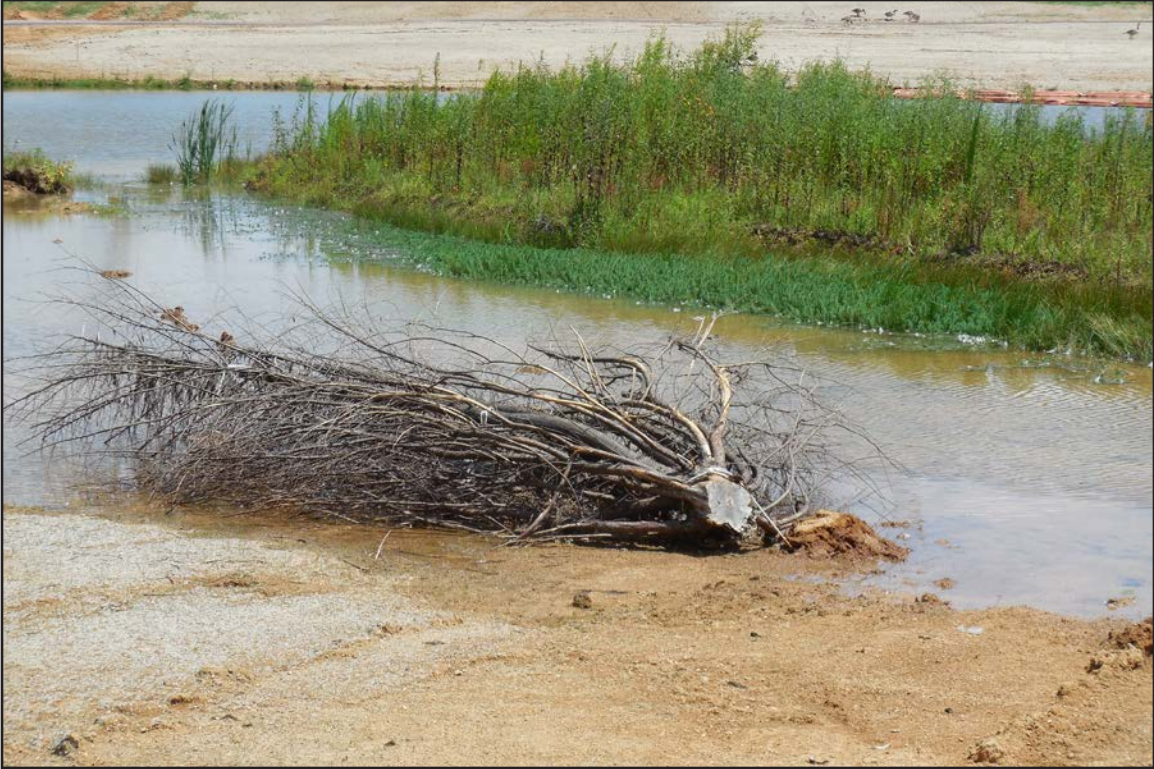
7A – Fish habitat structures - Fish attractor. July 29, 2014.

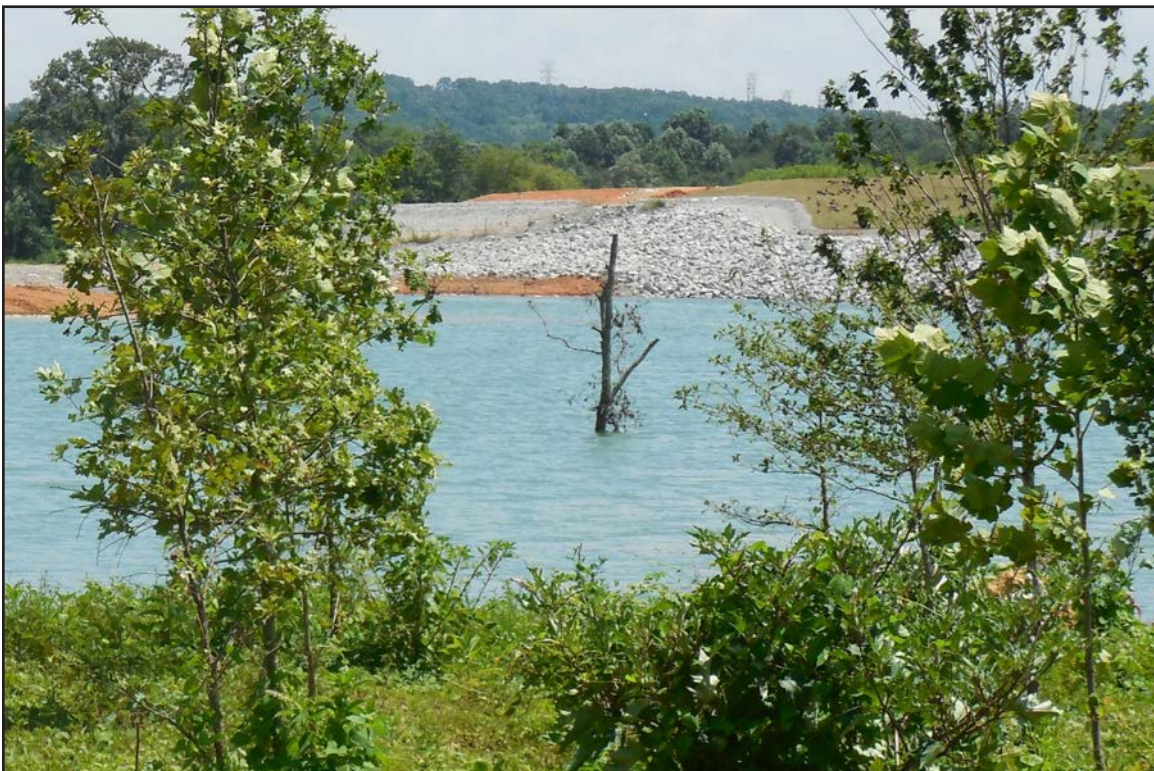
7B – Simulated tree snag in the Middle Embayment. July 29, 2014.

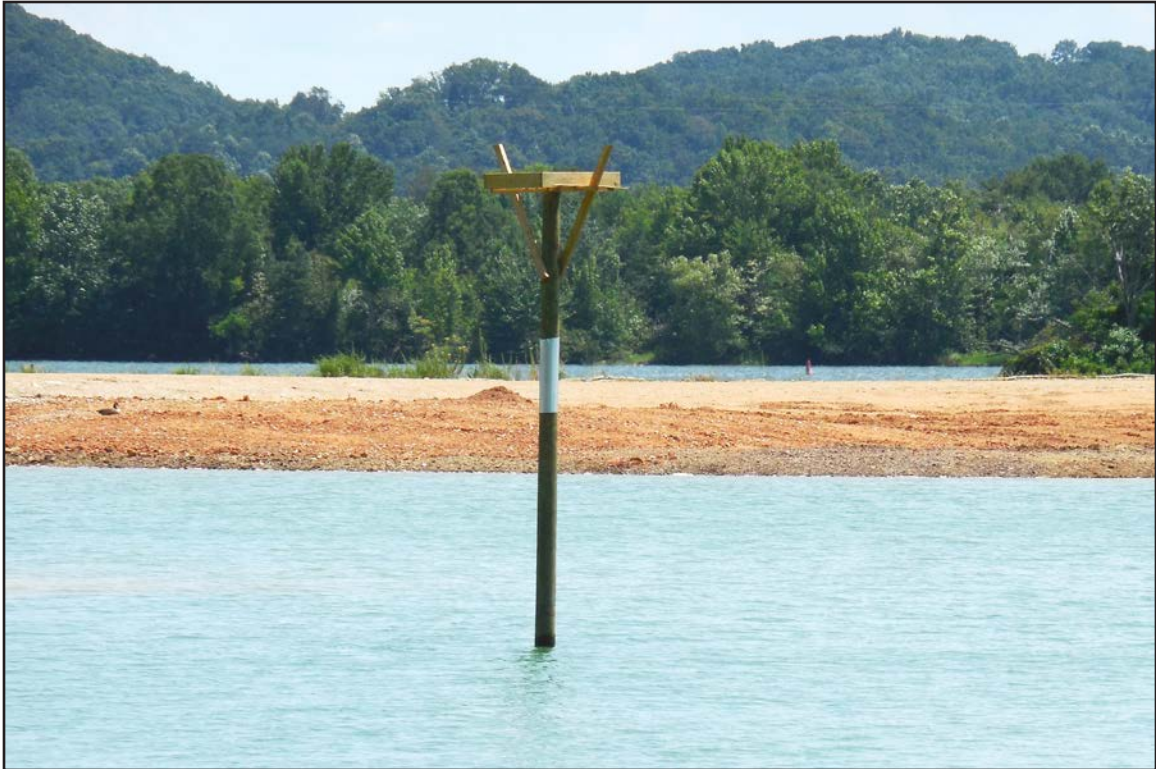
8A – Osprey platform erected in the Middle Embayment. July 29, 2014.

attractors. One osprey nesting platform, consisting of a raised nesting box set on a utility pole, was erected in the Middle Embayment. Two heron nesting platforms, consisting of a wooden support structure with 3 tiers of nesting boxes were placed on the riparian shoreline in the Middle Embayment. Simulated snags, consisting of large standing felled trees, were erected in the transitional wetland area to provide habitat for woodpeckers that feed on insects dwelling in the decomposing wood. Vernal pools, consisting of shallow ephemeral ponds, were created near the shoreline to provide habitat for amphibian and insect species to be safe from predation by fish.

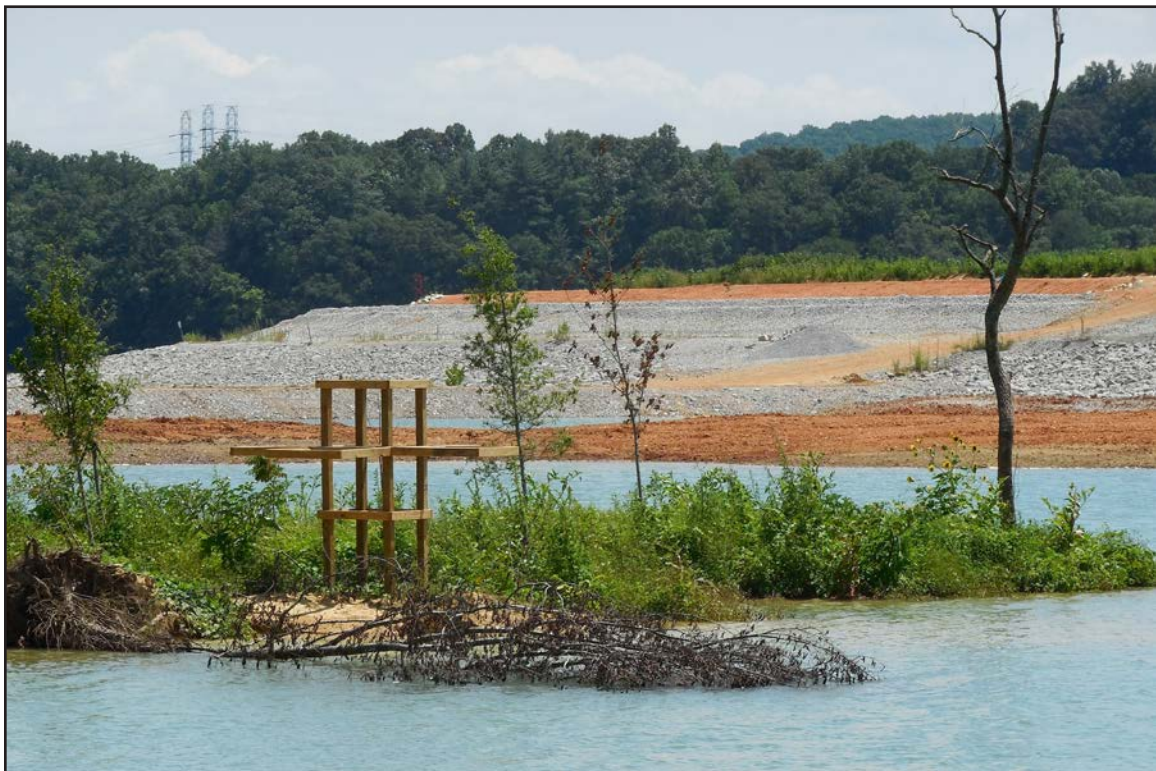
8B – Heron platform erected in the Middle Embayment. July 29, 2014.

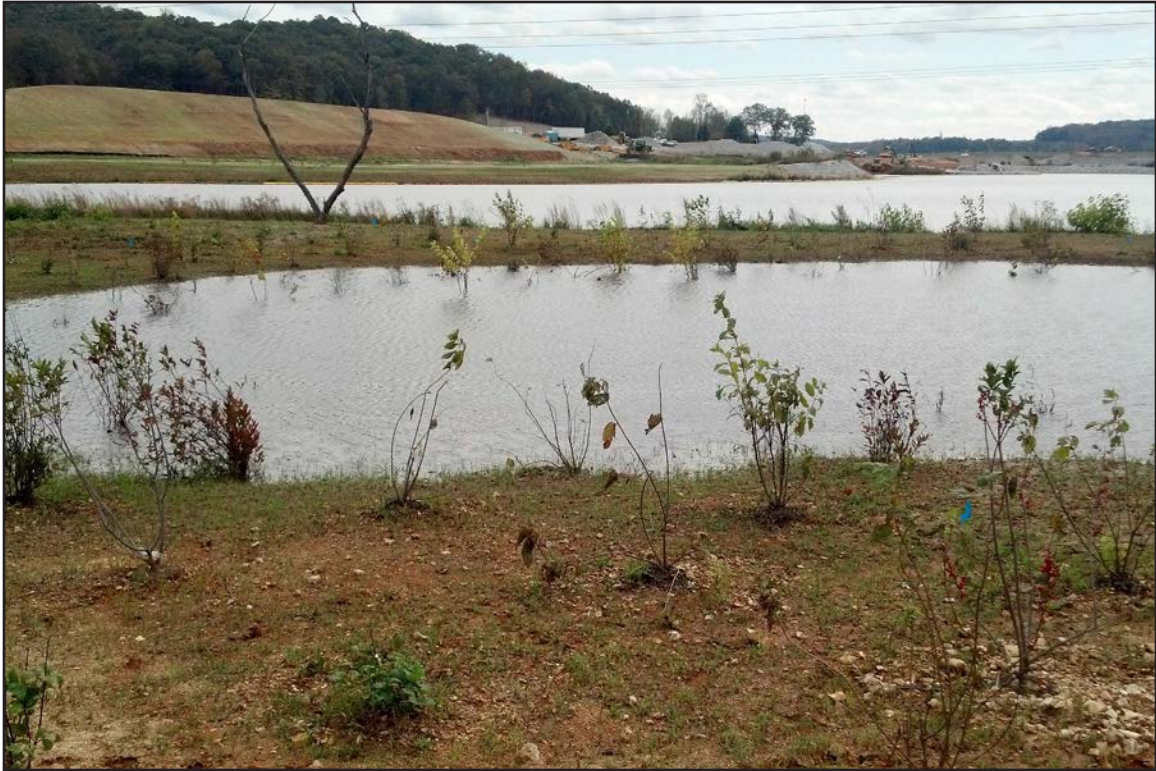
9A – Vernal pools in the North Embayment with plantings of wetland shrubs. October 20, 2014.

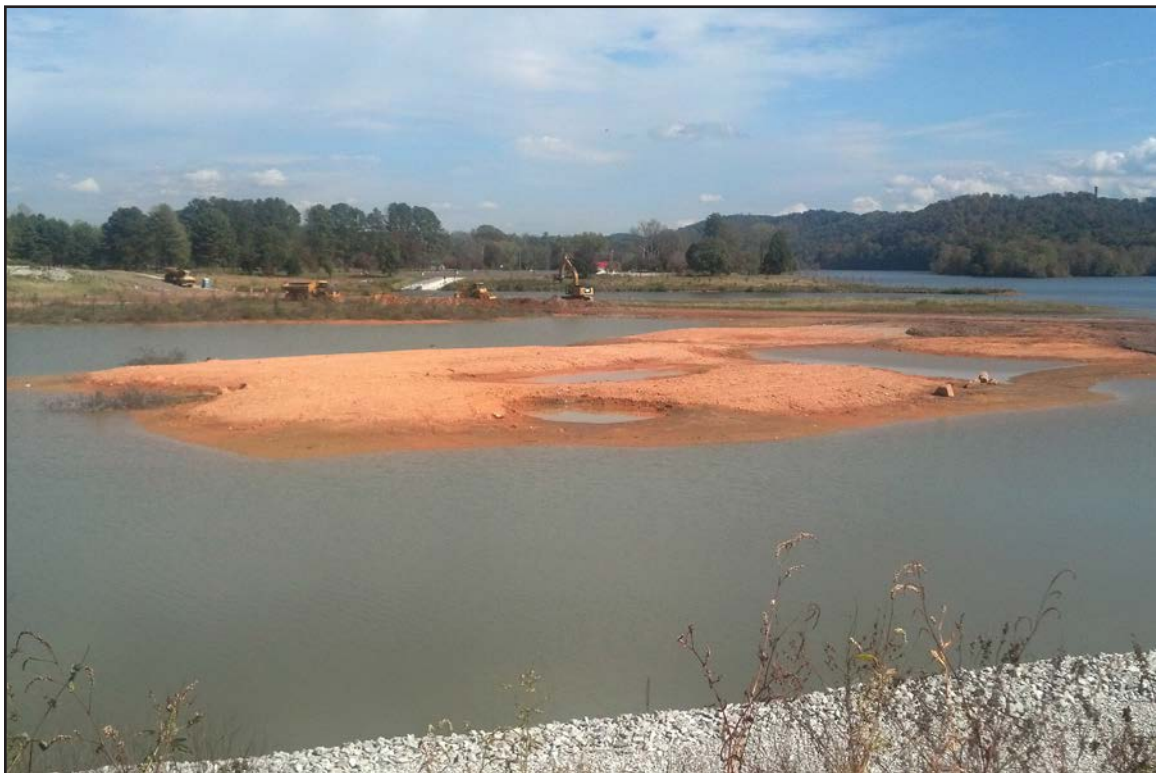
9B – Vernal pools in the Middle Embayment. October 20, 2014.

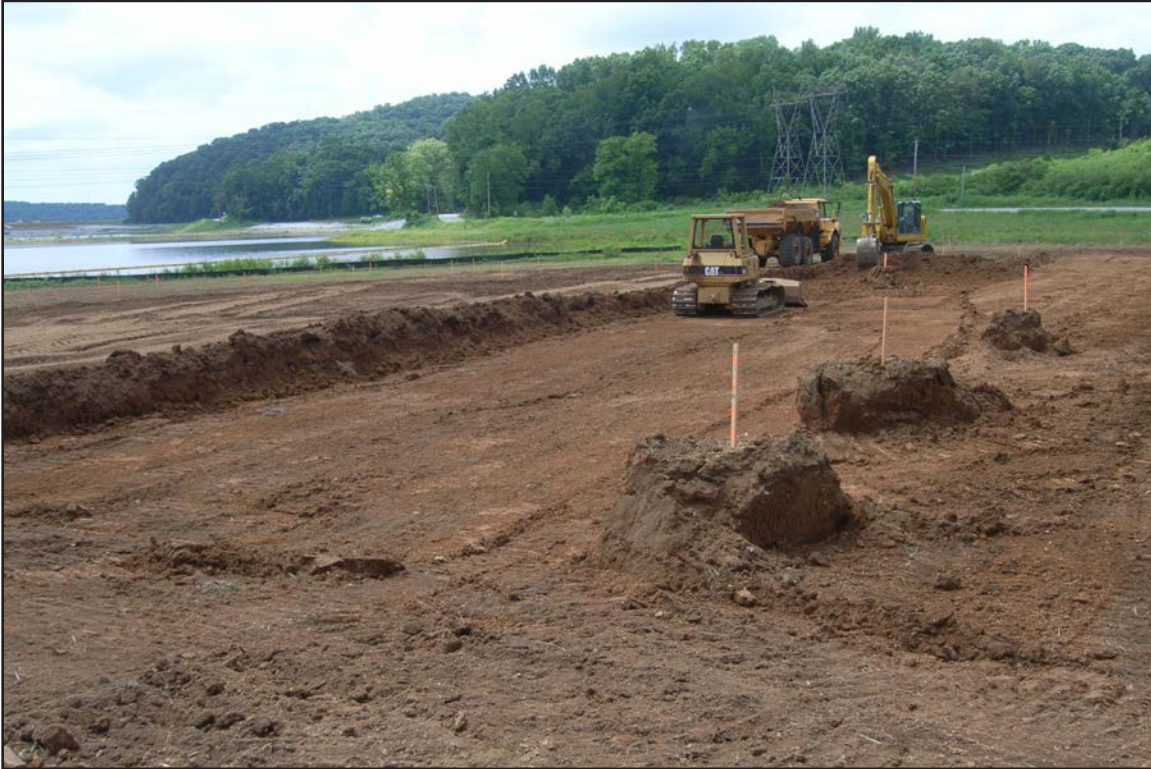
10A – Wetlands construction - Grading for wetland in the North Embayment. June 10, 2014.

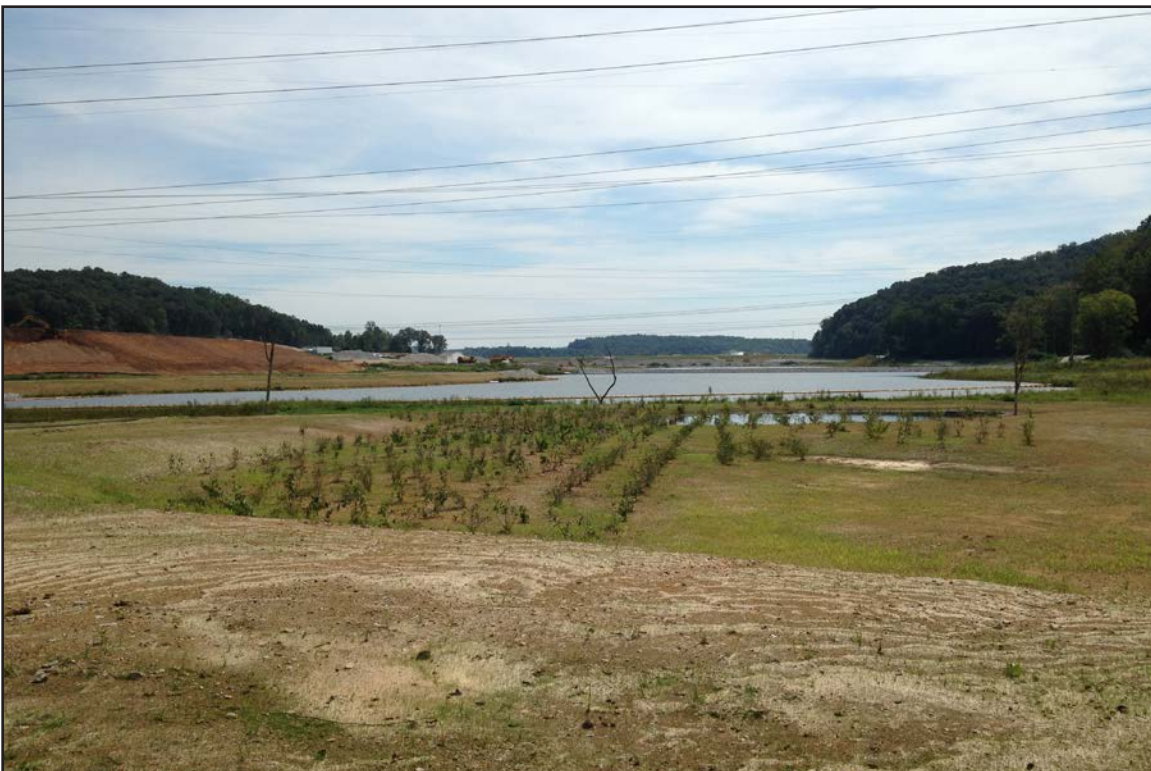
10B – Wetland construction - Completed wetland in the North Embayment. September 18, 2014.

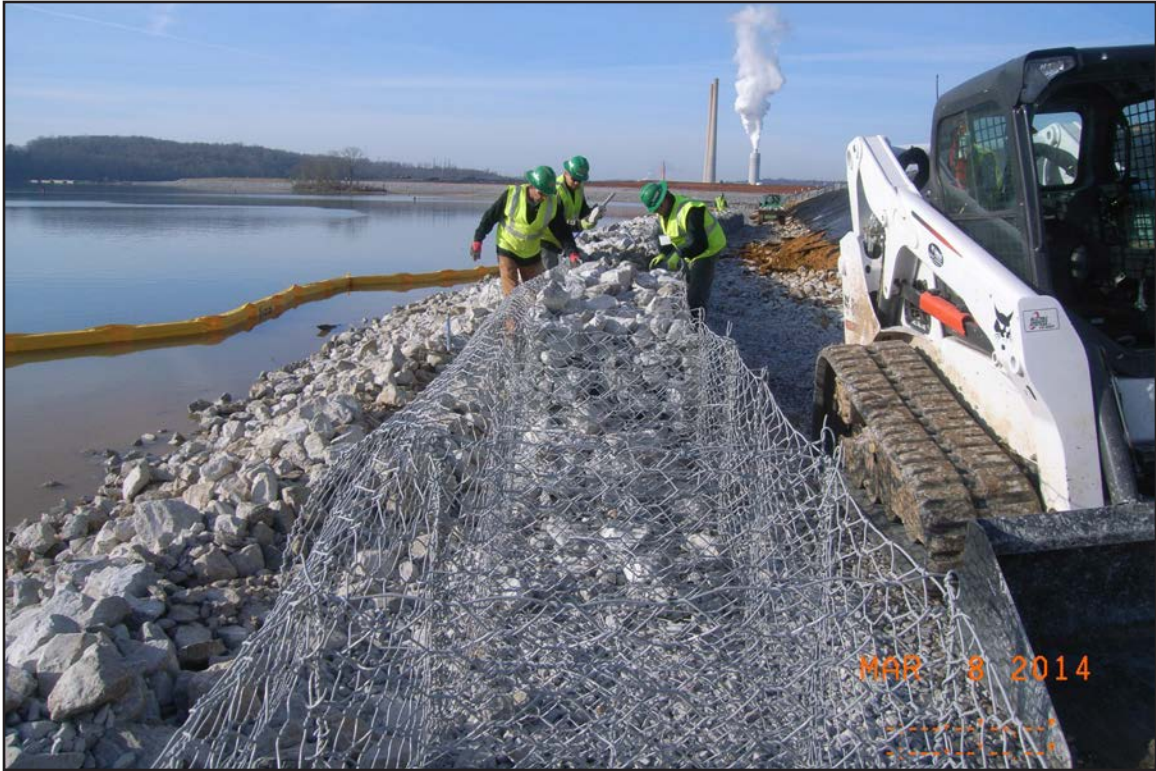
11A – Vegetative slope stabilization - Placing gabions. March 8, 2014.

Historical bank erosion in two areas along the Emory River shoreline had created unstable conditions. To stabilize the slope and provide for a natural-appearing bank, a vegetative retaining wall system was constructed. The retaining wall system consisted of modular units with mechanically-stabilized reinforced backfill. AMEC Environment and Infrastructure completed the wall design per Submittal 0173.

The wall was constructed in two parts: Wall A at the southern end of the Lakeshore peninsula was approximately 430 ft long and Wall B at the northern end was approximately 490 ft long. Initial construction, beginning on February 27, 2014, consisted of excavating to a firm, level foundation while water levels in Watts Bar Reservoir were relatively low. Although the original design called for two rows of gabions to be placed, one above the other, due to rising lake levels in early spring, an 18-inch layer of rock was placed first. The rock layer was placed between elevations 739.5 and 741.0 ft msl. A single row of gabions was then placed as foundation platform on top of the rock foundation. The gabions consisted of woven wire baskets 3 ft high and 3 ft thick that were filled with cobble-sized rock. Riprap was placed for scour protection outboard of the gabion and rock foundation, between elevations 735.0 and 744.0 ft msl.
