Document No. EPA-AO-063A

Kingston Ash Recovery Project

**On-Scene Coordinator Report Addendum for the
Non-Time-Critical Removal Action
for the Embayment/Dredge Cell**

**TVA Kingston Fossil Fuel Plant Release Site,
Roane County, Tennessee**

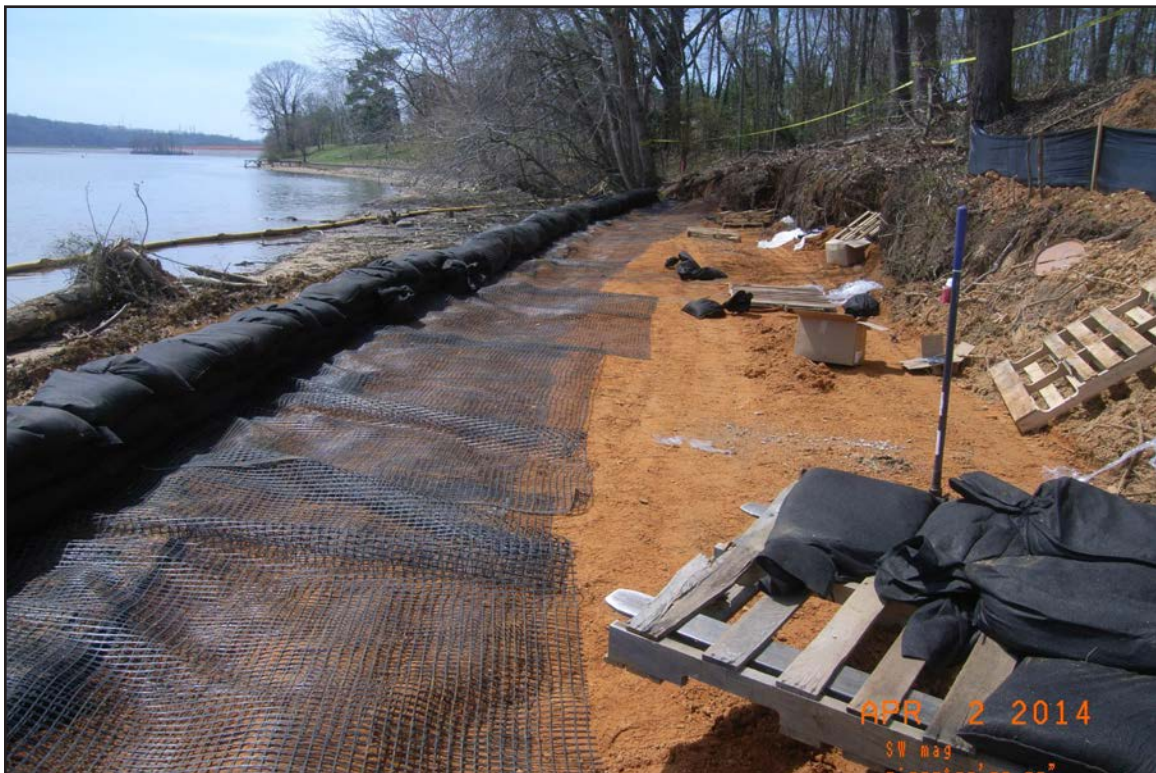
11B – Vegetative slope stabilization - Placing geogrid tiebacks. April 2, 2014.

Historical bank erosion in two areas along the Emory River shoreline had created unstable conditions. To stabilize the slope and provide for a natural-appearing bank, a vegetative retaining wall system was constructed. The retaining wall system consisted of modular units with mechanically-stabilized reinforced backfill. AMEC Environment and Infrastructure completed the wall design per Submittal 0173.

The wall was constructed in two parts: Wall A at the southern end of the Lakeshore peninsula was approximately 430 ft long and Wall B at the northern end was approximately 490 ft long. Initial construction, beginning on February 27, 2014, consisted of excavating to a firm, level foundation while water levels in Watts Bar Reservoir were relatively low. Although the original design called for two rows of gabions to be placed, one above the other, due to rising lake levels in early spring, an 18-inch layer of rock was placed first. The rock layer was placed between elevations 739.5 and 741.0 ft msl. A single row of gabions was then placed as foundation platform on top of the rock foundation. The gabions consisted of woven wire baskets 3 ft high and 3 ft thick that were filled with cobble-sized rock. Riprap was placed for scour protection outboard of the gabion and rock foundation, between elevations 735.0 and 744.0 ft msl.

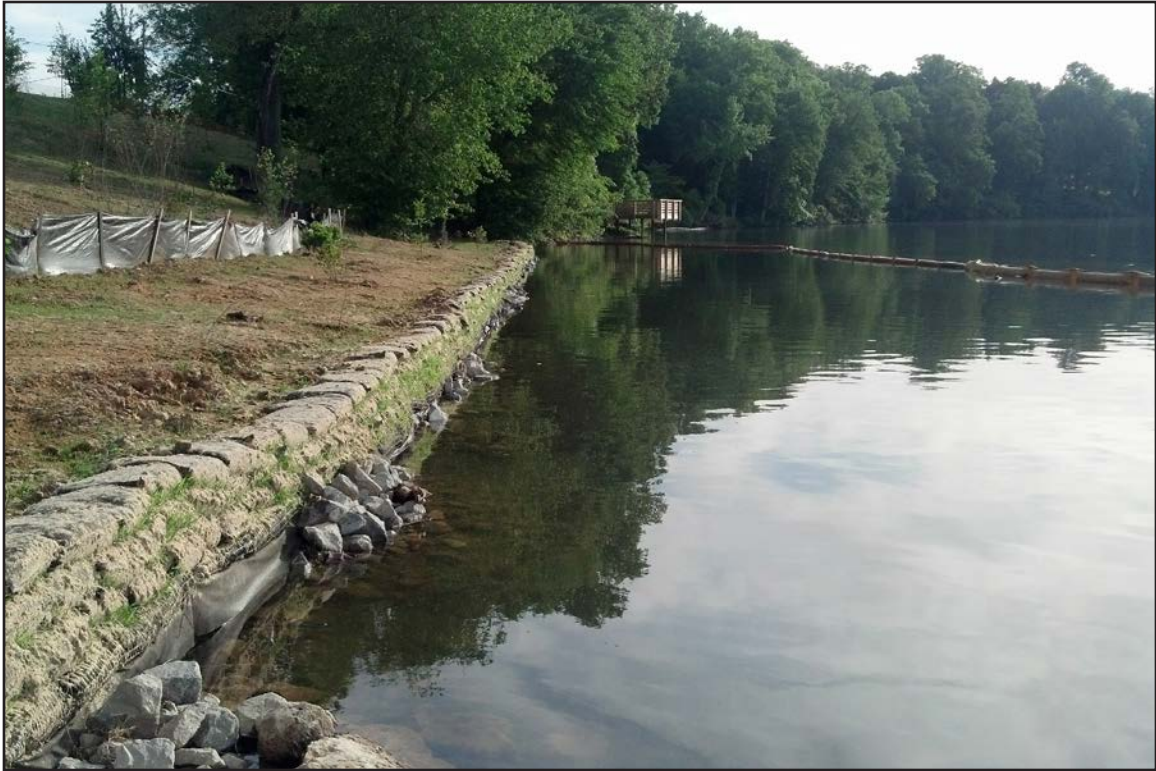
12A – Vegetative slope stabilization - Emory River shoreline. May 24, 2014.

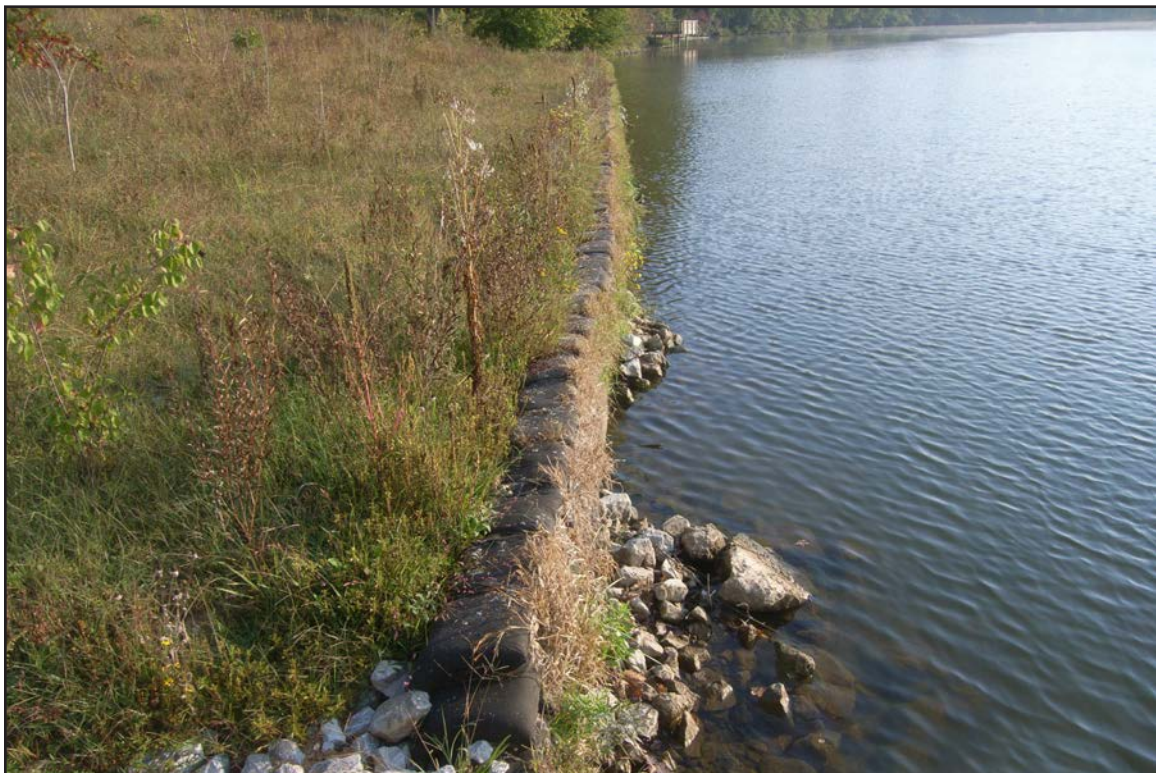
12B – Vegetative slope stabilization - Established wall vegetation. October 2, 2014.

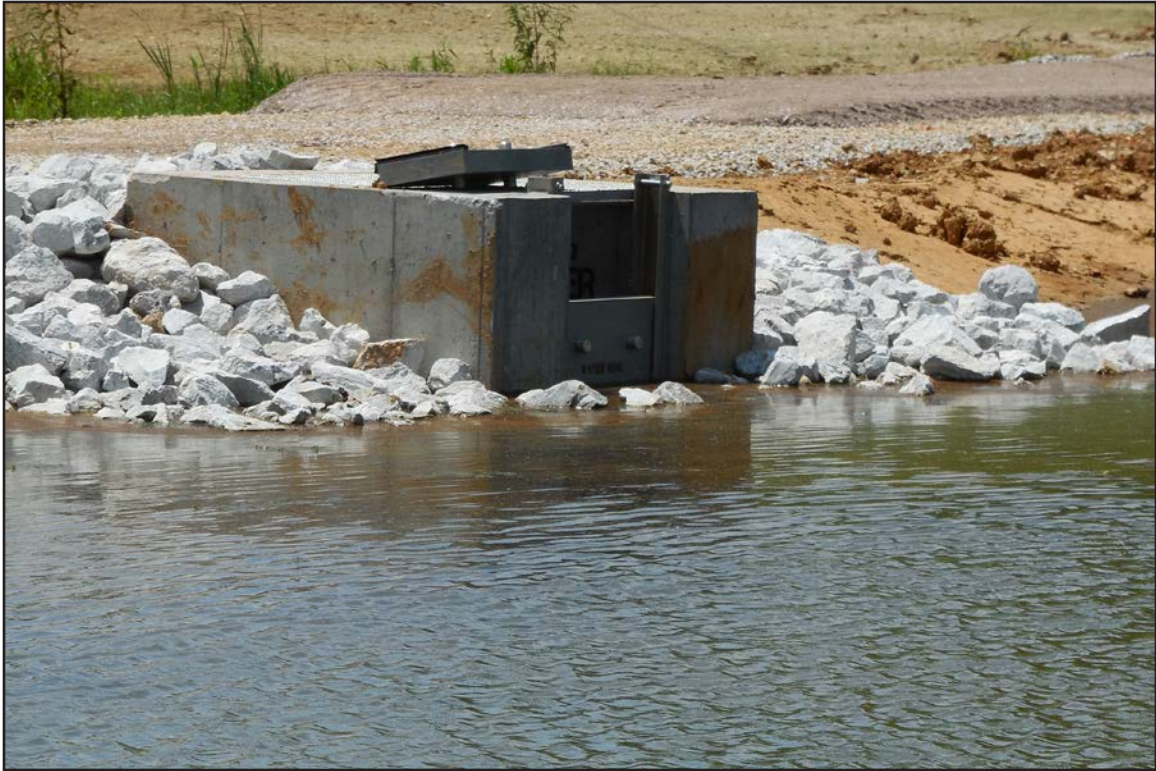
13A – Weir 1 at the transitional wetlands in the North Embayment. July 29, 2014.

Weirs will be inspected annually; their condition will be recorded and any debris interfering with their function will be removed.

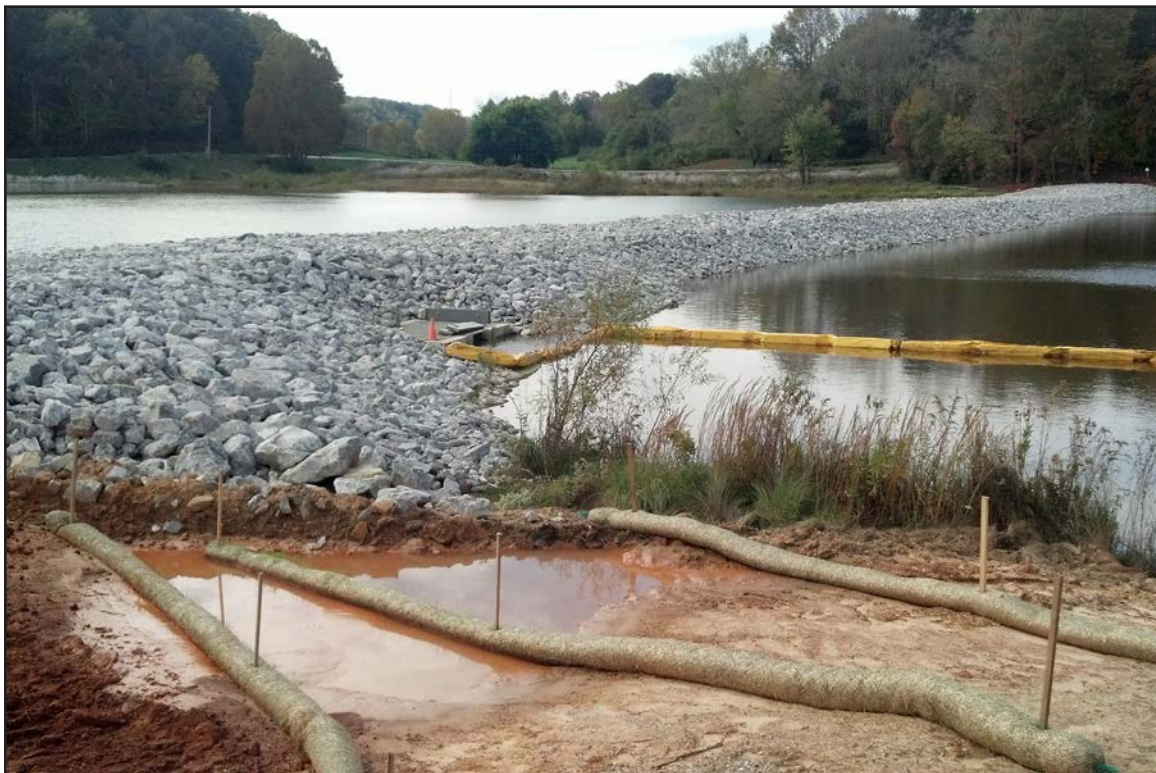
13B – Weir 2 at the North Berm dike in the North Embayment. October 20, 2014.

The berm traversing the North Embayment had been installed in 2010 as a temporary storm water control berm during ash removal from the North Embayment. In cooperation with the Natural Resource Damage Assessment (NRDA) trustees, it was agreed that the berm would remain permanently so as to establish optimum riparian habitat under a stable (fixed) shoreline in the upper half of the North Embayment. The TVA Dam Safety Governance organization classified the berm as a low risk dam that could be overtopped during significant storm events. As a result, riprap armoring was placed on the berm for erosion protection. The riprap extended partially down the upstream face of the berm, across the top of the berm, and full depth of the downstream face of the berm. The riprap armoring extended from abutment to abutment, approximately 670 ft. The riprap armoring was constructed by SCS in July and August 2014.
