SITCUM WATERWAY REMEDIATION PROJECT

MILWAUKEE HABITAT AREA MONITORING REPORT, 2004

NOVEMBER 2004

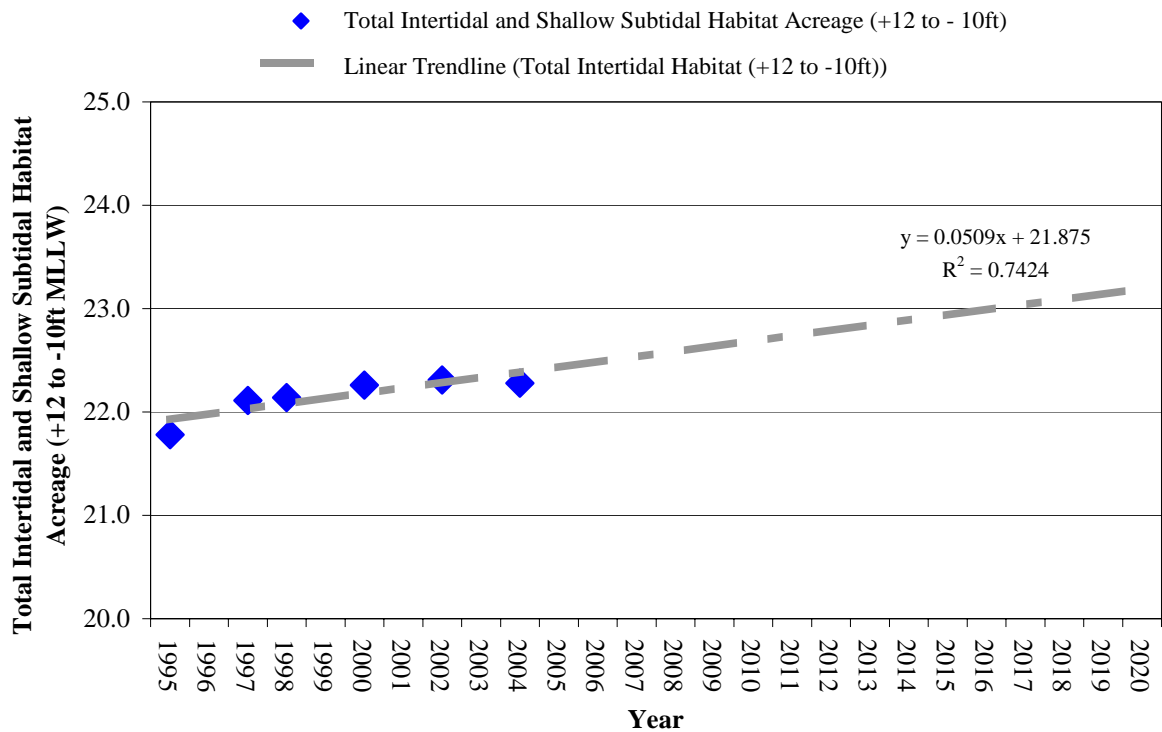
Figure 2. Total intertidal and shallow subtidal habitat acreage at the Milwaukee Habitat Area with extrapolated linear trendline, 1995 to 2020¹.

The design of the Milwaukee Habitat Area maximized the acreage of intertidal habitat while recognizing that both intertidal and shallow subtidal habitat is valuable for juvenile salmonids. Further, due to the proximity of the site to the Puyallup River, it was expected that sediment accumulation would occur at the site and increase the acreage of shallow water habitat. This expectation has been borne out by the monitoring as the total acreage of intertidal and shallow subtidal habitat combined has increased and is expected to continue to increase based on the results of a linear regression (Figure 2). The linear regression, which was presented in the 2002 monitoring report (Grette Associates 2003) has been recalculated incorporating the results of the 2004 monitoring. The linear regression includes extrapolation with these data and is considered valid based on the observed growth of the Puyallup River delta. The location of the -4 ft MLLW contour has moved either bayward or landward during the different monitoring years, with the 2004 results indicating a bayward movement of approximately 22 ft (this is based on the length of the -4 ft MLLW contour and the increase in area encompassed by the -4 ft MLLW contour). The -10 ft MLLW contour has primarily moved bayward since 1995 due to the constant input of sediments from the river, however from 2002 to 2004 the -10 ft MLLW contour has moved approximately 3.5 ft landward (calculated the same way as the -4 ft MLLW contour).

Based on the growth in the delta over the last 50 to 60 years and the monitoring results for the -10 ft MLLW contour, it is expected that shallow subtidal habitat will continue to increase beyond the limits of the habitat area. As this habitat receives more deposition it will reduce wave energy at the -4 ft MLLW contour allowing greater deposition at that elevation. Therefore, the -10 ft MLLW contour is expected to continue to move bayward while the -4 ft MLLW contour will change each year based on the balance between wave action and deposition. The intertidal habitat area (+12 ft to -4 ft MLLW) is expected to vary between years, but that area is expected to eventually follow the increasing trend shown in Figure 2 for intertidal and shallow subtidal habitat combined. The results of the monitoring activities support these statements; as the shallower -4 ft MLLW contour varies more from year to year (approximately 22 ft from 2002 to 2004), then the location of the -10 ft MLLW contour, which varies very little (approximately 3.5 ft from 2002 to 2004). Overall, it is expected that performance standard 1 will be met in the future as the -4 ft contour moves bayward in response to the continued growth of the Puyallup River delta.

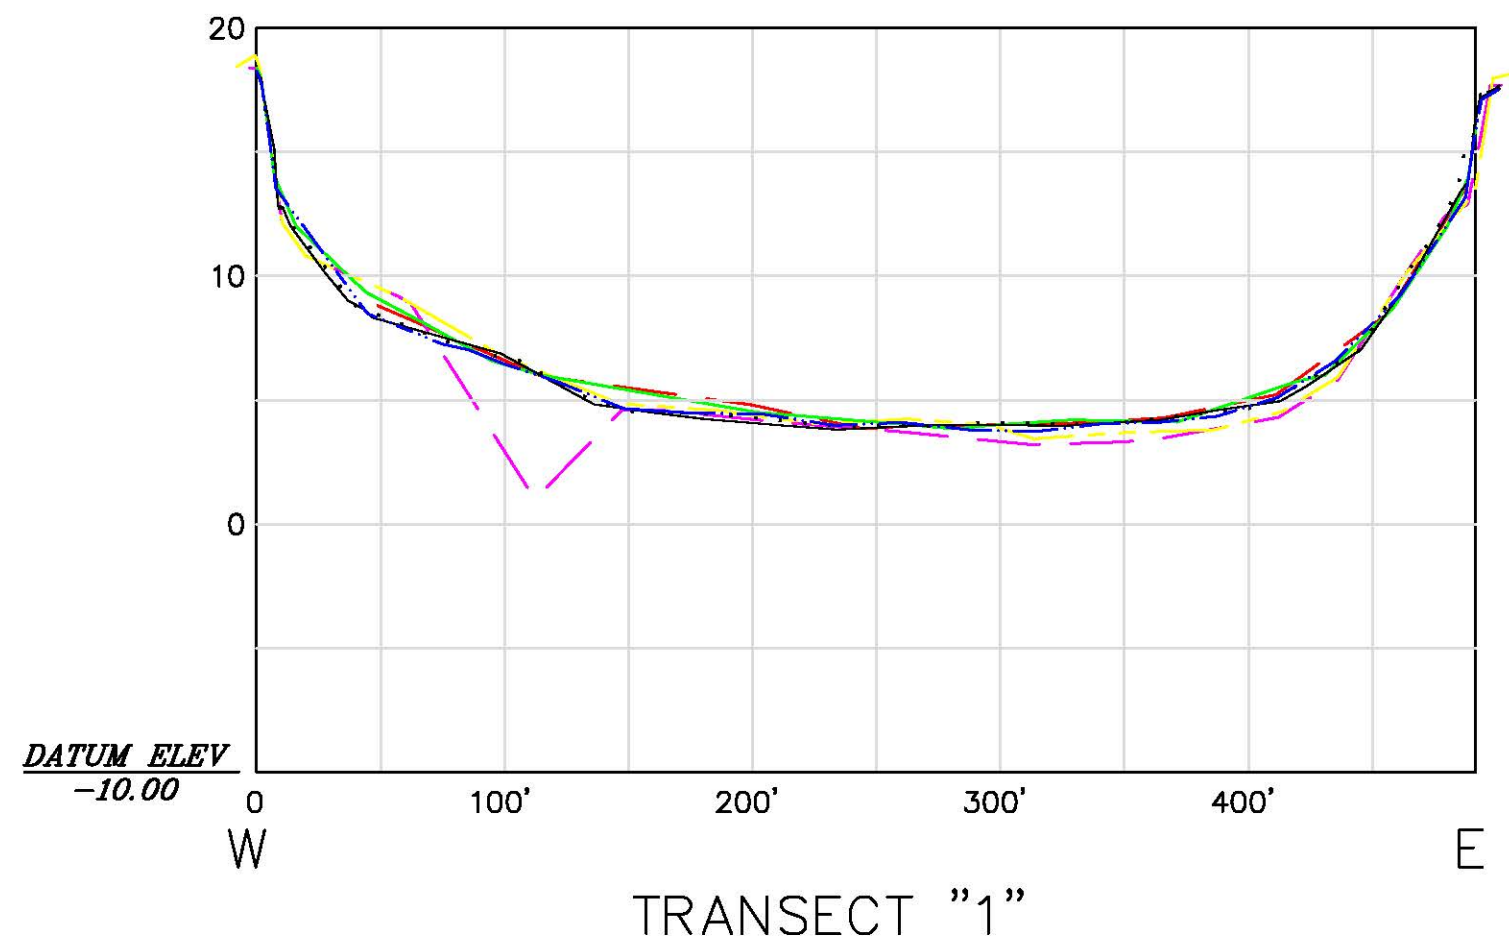
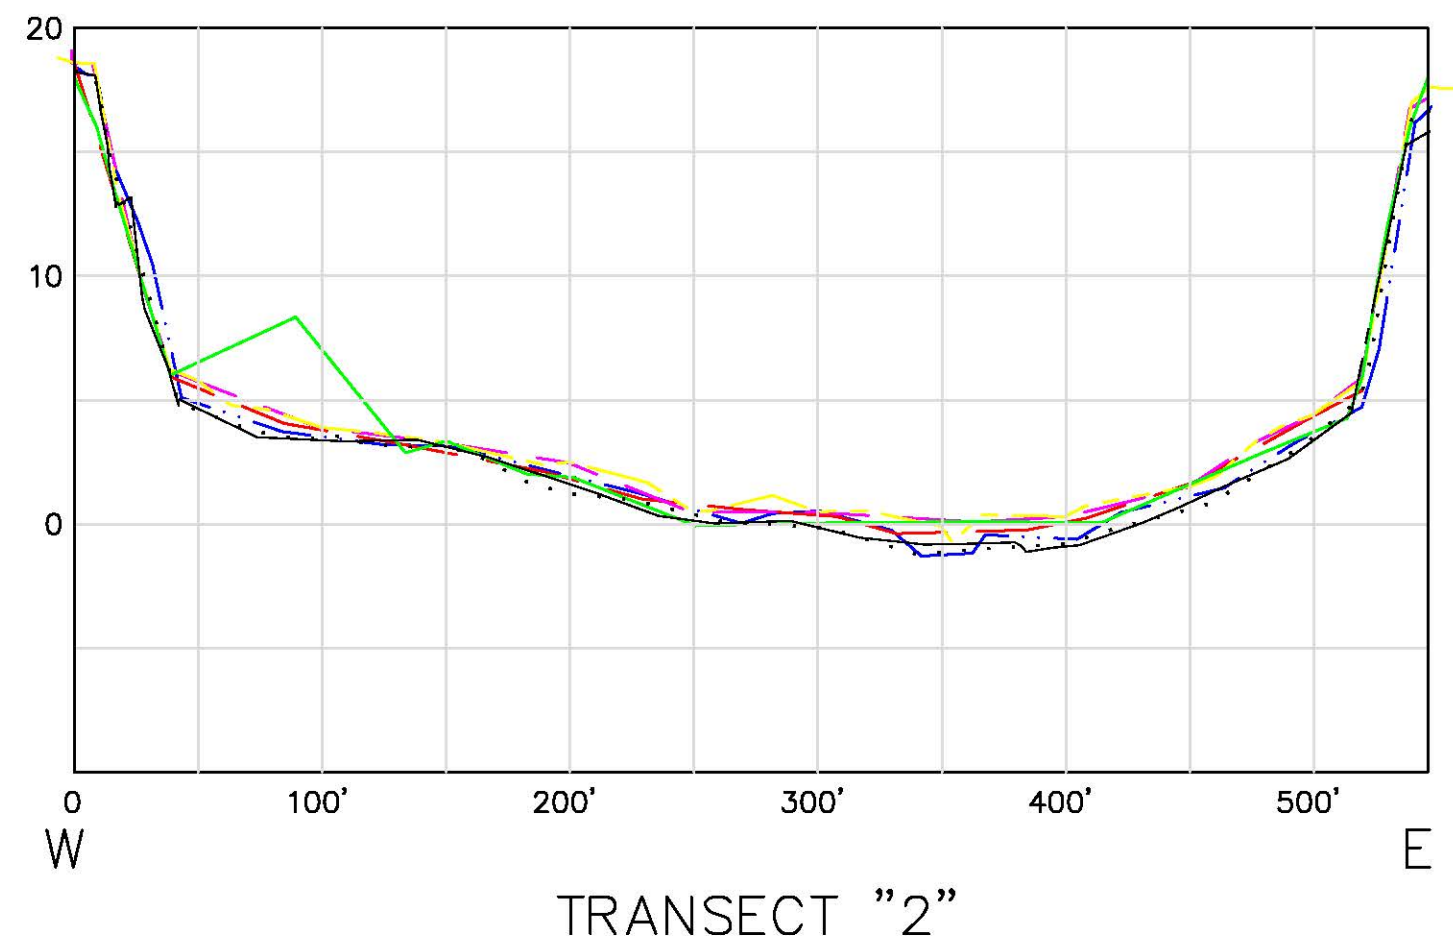
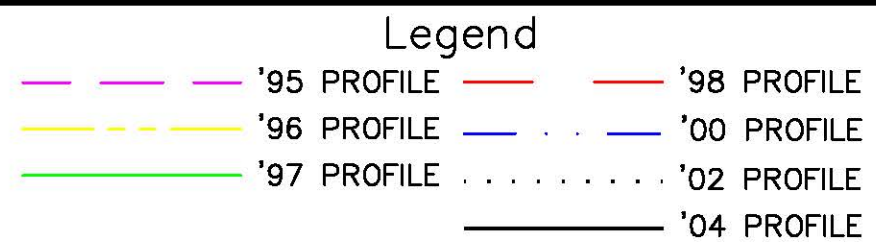
Figure 3
Milwaukee Habitat Area,
Transect Profiles 1 & 2

Surveyors determined the locations and elevations of points along all transects (Figure 1). All elevation data were referenced to MLLW and all survey coordinates were referenced to state plane coordinates (Washington State Plane South, North American Datum 1983). The survey information was downloaded into a CAD (Computer Aided Design) format for mapping. Results from the 2004 survey of transects 1 and 2 were compared with the 1995 profiles, as well as all subsequent surveys (Figure 3).

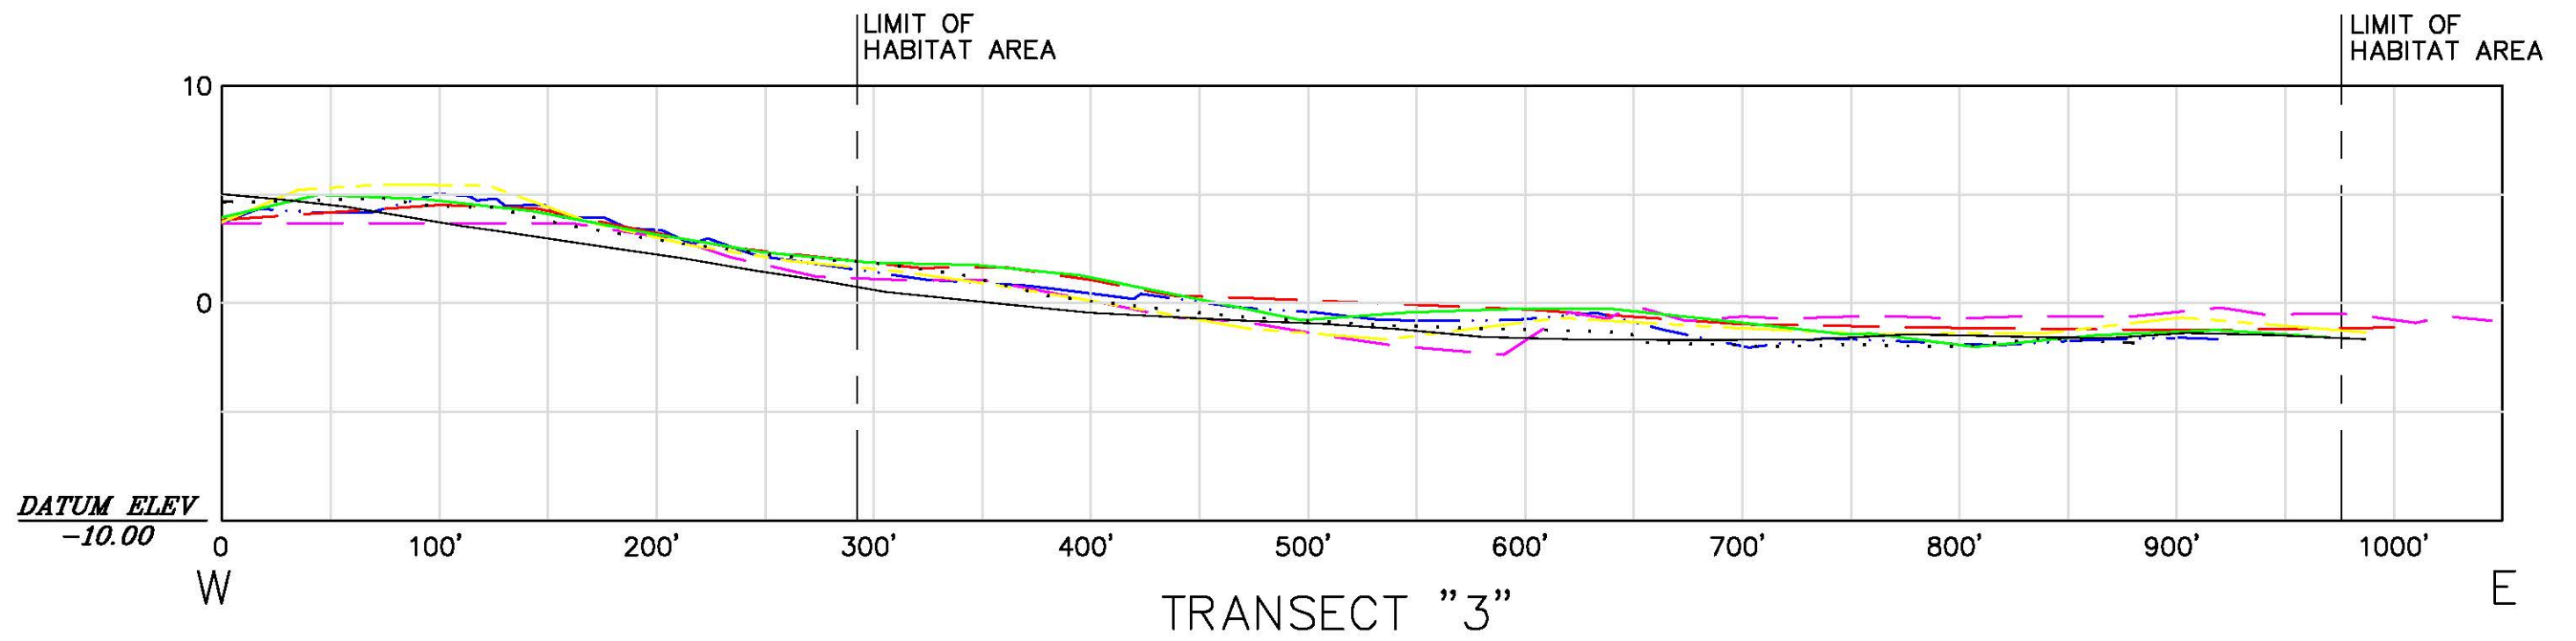
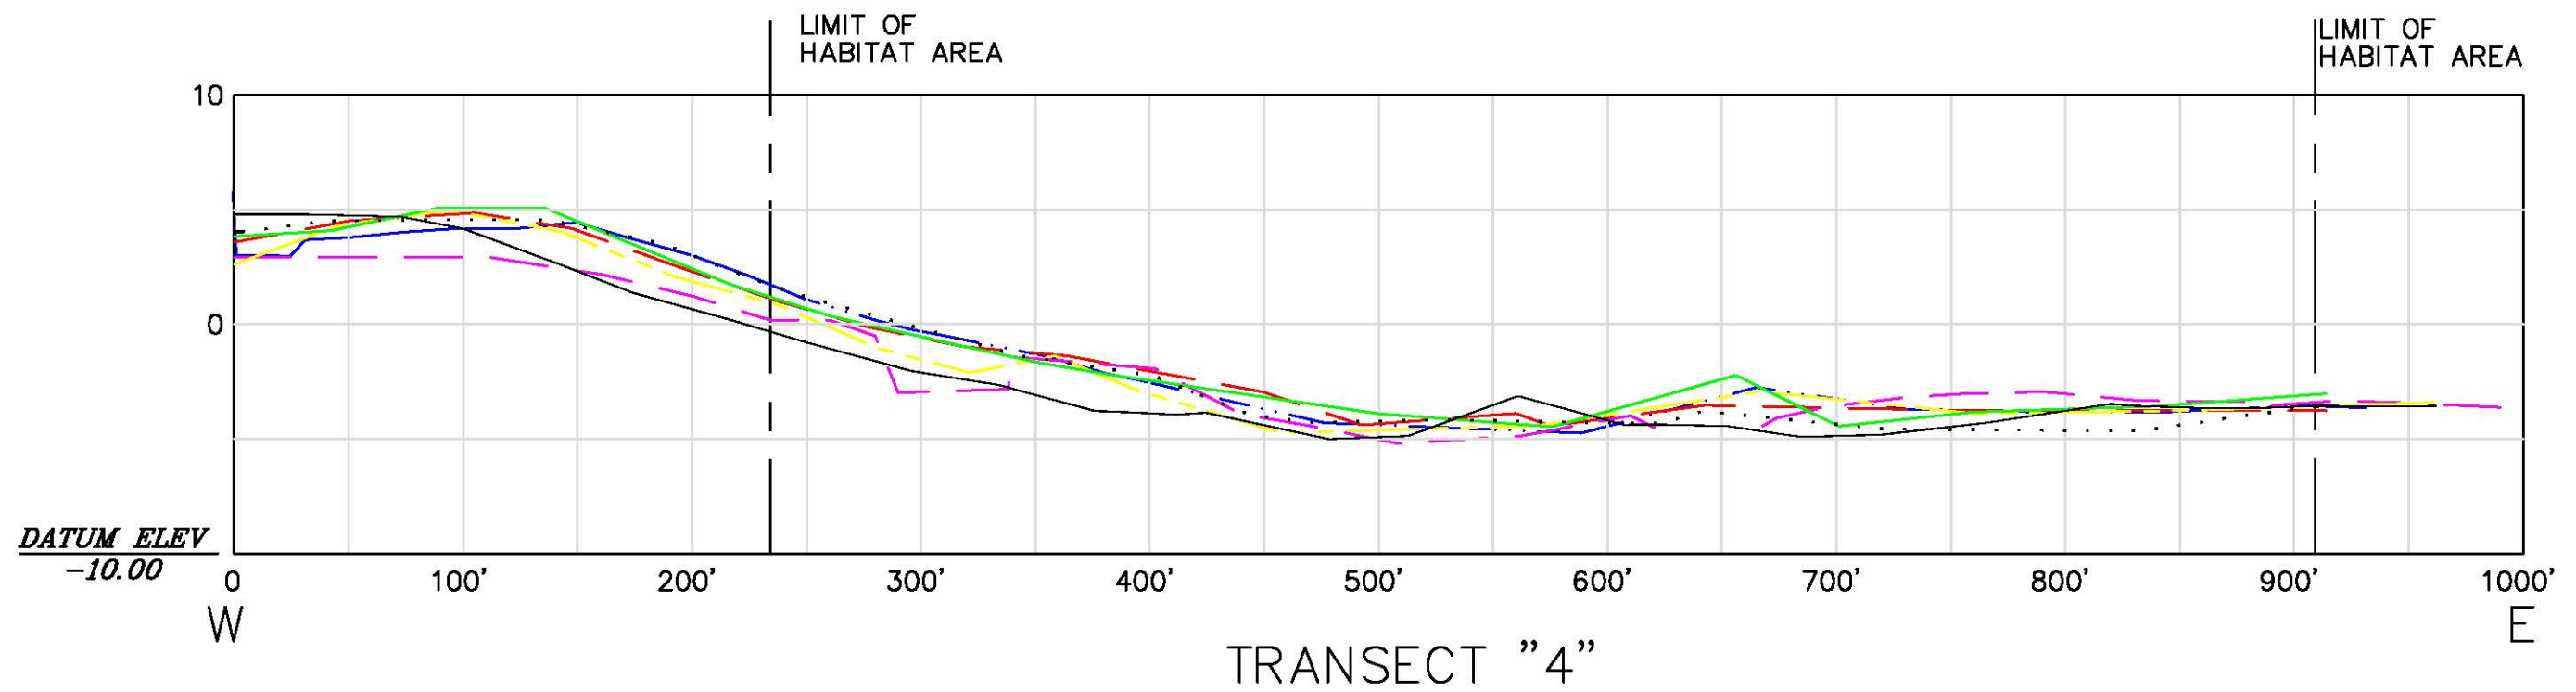
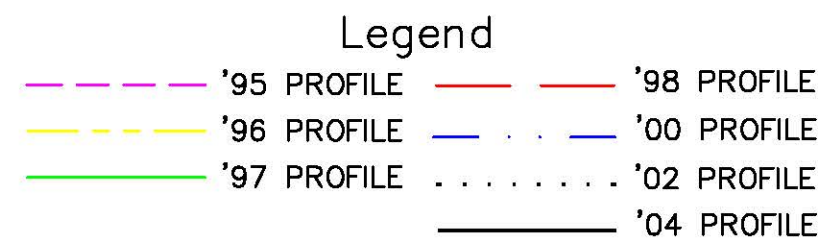
Figure 4
Milwaukee Habitat Area,
Transect Profiles 3 & 4

In 1995, transect data for transects 3 and 4 were developed by overlaying the transect location on the “as-built” drawing and determining an elevation and a relative location from the 0 point of the transect (defined as the training wall). Therefore, the 1996 data

are the first measured profiles for transects 3 and 4. These are compared with the all subsequent profiles in Figure 4.

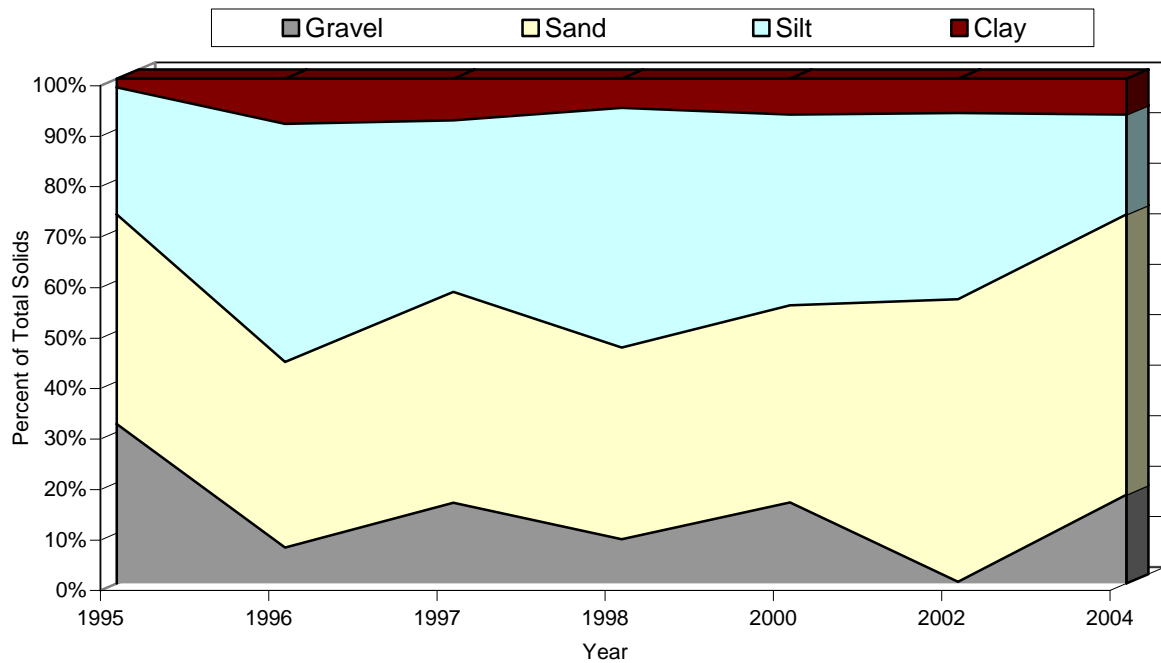
Figure 5. Substrate characterization from transects 1 & 2 of the Milwaukee Habitat Area, as an average percent of total solids.

In 2004, sand and silt were the dominant substrate materials within all transects (Table 2, Figures 5 and 6). Transects 1 and 2, which were located within the area that once was gravel/cobble habitat type now contains less than 1 percent gravel. Deposition of sand and silt from the Puyallup River has covered the gravel. This deposition of fine material has yielded a decrease in gravel/cobble habitat and an increase in sandflat/mudflat habitat (Figure 5 and Table 1). Substrates from transects 3 and 4 have remained consistent from year to year (Figure 6). Clay was not abundant within any of the transects (Table 2).

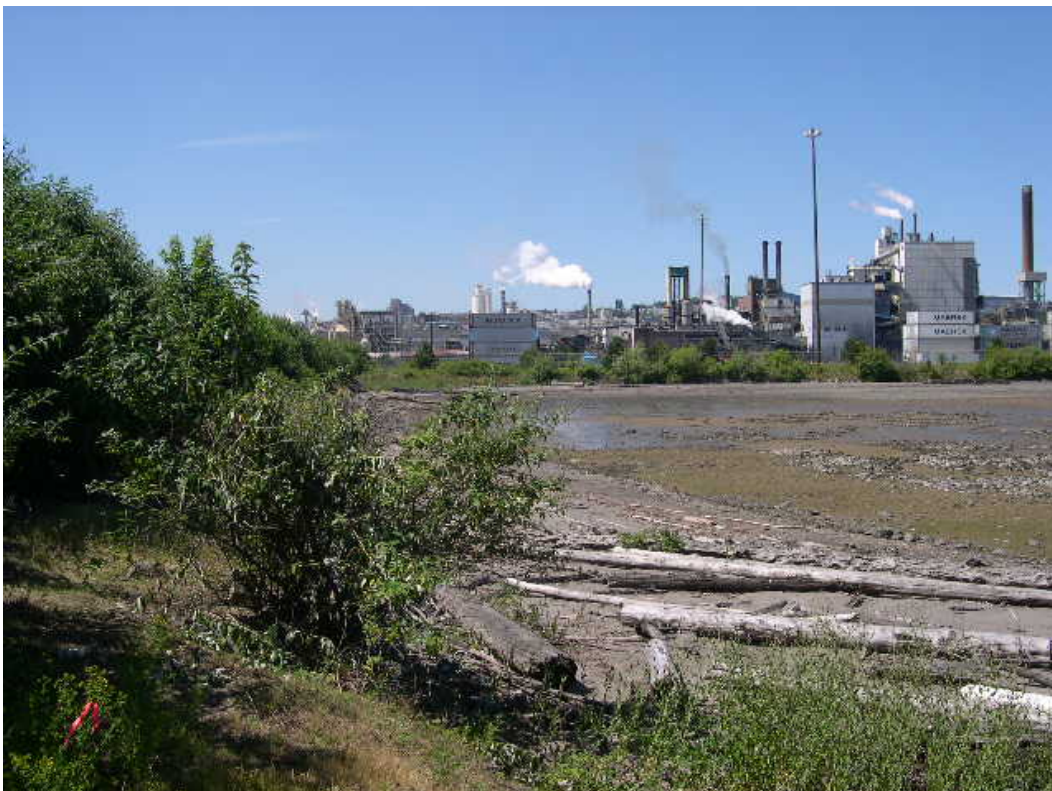
PHOTO 1: Milwaukee Habitat Area, June 6, 2004. Photopoint at southeast corner of the habitat, facing southwest. Tidal level = -3.5 ft MLLW.

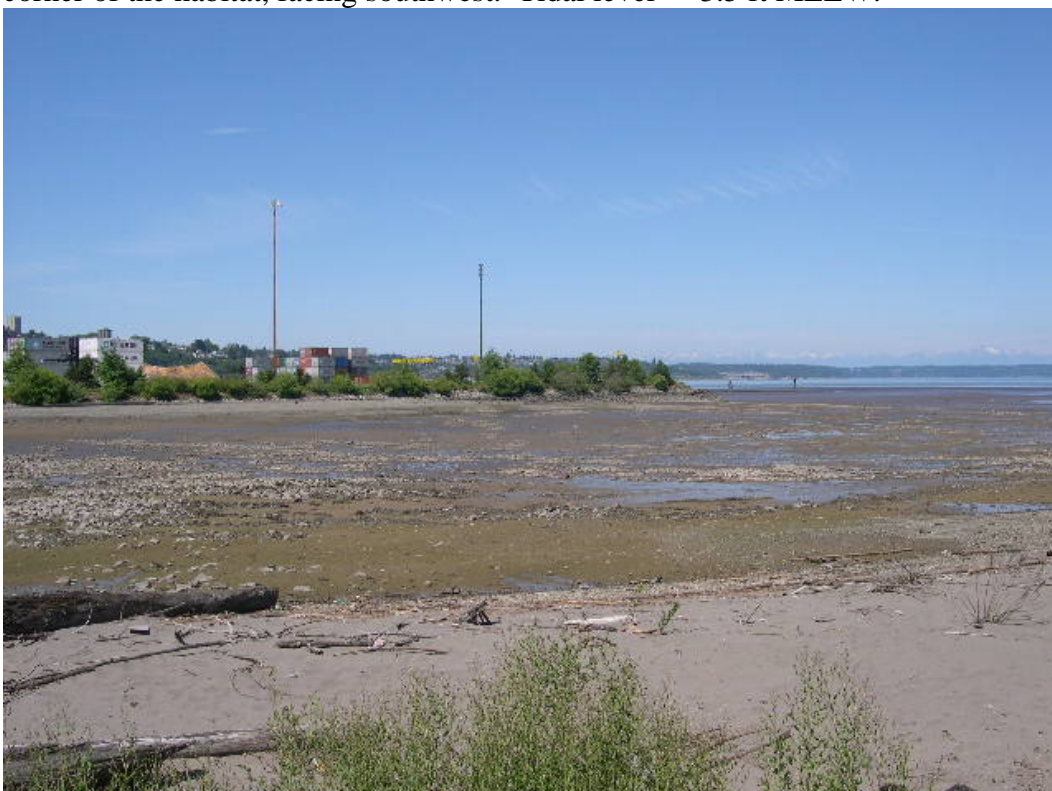
PHOTO 2: Milwaukee Habitat Area, June 6, 2004. Photopoint at southeast corner of the habitat, facing west. Tidal level = -3.5 ft MLLW.

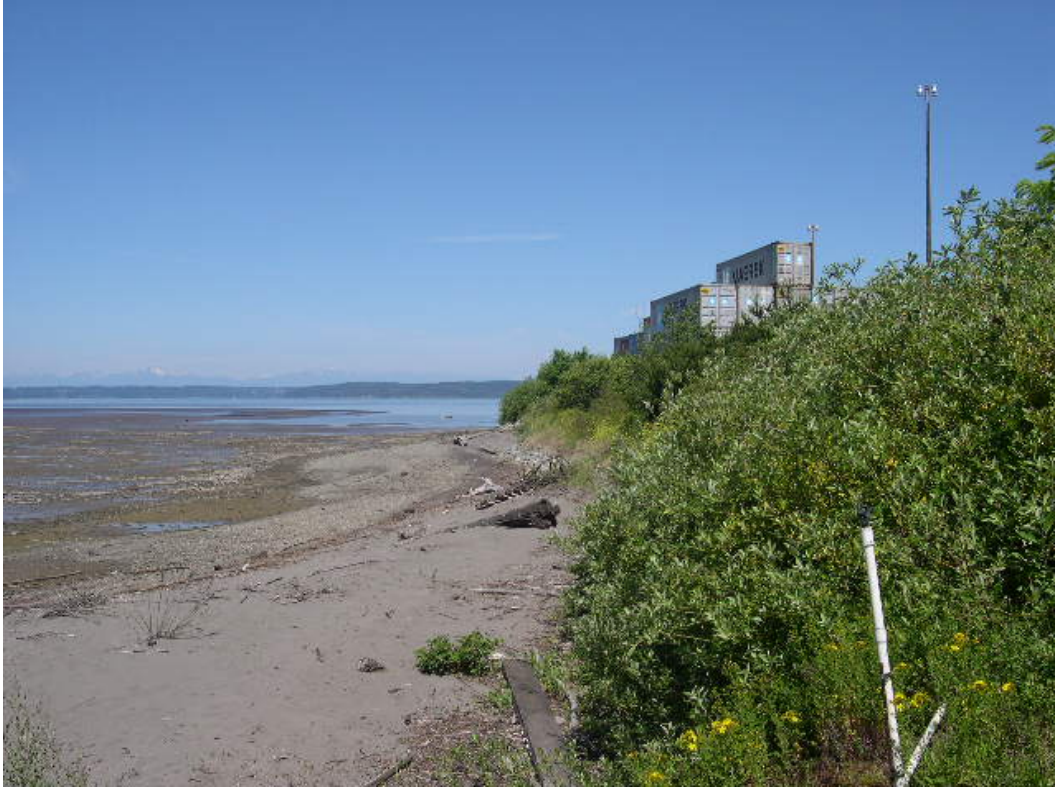
PHOTO 3: Milwaukee Habitat Area, June 6, 2004. Photopoint at southeast corner of the habitat, facing northwest. Tidal level = -3.5 ft MLLW.

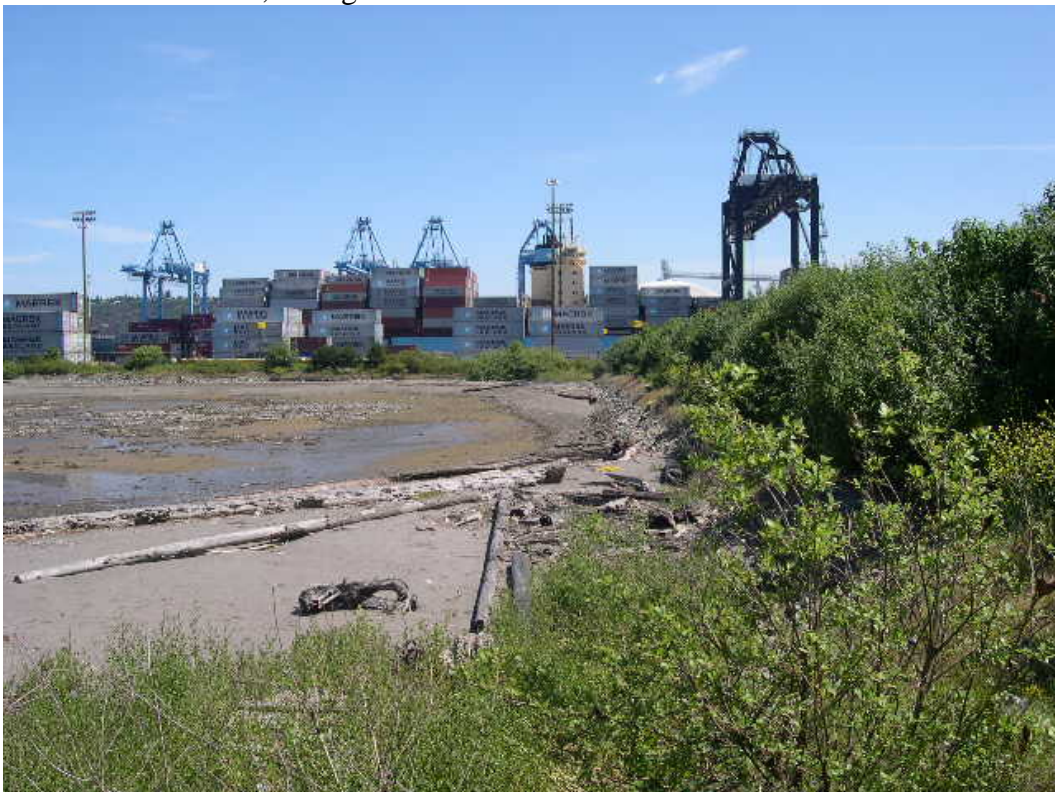
PHOTO 4: Milwaukee Habitat Area, June 6, 2004. Photopoint at southwest corner of the habitat, facing northeast. Tidal level = -3.4 ft MLLW.

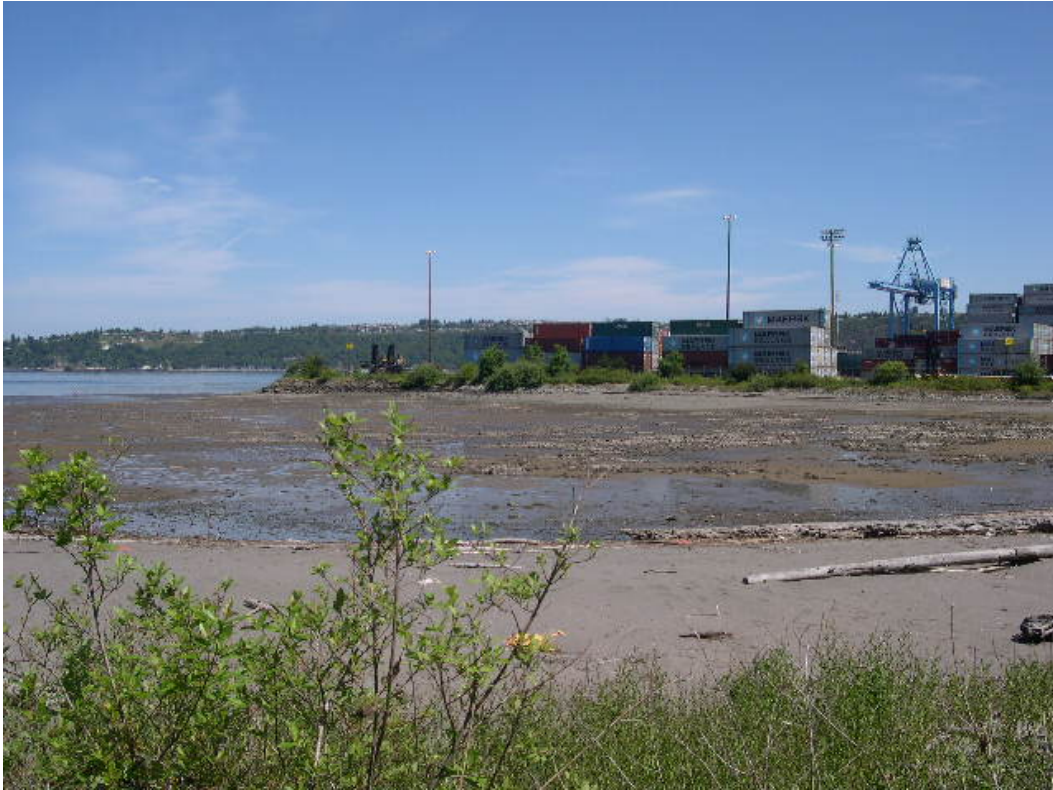
PHOTO 5: Milwaukee Habitat Area, June 6, 2004. Photopoint at southwest corner of the habitat, facing north. Tidal level = -3.4 ft MLLW.

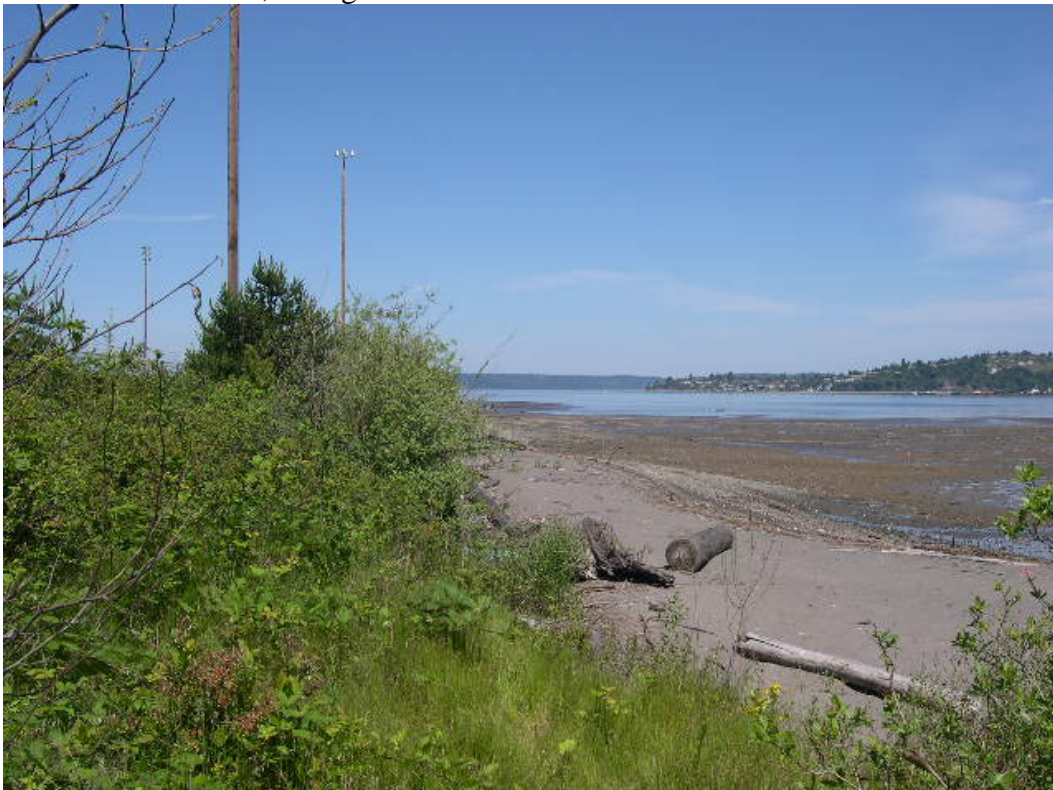
PHOTO 6: Milwaukee Habitat Area, June 6, 2004. Photopoint at southwest corner of the habitat, facing northwest. Tidal level = -3.4 ft MLLW.

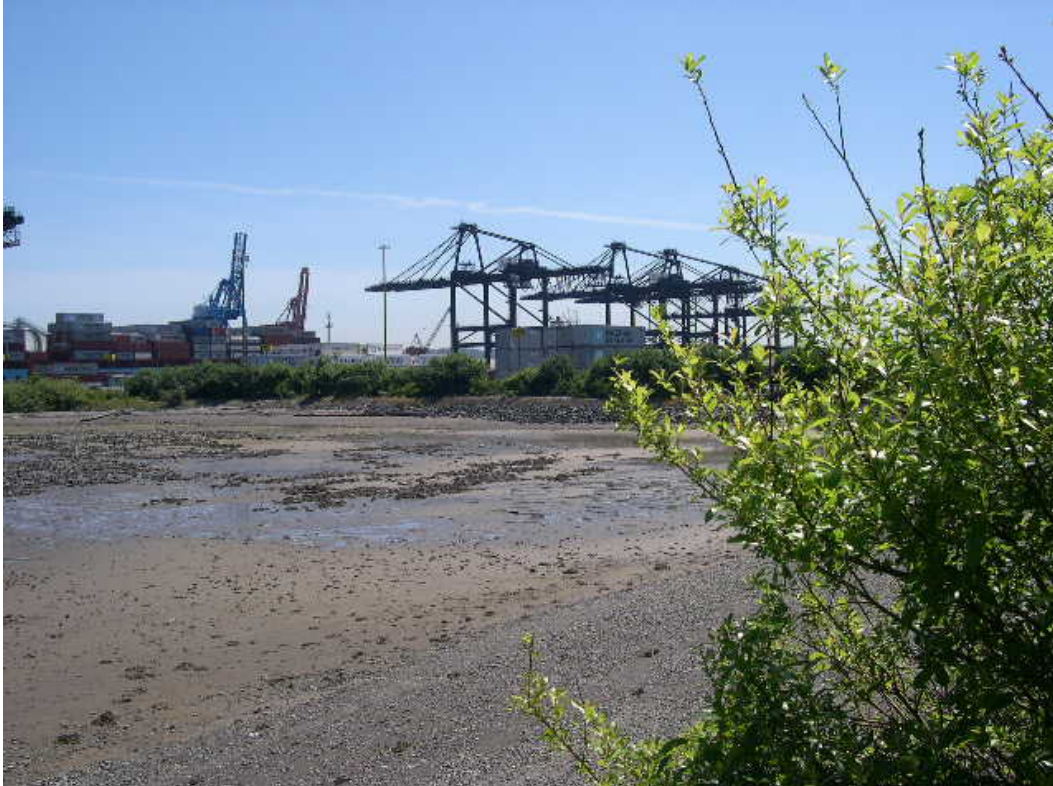
PHOTO 7: Milwaukee Habitat Area, June 6, 2004. Photopoint at the middle of the west side of the habitat, facing east. Tidal level = -3.2 ft MLLW.

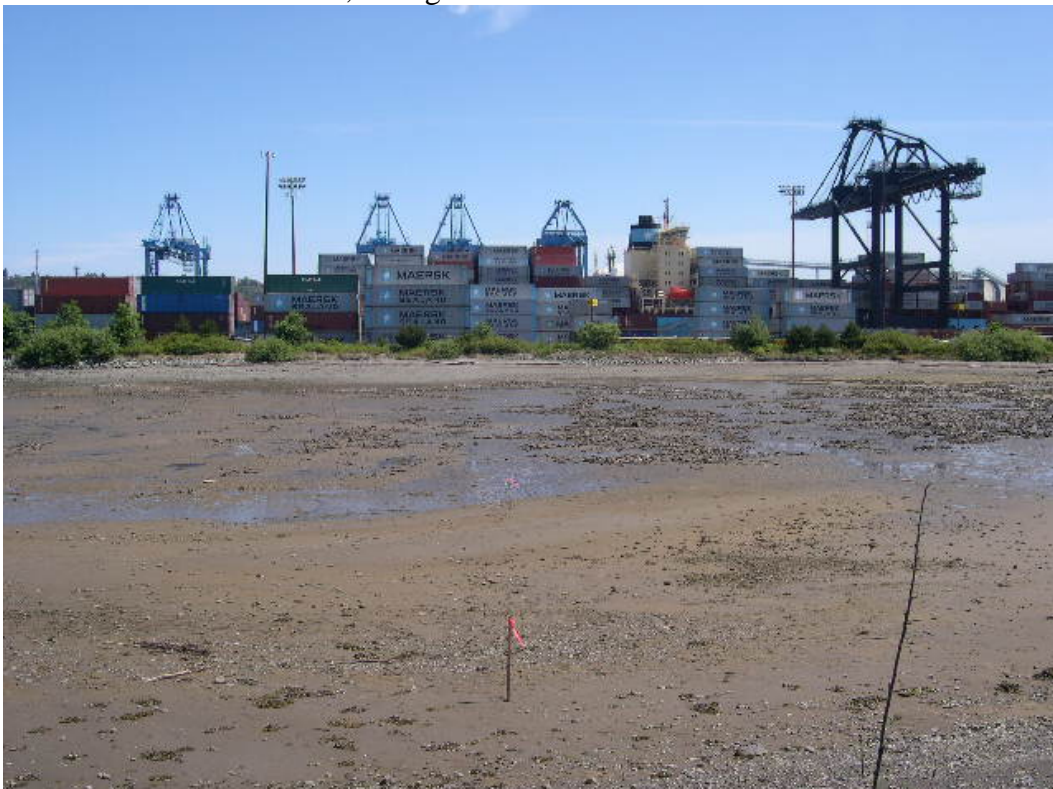
PHOTO 8: Milwaukee Habitat Area, June 6, 2004. Photopoint at the middle of the west side of the habitat, facing northeast. Tidal level = -3.2 ft MLLW.

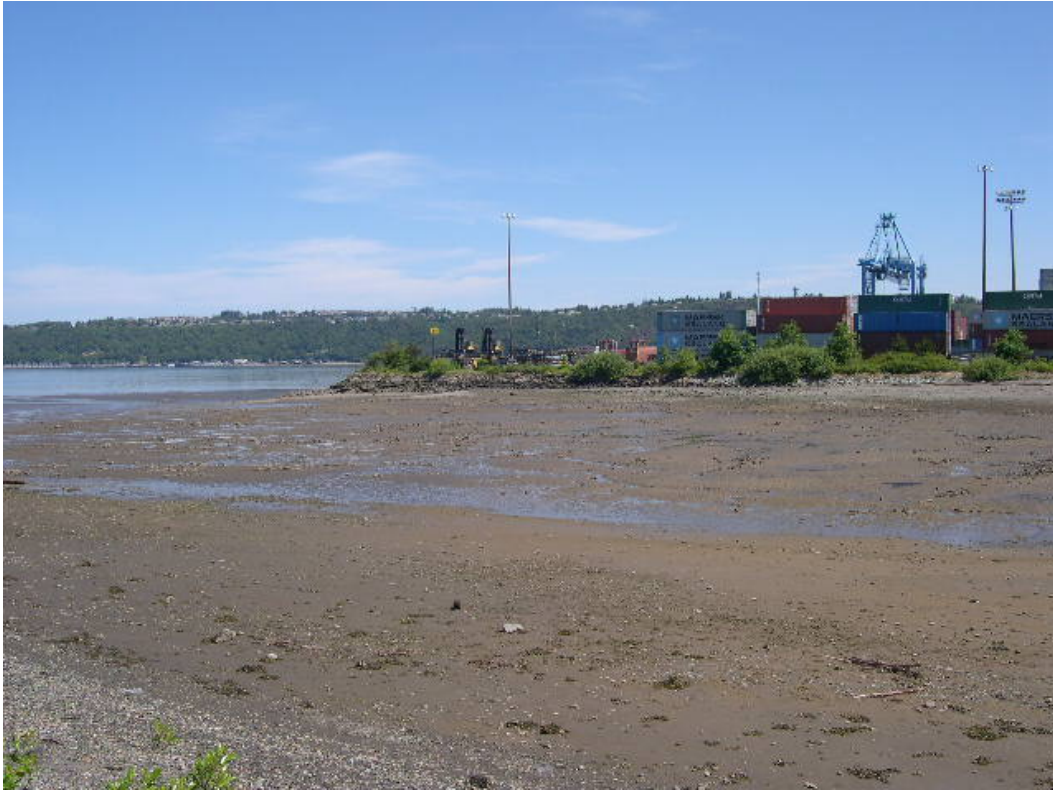
PHOTO 9: Milwaukee Habitat Area, June 6, 2004. Photopoint at the middle of the west side of the habitat, facing north. Tidal level = -3.2 ft MLLW.

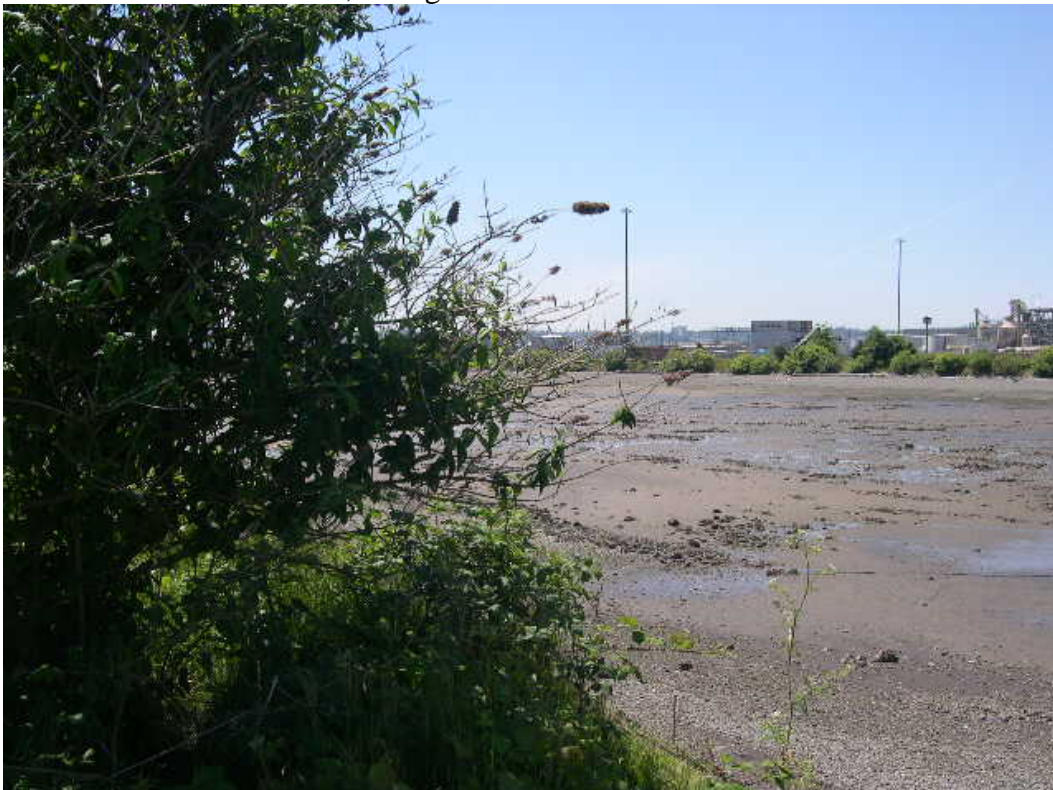
PHOTO 10: Milwaukee Habitat Area, June 6, 2004. Photopoint at the northeast tip of the habitat, facing south. Tidal level = -3.8 ft MLLW.

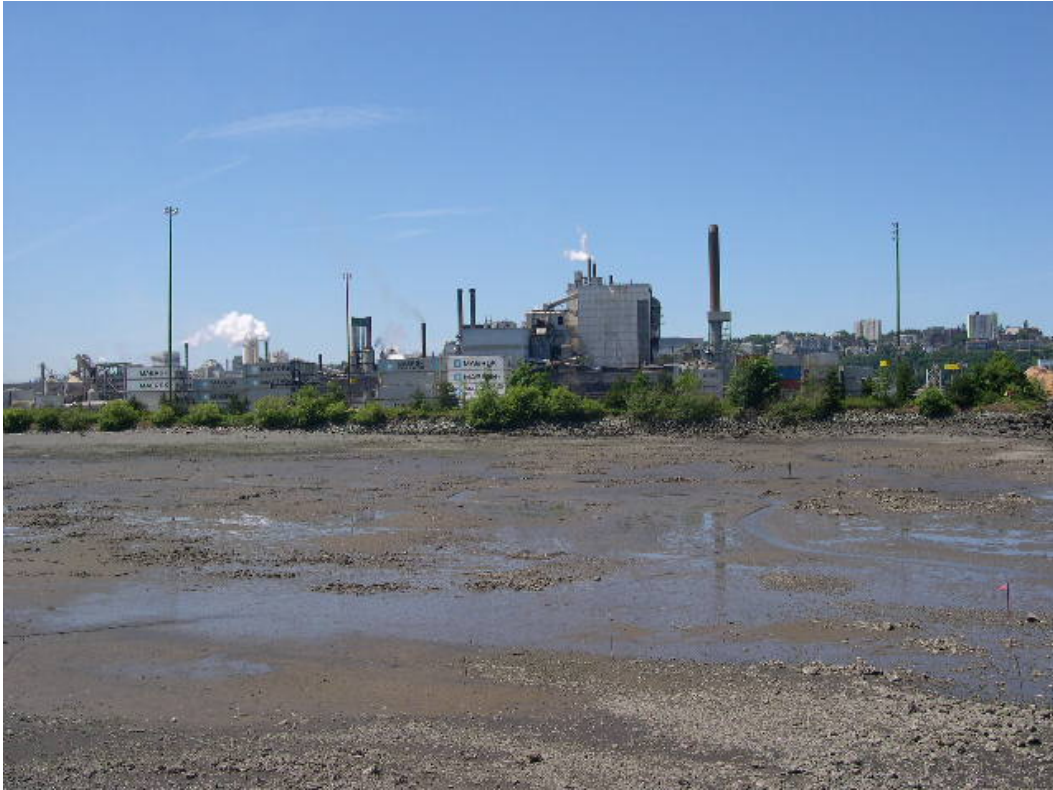
PHOTO 11: Milwaukee Habitat Area, June 6, 2004. Photopoint at the northeast tip of the habitat, facing southwest. Tidal level = -3.8 ft MLLW.

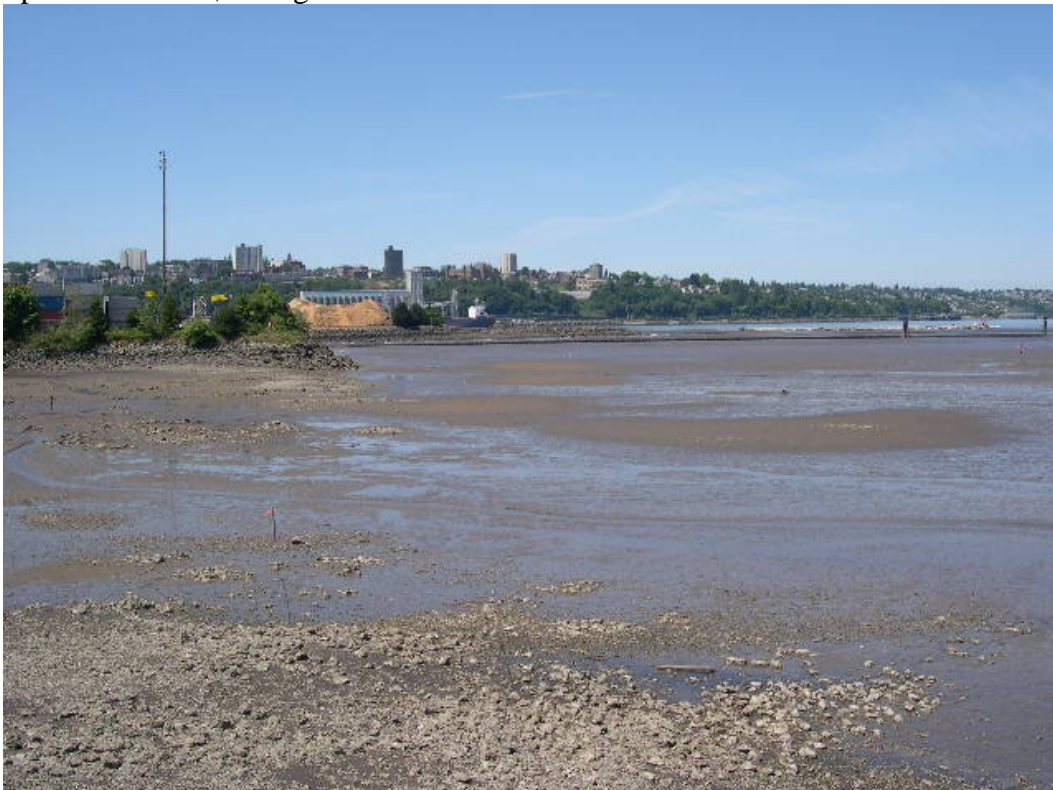
PHOTO 12: Milwaukee Habitat Area, June 6, 2004. Photopoint at the northeast tip of the habitat, facing west. Tidal level = -3.8 ft MLLW.

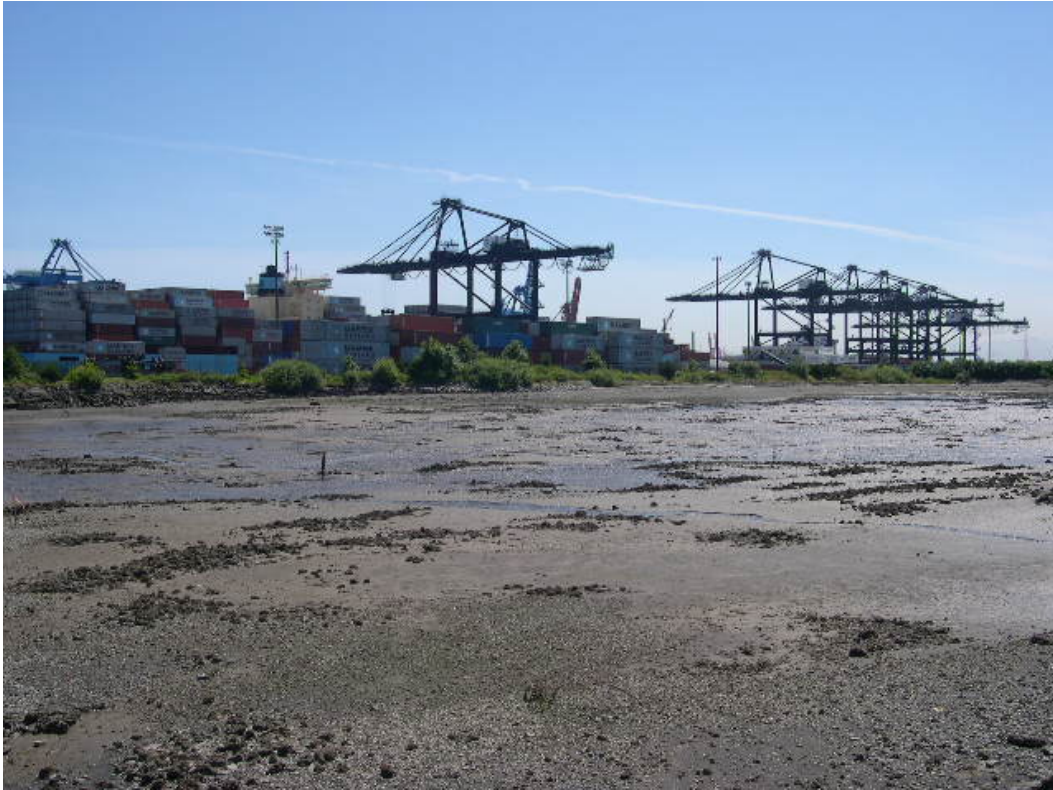
PHOTO 13: Milwaukee Habitat Area, June 6, 2004. Photopoint at the northwest tip of the habitat, facing northeast. Tidal level = -2.9 ft MLLW.

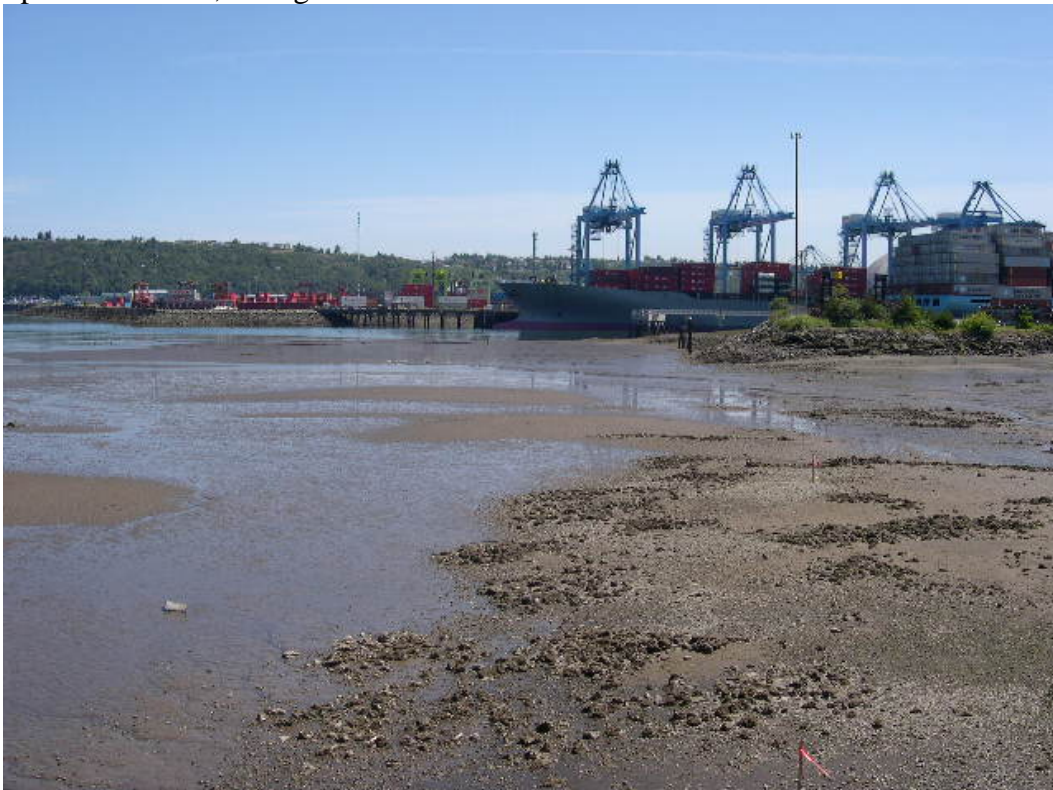
PHOTO 14: Milwaukee Habitat Area, June 6, 2004. Photopoint at the northwest tip of the habitat, facing north. Tidal level = -2.9 ft MLLW.

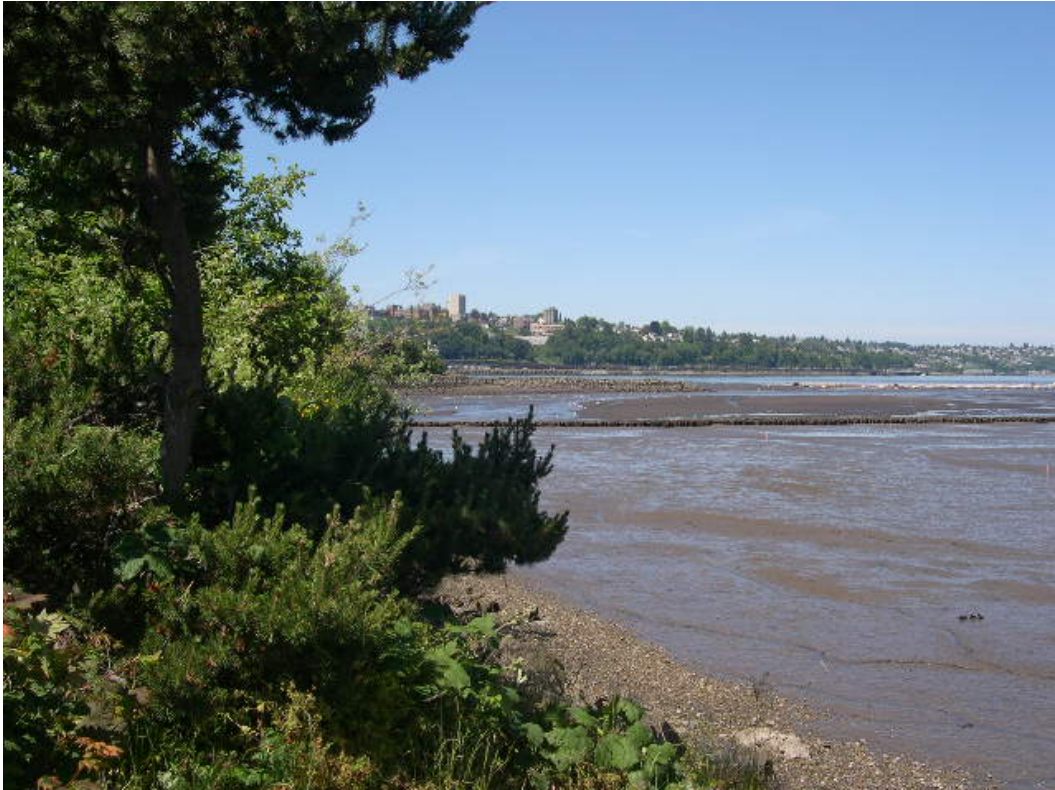
PHOTO 15: Milwaukee Habitat Area, June 6, 2004. Photopoint at the northwest tip of the habitat, facing northwest. Tidal level = -2.9 ft MLLW.
