SITCUM WATERWAY REMEDIATION PROJECT

MILWAUKEE HABITAT AREA MONITORING REPORT, 2004

NOVEMBER 2004

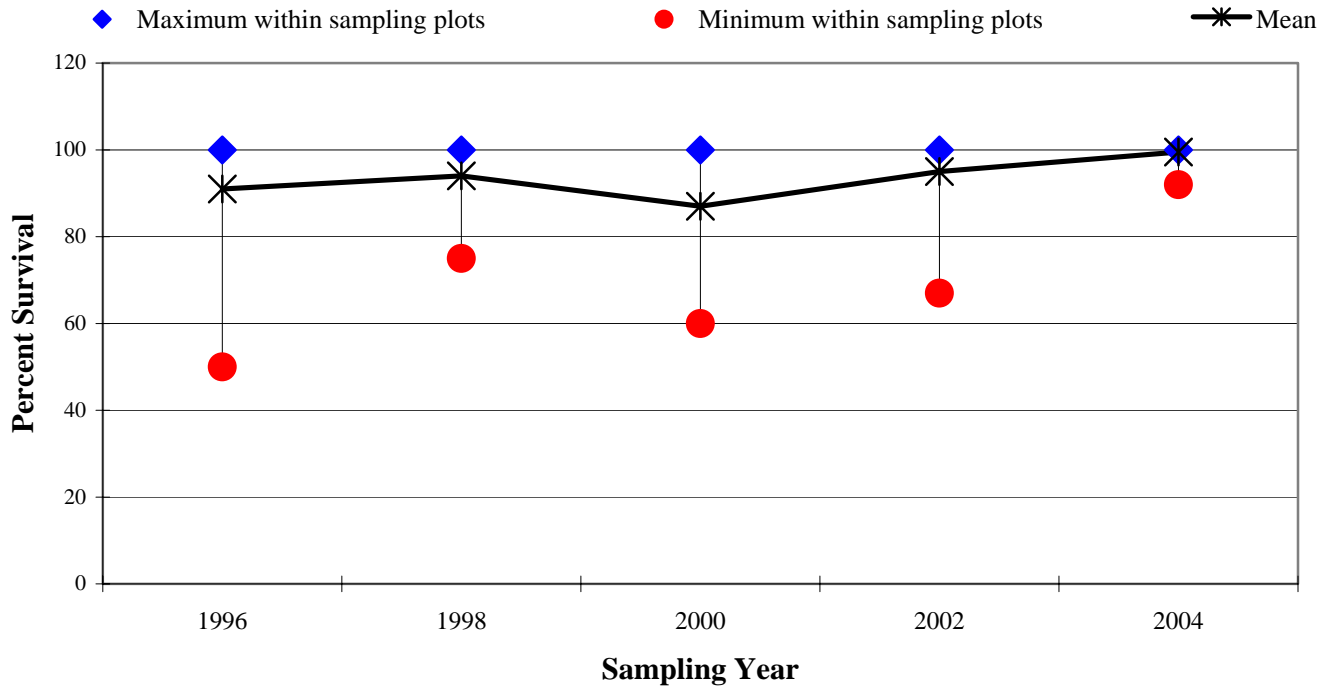
**Average Woody Plant Survival on the East and West Sides of the Milwaukee
Habitat Area, from Monitoring Efforts between 1996 and 2004.**

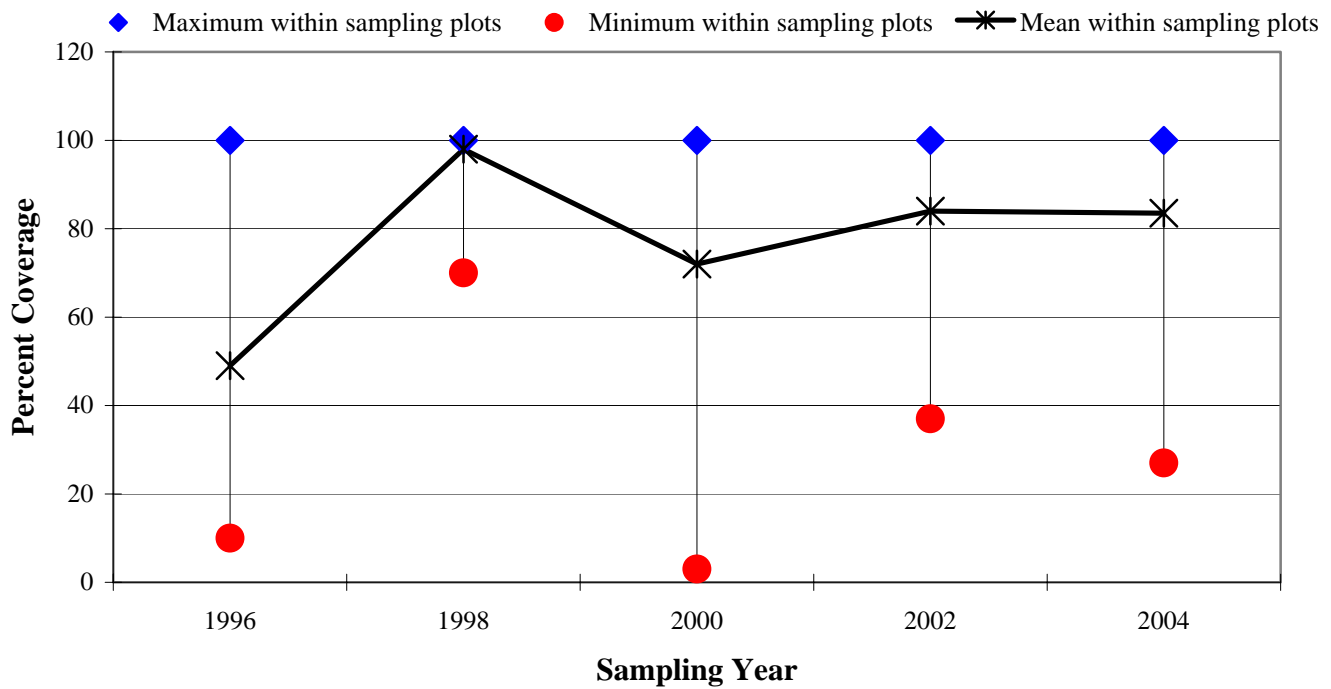
**Average Tree and Shrub Coverage on the East and West Sides of the Milwaukee
Habitat, from Monitoring Efforts between 1996 and 2004.**

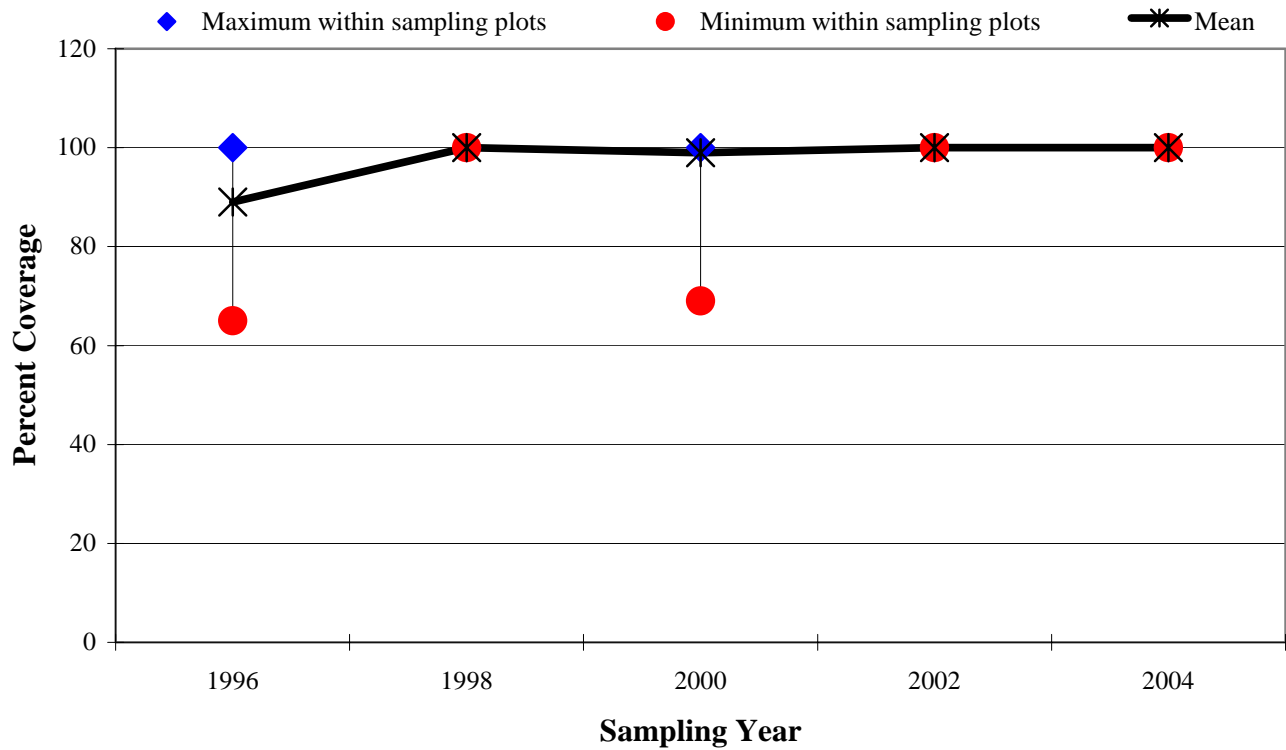
Average Total Vegetation Coverage on the East and West Sides of the Milwaukee Habitat Area, from Monitoring Efforts between 1996 and 2004.

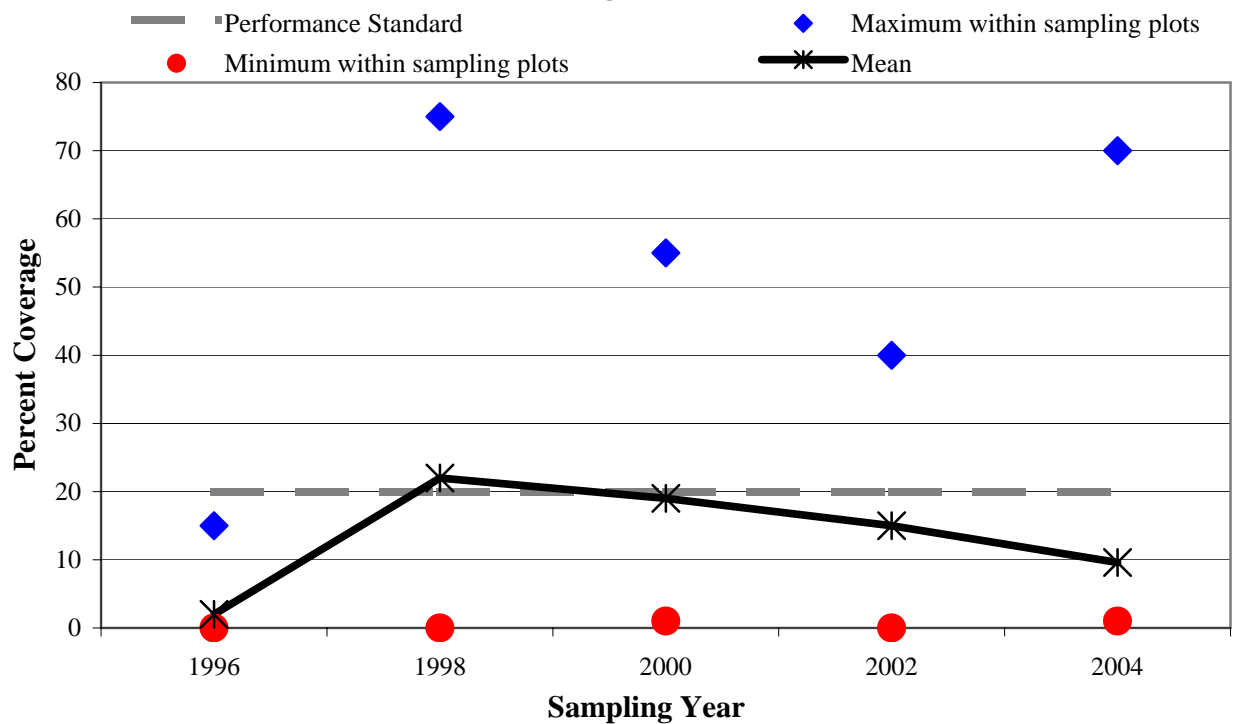
Average Invasive Species Coverage on the East and West Sides of the Milwaukee Habitat Area, from Monitoring Efforts between 1996 and 2004.
