**SEVENTH FIVE-YEAR REVIEW REPORT FOR  
LEE'S LANE LANDFILL SUPERFUND SITE  
JEFFERSON COUNTY, KENTUCKY**

**AUGUST 2023**

**U.S. Environmental Protection Agency  
Region 4  
Atlanta, Georgia**

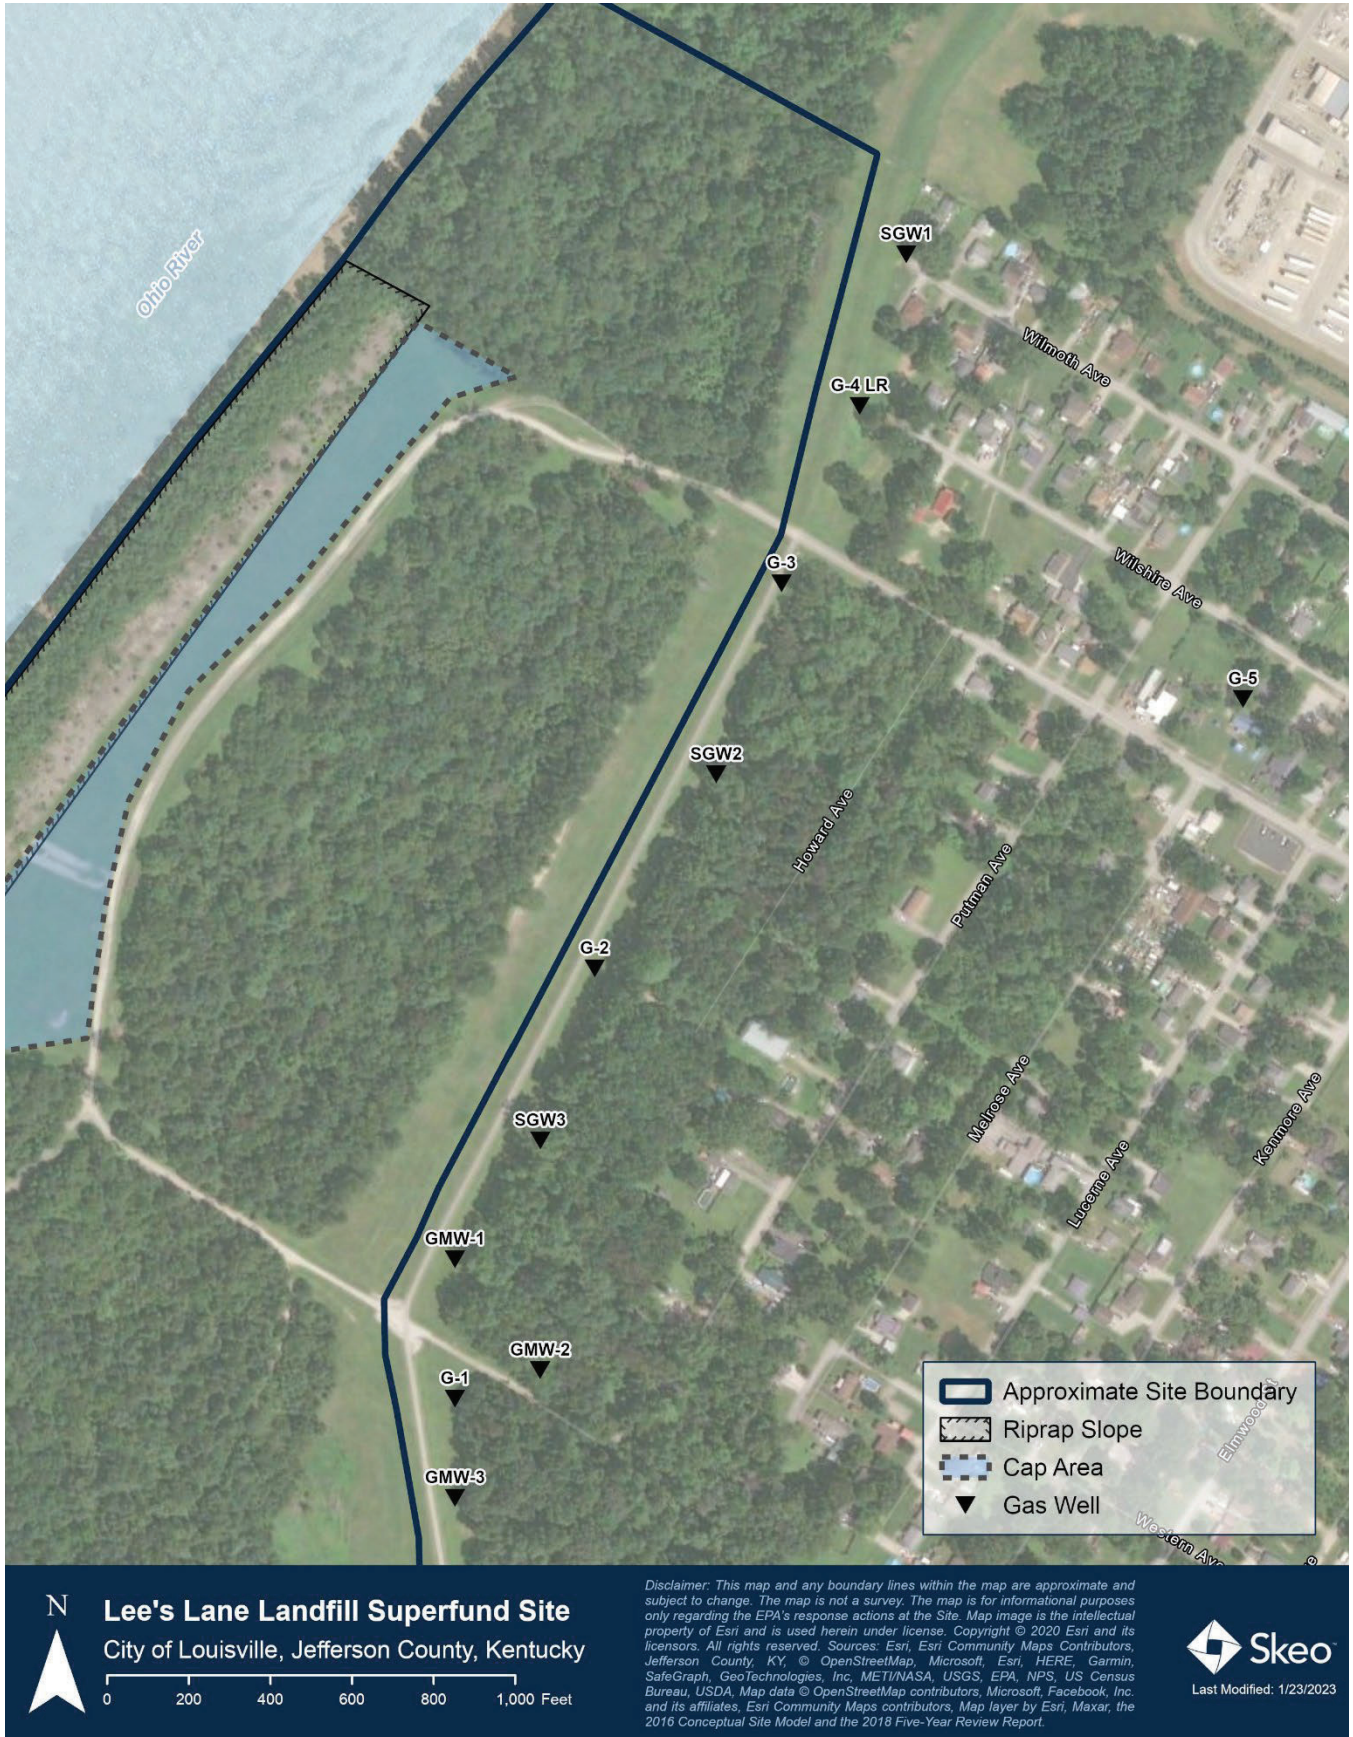
**Figure 3: Detailed Site Map**

Prior to fulfilling its O&M obligations in October 2020, Louisville MSD monitored soil gas twice per year. During this FYR period, soil gas was collected in 2019 (June and October by Louisville MSD) and in 2020 (June, July and December by KDEP). KDEP conducted soil gas monitoring, in response to recommendations from the previous FYR, at locations that have historically shown elevated levels of carbon tetrachloride and lower exceedances of several other organic contaminants. The soil gas samples are analyzed for VOCs, methane and other general gases. Gas probe locations are shown in Figure 3.

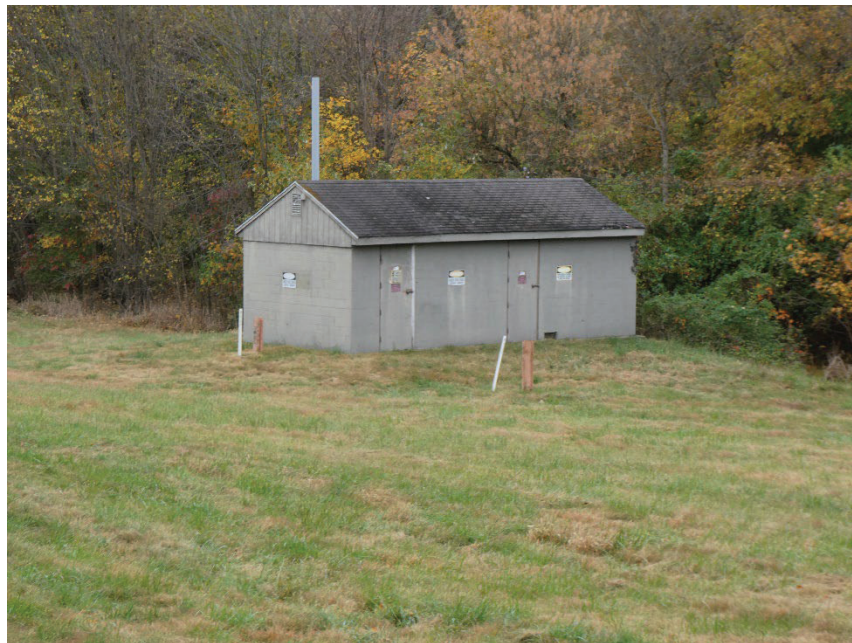
The electrical housing for the former landfill gas venting system.  
(Removed March 2023)

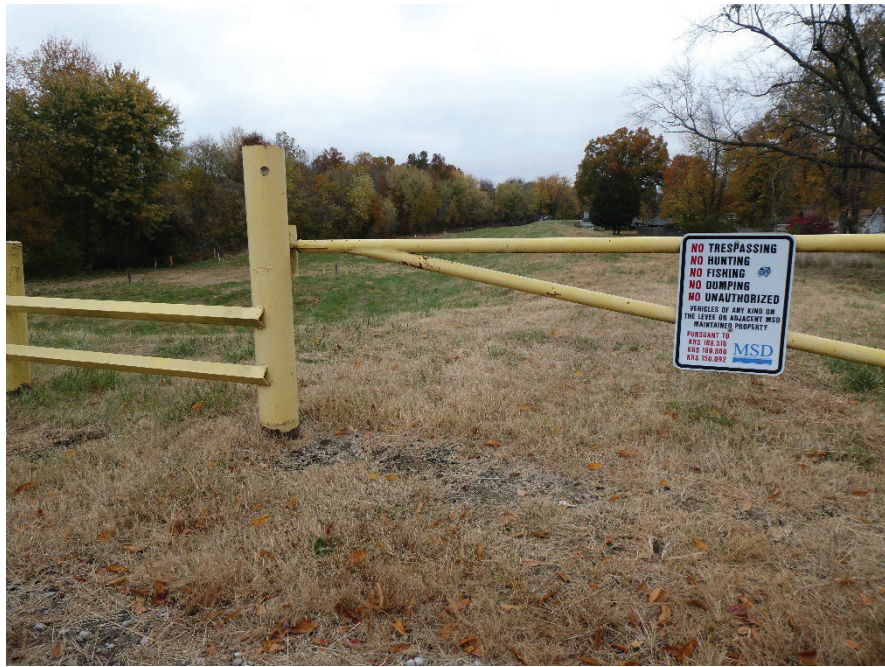
| | Remarks: <u>Site signage is in poor condition and difficult to find. The signs should be replaced according to the O&amp;M plan approved by EPA in November 2021.</u> | | |

Gate and signage near the Site entrance

KDEP plans to install new signage at the Site, repair monitoring well WM-102 and monitor and take appropriate maintenance actions for the swales and depressions in the engineered cap before the end of the 2023 calendar year. KDEP spoke with MSD in February 2023, and it was decided that the repairs to the Wilmoth Avenue barricade are MSD's responsibility. KDEP will continue to monitor the Wilmoth Avenue barricade during site inspections. KDEP will continue to monitor off-road activities and corresponding damage and will take appropriate maintenance actions, if needed.

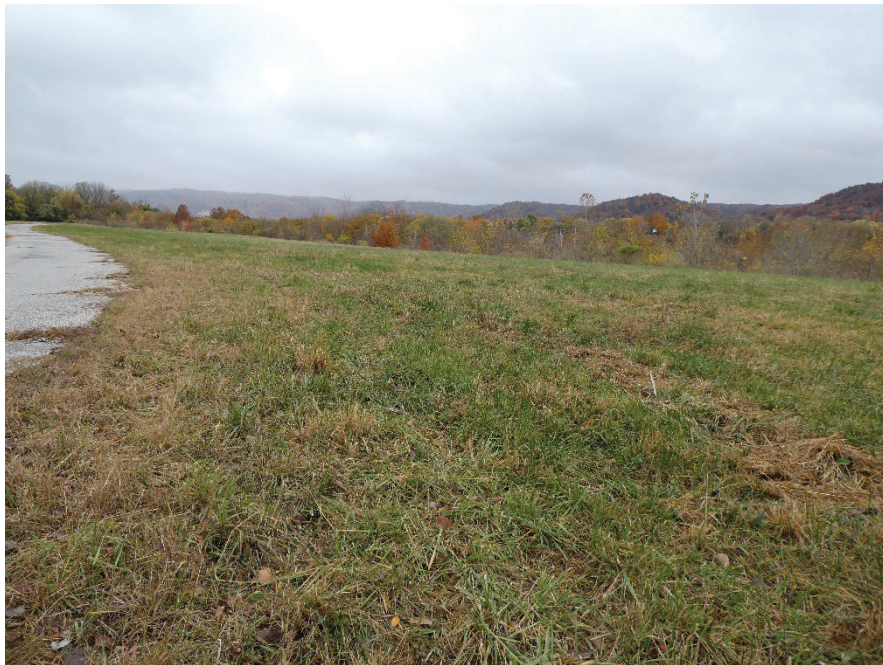
| Remarks: <u>The historical landfill cover was not properly established. Material from historical unauthorized (non-hazardous) waste disposal has been uncovered.</u> | | | |

Landfill cap

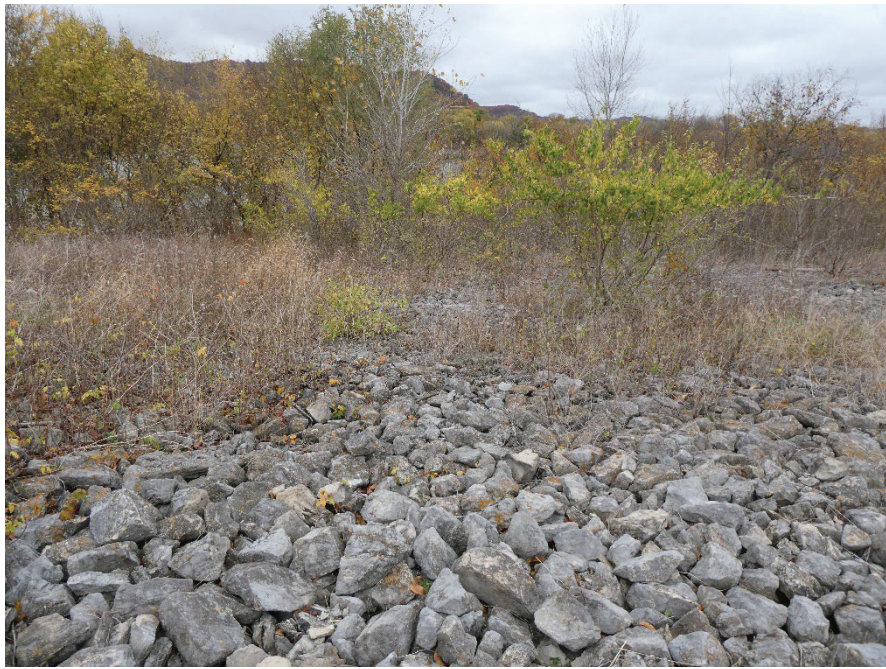
- Most of the site signage is damaged or missing.
- Barricade behind the Wilmoth Avenue soil gas monitoring wells is damaged.
- Groundwater monitoring well WM-102 is damaged and needs to be repaired.
- Several swales and depressions about 2 to 12 inches deep and 1 to 5 feet wide across the engineered cap.
- Evidence of off-road driving and ponding water east of the cap and on the southern section of the site.
- Trees and vegetation growing on the riprap.

Riprap and vegetation

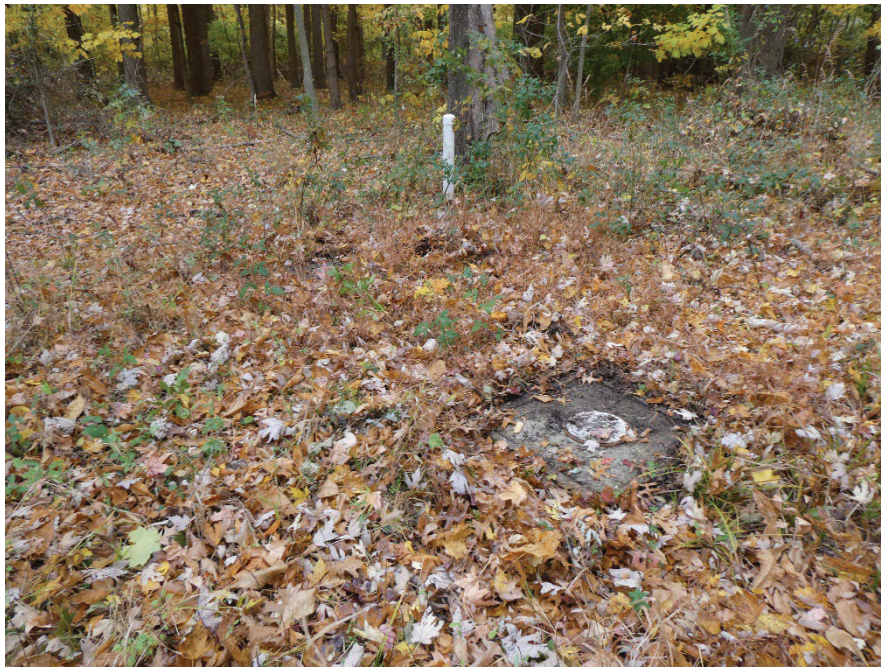
New gas collection wells

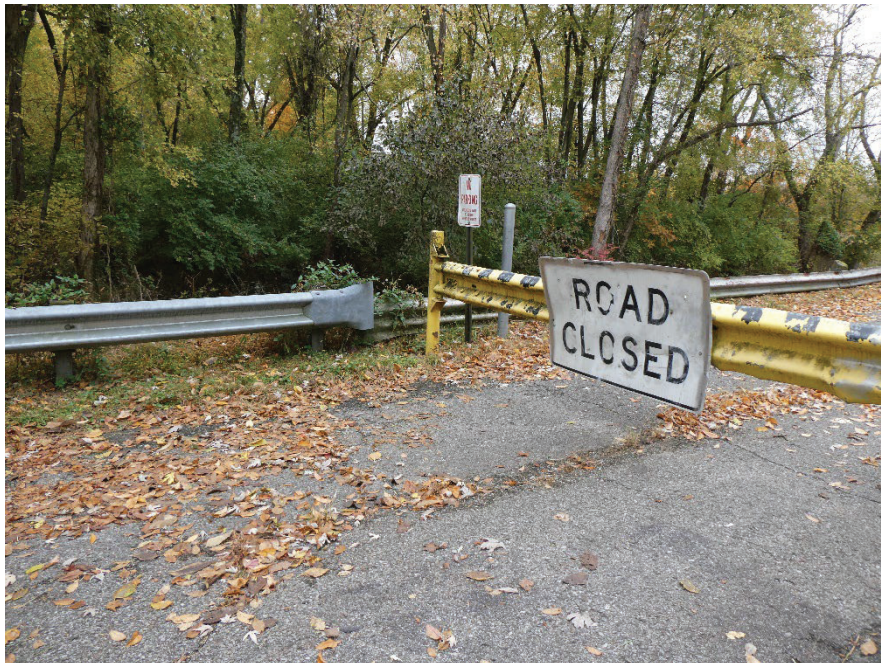
Locked gate at site entrance

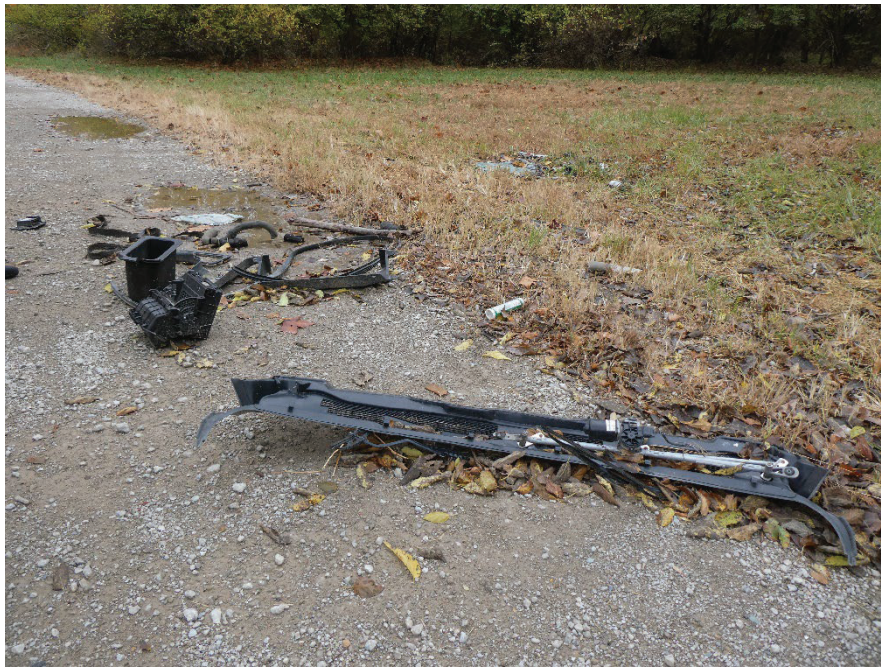
Evidence of trespassing

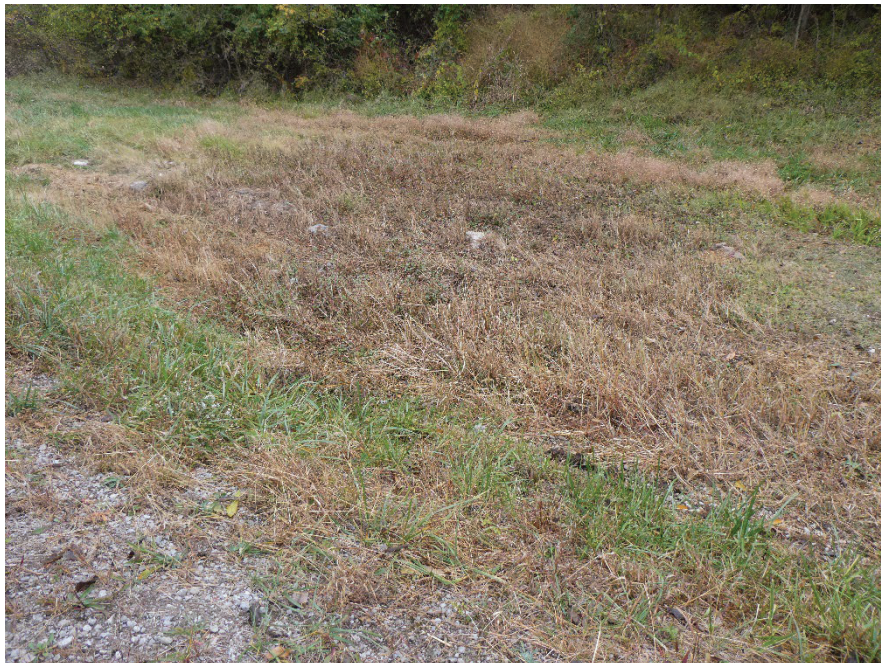
| Remarks: <u>Vegetation, mostly grasses, was observed in the culvert on both sides of the road.</u> | | | |

Culvert drain with vegetation on the landfill cap
